**Flood Control Project Maintenance
Levee Inspections**

Maintenance Issue Types Only, Levee Inspection Report By Mile - Spring 2016

Levee District No. 0009 (Sutter County)

Waterway	Bank	Unit Miles	Inspection Start/End	Inspector
Unit No. 01 Sutter County, Feather River	Right	6.25	04/05/2016 04/07/2016	Sterling York

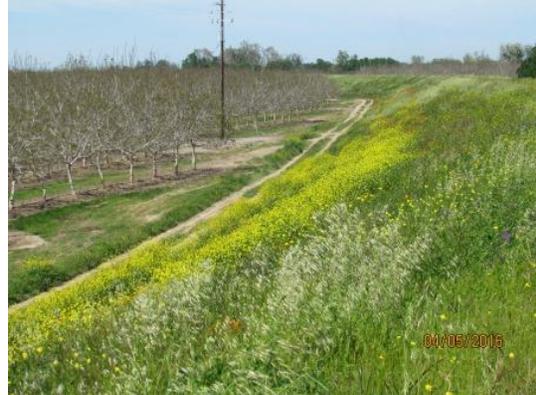
Photo 1 of 1 : SP_2016_LD0009_202_17_20160418_00029.jpg

LM Start	0.02	Rating **	M	Issue No.	17
LM End	6.24	Issue Type +	Ma	Location *	LS
Category	Earthen Levee		GPS Latitude/Longitude		
			Start	End	
Item	Vegetation		39.168989 °	39.255713 °	
			-121.622552 °	-121.636361 °	
DWR ID	DWR_LD0009_01_s_2016_17				
Comment Code					
V1 : Control annual grass and weeds on the levee slopes and easements.					
Inspector Comment

Typical vegetation landside looking upstream.

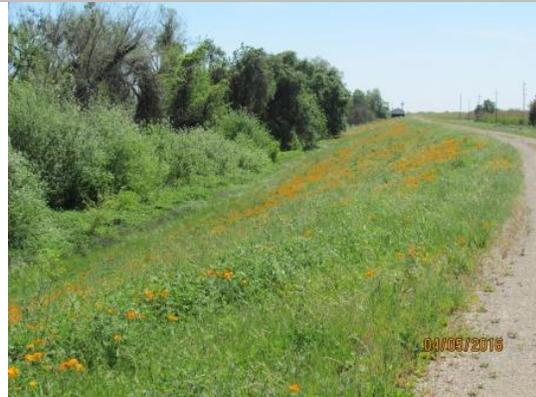
Photo 1 of 1 : SP_2016_LD0009_202_22_20160418_00028.jpg

LM Start	0.02	Rating **	M	Issue No.	22
LM End	6.24	Issue Type +	Ma	Location *	WS
Category	Earthen Levee		GPS Latitude/Longitude		
			Start	End	
Item	Vegetation		39.168989 °	39.255713 °	
			-121.622552 °	-121.636361 °	
DWR ID	DWR_LD0009_01_s_2016_22				
Comment Code					
V1 : Control annual grass and weeds on the levee slopes and easements.					
Inspector Comment

Typical vegetation waterside looking downstream.

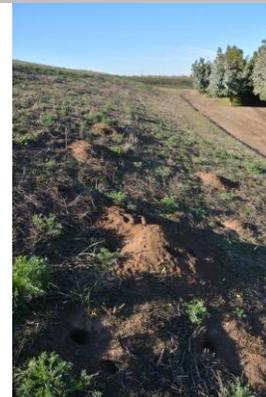
Photo 1 of 1 : SP_2016_LD0009_202_19_20160307_00004.jpg

LM Start	5.32	Rating **	A	Issue No.	19
LM End	5.32	Issue Type +	Ma	Location *	CR
Category	Earthen Levee		GPS Latitude/Longitude		
			Start	End	
Item	Animal Control		39.242582 °	39.242582 °	
			-121.637032 °	-121.637032 °	
DWR ID	DWR_LD0009_01_f_2015_19				
Comment Code					
A3 : No rodents visible, but rodent burrows visible; need to backfill and compact or grout burrows.					
Inspector Comment					
This rodent site has been repaired by the LMA and there is no new evidence of rodent activity at this location. The picture was taken during the 2015 Fall Inspection.

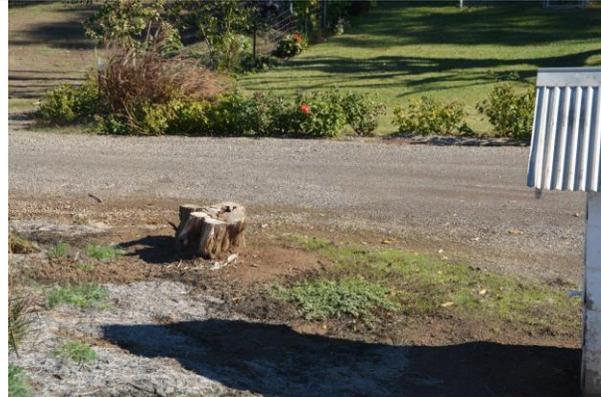
Photo 1 of 1 : SP_2016_LD0009_202_21_20160307_00006.jpg

LM Start	5.71	Rating **	N	Issue No.	21
LM End	5.71	Issue Type +	Ma	Location *	WS
Category	Earthen Levee			GPS Latitude/Longitude	
				Start	End
Item	Trim / Thin Trees			39.248009 °	39.248009 °
				-121.637306 °	-121.637306 °
DWR ID	DWR_LD0009_01_f_2015_21				
Comment Code					
T5 : Tree stumps.					
Inspector Comment					
Tree stump

Stump at waterside toe.
