**Flood Control Project Maintenance
Levee Inspections**

Fall 2013 Levee Maintenance Deficiency Summary Report

Sacramento River Basin

Sutter Maintenance Yard Maintenance Area 0001

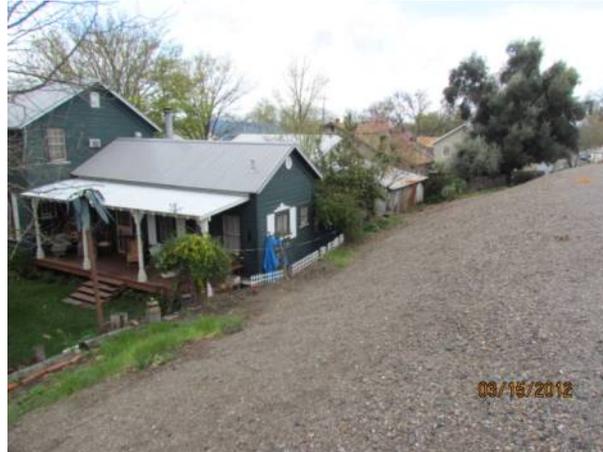
Levee Mile Report Line	5
Start Levee Mile	0.69
End Levee Mile	0.71
Location	Land Side
Category	Earthen Levee
Item	Encroachments
View of the buildings along the L/S toe.	
rduffey_f_20130919_743.jpg

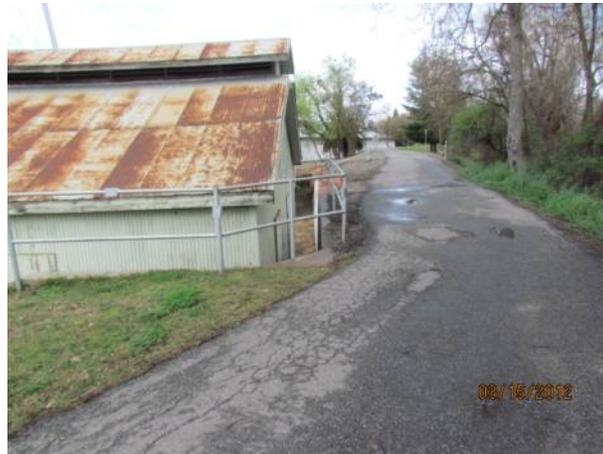
Levee Mile Report Line	18
Start Levee Mile	1.20
End Levee Mile	1.20
Location	Land Side
Category	Supplemental
Item	DWR UCIP Field Study
Other appurtances associated with crossing- Structure, pump, distribution box, and power pole located on WS bank.	
UCIP_4869.jpg

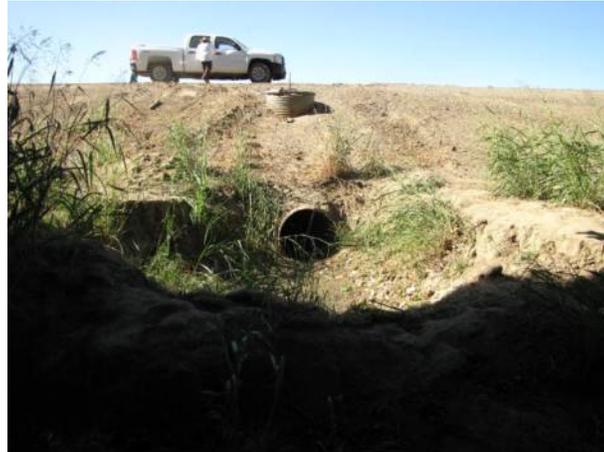
Levee Mile Report Line	82
Start Levee Mile	3.76
End Levee Mile	3.76
Location	Land Side
Category	Supplemental
Item	DWR UCIP Field Study
Overview of levee crown looking upstream at crossing.	
UCIP_4943.jpg

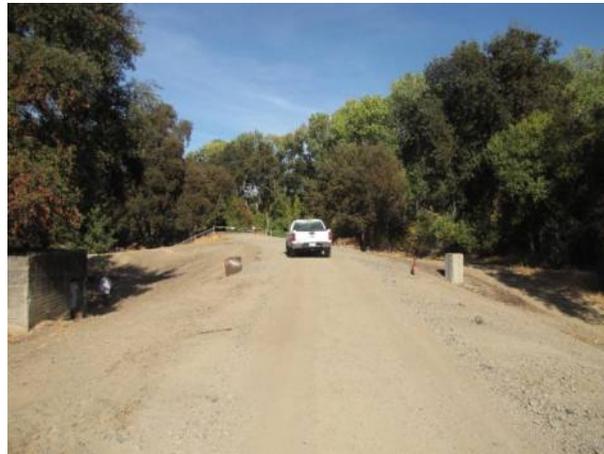
Levee Mile Report Line	87
Start Levee Mile	3.79
End Levee Mile	3.79
Location	Land Side
Category	Supplemental
Item	DWR UCIP Field Study
Concrete distribution box located on landward side.	
UCIP_4241.jpg

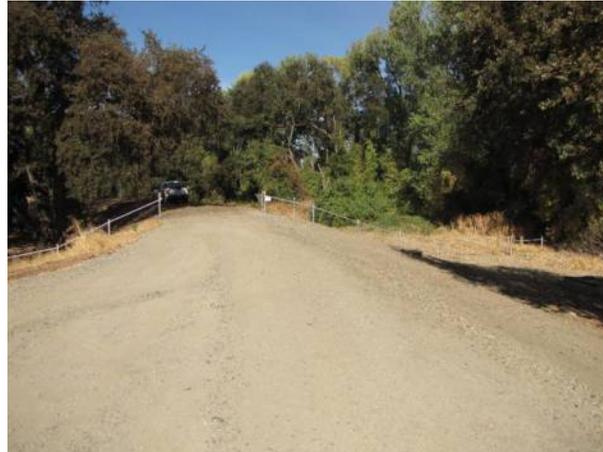
Levee Mile Report Line	108
Start Levee Mile	3.87
End Levee Mile	3.87
Location	Land Side
Category	Supplemental
Item	DWR UCIP Field Study
Levee crown looking downstream. No appurtances visible on levee crown or slope.	
UCIP_4247.jpg

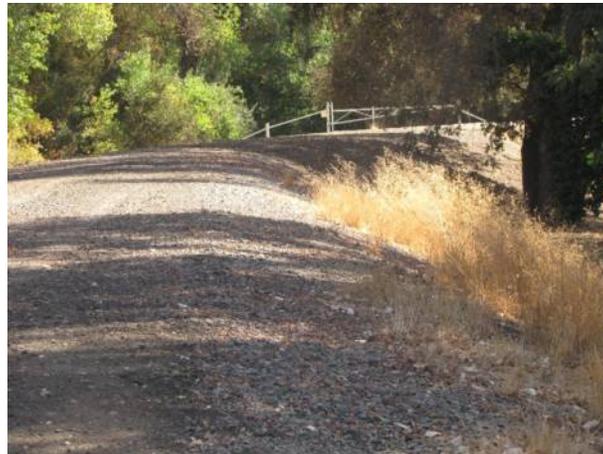
Levee Mile Report Line	109
Start Levee Mile	3.96
End Levee Mile	3.96
Location	Land Side
Category	Earthen Levee
Item	Vegetation
View of the elderberry on the landside slope.	
rduffey_f_20131122_181.JPG

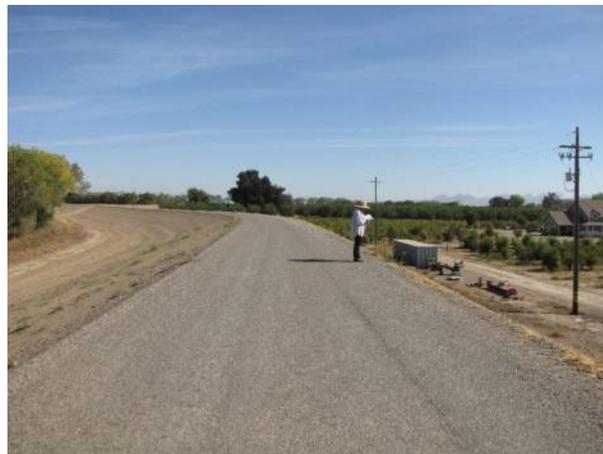
Levee Mile Report Line	136
Start Levee Mile	5.84
End Levee Mile	5.84
Location	Water Side
Category	Supplemental
Item	DWR UCIP Field Study
View of waterward slope and access road. Slide gate is second crossing at this location.	
UCIP_4614.jpg

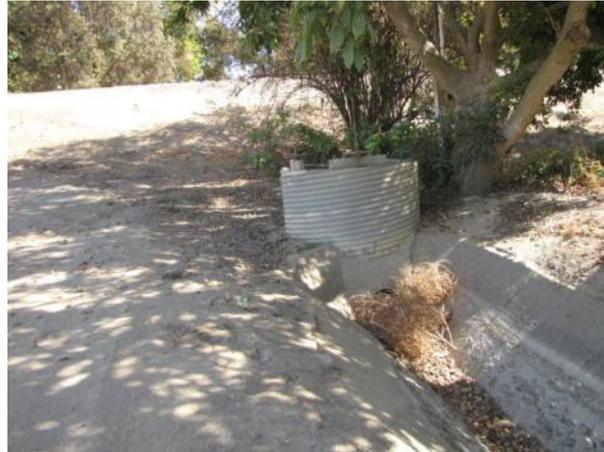
Levee Mile Report Line	157
Start Levee Mile	6.37
End Levee Mile	6.37
Location	Land Side
Category	Supplemental
Item	DWR UCIP Field Study
CMP riser located on waterward slope.	
UCIP_3926.jpg

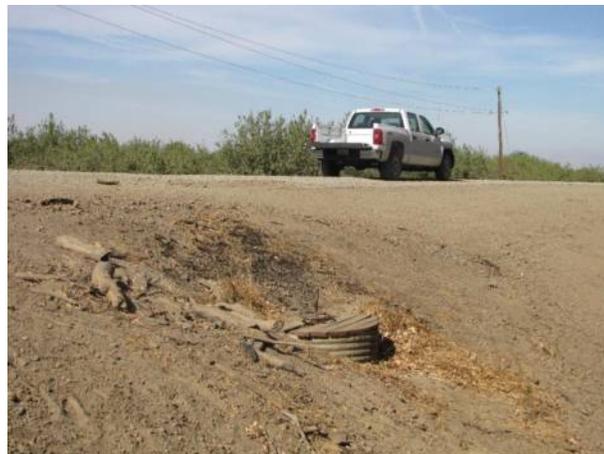
Levee Mile Report Line	159
Start Levee Mile	6.51
End Levee Mile	6.51
Location	Land Side
Category	Earthen Levee
Item	Encroachments
View of the prunings along the L/S toe.	
rduffey_f_20130919_740.jpg

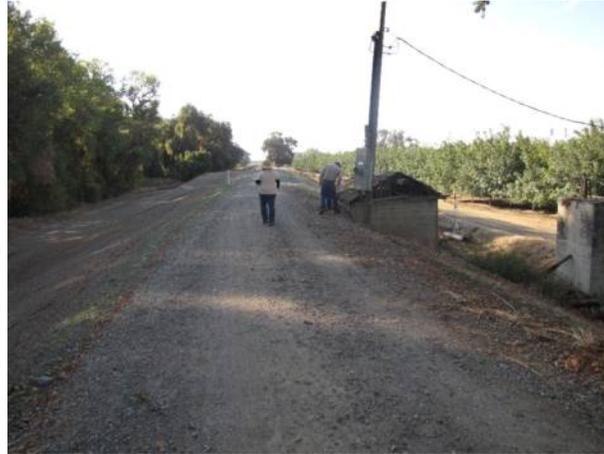
Levee Mile Report Line	204
Start Levee Mile	9.54
End Levee Mile	9.54
Location	Land Side
Category	Earthen Levee
Item	Animal Control
View of the grouted rodent holes and the bait station.	
rduffey_f_20131122_182.JPG

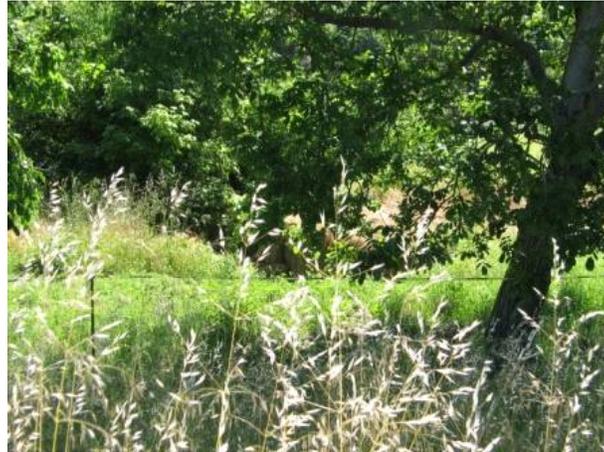
Levee Mile Report Line	238
Start Levee Mile	11.25
End Levee Mile	11.25
Location	Water Side
Category	Supplemental
Item	DWR UCIP Field Study
View of abandoned structure located on waterward side (inside ring levee).	
UCIP_5369.jpg

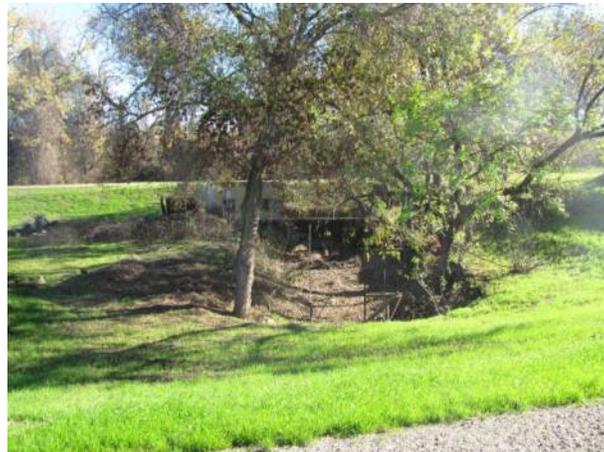
Levee Mile Report Line	258
Start Levee Mile	11.43
End Levee Mile	11.43
Location	Water Side
Category	Supplemental
Item	DWR UCIP Field Study
View of concrete distribution box located on landward toe.	
UCIP_4836.jpg

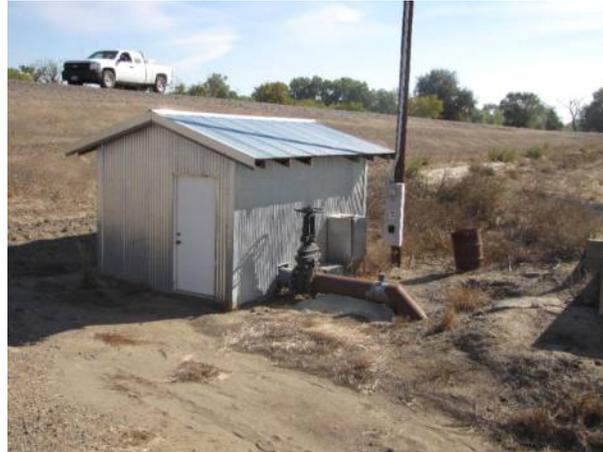
Levee Mile Report Line	307
Start Levee Mile	13.56
End Levee Mile	13.56
Location	Land Side
Category	Earthen Levee
Item	Animal Control
View of the grouted rodent holes.	
rduffey_f_20131122_187.JPG

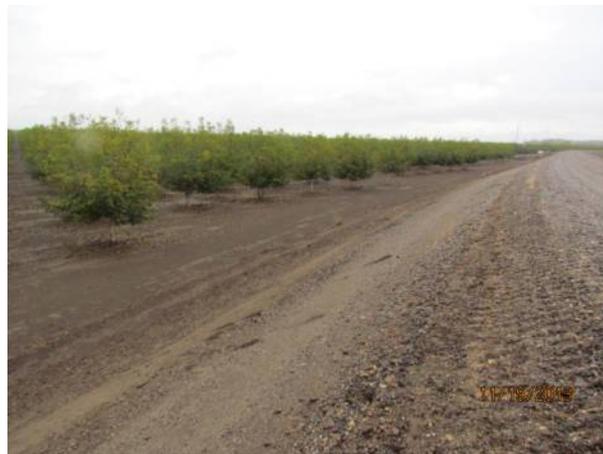
Levee Mile Report Line	314
Start Levee Mile	13.76
End Levee Mile	13.76
Location	Land Side
Category	Supplemental
Item	DWR UCIP Field Study
View of landward side looking downstream at crossing.	
UCIP_4965.jpg

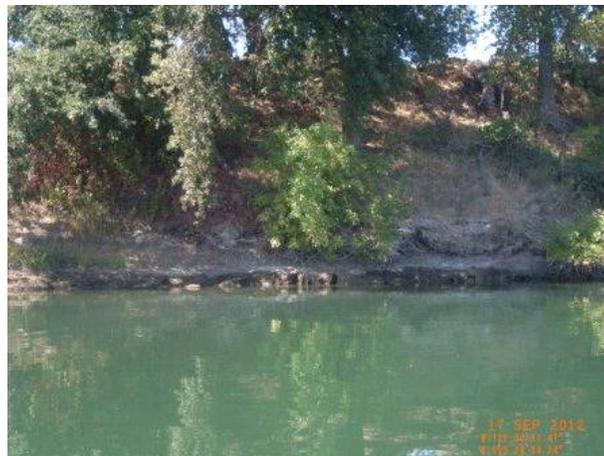
Levee Mile Report Line	342
Start Levee Mile	16.91
End Levee Mile	16.91
Location	Water Side
Category	Supplemental
Item	DWR UCIP Field Study

Damage marker located on waterward slope.
