**Flood Control Project Maintenance
Levee Inspections**

Fall 2014 Levee Maintenance Deficiency Summary Report

Sacramento River Basin

Sutter Maintenance Yard Maintenance Area 0001

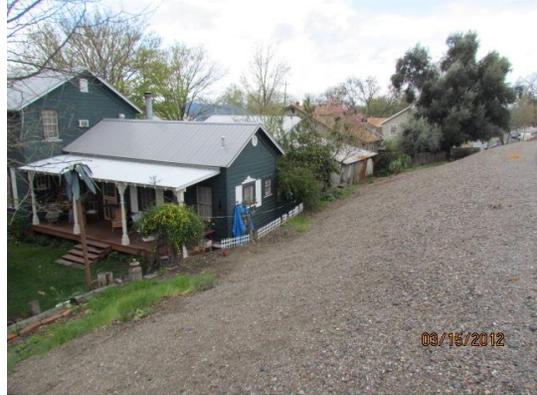
Photo 1 of 1 : FA_2014_MA0001_297_2_20141013_00003.jpg

LM Start	0.04	Rating **	U	Issue No.	2
LM End	0.23	Issue Type +	En	Location *	LS
Category	Earthen Levee		GPS Latitude/Longitude		
			Start	End	
Item	Encroachments		39.213988 °	39.215198 °	
			-122.001537 °	-122.004775 °	
DWR ID	DWR_MA0001_01_s_2012_2				
Action/Comments					
Building

View of the building along the L/S toe.

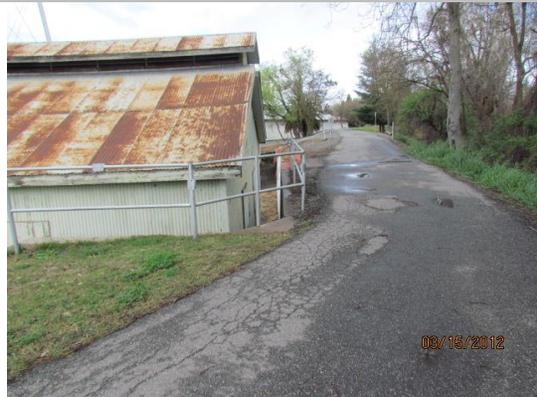
Photo 1 of 1 : FA_2014_MA0001_297_7_20141013_00006.jpg

LM Start	0.69	Rating **	U	Issue No.	7
LM End	0.71	Issue Type +	En	Location *	LS
Category	Earthen Levee		GPS Latitude/Longitude		
			Start	End	
Item	Encroachments		39.216533 °	39.216680 °	
			-122.012512 °	-122.012907 °	
DWR ID	DWR_MA0001_01_s_2012_7				
Action/Comments					
Building

View of the buildings along the L/S toe.

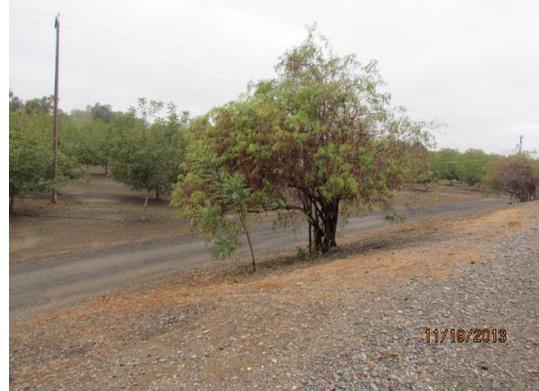
Photo 1 of 1 : FA_2014_MA0001_297_50_20141013_00011.jpg

LM Start	3.96	Rating **	M	Issue No.	50
LM End	3.96	Issue Type +	Ma	Location *	LS
Category	Earthen Levee		GPS Latitude/Longitude		
			Start	End	
Item	Vegetation		39.257125 °	39.257125 °	
			-122.012648 °	-122.012648 °	
DWR ID	DWR_MA0001_01_f_2013_50				
Action/Comments					
Elderberries are blocking visibility and flood fight capability.

View of the elderberry on the landside slope.

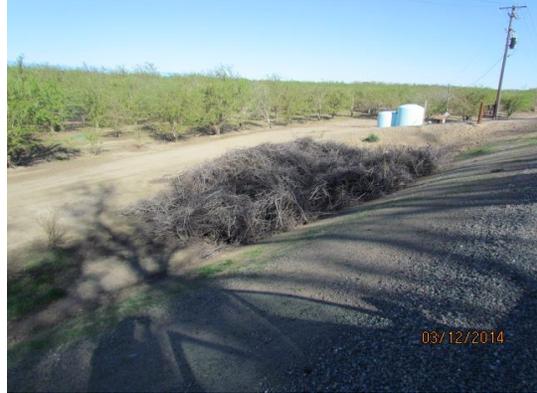
Photo 1 of 1 : FA_2014_MA0001_297_76_20141013_00014.jpg

LM Start	6.34	Rating **	M	Issue No.	76
LM End	6.34	Issue Type +	En	Location *	LS
Category	Earthen Levee			GPS Latitude/Longitude	
				Start	End
Item	Encroachments			39.278917 °	39.278917 °
				-122.022595 °	-122.022595 °
DWR ID	DWR_MA0001_01_s_2014_76				
Action/Comments					
Prunings

View of the prunings along the landside toe.

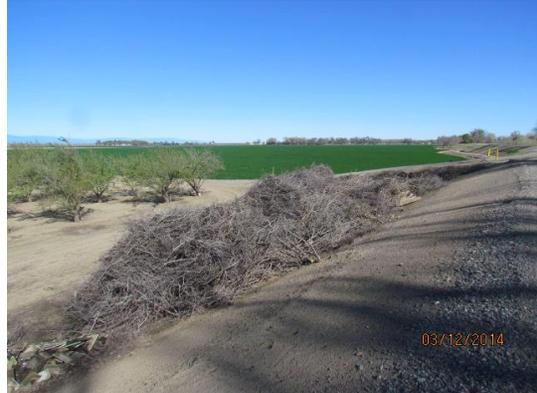
Photo 1 of 1 : FA_2014_MA0001_297_77_20141013_00015.jpg

LM Start	6.51	Rating **	A/W	Issue No.	77
LM End	6.51	Issue Type +	En	Location *	LS
Category	Earthen Levee			GPS Latitude/Longitude	
				Start	End
Item	Encroachments			39.281364 °	39.281364 °
				-122.022038 °	-122.022038 °
DWR ID	DWR_MA0001_01_s_2014_77				
Action/Comments					
Prunings

View of the prunings along the landside toe.

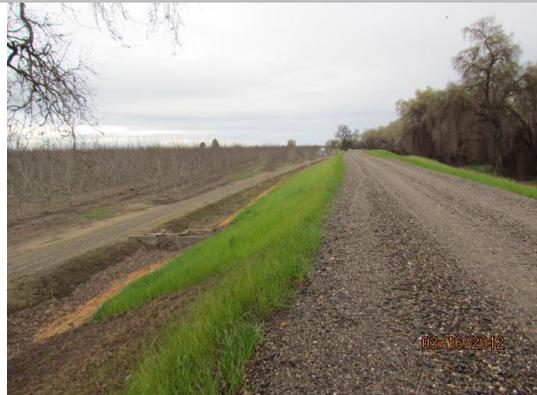
Photo 1 of 1 : FA_2014_MA0001_297_25_20141013_00009.jpg

LM Start	8.94	Rating **	M	Issue No.	25
LM End	9.39	Issue Type +	En	Location *	LS
Category	Earthen Levee		GPS Latitude/Longitude		
			Start	End	
Item	Encroachments		39.308390 °	39.315125 °	
			-122.031157 °	-122.030206 °	
DWR ID	DWR_MA0001_01_s_2012_25				
Action/Comments					
Ditch

View of the ag. ditch along the L/S toe.

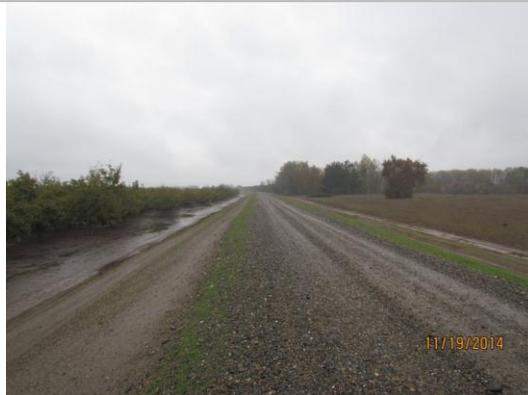
Photo 1 of 1 : FA_2014_MA0001_297_635_20141121_00447.jpg

LM Start	9.74	Rating **	A	Issue No.	635
LM End	9.74	Issue Type +	Ma	Location *	LS
Category	Earthen Levee			GPS Latitude/Longitude	
				Start	End
Item	Vegetation			39.320002 °	39.320002 °
				-122.030058 °	-122.030058 °
DWR ID	DWR_MA0001_01_f_2014_635				
Action/Comments					
Control annual grass and weeds on the levee slopes and easements.

View of the controlled vegetation on both slopes.

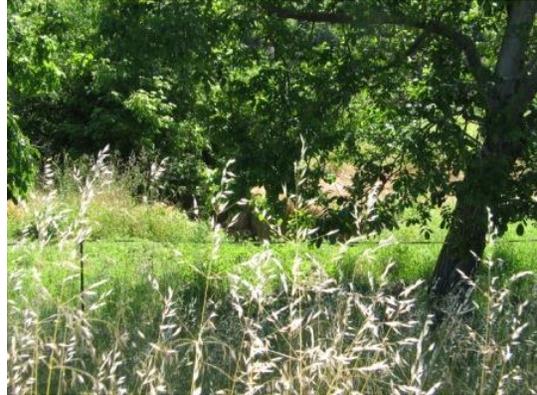
Photo 1 of 1 : FA_2014_MA0001_297_18_20141013_00007.jpg

LM Start	10.35	Rating **	A/W	Issue No.	18
LM End	10.35	Issue Type +	En	Location *	WS
Category	Earthen Levee		GPS Latitude/Longitude		
			Start	End	
Item	Erosion / Bank Caving		39.328697 °	39.328697 °	
			-122.029262 °	-122.029262 °	
DWR ID	DWR_MA0001_01_s_2012_18				
Action/Comments					
Note and monitor erosion site.

View of the erosion along the waterside of the levee.

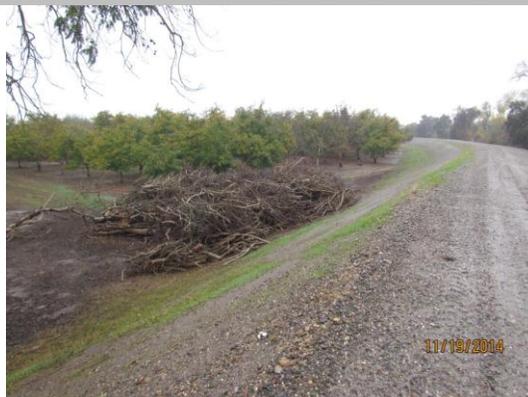
Photo 1 of 1 : FA_2014_MA0001_297_636_20141121_00448.jpg

LM Start	10.54	Rating **	M	Issue No.	636
LM End	10.54	Issue Type +	En	Location *	LS
Category	Earthen Levee		GPS Latitude/Longitude		
			Start	End	
Item	Encroachments		39.331320 °	39.331320 °	
			-122.029932 °	-122.029932 °	
DWR ID	DWR_MA0001_01_f_2014_636				
Action/Comments					
Prunings

View of the pruning along the landside toe.

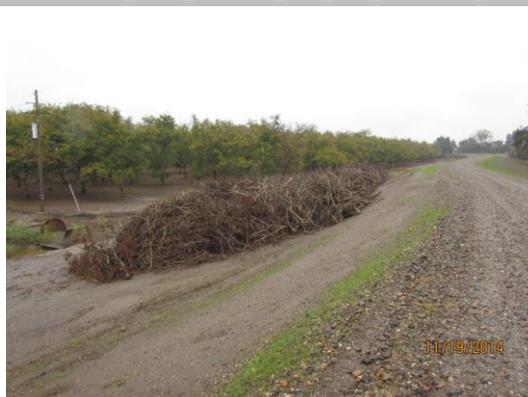
Photo 1 of 1 : FA_2014_MA0001_297_637_20141121_00449.jpg

LM Start	11.00	Rating **	M	Issue No.	637
LM End	11.00	Issue Type +	En	Location *	LS
Category	Earthen Levee		GPS Latitude/Longitude		
			Start	End	
Item	Encroachments		39.337523 °	39.337523 °	
			-122.032437 °	-122.032437 °	
DWR ID	DWR_MA0001_01_f_2014_637				
Action/Comments					
Prunings

View of the pruning along the landside toe.

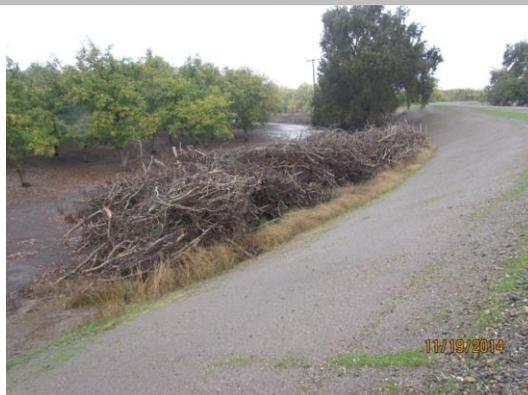
Photo 1 of 1 : FA_2014_MA0001_297_638_20141121_00450.jpg

LM Start	11.20	Rating **	M	Issue No.	638
LM End	11.20	Issue Type +	En	Location *	LS
Category	Earthen Levee		GPS Latitude/Longitude		
			Start	End	
Item	Encroachments		39.340217 °	39.340217 °	
			-122.032605 °	-122.032605 °	
DWR ID	DWR_MA0001_01_f_2014_638				
Action/Comments					
Prunings

View of the pruning along the landside toe.

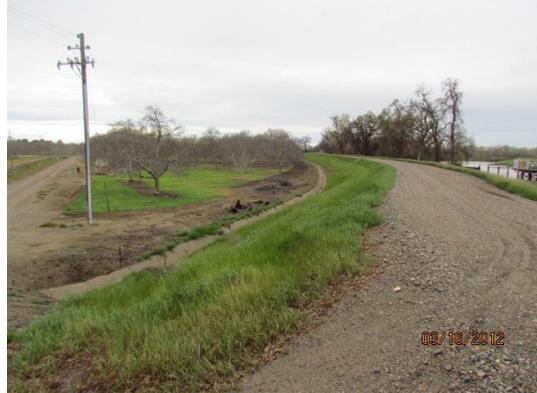
Photo 1 of 1 : FA_2014_MA0001_297_27_20141013_00010.jpg

LM Start	11.45	Rating **	M	Issue No.	27
LM End	11.71	Issue Type +	En	Location *	LS
Category	Earthen Levee			GPS Latitude/Longitude	
				Start	End
Item	Encroachments			39.343542 °	39.347185 °
				-122.032107 °	-122.031525 °
DWR ID	DWR_MA0001_01_s_2012_27				
Action/Comments					
Ditch

View of the ag. ditch along the L/S toe.

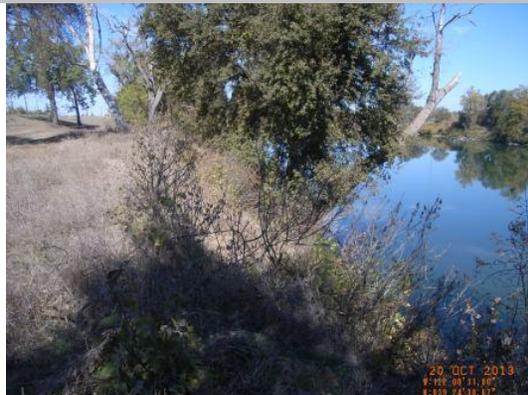
Photo 1 of 2 : FA_2014_MA0001_297_1_20141013_00001.jpg

LM Start	16.34	Rating **	M	Issue No.	1
LM End	16.57	Issue Type +	Ma	Location *	WS
Category	Supplemental		GPS Latitude/Longitude		
			Start	End	
Item	USACE Erosion Survey		39.411111 °	39.407837 °	
			-122.009238 °	-122.008763 °	
DWR ID	DWR_MA0001_01_f_2014_1				
Action/Comments					
Inspector Comments: Erosion site added in 1997 and removed in 2005. 2009 - Site added back in, hard toe with slow moving erosion. Potential geotechnical failure. 2011 - Site extended downstream. 2013: No observed changes. [2013 Site ID: SAC_164-3_R]

USACE 2013 Photo #1

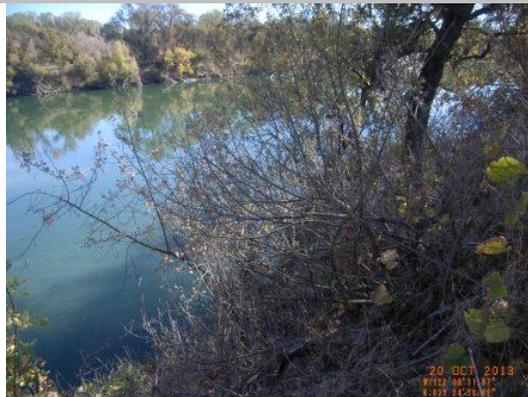
Photo 2 of 2 : FA_2014_MA0001_297_1_20141013_00002.jpg

LM Start	16.34	Rating **	M	Issue No.	1 (cont)
LM End	16.57	Issue Type +	Ma	Location *	WS

USACE 2013 Photo #2

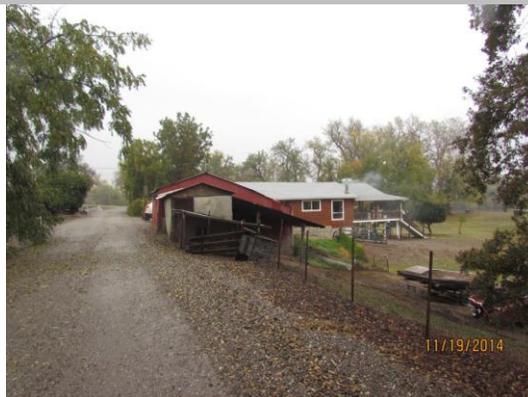
Photo 1 of 1 : FA_2014_MA0001_297_14_20141121_00451.jpg

LM Start	16.43	Rating **	U	Issue No.	14
LM End	16.43	Issue Type +	En	Location *	WS
Category	Earthen Levee		GPS Latitude/Longitude		
			Start	End	
Item	Encroachments		39.403930 °	39.403930 °	
			-122.008925 °	-122.008925 °	
DWR ID	DWR_MA0001_01_s_2012_14				
Action/Comments					
Building

View of the building on the waterside slope.

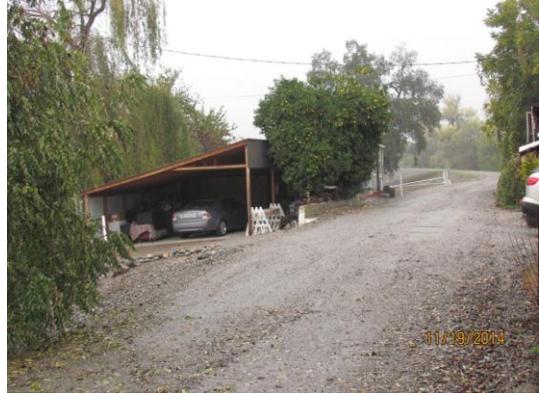
Photo 1 of 1 : FA_2014_MA0001_297_26_20141121_00452.jpg

LM Start	16.45	Rating **	U	Issue No.	26
LM End	16.45	Issue Type +	En	Location *	LS
Category	Earthen Levee		GPS Latitude/Longitude		
			Start	End	
Item	Encroachments		39.404135 °	39.404135 °	
			-122.008797 °	-122.008797 °	
DWR ID	DWR_MA0001_01_s_2012_26				
Action/Comments					
Building

View of the building on the landside slope.

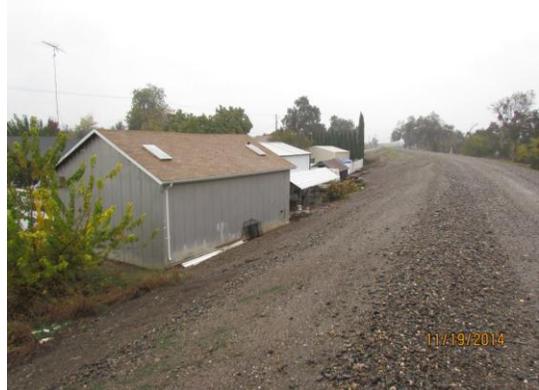
Photo 1 of 1 : FA_2014_MA0001_297_46_20141121_00455.jpg

LM Start	16.66	Rating **	U	Issue No.	46
LM End	16.69	Issue Type +	En	Location *	LS
Category	Earthen Levee		GPS Latitude/Longitude		
			Start	End	
Item	Encroachments		39.407225 °	39.407545 °	
			-122.008570 °	-122.008640 °	
DWR ID	DWR_MA0001_01_s_2012_46				
Action/Comments					
Building

View of the building along the landside toe.
