**Flood Control Project Maintenance
Levee Inspections
LMA District Cover Sheet
Spring 2010 Levee Inspection Results**

Spring 2010 Levee Inspection Results

Sutter Maintenance Yard Maintenance Area 0001

Levee Inspection Report By Mile - Spring 2010

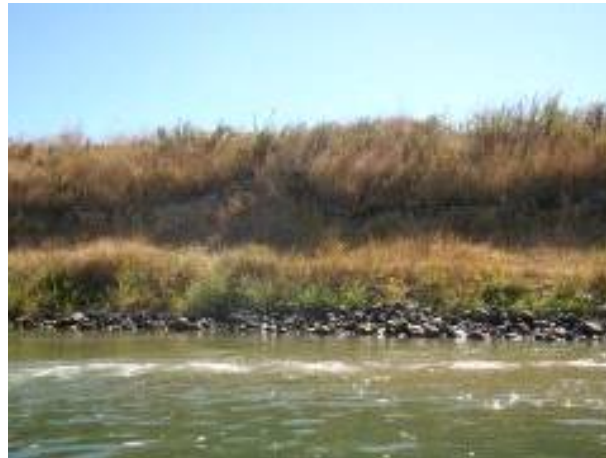
Levee Mile Report Line	14
Start Levee Mile	5.21
End Levee Mile	5.36
Location	Water Side
Category	Supplemental
Item	USACE Erosion Survey
2009: 15 ft berm, 2:1 slope, slumping, clays and cobbles, 4.24 ft/s [2009 SiteID:SAC_151-0_R]	
USACE2009_SAC_151-0_R_2009_09_15-D1P50_small.JPG

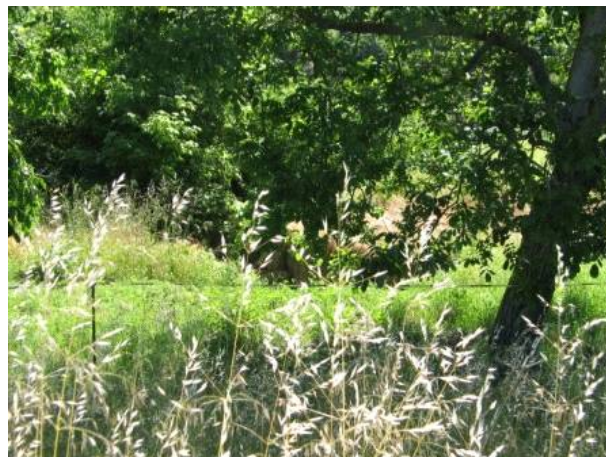
Levee Mile Report Line	20
Start Levee Mile	10.35
End Levee Mile	10.35
Location	Water Side
Category	Earthen Levee
Item	Erosion / Bank Caving
View of the erosion along the waterside of the levee.	
rduffey_s_20100607_004.jpg

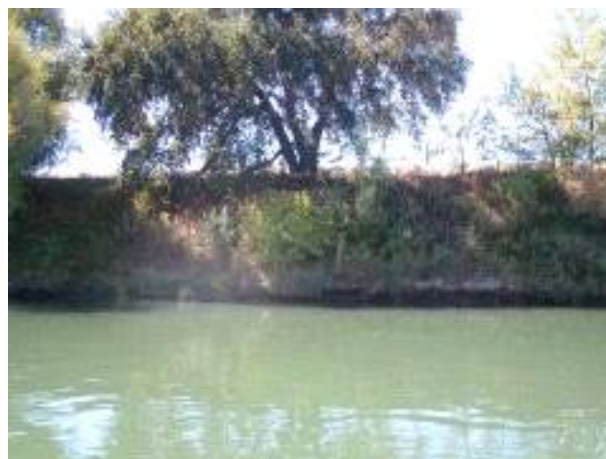
Levee Mile Report Line	33
Start Levee Mile	16.82
End Levee Mile	16.94
Location	Water Side
Category	Supplemental
Item	USACE Erosion Survey
2009: 15 ft berm, 1.5:1 slope, tree hazards, holes, and slumping, clays and silts, 8.62 ft/s [2009 SiteID:SAC_164-3_R]	
USACE2009_SAC_164-3_R_2009_09_15-D1P28_small.JPG
