**Flood Control Project Maintenance  
Levee Inspections  
LMA District Cover Sheet  
Spring 2011 Levee Inspection Results**

**Sutter Maintenance Yard Maintenance Area 0001**

**Spring 2011 Levee Inspection Results**

**Levee Inspection Report By Mile - Spring 2011**

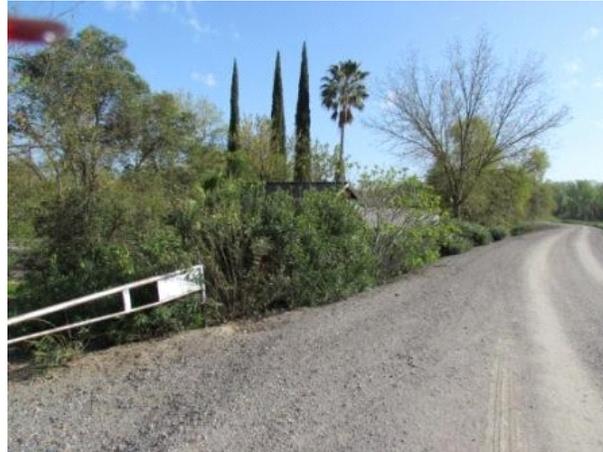
Levee Mile Report Line	7
Start Levee Mile	2.58
End Levee Mile	2.60
Location	Land Side
Category	Earthen Levee
Item	Encroachments

7	2.58	2.60	Earthen Levee	Encroachments	LS	CO	Buildings	39.239750 ° -122.010390 °	39.239955 ° -122.010090 °	20 Y
8	3.96	3.96	Earthen Levee	Vegetation	LS	M	Elderberries are blocking visibility and flood fight capability.	39.257125 ° -122.012648 °	39.257125 ° -122.012648 °	50
9	5.21	5.36	Supplemental	USACE Erosion Survey	WS	M	Inspector Comments: 2009: 15 ft berm, 2:1 slope, slumping, clays and cobbles, 4.24 ft/s [2009 SiteID:SAC_151-0_R]	39.266367 ° -122.020650 °	39.265408 ° -122.018183 °	16 Y
10	5.83	5.83	Earthen Levee	Slope Stability	WS	M	Repair the levee slope damaged by vehicle traffic and prevent access where possible.	39.271868 ° -122.023228 °	39.271868 ° -122.023228 °	1 Y
11	5.89	5.89	Earthen Levee	Vegetation	LS	M	Elderberries are blocking visibility and flood fight capability.	39.272773 ° -122.023290 °	39.272773 ° -122.023290 °	35
12	7.87	7.87	Earthen Levee	Vegetation	WS	M	Elderberries are blocking visibility and flood fight capability.	39.297303 ° -122.025257 °	39.297303 ° -122.025257 °	52

View of the house next to the levee.

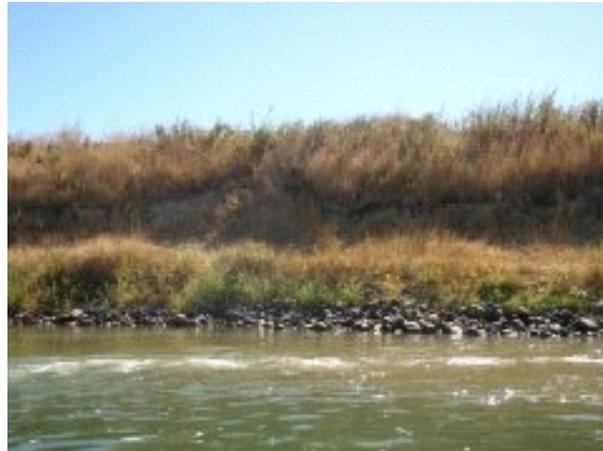
Levee Mile Report Line	9
Start Levee Mile	5.21
End Levee Mile	5.36
Location	Water Side
Category	Supplemental
Item	USACE Erosion Survey

2009: 15 ft berm, 2:1 slope, slumping, clays and cobbles, 4.24 ft/s [2009 SiteID:SAC\_151-0\_R]

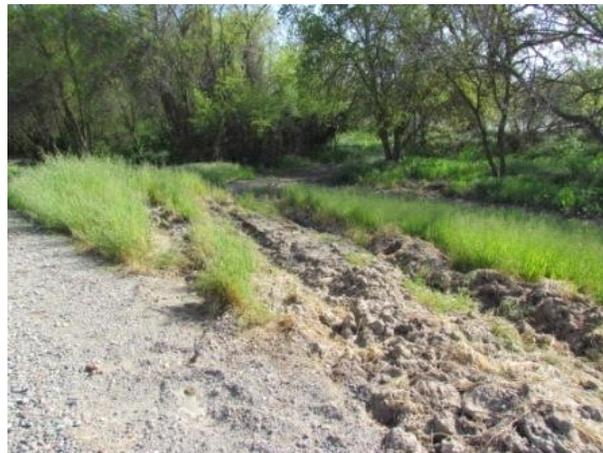
Levee Mile Report Line	10
Start Levee Mile	5.83
End Levee Mile	5.83
Location	Water Side
Category	Earthen Levee
Item	Slope Stability

View of the erosion on the w/s slope.
