**Flood Control Project Maintenance
Levee Inspections****LMA District Cover Sheet****Spring 2012 Levee Inspection Results****Sutter Maintenance Yard Maintenance Area 0001**

Spring 2012 Levee Inspection Results

Sutter Maintenance Yard Maintenance Area 0001

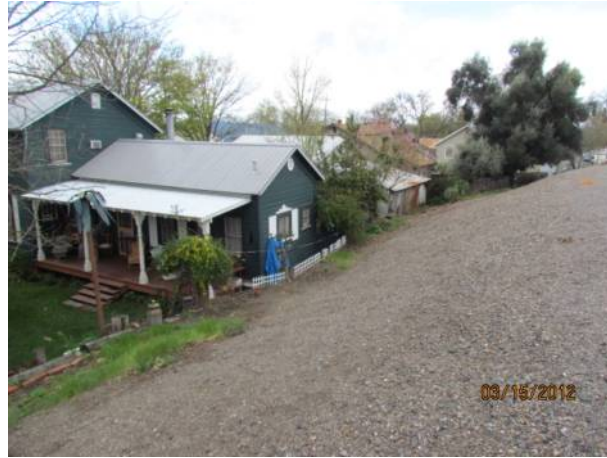
Levee Mile Report Line	4
Start Levee Mile	0.04
End Levee Mile	0.23
Location	Land Side
Category	Earthen Levee
Item	Encroachments

View of the building along the L/S toe.

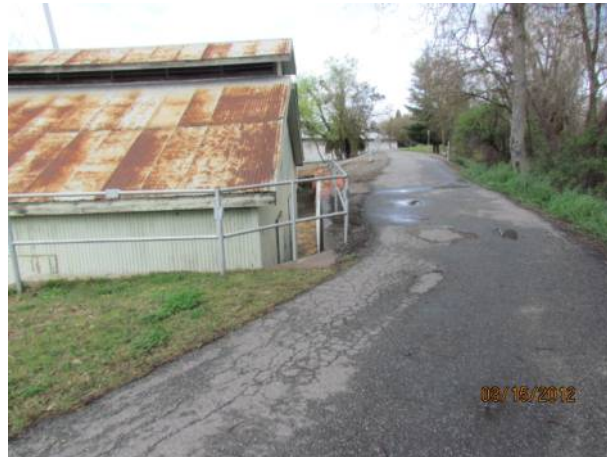
Levee Mile Report Line	5
Start Levee Mile	0.69
End Levee Mile	0.71
Location	Land Side
Category	Earthen Levee
Item	Encroachments

View of the buildings along the L/S toe.

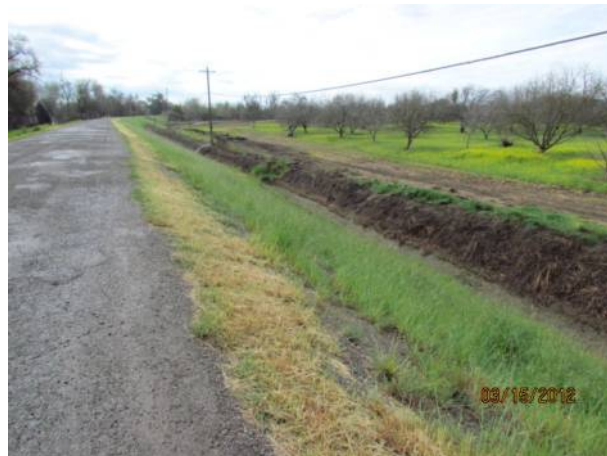
Levee Mile Report Line	7
Start Levee Mile	1.23
End Levee Mile	1.37
Location	Land Side
Category	Earthen Levee
Item	Encroachments

View of ag. ditch along the L/S toe.

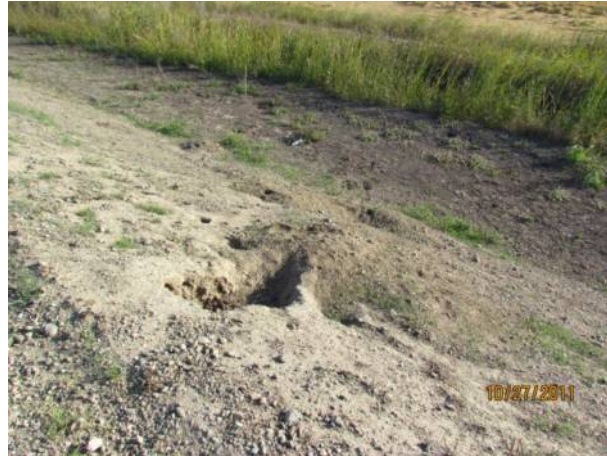
Levee Mile Report Line	9
Start Levee Mile	1.96
End Levee Mile	1.96
Location	Land Side
Category	Earthen Levee
Item	Animal Control

View of the rodent holes along the L/S slope.

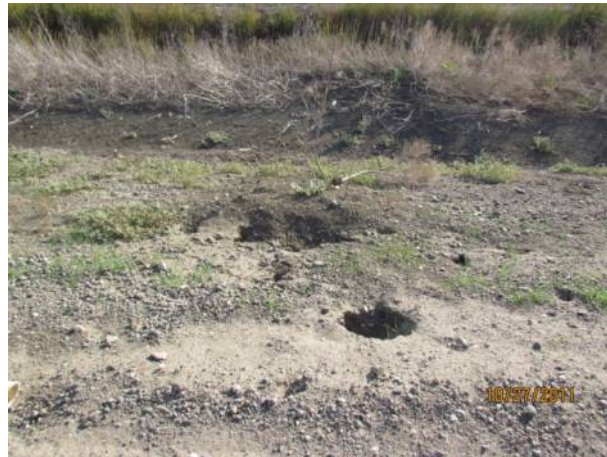
Levee Mile Report Line	10
Start Levee Mile	2.03
End Levee Mile	2.03
Location	Land Side
Category	Earthen Levee
Item	Animal Control

View of the rodent holes along the L/S slope.

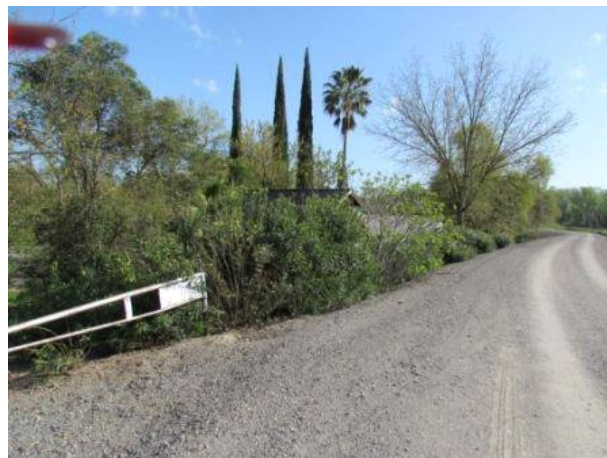
Levee Mile Report Line	11
Start Levee Mile	2.58
End Levee Mile	2.60
Location	Land Side
Category	Earthen Levee
Item	Encroachments

View of the house next to the levee.

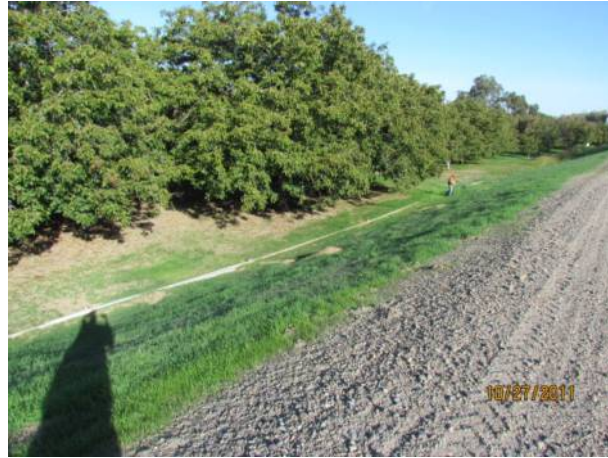
Levee Mile Report Line	12
Start Levee Mile	2.66
End Levee Mile	2.70
Location	Land Side
Category	Earthen Levee
Item	Animal Control

View of the rodent holes along the L/S slope.

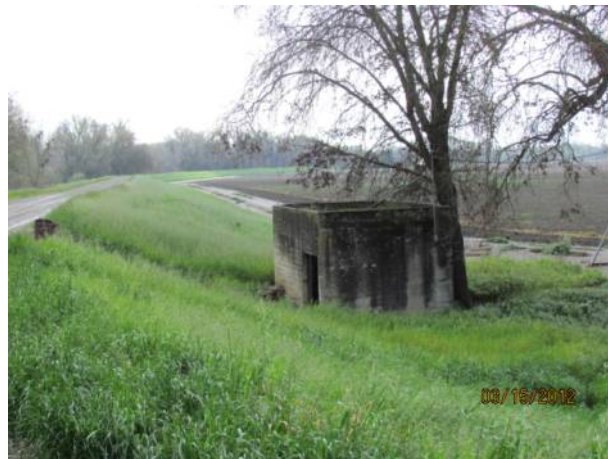
Levee Mile Report Line	13
Start Levee Mile	3.10
End Levee Mile	3.78
Location	Land Side
Category	Earthen Levee
Item	Encroachments

View of the ag. ditch & concrete building along the L/S toe.

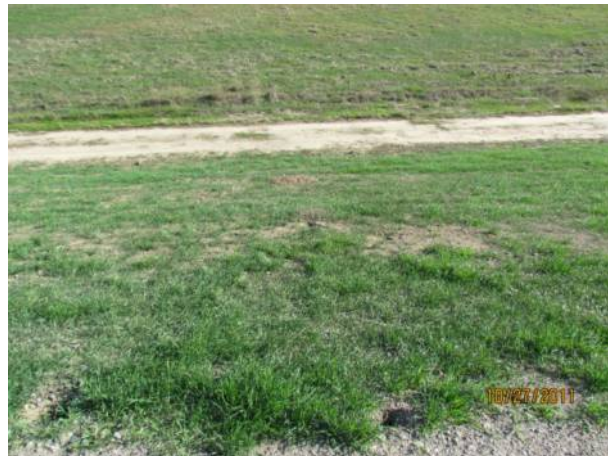
Levee Mile Report Line	15
Start Levee Mile	4.64
End Levee Mile	4.64
Location	Water Side
Category	Earthen Levee
Item	Animal Control

View of the rodent holes along the W/S slope.

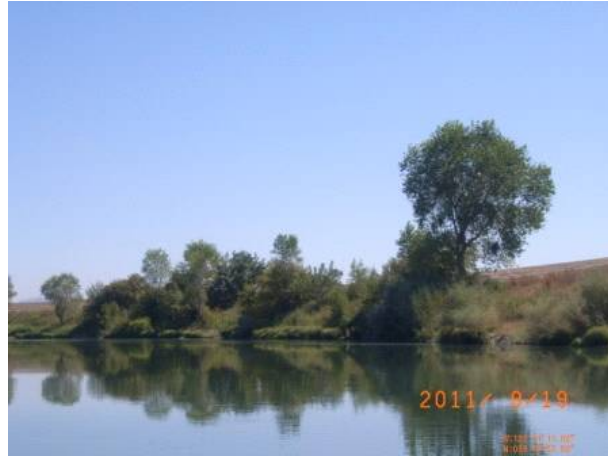
Levee Mile Report Line	16
Start Levee Mile	4.89
End Levee Mile	5.25
Location	Water Side
Category	Supplemental
Item	USACE Erosion Survey

USACE 2011 Photo #1

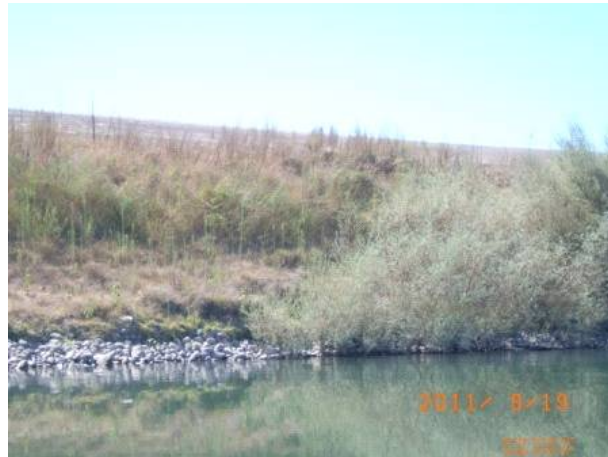
Levee Mile Report Line	16
Start Levee Mile	4.89
End Levee Mile	5.25
Location	Water Side
Category	Supplemental
Item	USACE Erosion Survey

USACE 2011 Photo #2

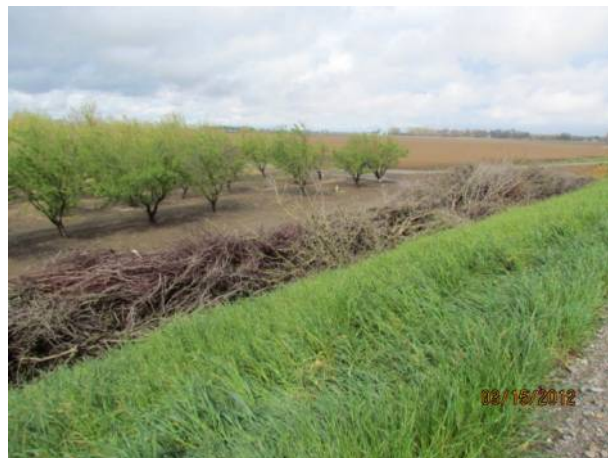
Levee Mile Report Line	19
Start Levee Mile	6.51
End Levee Mile	6.51
Location	Land Side
Category	Earthen Levee
Item	Encroachments

View of the prunings along the L/S toe.

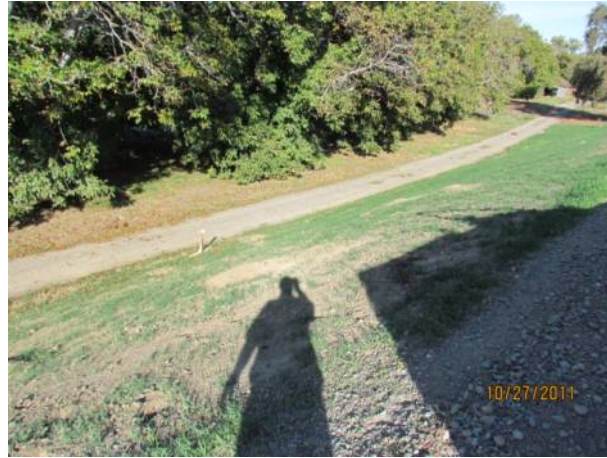
Levee Mile Report Line	20
Start Levee Mile	6.85
End Levee Mile	6.85
Location	Land Side
Category	Earthen Levee
Item	Animal Control

View of the rodent holes & bait station along the L/S slope.

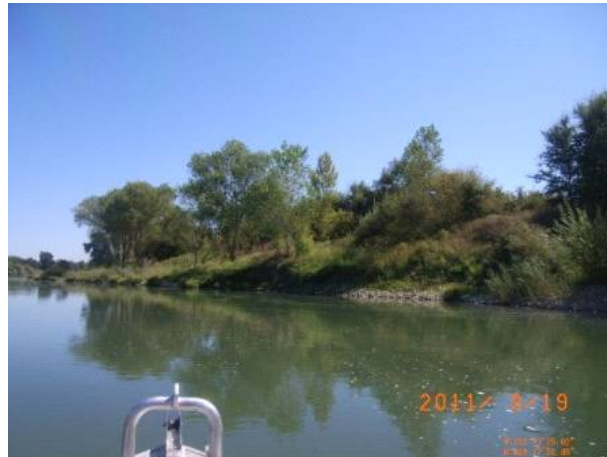
Levee Mile Report Line	21
Start Levee Mile	7.70
End Levee Mile	7.71
Location	Water Side
Category	Supplemental
Item	USACE Erosion Survey

USACE 2011 Photo #1

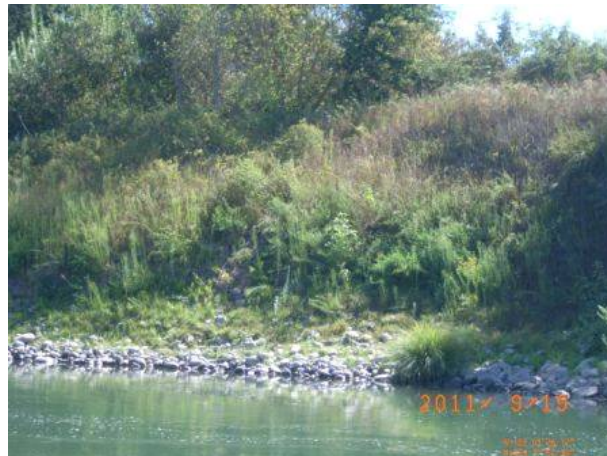
Levee Mile Report Line	21
Start Levee Mile	7.70
End Levee Mile	7.71
Location	Water Side
Category	Supplemental
Item	USACE Erosion Survey

USACE 2011 Photo #2

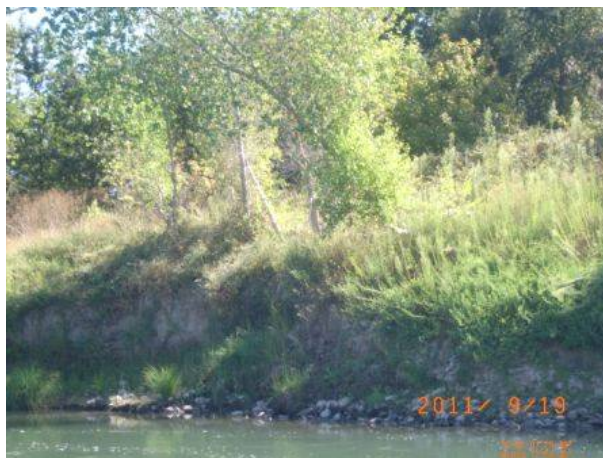
Levee Mile Report Line	21
Start Levee Mile	7.70
End Levee Mile	7.71
Location	Water Side
Category	Supplemental
Item	USACE Erosion Survey

USACE 2011 Photo #3

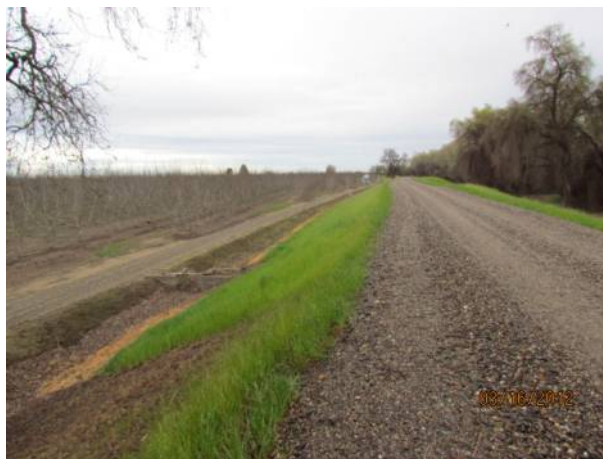
Levee Mile Report Line	24
Start Levee Mile	8.94
End Levee Mile	9.39
Location	Land Side
Category	Earthen Levee
Item	Encroachments

View of the ag. ditch along the L/S toe.

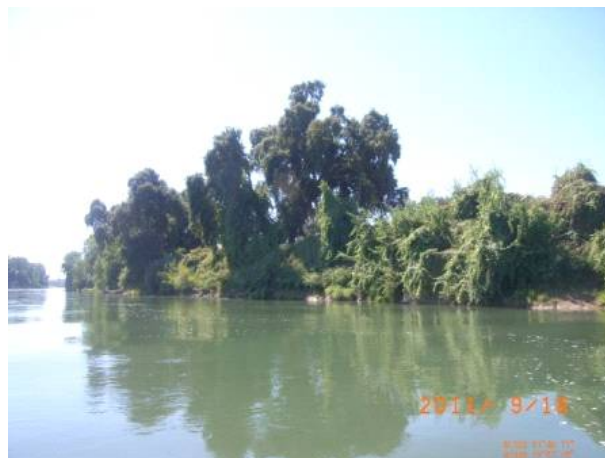
Levee Mile Report Line	27
Start Levee Mile	10.46
End Levee Mile	10.46
Location	Water Side
Category	Supplemental
Item	USACE Erosion Survey

DWR ID: DWR_MA0001_01_s_2012_18										
27	10.46	10.46	Supplemental	USACE Erosion Survey	WS	M Ma	Inspector Comments: 2004 - Slowly eroding but near vertical with no vegetation to hold it. 2005 - Erosion is close to levee toe but not into the levee section yet. 2010 - Some new toe scour. 2011: No observed change. [2011 Site ID: SAC_157-7_R]	39.331447 ° -122.029440 °	39.332716 ° -122.029953 °	17 Y
DWR ID: DWR_MA0001_01_s_2012_17

USACE 2011 Photo #1

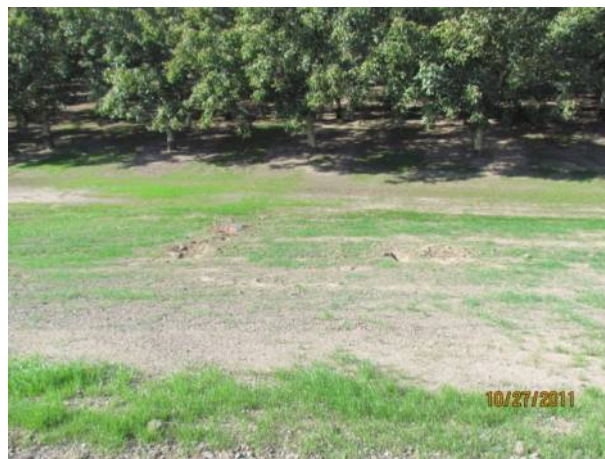
Levee Mile Report Line	28
Start Levee Mile	10.91
End Levee Mile	10.91
Location	Land Side
Category	Earthen Levee
Item	Animal Control

View of the rodent holes along the L/S slope.

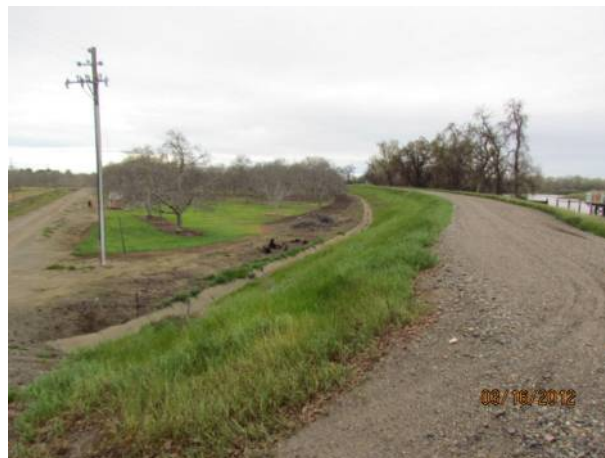
Levee Mile Report Line	31
Start Levee Mile	11.45
End Levee Mile	11.71
Location	Land Side
Category	Earthen Levee
Item	Encroachments

View of the ag. ditch along the L/S toe.

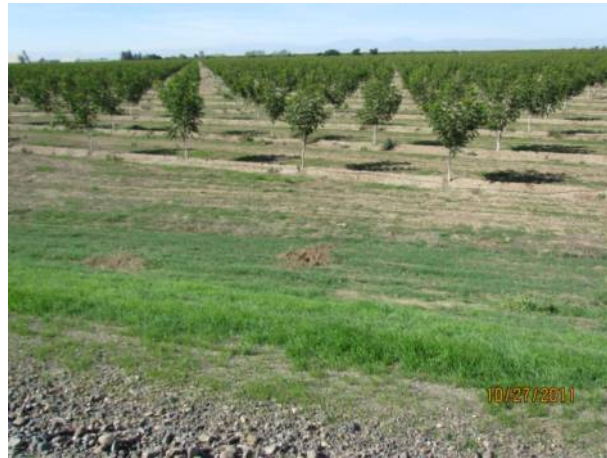
Levee Mile Report Line	35
Start Levee Mile	13.59
End Levee Mile	13.65
Location	Land Side
Category	Earthen Levee
Item	Animal Control

View of the rodent holes along the L/S toe.

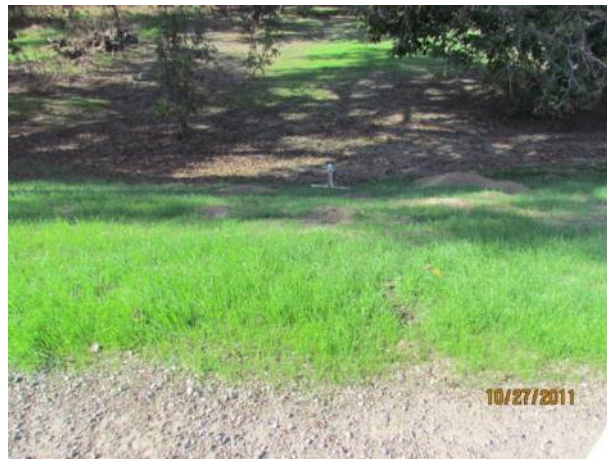
Levee Mile Report Line	38
Start Levee Mile	16.53
End Levee Mile	16.59
Location	Land Side
Category	Earthen Levee
Item	Animal Control

View of the rodent holes along the L/S slope.

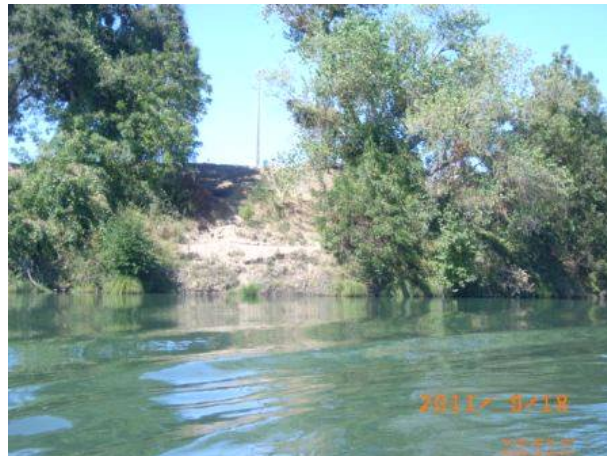
Levee Mile Report Line	40
Start Levee Mile	16.66
End Levee Mile	16.66
Location	Water Side
Category	Supplemental
Item	USACE Erosion Survey

USACE 2011 Photo #1

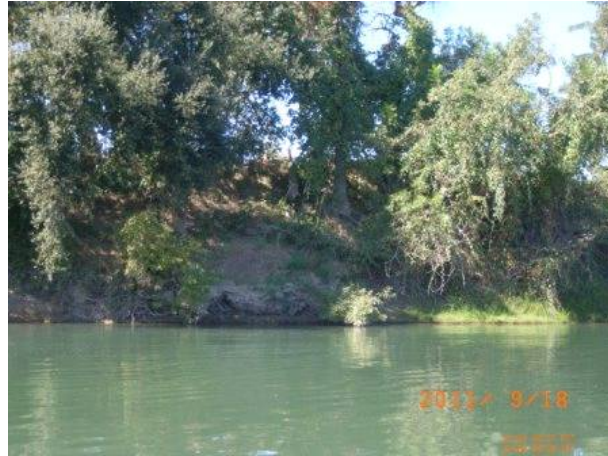
Levee Mile Report Line	40
Start Levee Mile	16.66
End Levee Mile	16.66
Location	Water Side
Category	Supplemental
Item	USACE Erosion Survey
USACE 2011 Photo #2	
rduffey_s_20120312_287.jpg
