**Flood Control Project Maintenance
Levee Inspections****LMA District Cover Sheet****Spring 2013 Levee Inspection Results****Sutter Maintenance Yard Maintenance Area 0001**

Spring 2013 Levee Inspection Results

Sutter Maintenance Yard Maintenance Area 0001

Waterway			Bank	Unit Miles
Unit No. 01 Sacramento River			Right	17.12
	Spring (March - May)	Summer (June - August)	(September - November) Fall	Winter (December - February)
Unit Maintenance Rating (Fall Only)				
Date of Inspection	03/14/2013 - 03/14/2013			
DWR Inspector	Bob Duffey			
Accompanied By	Bryan Reniff Sutter Maintenance Yard

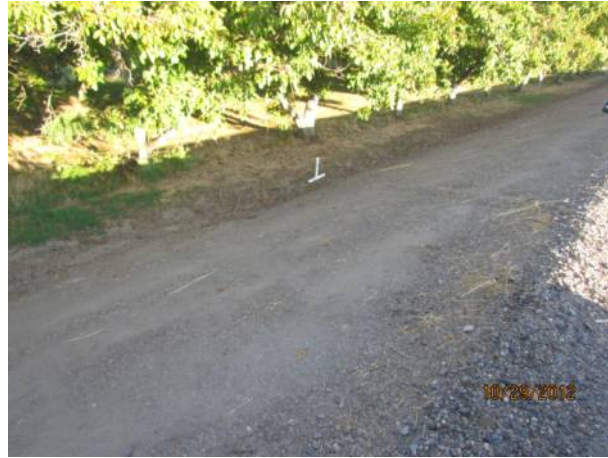
Levee Mile Report Line	8
Start Levee Mile	2.03
End Levee Mile	2.03
Location	Land Side
Category	
Item	Animal Control

View of the rodent activity & bait station at the toe the levee.

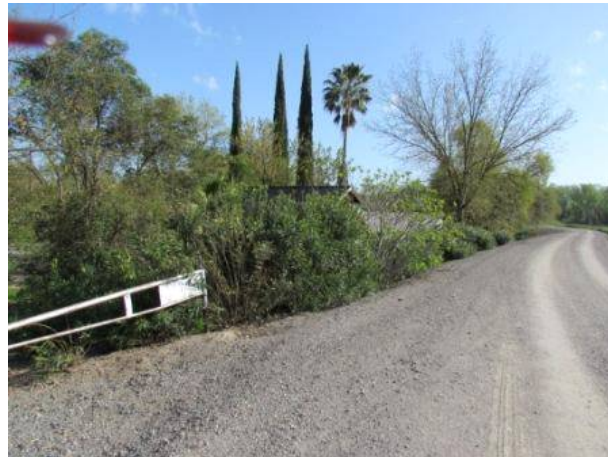
Levee Mile Report Line	9
Start Levee Mile	2.58
End Levee Mile	2.60
Location	Land Side
Category	
Item	Encroachments

View of the house next to the levee.

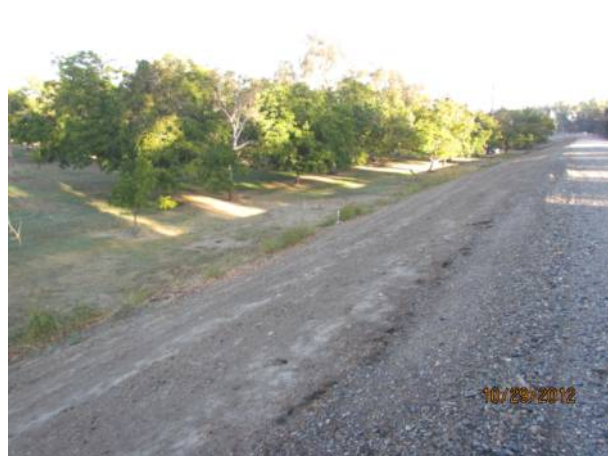
Levee Mile Report Line	10
Start Levee Mile	2.66
End Levee Mile	2.70
Location	Land Side
Category	
Item	Animal Control

View of the bait station at the toe of the levee.

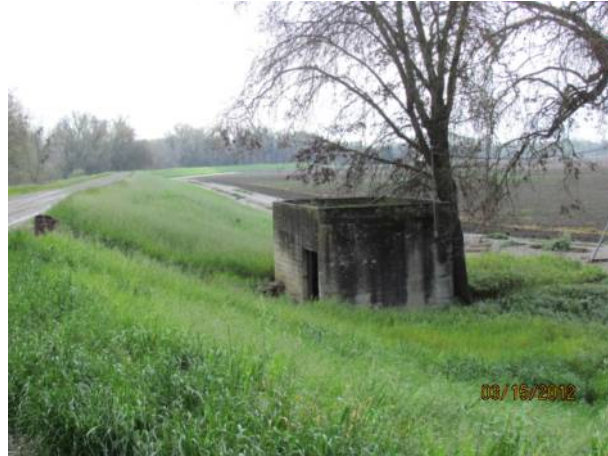
Levee Mile Report Line	11
Start Levee Mile	3.10
End Levee Mile	3.78
Location	Land Side
Category	
Item	Encroachments
View of the ag. ditch & concrete building along the L/S toe.	
rduffey_s_20130225_052.jpg

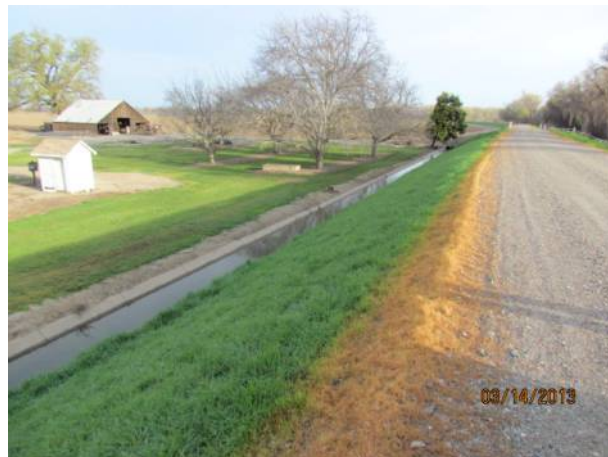
Levee Mile Report Line	12
Start Levee Mile	3.11
End Levee Mile	3.75
Location	Land Side
Category	
Item	Encroachments
View of the concrete ditch along the landside toe.	
rduffey_s_20130402_336.JPG

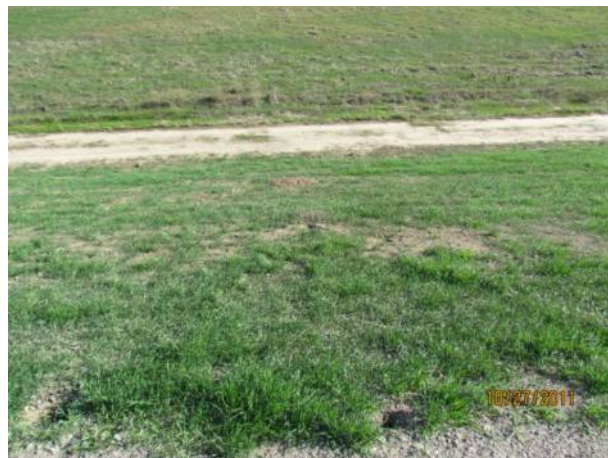
Levee Mile Report Line	14
Start Levee Mile	4.64
End Levee Mile	4.64
Location	Water Side
Category	
Item	Animal Control
View of the rodent holes along the W/S slope.	
rduffey_s_20130225_067.jpg

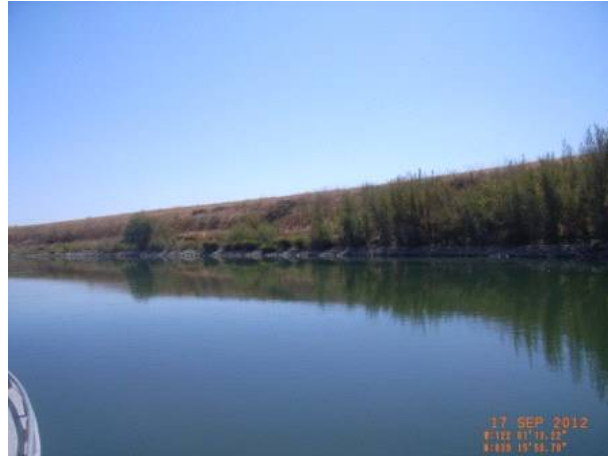
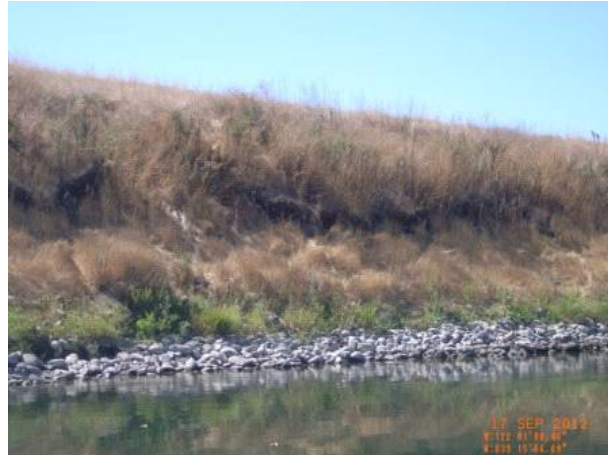
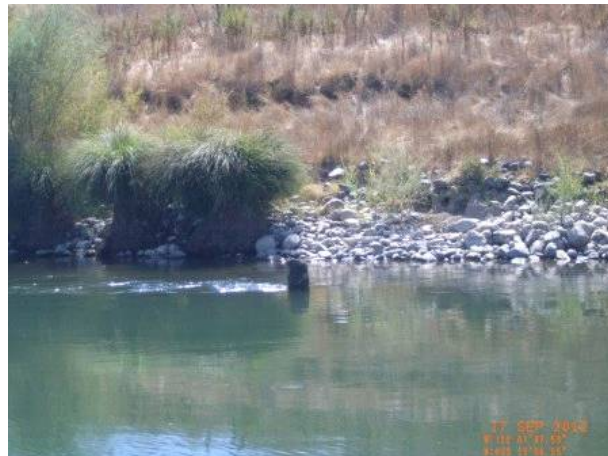
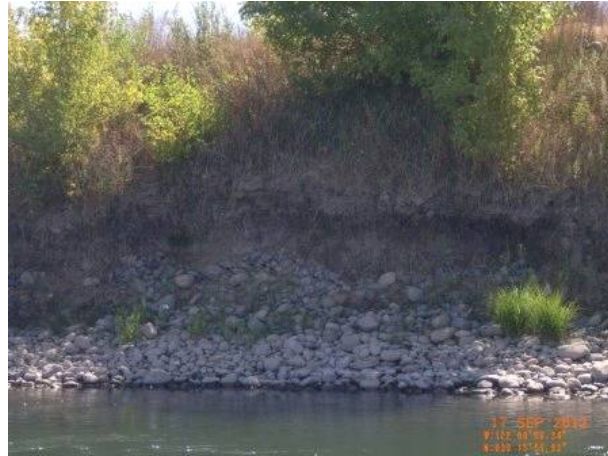
Levee Mile Report Line	15
Start Levee Mile	5.00
End Levee Mile	5.38
Location	Water Side
Category	Supplemental
Item	USACE Erosion Survey

LMR No.	Levee Mile		Category	Item	Location	Rating	Action/Comment	GPS Latitude/Longitude		Issue No.
	Start	End						Start	End	
15	5.00	5.38	Supplemental	USACE Erosion Survey	WS	M Ma	Inspector Comments: 2009 - Slump in the middle of the section has left a vertical section on the bank. 2010 - Old cobble site unraveling, site extended downstream. 2012: No observed change. [2012 Site ID: SAC_151-0_R]	39.266315 ° -122.020682 °	39.265730 ° -122.014925 °	1 Y
DWR ID: DWR_MA0001_01_s_2013_1										
16	5.89	5.89		Vegetation	LS	M Ma	V4 : Elderberries are blocking visibility and flood fight capability.	39.272773 ° -122.023290 °	39.272773 ° -122.023290 °	35
DWR ID: DWR_MA0001_01_s_2012_35										
17	6.51	6.51		Encroachments	LS	M En	PR : Prunings	39.281343 ° -122.022029 °	39.281343 ° -122.022029 °	3 Y
DWR ID: DWR_MA0001_01_s_2012_3										
18	6.85	6.85		Animal Control	LS	A/W Ma	A3 : No rodents visible, but rodent burrows visible; need to backfill and compact or grout burrows.	39.286117 ° -122.021570 °	39.286117 ° -122.021570 °	470 Y

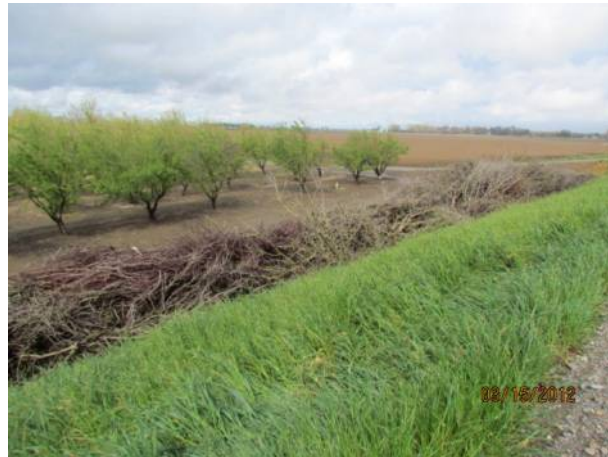
Levee Mile Report Line	17
Start Levee Mile	6.51
End Levee Mile	6.51
Location	Land Side
Category	
Item	Encroachments

View of the prunings along the L/S toe.

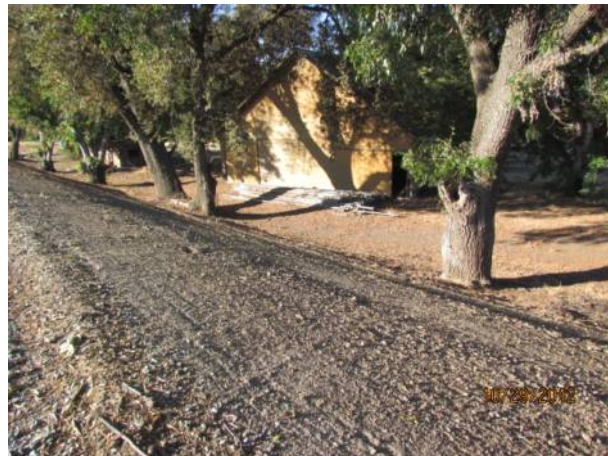
Levee Mile Report Line	18
Start Levee Mile	6.85
End Levee Mile	6.85
Location	Land Side
Category	
Item	Animal Control

View of the levee with no rodent holes.

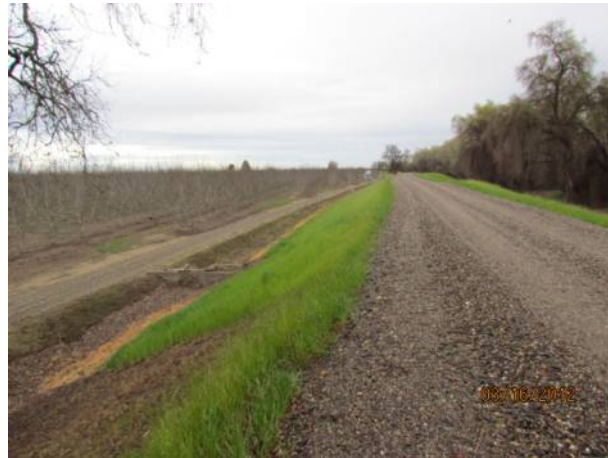
Levee Mile Report Line	21
Start Levee Mile	8.94
End Levee Mile	9.39
Location	Land Side
Category	
Item	Encroachments

View of the ag. ditch along the L/S toe.

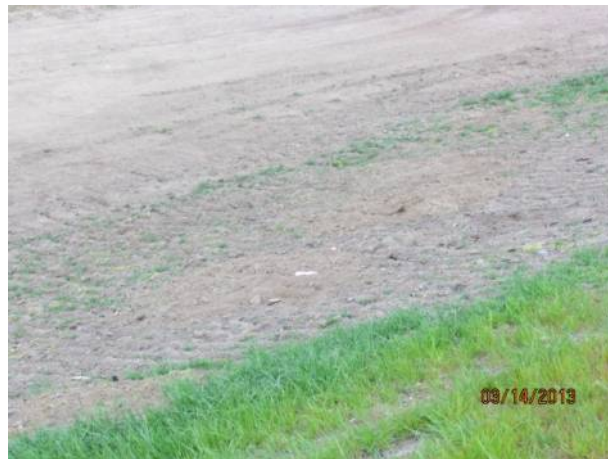
Levee Mile Report Line	22
Start Levee Mile	9.54
End Levee Mile	9.54
Location	Land Side
Category	
Item	Animal Control

View of the rodent holes along landside slope.

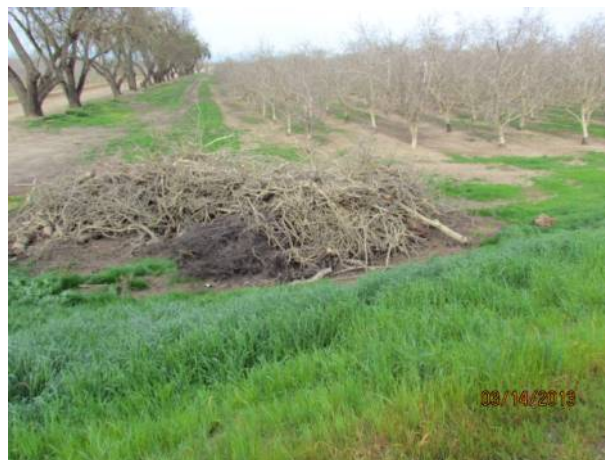
Levee Mile Report Line	25
Start Levee Mile	10.55
End Levee Mile	10.55
Location	Land Side
Category	
Item	Encroachments

View of the orchard prunings along the landside slope.

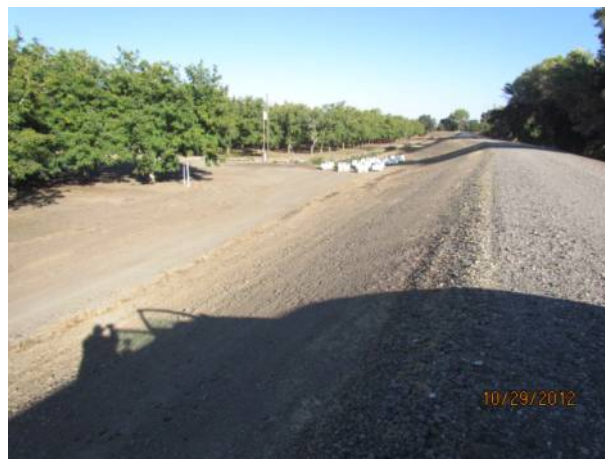
Levee Mile Report Line	26
Start Levee Mile	10.91
End Levee Mile	10.91
Location	Land Side
Category	
Item	Animal Control

View of the levee with no rodent holes.

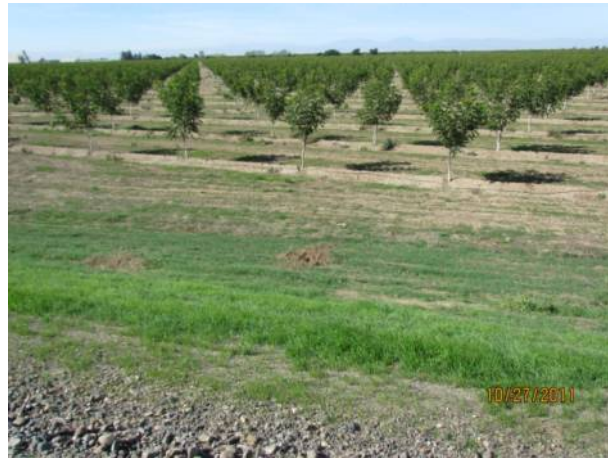
Levee Mile Report Line	32
Start Levee Mile	13.59
End Levee Mile	13.65
Location	Land Side
Category	
Item	Animal Control

View of the rodent holes along the L/S toe.

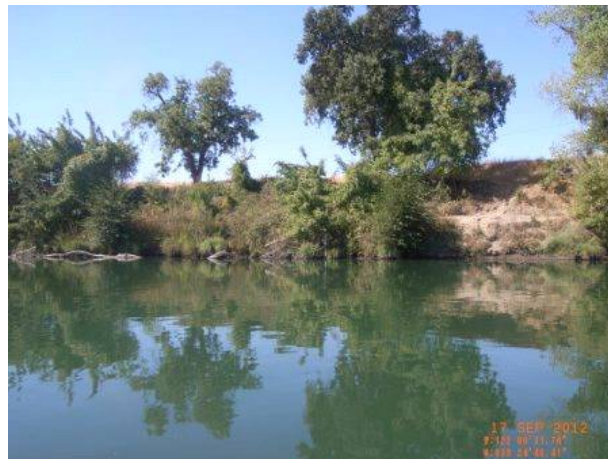
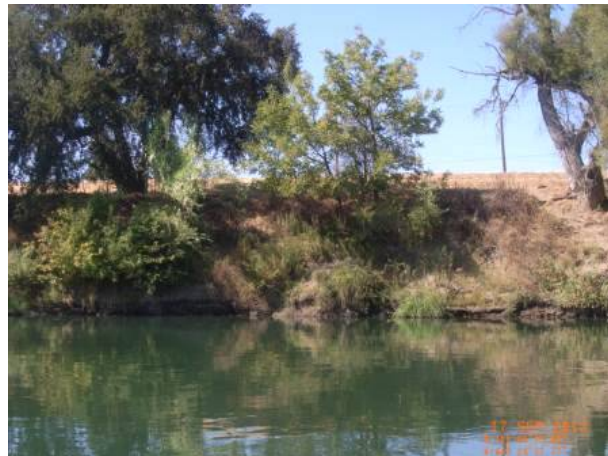
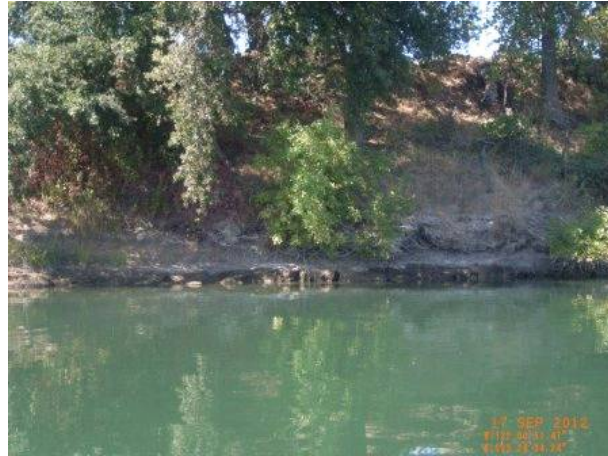
Levee Mile Report Line	35
Start Levee Mile	16.49
End Levee Mile	16.69
Location	Water Side
Category	Supplemental
Item	USACE Erosion Survey

DWR ID: DWR_MA0001_01_s_2012_14										
34	16.45	16.45		Encroachments	LS	U En	BU : Building	39.404135 ° -122.008797 °	39.404135 ° -122.008797 °	26
DWR ID: DWR_MA0001_01_s_2012_26										
35	16.49	16.69	Supplemental	USACE Erosion Survey	WS	M Ma	Inspector Comments: Erosion site added in 1997 and removed in 2005. 2009 - Site added back in, hard toe with slow moving erosion. Potential geotechnical failure. 2011 - Site extended downstream. 2012: No observed change. [2012 Site ID: SAC_164-3_R]	39.411111 ° -122.009238 °	39.407837 ° -122.008763 °	16 Y
DWR ID: DWR_MA0001_01_s_2013_16										
36	16.65	16.68		Encroachments	LS	M En	BU : Building	39.407066 ° -122.008730 °	39.407363 ° -122.008780 °	15
DWR ID: DWR_MA0001_01_s_2012_15										
37	16.66	16.69		Encroachments	LS	U En	BU : Building	39.407225 ° -122.008570 °	39.407545 ° -122.008640 °	46
DWR ID: DWR_MA0001_01_s_2012_46										
38	16.70	16.71		Encroachments	LS	U En	FE : Fence	39.407670 ° -122.008685 °	39.407823 ° -122.008740 °	47
