**Flood Control Project Maintenance  
Levee Inspections****LMA District Cover Sheet****Spring 2015 Levee Inspection Results****Sutter Maintenance Yard Maintenance Area 0001**

**Unit Cover Sheet**

**Spring 2015 Levee Inspection Results**

| Waterway | | | Bank | Unit Miles |
|--|---|---|---|---|
| Unit No. 01 Sacramento River | | | Right | 16.76 |

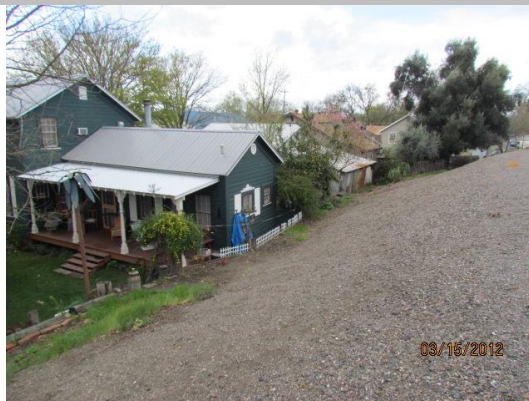
Photo 1 of 1 : SP\_2015\_MA0001\_297\_2\_20150310\_00003.jpg

View of the building along the L/S toe.

| LM Start | 0.67 | Rating ** | U | Issue No. | 7 |

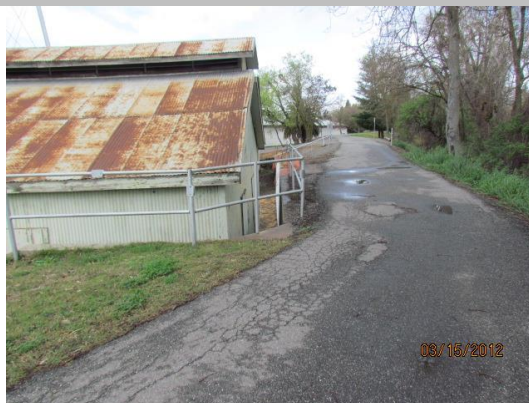
Photo 1 of 1 : SP\_2015\_MA0001\_297\_7\_20150310\_00006.jpg

View of the buildings along the L/S toe.

| LM Start | 0.79 | Rating ** | U | Issue No. | 8 |

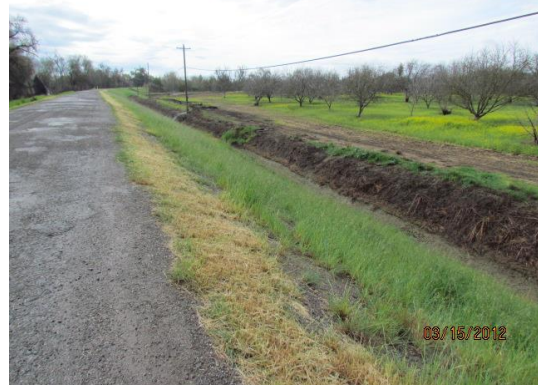
Photo 1 of 1 : SP\_2015\_MA0001\_297\_6\_20150310\_00005.jpg

View of ag. ditch along the L/S toe.

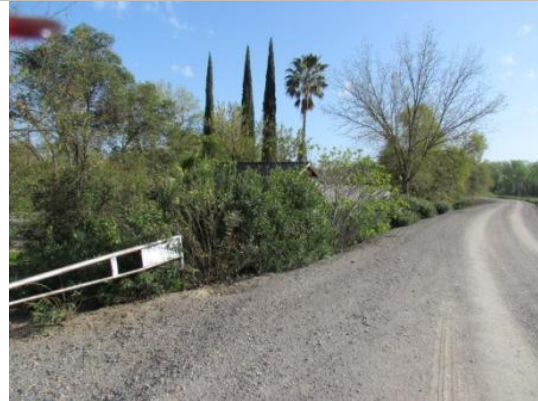
Photo 1 of 1 : SP\_2015\_MA0001\_297\_20\_20150310\_00009.jpg

View of the house next to the levee.

| LM Start | 2.87 | Rating ** | U | Issue No. | 17 |

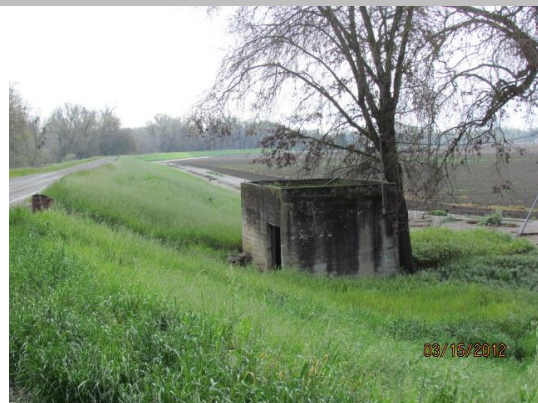
Photo 1 of 1 : SP\_2015\_MA0001\_297\_5\_20150310\_00004.jpg

View of the ag. ditch &amp; concrete building along the L/S toe.

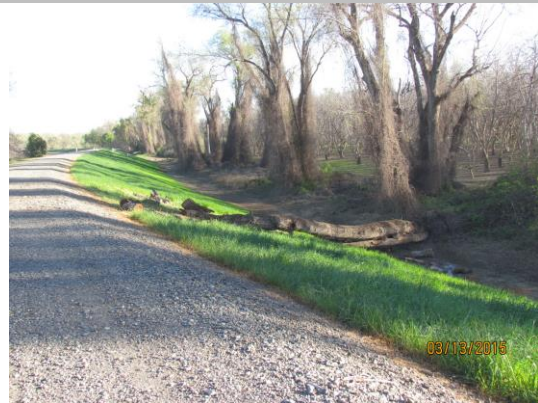
Photo 1 of 1 : SP\_2015\_MA0001\_297\_72\_20150406\_00021.jpg

View of the tree along the waterside slope and toe.

| LM Start | 3.40 | Rating ** | M | Issue No. | 31 |

| Inspector Comments: Sutter Yard needs to remove the large tree. | | | | | |

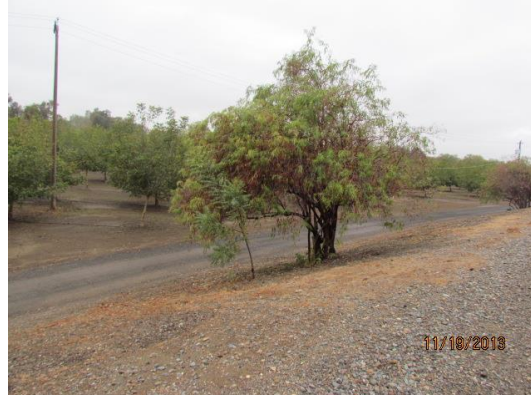
Photo 1 of 1 : SP\_2015\_MA0001\_297\_50\_20150310\_00015.jpg

| Elderberries are blocking visibility and flood fight capability. | | | | | |

View of the elderberry on the landside slope.

| LM Start | 4.04 | Rating ** | M | Issue No. | 37 |

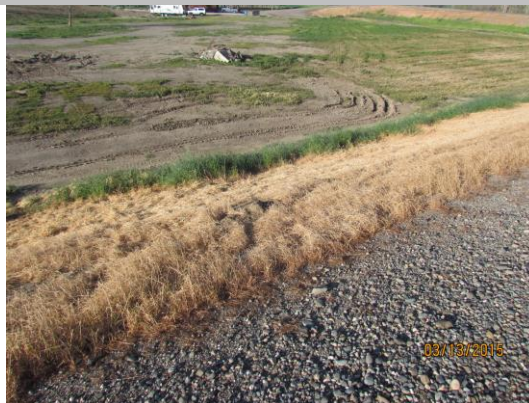
Photo 1 of 1 : SP\_2015\_MA0001\_297\_73\_20150406\_00022.jpg

View of the rodent hole along the landside slope.

| LM Start | 4.75 | Rating ** | M | Issue No. | 38 |

| Exterminate rodents and backfill and compact or grout burrows. | | | | | |

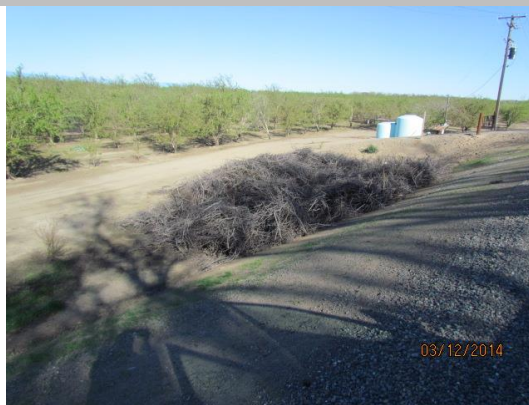
Photo 1 of 1 : SP\_2015\_MA0001\_297\_76\_20150310\_00016.jpg

View of the prunings along the landside toe.

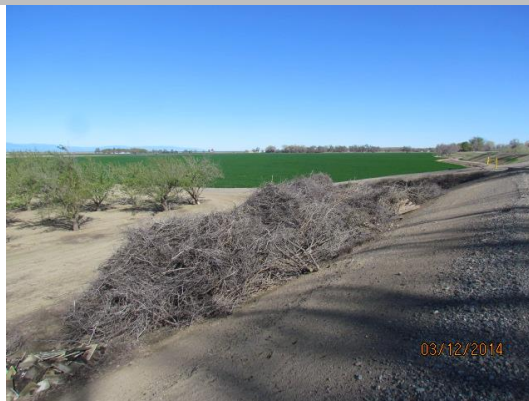
Photo 1 of 1 : SP\_2015\_MA0001\_297\_77\_20150310\_00017.jpg

View of the prunings along the landside toe.

| LM Start | 6.37 | Rating ** | U | Issue No. | 42 |

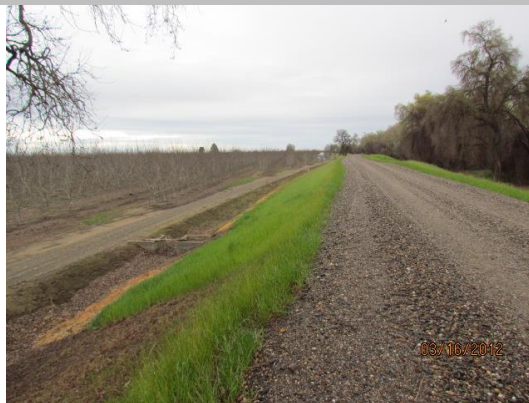
Photo 1 of 1 : SP\_2015\_MA0001\_297\_25\_20150310\_00010.jpg

View of the ag. ditch along the L/S toe.

| LM Start | 9.11 | Rating ** | M | Issue No. | 51 |

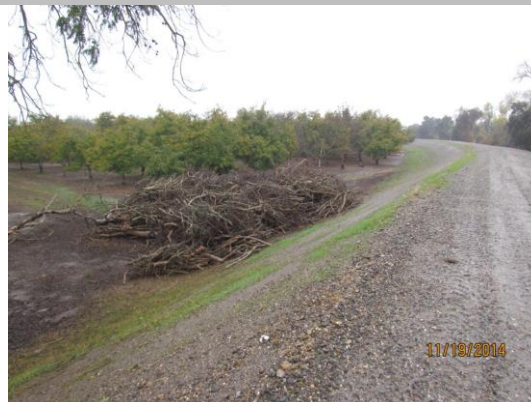
Photo 1 of 1 : SP\_2015\_MA0001\_297\_636\_20150310\_00018.jpg

View of the pruning along the landside toe.

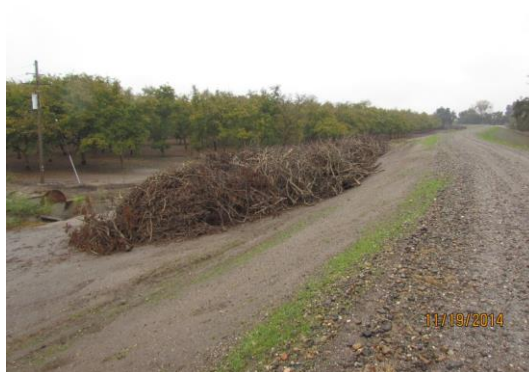
Photo 1 of 1 : SP\_2015\_MA0001\_297\_637\_20150310\_00019.jpg

View of the pruning along the landside toe.

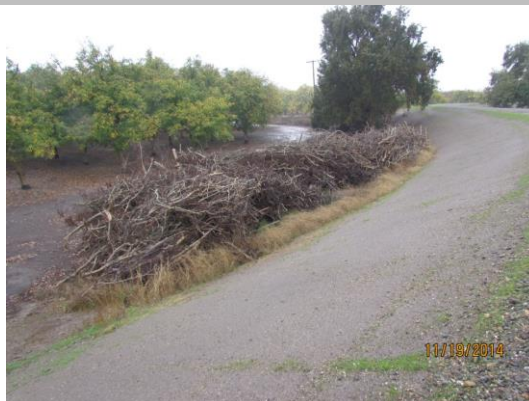
Photo 1 of 1 : SP\_2015\_MA0001\_297\_638\_20150310\_00020.jpg

View of the pruning along the landside toe.

| LM Start | 11.01 | Rating ** | M | Issue No. | 12 |

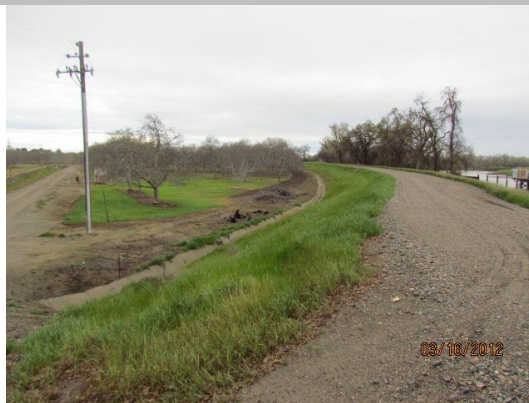
Photo 1 of 1 : SP\_2015\_MA0001\_297\_27\_20150310\_00012.jpg

View of the ag. ditch along the L/S toe.

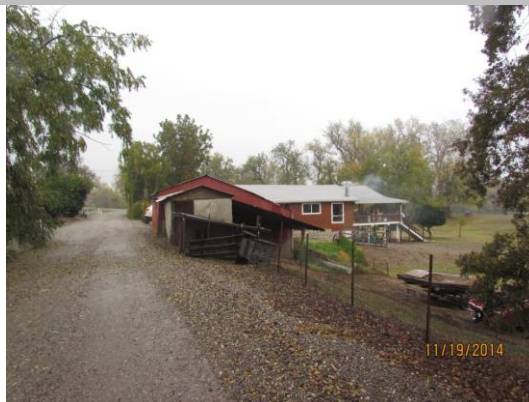
Photo 1 of 1 : SP\_2015\_MA0001\_297\_14\_20150310\_00007.jpg

View of the building on the waterside slope.

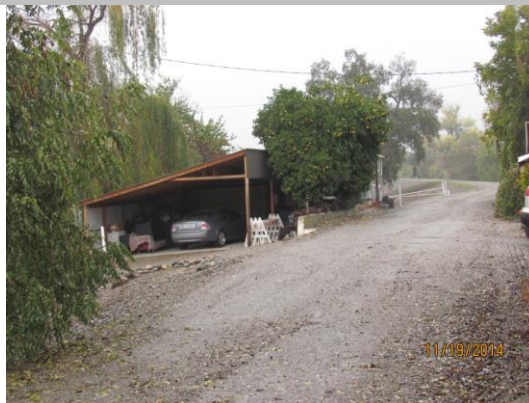
Photo 1 of 1 : SP\_2015\_MA0001\_297\_26\_20150310\_00011.jpg

View of the building on the landside slope.

| LM Start | 16.10 | Rating ** | M | Issue No. | 74 |

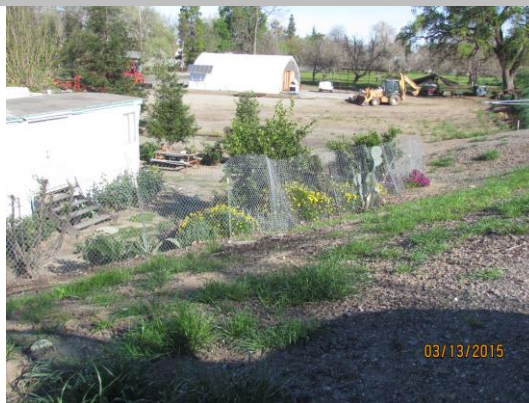
Photo 1 of 1 : SP\_2015\_MA0001\_297\_74\_20150406\_00023.jpg

View of the landscape along the landside slope and toe.

| LM Start | 16.30 | Rating ** | M | Issue No. | 15 |

| Inspector Comments: Remove the landscape from the landside slope and toe. | | | | | |

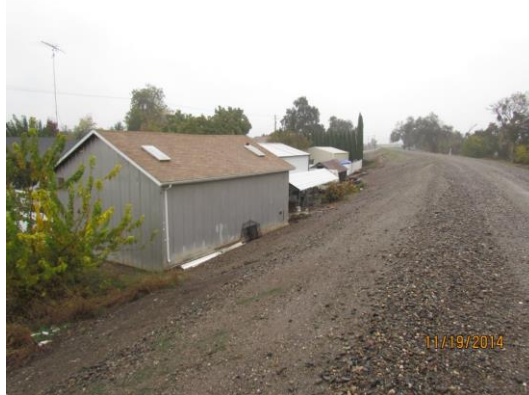
Photo 1 of 1 : SP\_2015\_MA0001\_297\_46\_20150310\_00013.jpg

View of the building along the landside toe.

| LM Start | 16.34 | Rating ** | U | Issue No. | 47 |

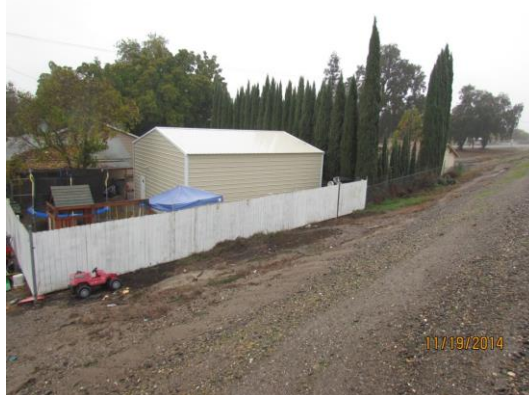
Photo 1 of 1 : SP\_2015\_MA0001\_297\_47\_20150310\_00014.jpg

View of the fence along the landside toe.

| LM Start | 16.35 | Rating ** | M | Issue No. | 1 |

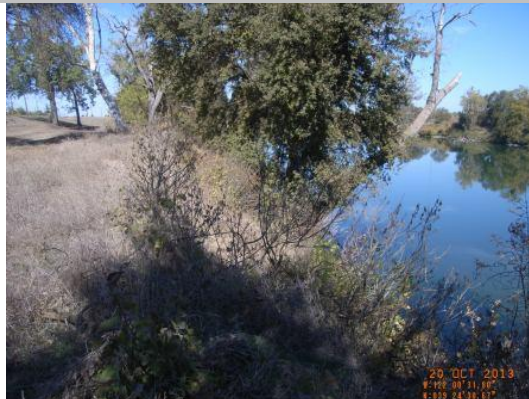
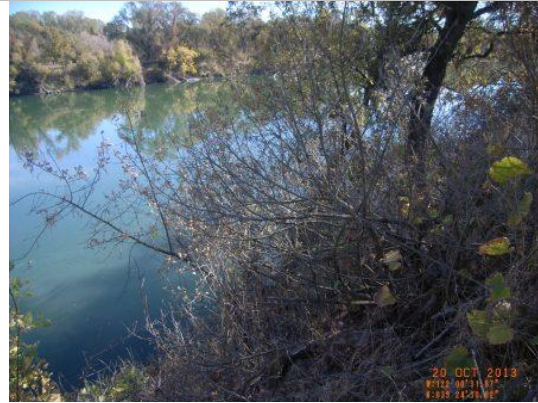
| Inspector Comments: Erosion site added in 1997 and removed in 2005. 2009 - Site added back in, hard toe with slow moving erosion. Potential geotechnical failure. 2011 - Site extended downstream. 2013: No observed changes. [2013 Site ID: SAC_164-3_R] | | | | | |

USACE 2013 Photo #1

USACE 2013 Photo #2

| LM Start | 16.85 | Rating ** | M | Issue No. | 70 |
