**Flood Control Project Maintenance  
Levee Inspections**  
**LMA District Cover Sheet**  
**Spring 2016 Levee Inspection Results**

**Sutter Maintenance Yard Maintenance Area 0001**

**Spring 2016 Levee Inspection Results**

Waterway		Bank	Unit Miles
Unit No. 01 Sacramento River		Right	16.76

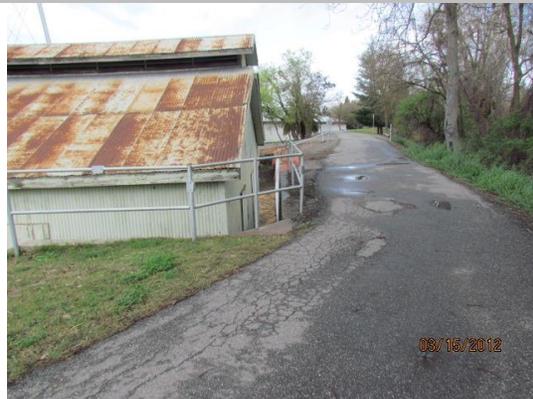
Photo 1 of 1 : SP\_2016\_MA0001\_297\_7\_20160316\_00005.jpg

View of the buildings along the L/S toe.

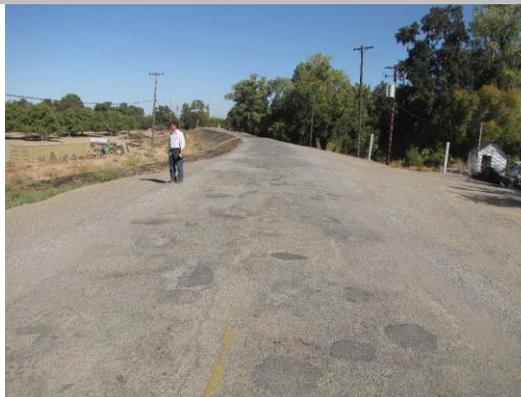
Photo 1 of 2 : UCIP\_SP\_2016\_47553\_70052.jpg

Item	DWR UCIP Field Study			39.221685 °	39.221685 °
				-122.015720 °	-122.015720 °
DWR ID					
Comment Code					
Inspector Comment					
<p>FS_ID:47553                  DS_ID:16431                  EP_NO: 9481                  Repair Type: Non-Urgent                  Crossing Status: Found                  UCIP Comments: 4/25/2016 LS pipe outlet is rusted and corroded. Wood debris on WS has been removed and erosion on toe road was repaired.4/20/2015 Same as last inspection. No repairs have been made yet. 6/18/2014 Same as last inspection.12/17/2013 Same as last inspection.7/18/2013 LS outlet was underwater and could not be inspected but nothing looks to have been changed.10/18/2012 Need pressure test/video inspection to determine integrity of pipe wall. WS-woody debris scattered along slope &amp; bank. Erosion on bank near ditch. LS-discharge pipe heavily corroded &amp; CMP section missing. This crossing was listed in the USACE Periodic Inspections as ID# USACE_CESPK_MA1C_2010_p_0097 for debris &amp; encroachment within 15 feet.                  FIELD_STRUCT_DESC: 36-inch irrigation corrugated metal pipe (CMP) through the levee at unknown depth, slide gate on the waterside (WS) slope. This structure was retained under an automatic board order (ABO) issued as Permit No. 9481. (Permit No. 9481-1974, Roberts Ditch Irrigation Company) Crossing penetrates the levee at an angle. Other appurtances located at this crossing include slant pump, concrete distribution box and shed structure located 100 feet northeast from levee crossing. Flow is carried from concrete distribution box to slide gate via concrete lined ditch. Outlet is vible on landside (LS). This entry matches the Drainage and Irrigation Structure referenced in O&amp;M manual (Station 63+53).                  FS Date: 5/4/2016 1:52:00 PM</p>

Overview of levee crown at crossing looking U/S.

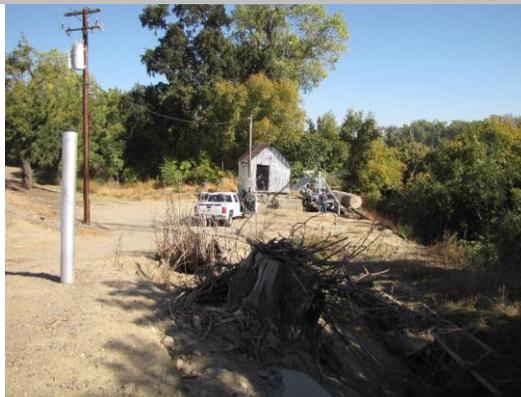
Photo 2 of 2 : UCIP\_SP\_2016\_47553\_70051.jpg

Other appurtances associated with crossing-Structure, pump, distribution box, and power pole located on WS bank.

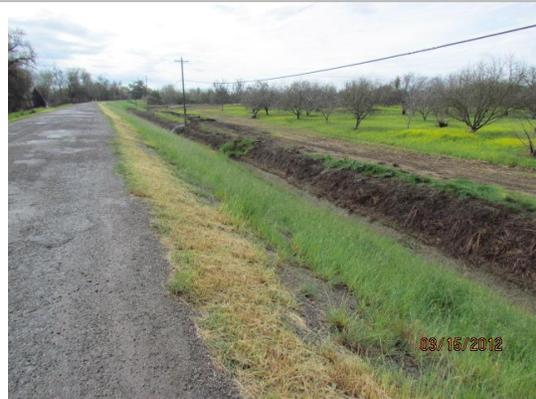
Photo 1 of 1 : SP\_2016\_MA0001\_297\_6\_20160316\_00004.jpg

View of ag. ditch along the L/S toe.

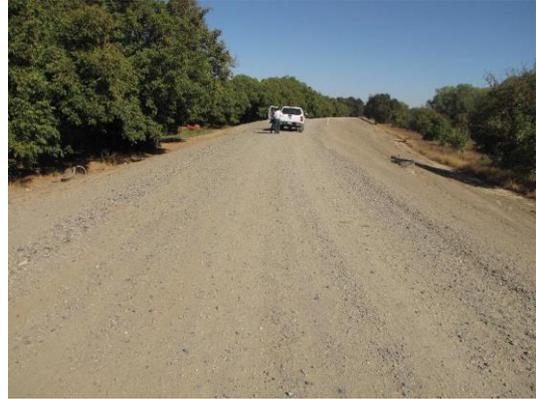
Photo 1 of 2 : UCIP\_SP\_2016\_47617\_70064.jpg

Item	DWR UCIP Field Study		39.231866 °	39.231866 °	
			-122.015442 °	-122.015442 °	
DWR ID					
Comment Code					
Inspector Comment					
<p>FS_ID:47617                  DS_ID:16430                  EP_NO: 9487                  Repair Type: Non-Urgent                  Crossing Status: Found                  UCIP Comments: 4/25/2016 WS pipe end is still plugged with soil. Rest of the pipe appeared to be in good condition.4/20/2015 WS pipe end is plugged about 50% by soil.6/18/2014 Same as last inspection.12/17/2013 Same as last inspection.7/18/2013 WS pipe end has been reformed but is still clogged about 50% by sediment.10/18/2012 Remove dirt and debris in riser. Outlet deformed and blocked over 50%. Debris-round concrete section on landward side. This crossing was listed in the USACE Periodic Inspections as ID# USACE_CESPK_MA1C_2010_p_0116 for crossing outlet deformed and clogged with dirt.                  FIELD_STRUCT_DESC: 1 of 2: 36-inch corrugated metal pipe (CMP) through the levee at approximately 12-15 feet below crown. Slide gates in CMP riser located on the waterside (WS) slope. Pipe daylights on landside (LS). This structure was retained under an automatic board order (ABO) issued as Permit No. 9487. (Permit No. 9487-1974, Jimeno Rancho) This entry matches the Drainage and Irrigation Structure referenced in O&amp;M manual (Station 103+18).                  FS Date: 5/4/2016 1:59:00 PM</p>

Overview of levee crown and slopes looking upstream towards crossing.

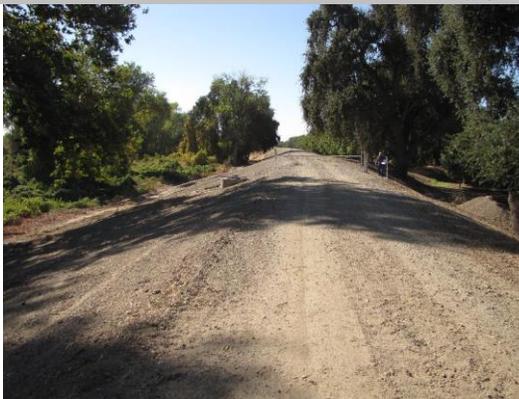
Photo 1 of 2 : UCIP\_SP\_2016\_47557\_70078.jpg

Item	DWR UCIP Field Study			39.235993 °	39.235993 °
				-122.012970 °	-122.012970 °
DWR ID					
Comment Code					
Inspector Comment					
<p>FS_ID:47557                  DS_ID:16429                  EP_NO: 9472                  Repair Type: Non-Urgent                  Crossing Status: Found                  UCIP Comments: 4/25/2016 Pipe still inside of riser and LS end plugged about 50% by soil.4/20/2015 Same as last inspection.6/18/2014 Same as last inspection.12/17/2013 Same as last inspection.7/18/2013 Same as last inspection.10/18/12 Remove debris from riser. Landward inlet is blocked by over 50%. This crossing was listed in the USACE Periodic Inspections as ID# USACE_CESPK_MA1C_2010_p_0128 for sediment build up at inlet (landward side) and debris inside riser.                  FIELD_STRUCT_DESC: 54-inch corrugated metal (CM) drain pipe through the levee approximately 12-15 feet below crown. Slide gate in CM pipe riser on the waterside (WS) slope. 48-inch CM pipe at landside (LS) slope. This crossing crosses the levee at an angle. This structure was retained under an automatic board order (ABO) issued as Permit No. 9472. (Permit No. 9472-1974, Ballard) This entry matches the Drainage and Irrigation Structure referenced in O&amp;M manual (Station 120+00) dated 1955.                  FS Date: 5/4/2016 2:00:00 PM</p>

View of levee crown looking downstream at crossing. CMP riser located on WS shoulder.

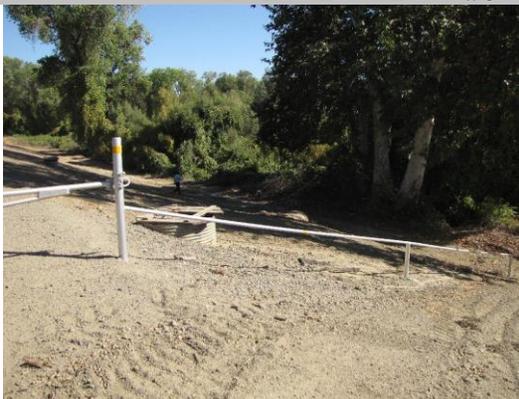
Photo 2 of 2 : UCIP\_SP\_2016\_47557\_70079.jpg

View of WS looking at slope and channel.

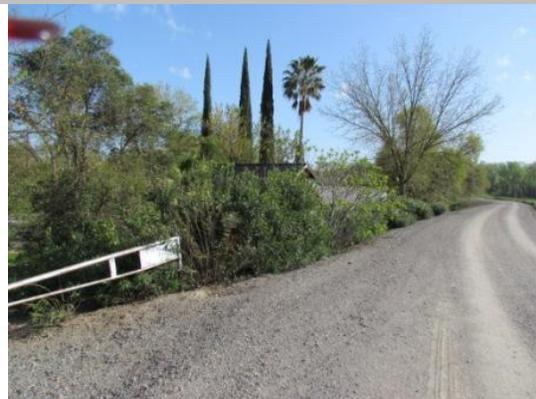
Photo 1 of 1 : SP\_2016\_MA0001\_297\_20\_20160316\_00010.jpg

View of the house next to the levee.

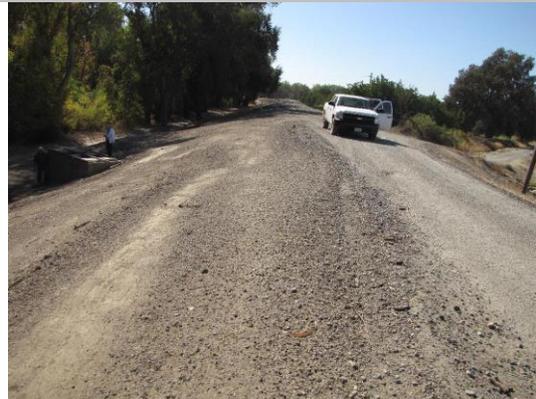
Photo 1 of 2 : UCIP\_SP\_2016\_47559\_70092.jpg

Item	DWR UCIP Field Study			39.243410 °	39.243410 °
				-122.008393 °	-122.008393 °
DWR ID					
Comment Code					
Inspector Comment					
<p>FS_ID:47559                      DS_ID:16416                      EP_NO: 9474                      Repair Type: Non-Urgent                      Crossing Status: Found                      UCIP Comments: 4/25/2016 Concrete box was filled with dirt to help prevent water from through during high water times.4/20/2015 Positive closure device is missing and water cannot be prevented from flowing through pipe during high water. 6/18/2014 Same as last inspection.12/17/2013 Same as last inspection.7/18/2013 Same as last inspection.10/18/12 During high water flow goes through levee. Missing positive closure device on waterward side. This structure appears abandoned-slide gates have been removed. Crossing needs to be properly abandoned. This crossing was listed in the USACE Periodic Inspection as ID# USACE_CESPK_MA1C_2010_p_0169 for concrete box partially filled with dirt.                      FIELD_STRUCT_DESC: 1 of 2: 60-inch irrigation concrete pipe through the levee at unknown depth. This crossing penetrates levee at an angle. Slide gates in concrete well at the waterside (WS) toe. Slide gates missing. Structure retained under an automatic board order (ABO) issued as Permit No. 9474. (Permit No. 9774-1974, George R. Zumwalt) This entry matches the Drainage and Irrigation Structure referenced in O&amp;M manual (Station 150+06). O&amp;M description is for 2-5 foot by 5 foot concrete culverts 2-slide gates hand operated. Culvert constructed with wing walls and gate well.                      FS Date: 5/4/2016 2:02:00 PM</p>

Overview of levee crown looking downstream at crossing.

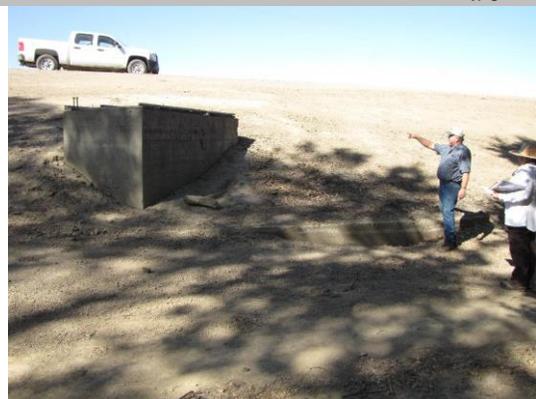
Photo 2 of 2 : UCIP\_SP\_2016\_47559\_70094.jpg

View of concrete distribution box and headwall located on WS.

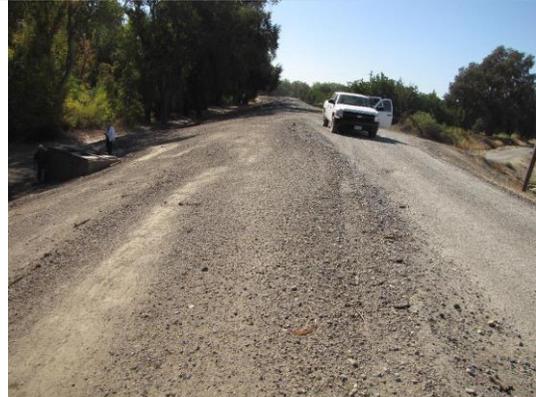
Photo 1 of 2 : UCIP\_SP\_2016\_47560\_70105.jpg

Item	DWR UCIP Field Study			39.243433 °	39.243433 °
				-122.008386 °	-122.008386 °
DWR ID					
Comment Code					
Inspector Comment					
<p>FS_ID:47560                  DS_ID:17567                  EP_NO: 9474                  Repair Type: Non-Urgent                  Crossing Status: Found                  UCIP Comments: 4/25/2016 Concrete box on WS was filled with soil to help prevent water from flowing through during times of high water.4/20/2015 Positive closure device is missing and water cannot be prevented from flowing through pipe during high water.6/18/2014 Same as last inspection.12/17/2013 Same as last inspection.7/18/2013 Same as last inspection.10/18/2015 During high water flow goes through levee. Missing positive closure device on waterward side. This structure appears abandoned-slide gates have been removed. Crossing needs to be properly abandoned. This crossing was listed in the USACE Periodic Inspection as ID# USACE_CESPK_MA1C_2010_p_0169 for concrete box partially filled with dirt.                  FIELD_STRUCT_DESC: 2 of 2: 60-inch irrigation pipe through the levee at an unknown depth. Crossing angles through levee. Slide gates in concrete well at the waterside (WS) toe. Slide gate missing. Structure was retained under an automatic board order (ABO) issued as Permit No. 9474. (Permit No. 9474-1974, George R. Zumwalt) This entry matches the Drainage and Irrigation Structure referenced in O&amp;M manual (Station 150+06). O&amp;M description is for 2-5 foot by 5 foot concrete culverts 2-slide gates hand operated. Culvert constructed with wing walls and gate well.                  FS Date: 5/4/2016 2:09:00 PM</p>

Overview of levee crown looking downstream at crossing.

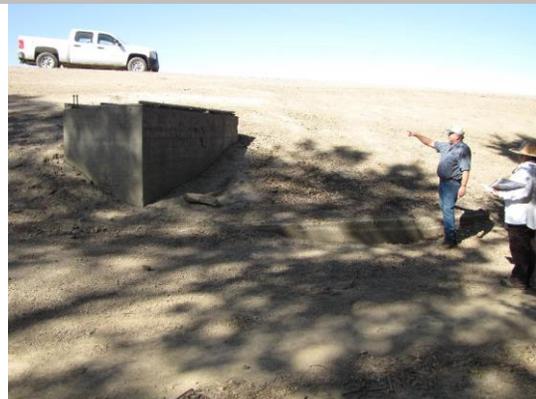
Photo 2 of 2 : UCIP\_SP\_2016\_47560\_70107.jpg

Concrete distribution box and headwall located on WS.

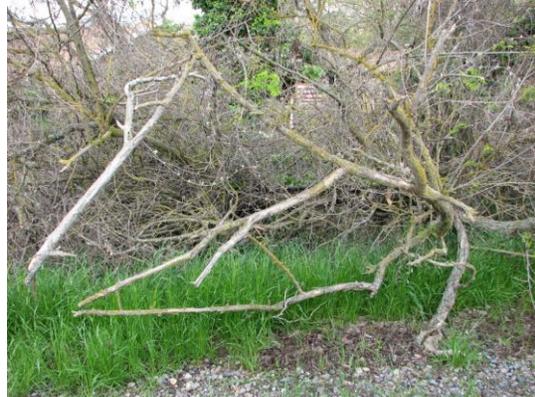
Photo 1 of 1 : SP\_2016\_MA0001\_297\_81\_20160405\_00144.jpg

Downed tree obstructing access

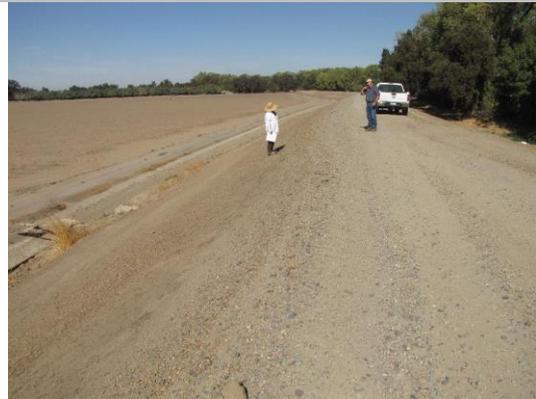
Photo 1 of 2 : UCIP\_SP\_2016\_47562\_70110.jpg

FS\_ID:47562  
 DS\_ID:16426  
 EP\_NO: 9490  
 Repair Type: Non-Urgent  
 Crossing Status: Found  
 UCIP Comments: 4/25/2016 WS slide gate is slightly bent. Rest of crossing appears to be in good condition. 4/20/2015 LS inlet still has some minor sediment build up. Needs to be cleaned.6/18/2014 Same as last inspection.12/17/2013 Same as last inspection.7/18/2013 WS slide gate looks to be in good condition but stem is slightly bent. Not sure if bend will hinder gates operation or not. LS inlet is still blocked by minor sediment build up.10/18/2012 LS pipe slightly deformed and sediment build up blocking about 30% of opening; need to check the condition of the slide gate-need photo. Metal marker down. This crossing was listed in the USACE Periodic Inspection as ID# USACE\_CESPK\_MA1C\_2010\_p\_0187 for sediment build up at landward toe.  
 FIELD\_STRUCT\_DESC: 36-inch drain pipe through the levee. Slide gate in corrugated metal pipe (CMP) riser on the waterside (WS) slope. (Permit No. 9490-1955, Charles & Virginia Yerxa) This entry matches the Drainage and Irrigation structure referenced in O&M manual (Station 177+67). (USACE-1955)

View of LS looking upstream.

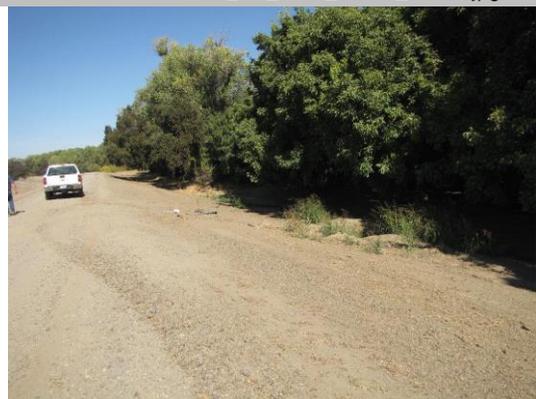
Photo 2 of 2 : UCIP\_SP\_2016\_47562\_70109.jpg

View of WS looking upstream.

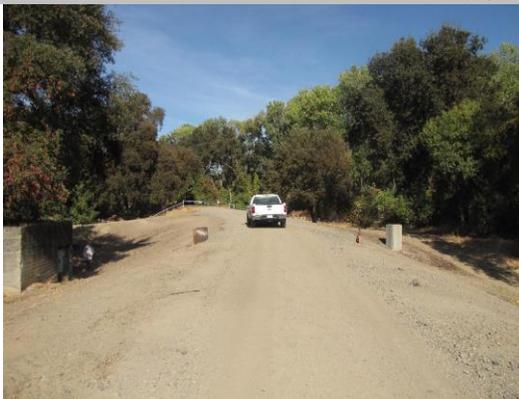
Photo 1 of 2 : UCIP\_SP\_2016\_47563\_70222.jpg

Item	DWR UCIP Field Study			39.255803 °	39.255803 °
				-122.009683 °	-122.009683 °
DWR ID					
Comment Code					
Inspector Comment					
FS_ID:47563 DS_ID:16436 EP_NO: 4213 Repair Type: Urgent Crossing Status: Found UCIP Comments: 4/25/2016 No repairs have been made since last inspection. Sink holes are still present above pipe next to concrete building on LS.4/20/2015 Sink hole over pipe alignment on LS up against the concrete building. Need to dig up pipe and see if its leaking.6/23/2014 Same as last inspection.6/18/2014 Same as last inspection.12/17/2013 Same as last inspection.7/18/2013 Same as last inspection.10/19/2012 Recommend adding door to LS concrete structure. Riser located on landward side is damaged. This crossing was listed in the USACE Periodic Inspection as ID# USACE_CESPK_MA1C_2010_p_0194 no issues logged. FIELD_STRUCT_DESC: 24-inch steel irrigation pipe through the levee at approximately 10 feet below crown. Gate valve on waterside (WS) shoulder. 1-1/4 inch conduit through the levee. Siphon breaker on the landside (LS) shoulder. Concrete distribution box and control box located on LS. Pump, walkway, and gate located on WS berm. (Permit No. 4213-1973, Scott Ranch) FS Date: 5/4/2016 2:15:00 PM

Overview of levee crown looking upstream at crossing.

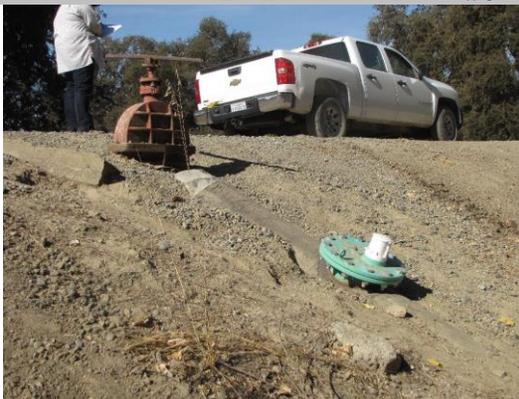
Photo 2 of 2 : UCIP\_SP\_2016\_47563\_70221.jpg

Gate valve and exposed section of the pipe located on WS.

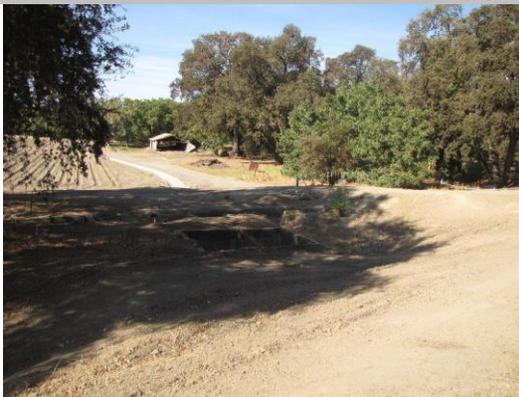
Photo 1 of 2 : UCIP\_SP\_2016\_48130\_70125.jpg

Item	DWR UCIP Field Study			39.256189 °	39.256189 °
				-122.009957 °	-122.009957 °
DWR ID					
Comment Code					
Inspector Comment					
FS_ID:48130 DS_ID:16424 EP_NO: 9490 Repair Type: Non-Urgent Crossing Status: Found UCIP Comments: 4/25/2016 ABANDONED crossing and should be abandoned properly. Concrete distribution box on LS is opened on top and could pose a safety hazard with falling.4/20/2015 Same as last inspection. 6/18/2014 Same as last inspection.12/17/2013 Same as last inspection.7/18/2013 Same as last inspection.10/19/2012 Crossing needs to be properly abandoned. This crossing was listed in the USACE Periodic Inspection as ID# USACE_CESPK_MA1C_2010_p_0194-6 & 7 no issues logged. FIELD_STRUCT_DESC: *ABANDONED* 36-inch corrugated metal irrigation pipe through levee, approximately 12-15 feet below crown. Concrete distribution box with pump system located on landside (LS). Slide gate on the waterside (WS) slope removed. 18-inch pipe visible on LS inside 10-ft x 16-ft concrete box. (Automatic Board Order (ABO) issued as Permit No. 9490-1974, Charles T & Virginia W. Yerxa) [Additional Reference(s): DWR Levee Log, 1992. USACE Sacramento O&M Manual 137, August 1955 (Station 197+19)] FS Date: 5/4/2016 2:16:00 PM

Concrete distribution box located on LS.

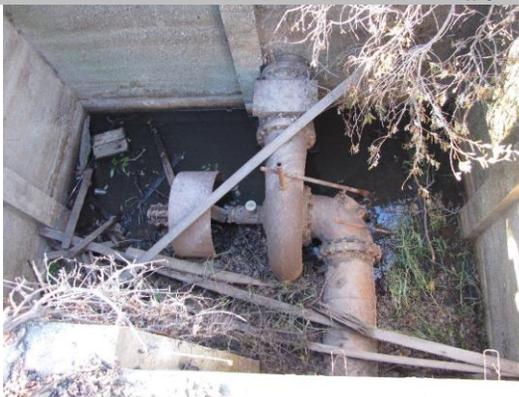
Photo 2 of 2 : UCIP\_SP\_2016\_48130\_70123.jpg

Abandoned pump system inside concrete structure located on LS.

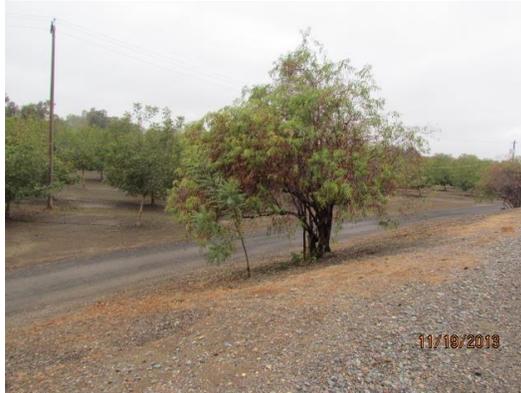
Photo 1 of 1 : SP\_2016\_MA0001\_297\_50\_20160316\_00016.jpg

View of the elderberry on the landside slope.

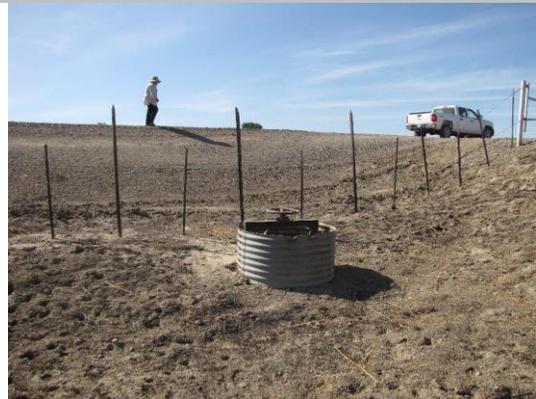
Photo 2 of 2 : UCIP\_SP\_2016\_47568\_70147.jpg

Riser with slide gate located on WS toe.

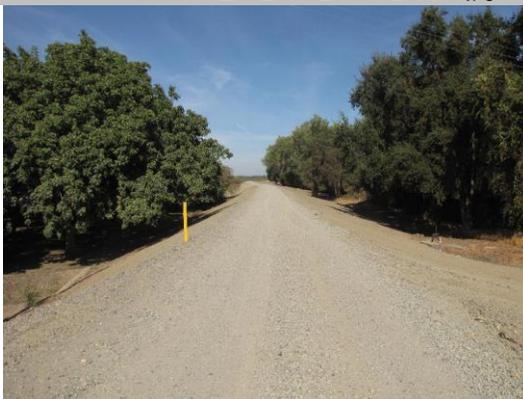
Photo 2 of 2 : UCIP\_SP\_2016\_47570\_70152.jpg

FS\_ID:47570  
 DS\_ID:16419  
 EP\_NO: 9476  
 Repair Type: Non-Urgent  
 Crossing Status: Found  
 UCIP Comments: 4/25/2016 WS entry still blocked and wingwalls still cracked.4/20/2015 WS entry still blocked and wingwalls still cracked.6/18/2014 Same as last inspection.12/17/2013 Same as last inspection.7/18/2013 Same as last inspection.10/19/2012 blocked, no entry on WS. This crossing was listed in the USACE Periodic Inspection as ID# USACE\_CESPK\_MA1C\_2010\_p\_0247 for u/s and d/s wing wall shows some cracking and tilting.  
 FIELD\_STRUCT\_DESC: 1 of 2: 36-inch irrigation corrugated metal pipe (CMP) and concrete box culvert through the levee at an unknown depth. Concrete headwall visible on landside (LS) toe. Structure retained under an automatic board order (ABO) issued as Permit No. 9476. (Permit No. 9476-1974, Howard C. & Nadine M. Ohliger)  
 FS Date: 5/4/2016 2:30:00 PM

View of crossing looking upstream at crossing.

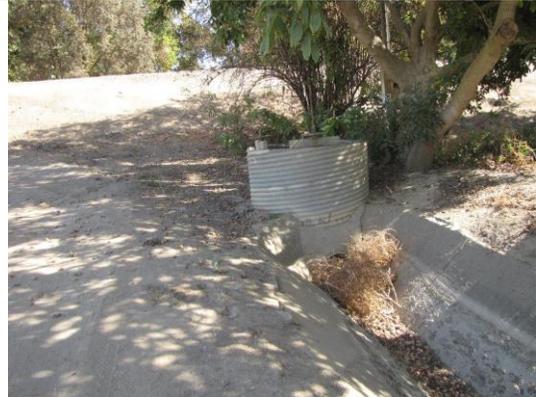
Photo 2 of 2 : UCIP\_SP\_2016\_47573\_70166.jpg

CMP riser and concrete lined v-ditch located on LS toe.

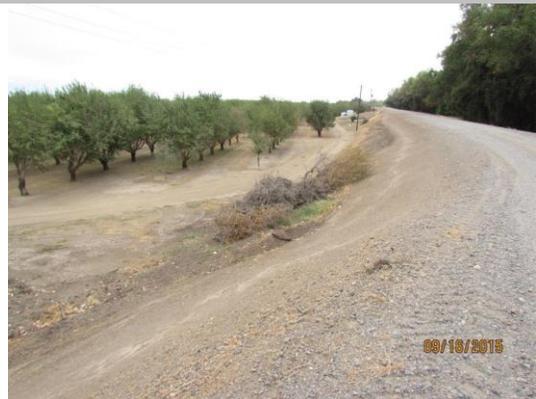
Photo 1 of 1 : SP\_2016\_MA0001\_297\_75\_20160316\_00018.jpg

View of the prunings along the landside toe.

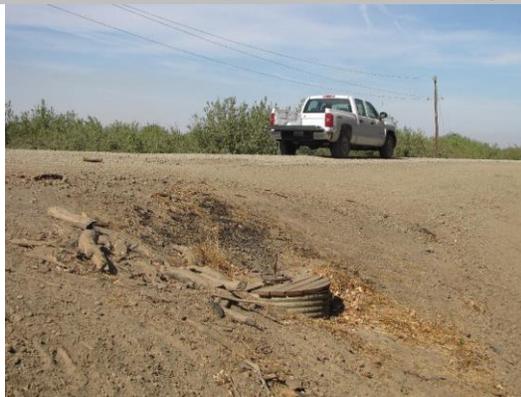
Photo 2 of 2 : UCIP\_SP\_2016\_47574\_70176.jpg

CMP riser located on WS slope.

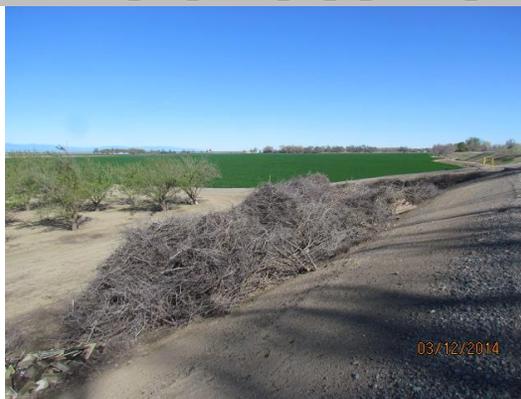
Photo 1 of 1 : SP\_2016\_MA0001\_297\_77\_20160316\_00020.jpg

View of the prunings along the landside toe.

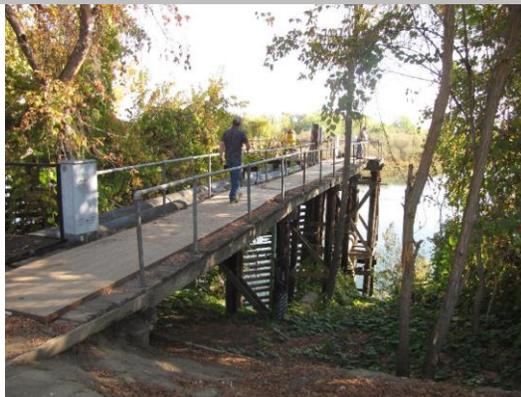
Photo 2 of 2 : UCIP\_SP\_2016\_47614\_70245.jpg

Dual 14-inch pipes along catwalk. 24-inch pipe crosses approximately 8 feet below catwalk floor.

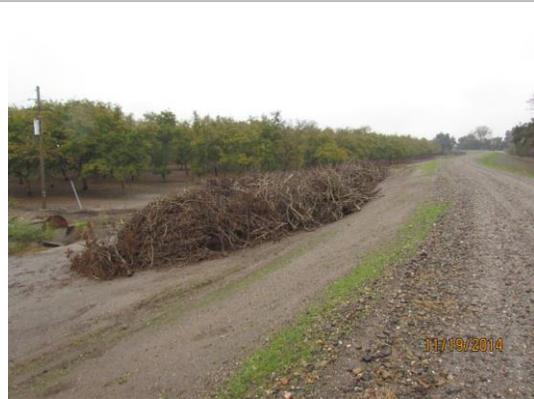
Photo 1 of 1 : SP\_2016\_MA0001\_297\_637\_20160316\_00024.jpg

View of the pruning along the landside toe.

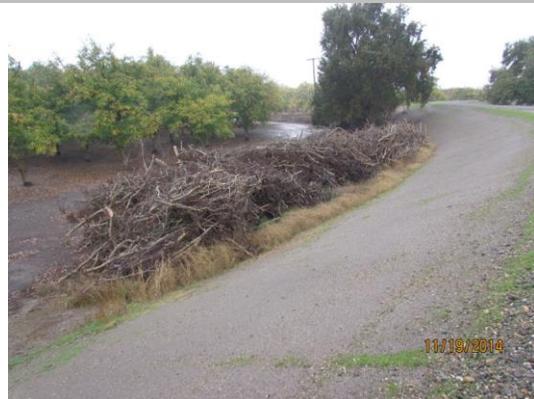
Photo 1 of 1 : SP\_2016\_MA0001\_297\_638\_20160316\_00025.jpg

View of the pruning along the landside toe.

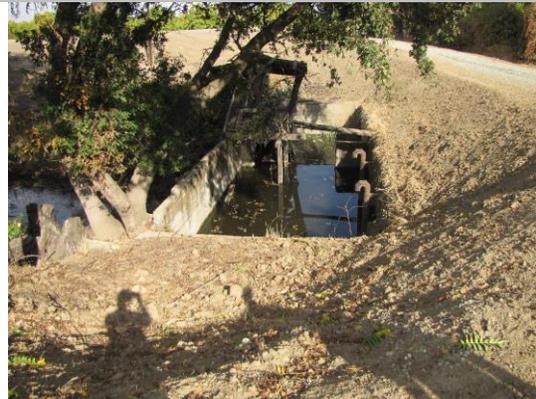
Photo 2 of 2 : UCIP\_SP\_2016\_47586\_70276.jpg

Abandoned structure (multiple headwalls and pump structure) located near the lower levee (ring levee).

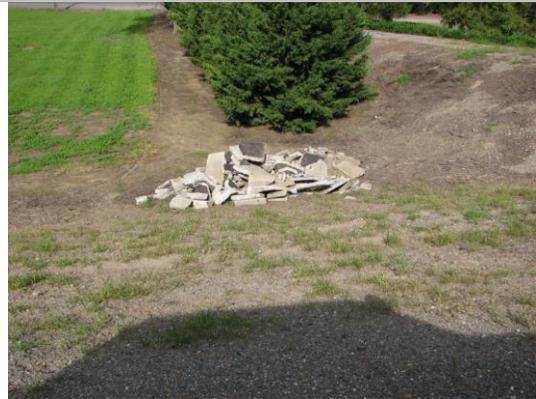
Photo 1 of 1 : SP\_2016\_MA0001\_297\_84\_20160405\_00145.jpg

Concrete debris pile at toe

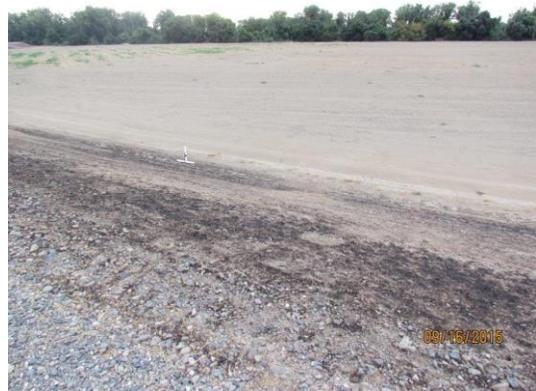
Photo 1 of 1 : SP\_2016\_MA0001\_297\_79\_20160316\_00022.jpg

View of the rodent holes along the waterside slope.

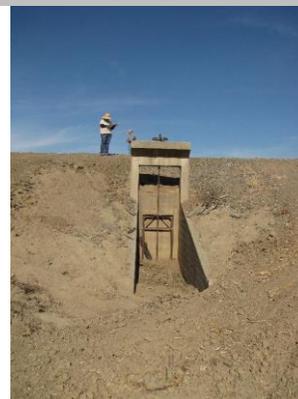
Photo 2 of 2 : UCIP\_SP\_2016\_47598\_70351.jpg

WS concrete structure with slide gate. Gate is blocked by sediment.

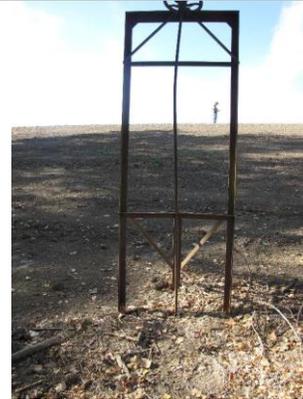
Photo 2 of 2 : UCIP\_SP\_2016\_47605\_70380.jpg

WS-Slide gate buried-non-functional.

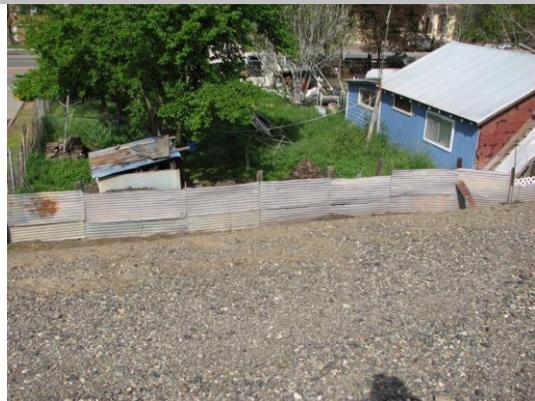
Photo 1 of 1 : SP\_2016\_MA0001\_297\_89\_20160405\_00148.jpg

Corrugated metal fence obstructing visibility and access

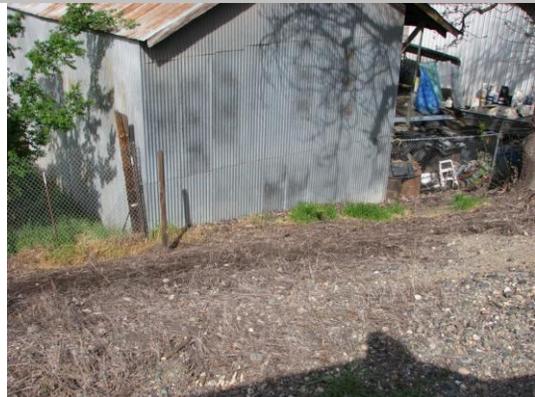
Photo 1 of 1 : SP\_2016\_MA0001\_297\_90\_20160405\_00149.jpg

Corrugated metal building obstructing visibility and access

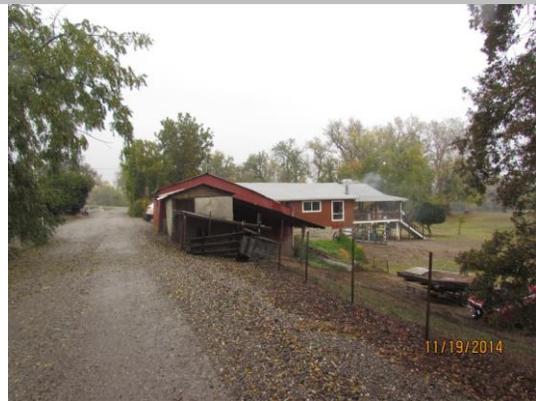
Photo 1 of 1 : SP\_2016\_MA0001\_297\_14\_20160316\_00008.jpg

View of the building on the waterside slope.

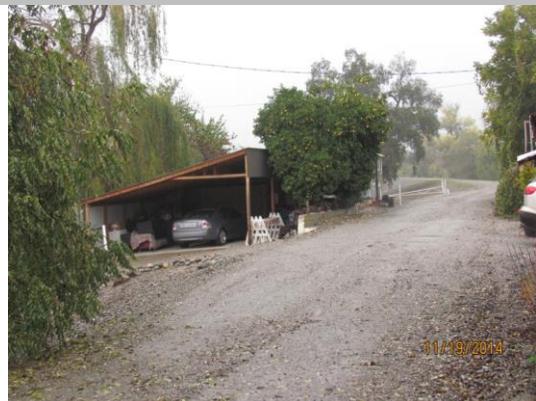
Photo 1 of 1 : SP\_2016\_MA0001\_297\_26\_20160316\_00012.jpg

View of the building on the landside slope.

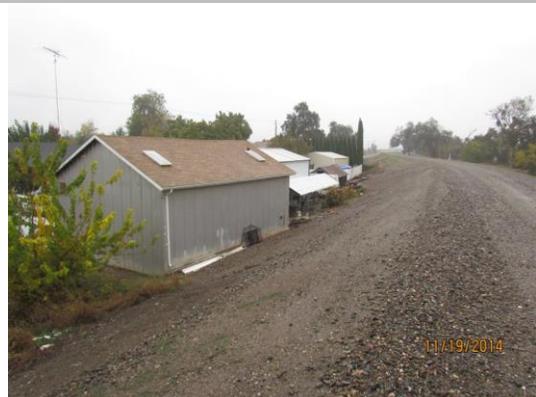
Photo 1 of 1 : SP\_2016\_MA0001\_297\_46\_20160316\_00014.jpg

View of the building along the landside toe.

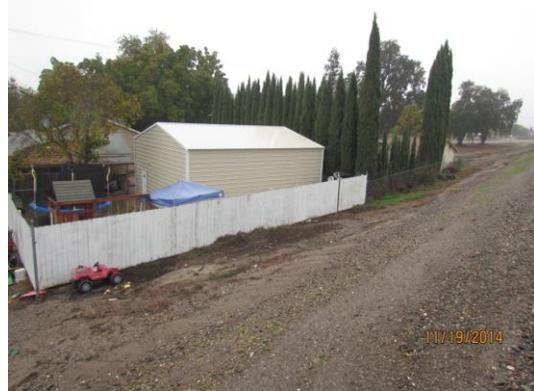
Photo 1 of 1 : SP\_2016\_MA0001\_297\_47\_20160316\_00015.jpg

View of the fence along the landside toe.
