**Flood Control Project Maintenance
Levee Inspections**
LMA District Cover Sheet
Spring 2019 Levee Inspection Results

Spring 2019 Levee Inspection Results

Sutter Maintenance Yard Maintenance Area 0001

Waterway			Bank	Unit Miles
Unit No. 01 Sacramento River			Right	16.76
	Spring (March - May)	Summer (June - August)	(September - November) Fall	Winter (December - February)
Unit Maintenance Rating (Fall Only)				
Date of Inspection	4/17/2019 - 4/17/2019			
DWR Inspector	Makar Sokol			
Accompanied By	Bryan Reniff Sutter Maintenance Yard

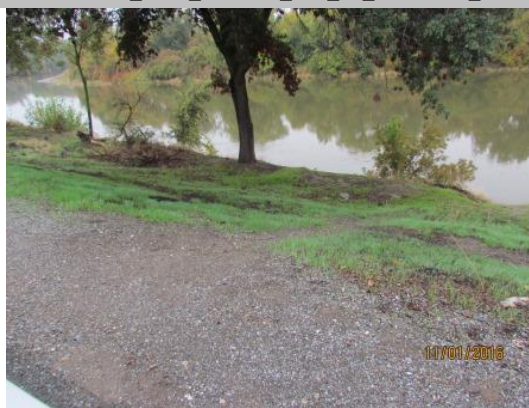
Photo 1 of 1 : SP_2019_MA0001_297_98_20190327_00029.jpg

LM Start	0.38	Rating **	A/W	Issue No.	98
LM End	0.38	Issue Type +	Ma	Location *	WS
Category	Earthen Levee			GPS Latitude/Longitude	
				Start	End
Item	Slope Stability			39.215878 °	39.215878 °
				-122.007278 °	-122.007278 °
DWR ID	DWR_MA0001_01_f_2016_98				
Comment Code					
S2 : Repair the levee slope damaged by foot traffic and prevent access where possible.					
Inspector Comment

View of the slope instability along the waterside slope.

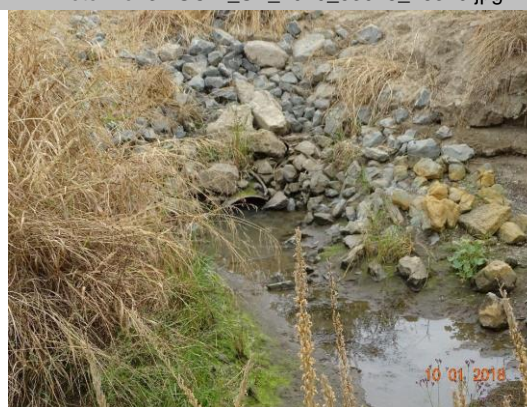
Photo 2 of 3 : UCIP_SP_2019_53078_78329.jpg

View of pipe end in irrigation ditch on LS.
