**Flood Control Project Maintenance
Levee Inspections**
LMA District Cover Sheet
Spring 2020 Levee Inspection Results

Sutter Maintenance Yard Maintenance Area 0001

Spring 2020 Levee Inspection Results

Waterway			Bank	Unit Miles
Unit No. 01 Sacramento River			Right	16.76
	Spring (March - May)	Summer (June - August)	(September - November) Fall	Winter (December - February)
Unit Maintenance Rating (Fall Only)				
Date of Inspection	3/10/2020 - 3/10/2020			
DWR Inspector	Makar Sokol			
Accompanied By	Bob Duffey Sutter Maintenance Yard

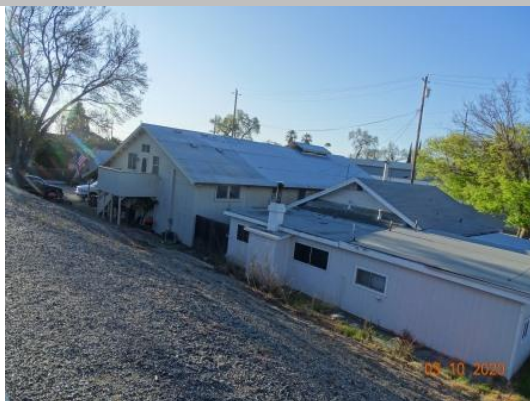
Photo 1 of 1 : SP_2020_MA0001_297_2_20200312_00141.jpg

View of the buildings along the landside toe. Spring 2020.

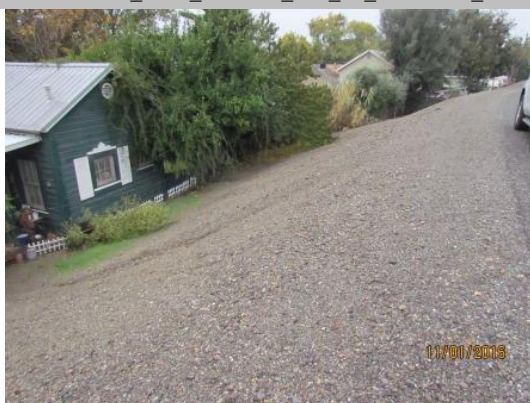
Photo 1 of 1 : SP_2020_MA0001_297_94_20200226_00024.jpg

LM Start	0.09	Rating **	A/W	Issue No.	94
LM End	0.09	Issue Type +	Ma	Location *	LS
Category	Earthen Levee			GPS Latitude/Longitude	
				Start	End
Item	Slope Stability			39.214217 °	39.214217 °
				-122.002378 °	-122.002378 °
DWR ID	DWR_MA0001_01_f _ 2016_94				
Comment Code					
S2 : Repair the levee slope damaged by foot traffic and prevent access where possible.					
Inspector Comment

View of the slope instability along the landside slope.

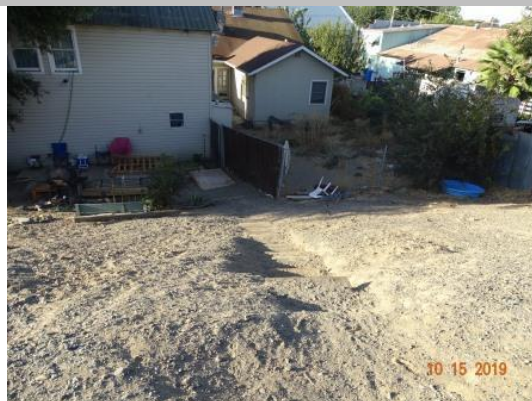
Photo 1 of 1 : SP_2020_MA0001_297_63_20200226_00012.jpg

View of the wooden stairs cut into the landside slope. Fall 2019.

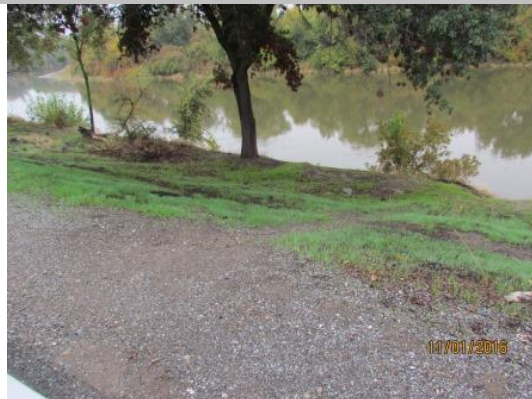
Photo 1 of 1 : SP_2020_MA0001_297_98_20200226_00025.jpg

LM Start	0.38	Rating **	A/W	Issue No.	98
LM End	0.38	Issue Type +	Ma	Location *	WS
Category	Earthen Levee			GPS Latitude/Longitude	
				Start	End
Item	Slope Stability			39.215878 °	39.215878 °
				-122.007278 °	-122.007278 °
DWR ID	DWR_MA0001_01_f _ 2016_98				
Comment Code					
S2 : Repair the levee slope damaged by foot traffic and prevent access where possible.					
Inspector Comment

View of the slope instability along the waterside slope.

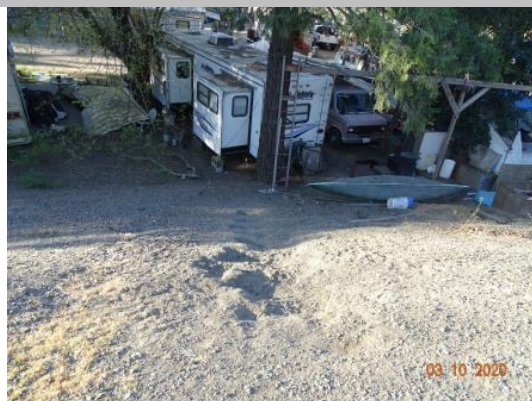
Photo 1 of 1 : SP_2020_MA0001_297_59_20200312_00143.jpg

View of the stairs cut into the landside slope. Spring 2020.

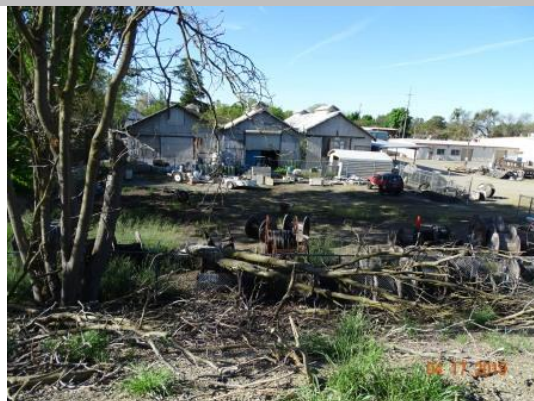
Photo 1 of 1 : SP_2020_MA0001_297_79_20200226_00016.jpg

View of the tree branches and limbs at the landside toe. Spring 2019.

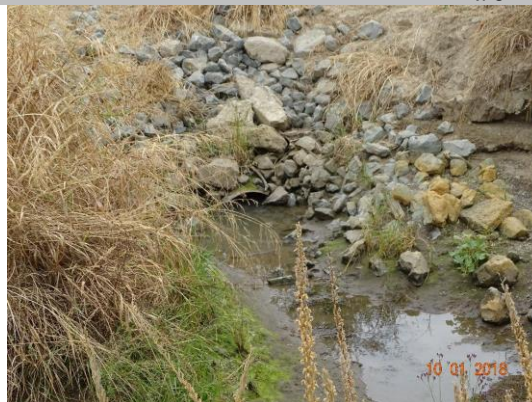
Photo 2 of 3 : UCIP_SP_2020_53078_78329.jpg

View of pipe end in irrigation ditch on LS.

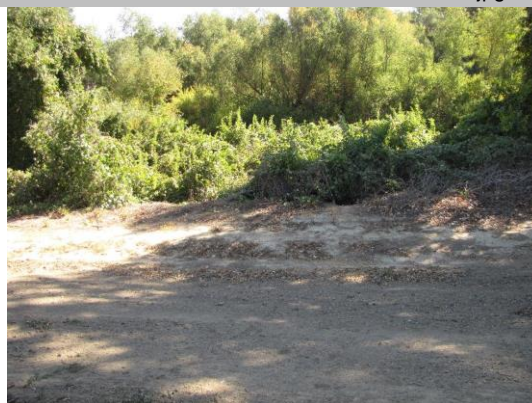
Photo 3 of 3 : UCIP_SP_2020_51855_70083.jpg

Unable to locate WS outlet.

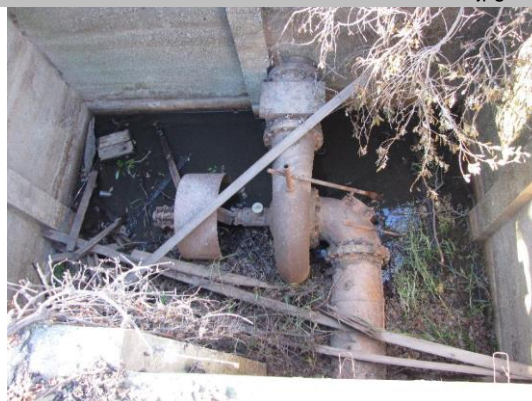
Photo 2 of 3 : UCIP_SP_2020_51861_70123.jpg

Abandoned pump system inside concrete structure located on LS.

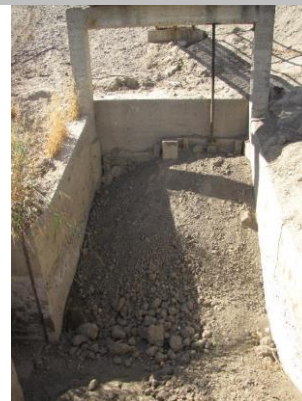
Photo 3 of 3 : UCIP_SP_2020_51875_70190.jpg

View of crossing from WS side. WS blocked by sediment. 2 slide gates part of structure design.

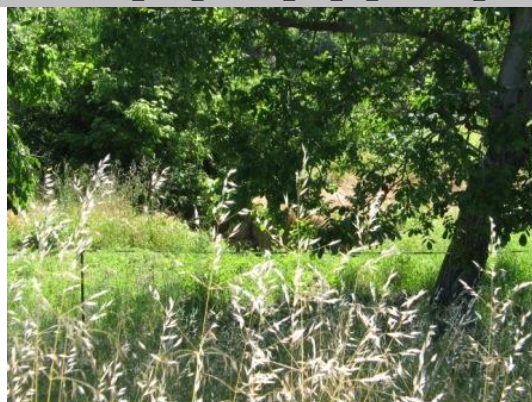
Photo 1 of 1 : SP_2020_MA0001_297_18_20200226_00008.jpg

View of the erosion along the waterside of the levee.

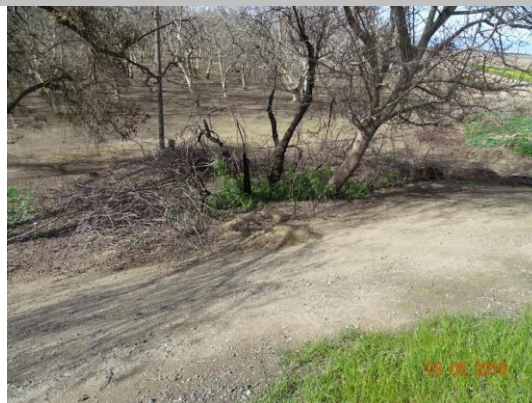
Photo 1 of 1 : SP_2020_MA0001_297_69_20200226_00013.jpg

View of the rodent holes along the landside slope.

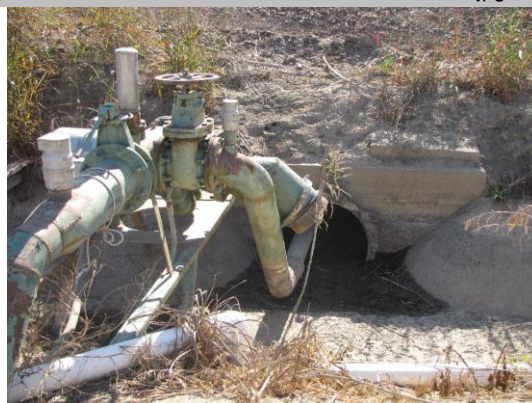
Photo 3 of 3 : UCIP_SP_2020_51903_70350.jpg

6-inch irrigation pipe through crossing at LS. Flap gate missing.

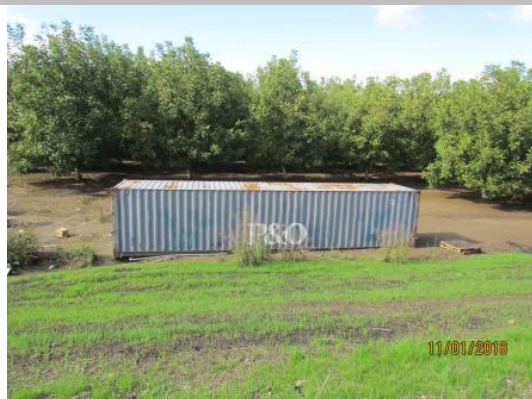
Photo 1 of 1 : SP_2020_MA0001_297_126_20200226_00027.jpg

View of a shipping container along the landside toe.

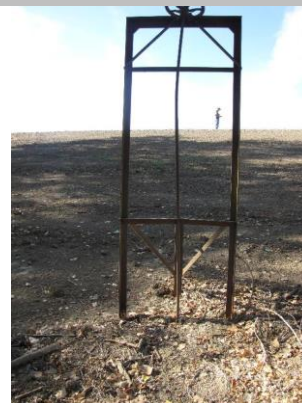
Photo 2 of 2 : UCIP_SP_2020_51910_70380.jpg

WS-Slide gate buried-non-functional.

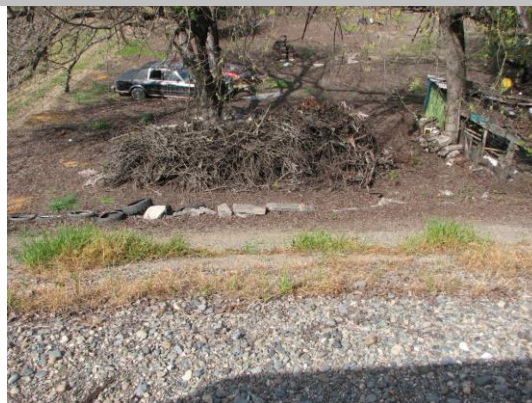
Photo 1 of 1 : SP_2020_MA0001_297_85_20200226_00018.jpg

View of prunings, concrete, and tires along the toe.

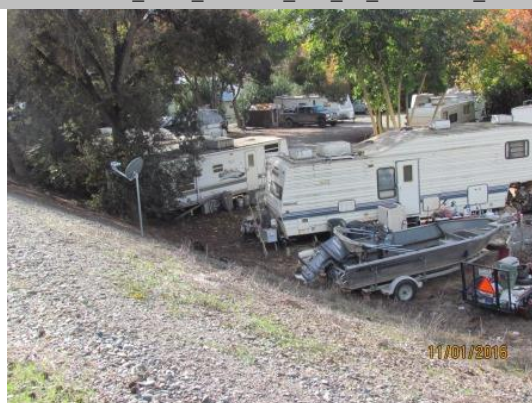
Photo 1 of 1 : SP_2020_MA0001_297_86_20200226_00019.jpg

View of the mobile homes and trailers along the landside toe.

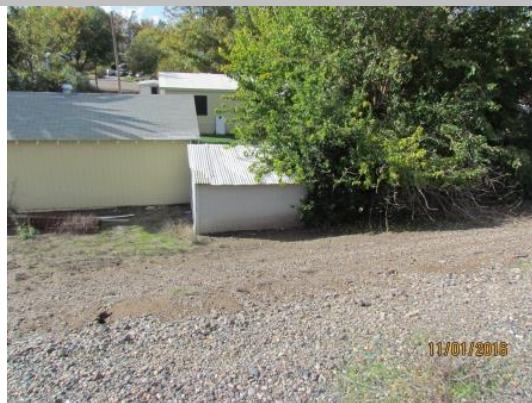
Photo 1 of 1 : SP_2020_MA0001_297_87_20200226_00020.jpg

View of a shed along the landside toe.

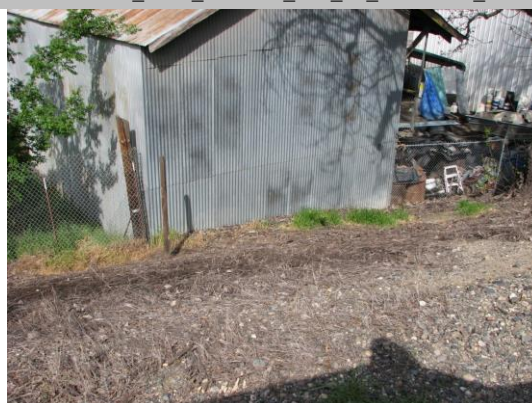
Photo 1 of 1 : SP_2020_MA0001_297_90_20200226_00022.jpg

View of a corrugated metal building obstructing visibility and access.

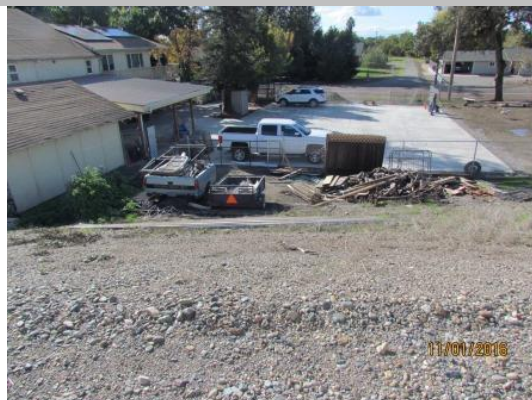
Photo 1 of 1 : SP_2020_MA0001_297_135_20200226_00030.jpg

View of metal sheets along the levee slope and debris and firewood along the landside toe.
