**Flood Control Project Maintenance  
Levee Inspections  
LMA District Cover Sheet**

**Sutter Maintenance Yard Maintenance Area 0001**

Waterway			Bank	Unit Miles
Unit No. 01 Sacramento River			Right	16.76
	Spring (March - May)	Summer (June - August)	(September - November) Fall	Winter (December - February)
Unit Maintenance Rating (Fall Only)				
Date of Inspection	3/19/2021 - 3/19/2021			
DWR Inspector	Makar Sokol			
Accompanied By	Bob Duffey Sutter Maintenance Yard

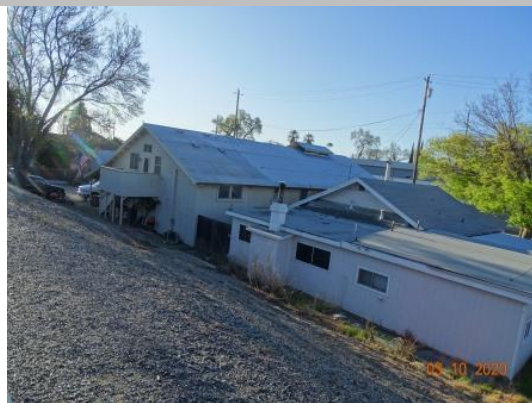
Photo 1 of 1 : SP\_2021\_MA0001\_297\_2\_20210224\_00001.jpg

View of the buildings along the landside toe. Spring 2020.

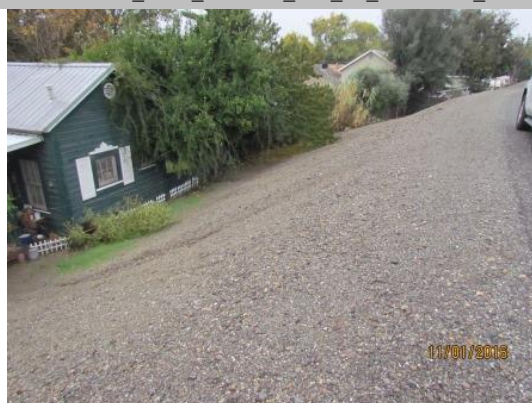
Photo 1 of 1 : SP\_2021\_MA0001\_297\_94\_20210224\_00026.jpg

LM Start	0.09	Rating **	A/W	Issue No.	94
LM End	0.09	Issue Type +	Ma	Location *	LS
Category	Earthen Levee			GPS Latitude/Longitude	
				Start	End
Item	Slope Stability			39.214217 °	39.214217 °
				-122.002378 °	-122.002378 °
DWR ID	DWR_MA0001_01_f _ 2016_94				
Comment Code					
S2 : Repair the levee slope damaged by foot traffic and prevent access where possible.					
Inspector Comment

View of the slope instability along the landside slope.

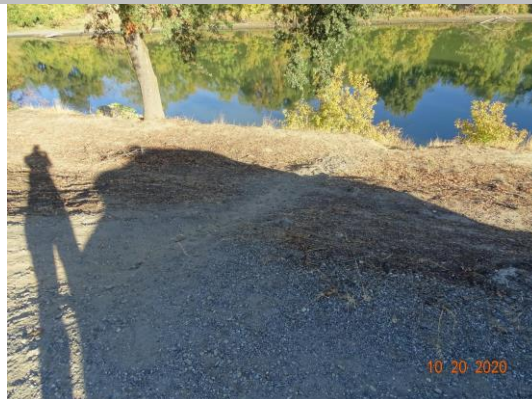
Photo 1 of 1 : SP\_2021\_MA0001\_297\_98\_20210224\_00027.jpg

LM Start	0.38	Rating **	A/W	Issue No.	98
LM End	0.38	Issue Type +	Ma	Location *	WS
Category	Earthen Levee			GPS Latitude/Longitude	
				Start	End
Item	Slope Stability			39.215878 °	39.215878 °
				-122.007278 °	-122.007278 °
DWR ID	DWR_MA0001_01_f _ 2020_98				
Comment Code					
S2 : Repair the levee slope damaged by foot traffic and prevent access where possible.					
Inspector Comment

View of the slope instability along the waterside slope. Fall 2020.

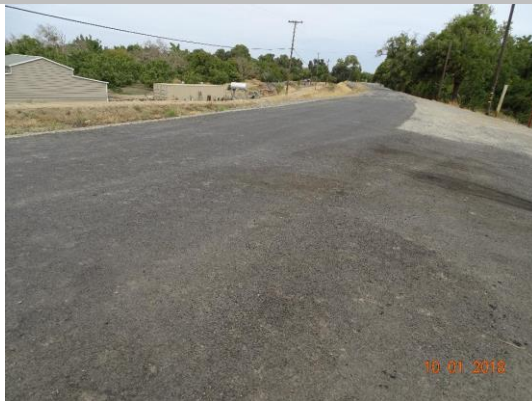
Photo 1 of 3 : UCIP\_SP\_2021\_58087\_78328.jpg

Comment Code					
Inspector Comment					
FS_ID:58087 DS_ID:25564 EP_NO: 9481-1 Repair Type: Non-Urgent Crossing Status: Found UCIP Comments: 10/01/2018 Pipe installed according to emergency work authorization dated 07-31-2017 under existing permit No. 9481. Owner Roberts Ditch Company needs to submit as-builts. (O.Yakimov - DWR UCIP) FIELD_STRUCT_DESC: 36-inch smooth steel epoxy coated interior/exterior irrigation pipe with positive closure device on the water side of the levee. Crossing penetrates the levee at an angle. Other appurtenances located at this crossing include 2 slant pumps connected to a concrete distribution box, and shed structure located 100 feet northeast from levee crossing. Flow is carried from concrete distribution box to slide gate via concrete lined ditch. pipe is open to an irrigation ditch on LS. (36-inch installed according to the board emergency work authorization dated 07-31-2017 under Permit No. 9481-1, 2018 - Roberts Ditch Company; existing 36-inch was removed [logged under UCIP DSID 16431]). FS Date: 10/1/2018 10:51:00 AM

View of levee crown at crossing.

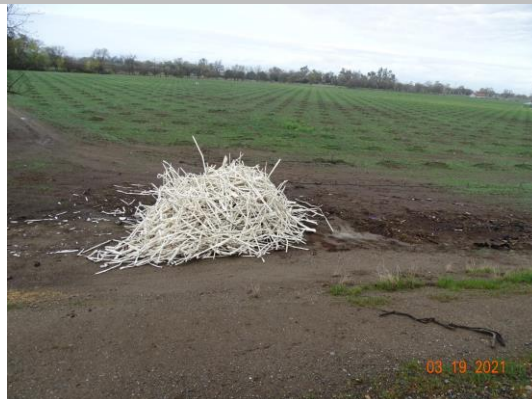
Photo 1 of 1 : SP\_2021\_MA0001\_297\_62\_20210322\_00143.jpg

View of the pile of PVC pipes at the landside toe. Spring 2021.

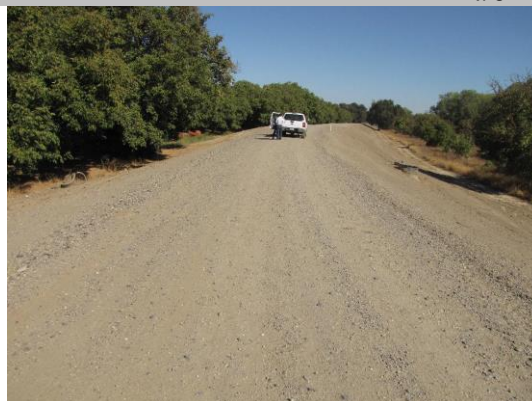
Photo 1 of 3 : UCIP\_SP\_2021\_58090\_70064.jpg

Comment Code						
Inspector Comment						
FS_ID:58090 DS_ID:16430 EP_NO: 9487 Repair Type: Non-Urgent Crossing Status: Found UCIP Comments: 05/03/2017 WS end still partially plugged. (A. Freitag - DWR Sutter Yard)10/24/2016 Ws end is till partially plugged. (A. Freitag - DWR Sutter Yard)04/25/2016 WS pipe end is still plugged with soil. Rest of the pipe appeared to be in good condition. (A. Freitag - DWR Sutter Yard)04/20/2015 WS pipe end is plugged about 50% by soil. (A. Freitag - DWR Sutter Yard)06/18/2014 Same as last inspection. (A. Freitag - DWR Sutter Yard)12/17/2013 Same as last inspection. (A. Freitag - DWR Sutter Yard)07/18/2013 WS pipe end has been reformed but is still clogged about 50% by sediment.10/18/2012 Remove dirt and debris in riser. Outlet deformed and blocked over 50%. Debris-round concrete section on landward side. This crossing was listed in the USACE Periodic Inspections as ID# USACE_CESPK_MA1C_2010_p_0116 for crossing outlet deformed and clogged with dirt. (O. Magana - DWR UCIP) FIELD_STRUCT_DESC: 1 of 2: 36-inch corrugated metal drainage pipe through the levee, approximately 12-15 feet below the crown. Slide gates in corrugated metal pipe (CMP) riser located on the waterside (WS) slope. Pipe daylights on the landside (LS). (36-inch pipe [HLM 1.97] authorized under Automatic Board Order (ABO) issued as Permit No. 9487, 1974 - Jimeno Rancho) [Additional Reference(s): DWR Levee Log, 1992. USACE Sacramento O&M Manual 137, August 1955, (Station 103+18)]. FS Date: 5/19/2017 1:20:00 PM

Overview of levee crown and slopes looking upstream towards crossing.

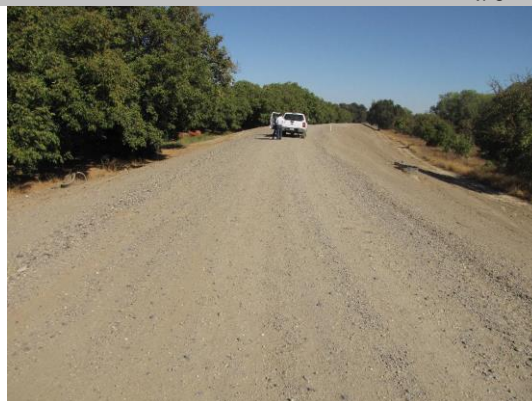
Photo 1 of 3 : UCIP\_SP\_2021\_58092\_70071.jpg

FS\_ID:58092  
DS\_ID:17565  
EP\_NO: 9487  
Repair Type: Non-Urgent  
Crossing Status: Found  
UCIP Comments: 05/03/2017 Ws end still partially plugged. (A. Freitag - DWR Sutter Yard)10/24/2016 Ws pipe end still plugged. (A. Freitag - DWR Sutter Yard)04/25/2016 WS pipe end still plugged with soil. rest of pipe appears in good condition. (A. Freitag - DWR Sutter Yard)04/20/2015 WS pipe end plugged about 50% by soil. (A. Freitag - DWR Sutter Yard)06/18/2014 Same as last inspection. (A. Freitag - DWR Sutter Yard)12/17/2013 Same as last inspection. (A. Freitag - DWR Sutter Yard)07/18/2013 WS pipe end has been reformed but is still partially blocked with dirt and debris.10/18/2012 WS-remove dirt and debris in riser. Outlet deformed and blocked over 50%. Burrow activity near outlet on waterward slope. Debris around concrete section on landward side. This crossing was listed in the USACE Periodic Inspections as ID# USACE\_CESPK\_MA1C\_2010\_p\_0116 for crossing outlet deformed and clogged with dirt. (O. Magana - DWR UCIP)

View of levee crown and slopes looking upstream at crossing.

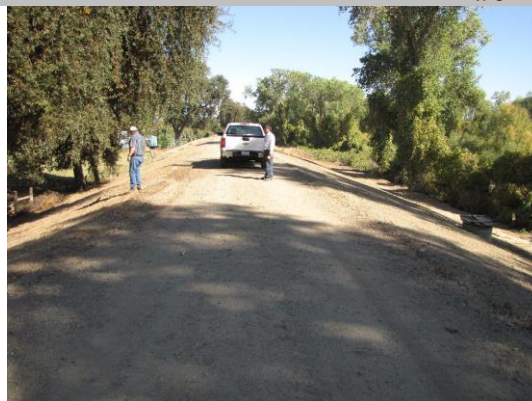
Photo 1 of 3 : UCIP\_SP\_2021\_58095\_70085.jpg

Comment Code						
Inspector Comment						
FS_ID:58095 DS_ID:16428 EP_NO: 9467 Repair Type: Non-Urgent Crossing Status: Found UCIP Comments: 05/03/2017 Abanoned- needs to be done so properly. (A. Freitag - DWR Sutter Yard)10/24/2016 Abandoned. (A. Freitag - DWR Sutter Yard)04/25/2016 Abandoned crossing. Unable to locate any WS and LS pipe ends. (A. Freitag - DWR Sutter Yard)04/20/2015 Same as last inspection. (A. Freitag - DWR Sutter Yard)06/18/2014 Same as last inspection. (A. Freitag - DWR Sutter Yard)12/17/2013 Same as last inspection. (A. Freitag - DWR Sutter Yard)07/18/2013 Same as last inspection. (A. Freitag - DWR Sutter Yard)10/18/2012 Only riser visible. Debris and sediment blocking gate. Gate inside riser is buried and non-functional. If crossing is abandoned, owner needs to properly abandon. This crossing was listed in the USACE Periodic Inspections as ID# USACE_CESPK_MA1C_2010_p_0132 no culvert through the levee is visible here. (O. Magana - DWR UCIP) FIELD_STRUCT_DESC: *ABANDONED* 24-inch corrugated metal drainage pipe through the levee, approximately 12-15 feet below the crown. Slide gate in CM pipe riser on the waterside (WS) slope. No signs of inlet visible on the landside (LS). (24-inch pipe [HLM 2.31] authorized under Automatic Board Order (ABO) issued as Permit No. 9467, 1974 - Lovell E. Spurgeon) [Additional Reference(s): DWR Levee Log, 1992. USACE Sacramento O&M Manual 137, August 1955, (Station 120+60)]. FS Date: 5/19/2017 1:48:00 PM

Overview of levee crown looking upstream at crossing.

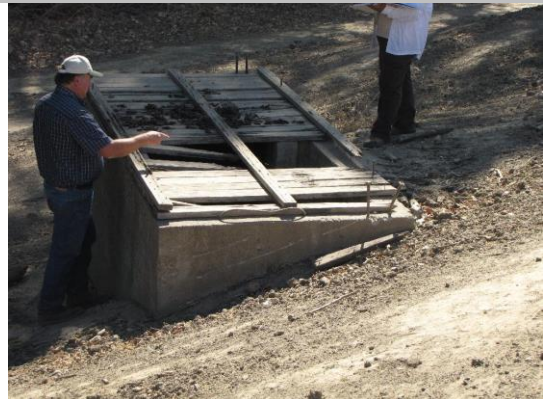
Photo 3 of 3 : UCIP\_SP\_2021\_58096\_70090.jpg

FS\_ID:58096  
DS\_ID:16416  
EP\_NO: 9474  
Repair Type: Non-Urgent  
Crossing Status: Found  
UCIP Comments: 05/03/2017 Appears abandoned- WS vault full of soil. Needs to be abandoned properly. (A. Freitag - DWR Sutter Yard)10/24/2016 Appears to be abandoned. WS vault full of soil to help prevent water from flowing through during high water season. (A. Freitag - DWR Sutter Yard)04/25/2016 Concrete box was filled with dirt to help prevent water from through during high water times. (A. Freitag - DWR Sutter Yard)04/20/2015 Positive closure device is missing and water cannot be prevented from flowing through pipe during high water. (A. Freitag - DWR Sutter Yard)06/18/2014 Same as last inspection. (A. Freitag - DWR Sutter Yard)12/17/2013 Same as last inspection. (A. Freitag - DWR Sutter Yard)07/18/2013 Same as last inspection. (A. Freitag - DWR Sutter Yard)10/18/2012 During high water flow goes through levee. Missing positive closure device on waterward side. This structure appears abandoned-slide gates have been removed. Crossing needs to be properly abandoned. This crossing was listed in the USACE Periodic Inspection as ID# USACE\_CESPK\_MA1C\_2010\_p\_0169 for concrete box partially filled with dirt. (O. Magana - DWR UCIP)

Concrete distribution box located on WS shoulder.

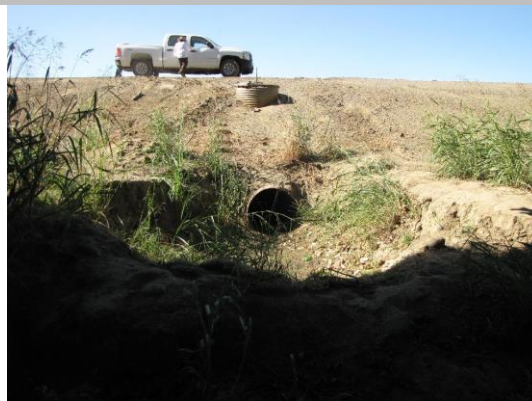
Photo 3 of 3 : UCIP\_SP\_2021\_58101\_70111.jpg

Comment Code						
Inspector Comment						
FS_ID:58101 DS_ID:16426 EP_NO: 9490 Repair Type: Non-Urgent Crossing Status: Found UCIP Comments: 05/03/2017 Sediment build up in WS pipe end. WS slide gate stem bent but it does not affect its operation. (A. Freitag - DWR Sutter Yard)10/24/2016 WS slide gate stem is still bent. (A. Freitag - DWR Sutter Yard)04/25/2016 WS slide gate is slightly bent. Rest of crossing appears to be in good condition. (A. Freitag - DWR Sutter Yard) 04/20/2015 LS inlet still has some minor sediment build up. Needs to be cleaned. (A. Freitag - DWR Sutter Yard)06/18/2014 Same as last inspection. (A. Freitag - DWR Sutter Yard)12/17/2013 Same as last inspection. (A. Freitag - DWR Sutter Yard)07/18/2013 WS slide gate looks to be in good condition but stem is slightly bent. Not sure if bend will hinder gates operation or not. LS inlet is still blocked by minor sediment build up.10/18/2012 LS pipe slightly deformed and sediment build up blocking about 30% of opening; need to check the condition of the slide gate-need photo. Metal marker down. This crossing was listed in the USACE Periodic Inspection as ID# USACE_CESPK_MA1C_2010_p_0187 for sediment build up at landward toe. (O. Magana - DWR UCIP) FIELD_STRUCT_DESC: 36-inch corrugated metal drainage pipe through the levee, approximately 12-15 feet below the crown. Slide gate in corrugated metal pipe (CMP) riser on the waterside (WS) slope. (36-inch pipe [HLM 3.78] authorized under Automatic Board Order (ABO) issued as Permit No. 9490, 1955 - Charles & Virginia Yerxa) [Additional Reference(s): DWR Levee Log, 1992. USACE Sacramento O&M Manual 137, August 1955, (Station 177+67)]. FS Date: 5/19/2017 1:53:00 PM

View of WS slope, riser with slide gate, and outlet.

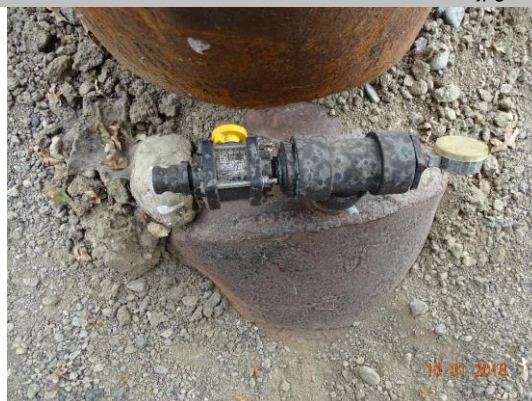
Photo 3 of 3 : UCIP\_SP\_2021\_58103\_78236.jpg

FS\_ID:58103  
DS\_ID:16436  
EP\_NO: 4213  
Repair Type: Urgent  
Crossing Status: Found  
UCIP Comments: 10/01/2018 Sinkhole near concrete structure on the LS was filled with soil and debris. Flow meter at the WS shoulder and a manometer on the pipe on the LS shoulder was installed. Video inspection is recommended to determine pipe integrity through levee. (O.Yakimov - DWR UCIP)05/03/2017 Sinkhole still present next to concrete structure on LS. (A. Freitag - DWR Sutter Yard)10/24/2016 Pump is on WS. Sinkhole still present over pipe alignment next to the concrete building. (A. Freitag - DWR Sutter Yard)04/25/2016 No repairs have been made since last inspection. Sink holes are still present above pipe next to concrete building on LS. (A. Freitag - DWR Sutter Yard)04/20/2015 Sink hole over pipe alignment on LS up against the concrete building. Need to dig up pipe and see if its leaking. (A. Freitag - DWR Sutter Yard)06/23/2014 Same as last inspection. (A. Freitag - DWR Sutter Yard)06/18/2014 Same as last inspection. (A. Freitag - DWR Sutter Yard)12/17/2013 Same as last inspection. (A. Freitag - DWR Sutter Yard)07/18/2013 Same as last inspection. (A. Freitag - DWR Sutter Yard)10/19/2012 Recommend adding door to LS concrete structure. Riser located on landward side is damaged. This crossing was listed in the USACE Periodic Inspection as ID# USACE\_CESPK\_MA1C\_2010\_p\_0194 no issues logged. (O. Magana - DWR UCIP)

Manometer and air valve installed on pipe at LS shoulder.

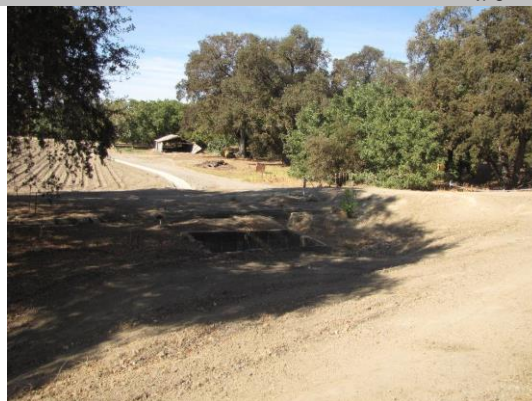
Photo 1 of 3 : UCIP\_SP\_2021\_58104\_70125.jpg

FS\_ID:58104  
DS\_ID:16424  
EP\_NO: 9490  
Repair Type: Non-Urgent  
Crossing Status: Found  
UCIP Comments: 05/03/2017 Abandoned- Needs to be done properly. (A. Freitag - DWR Sutter Yard)10/24/2016 Abandoned. Needs a cover made for the LS distribution box. (A. Freitag - DWR Sutter Yard)04/25/2016 ABANDONED crossing and should be abandoned properly. Concrete distribution box on LS is opened on top and could pose a safety hazard with falling. (A. Freitag - DWR Sutter Yard)04/20/2015 Same as last inspection. (A. Freitag - DWR Sutter Yard) 06/18/2014 Same as last inspection. (A. Freitag - DWR Sutter Yard)12/17/2013 Same as last inspection. (A. Freitag - DWR Sutter Yard)07/18/2013 Same as last inspection. (A. Freitag - DWR Sutter Yard)10/19/2012 Crossing needs to be properly abandoned. This crossing was listed in the USACE Periodic Inspection as ID# USACE\_CESPK\_MA1C\_2010\_p\_0194-6 & 7 no issues logged. (O. Magana - DWR UCIP)

Concrete distribution box located on LS.

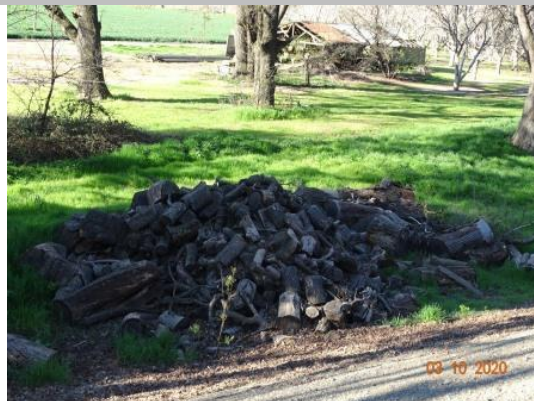
Photo 1 of 1 : SP\_2021\_MA0001\_297\_102\_20210224\_00028.jpg

View of the pile of firewood at the landside toe. Spring 2020.

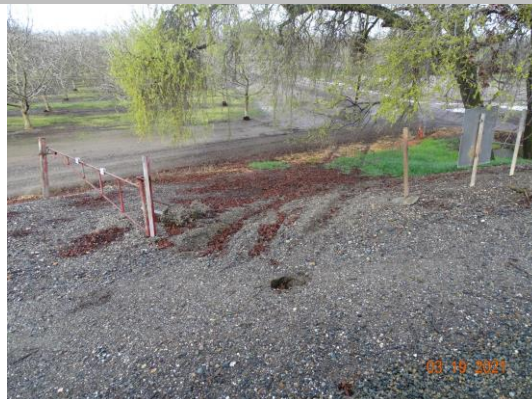
Photo 1 of 1 : SP\_2021\_MA0001\_297\_65\_20210322\_00144.jpg

View of the slope stability issue caused by vehicle tires. Spring 2021.

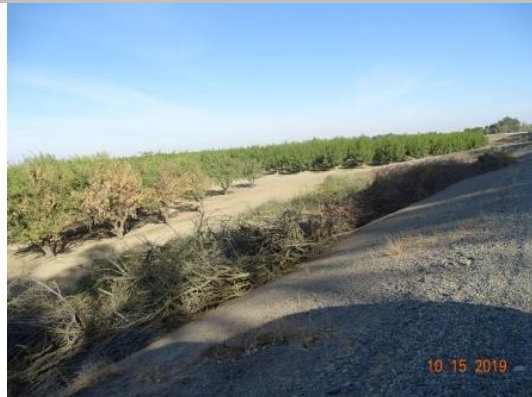
Photo 1 of 1 : SP\_2021\_MA0001\_297\_115\_20210224\_00029.jpg

View of the prunings along the landside slope and toe. Fall 2019.

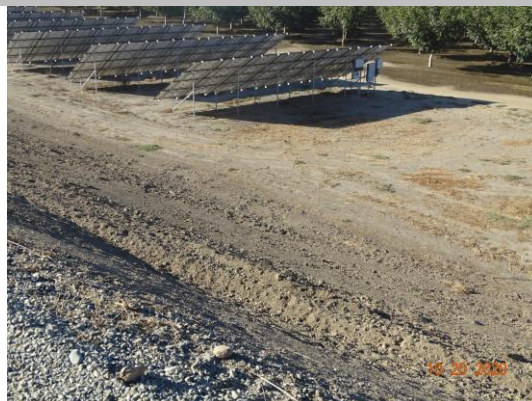
Photo 1 of 1 : SP\_2021\_MA0001\_297\_77\_20210224\_00018.jpg

View of the slope instability along the landside slope. Fall 2020.

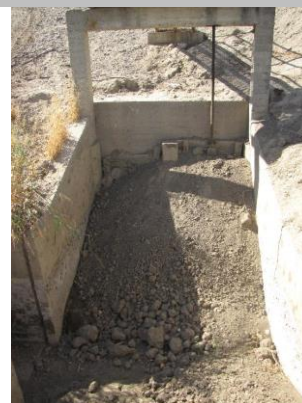
Photo 3 of 3 : UCIP\_SP\_2021\_58120\_70190.jpg

View of crossing from WS side. WS blocked by sediment. 2 slide gates part of structure design.

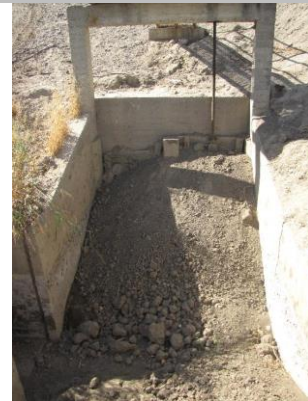
Photo 3 of 3 : UCIP\_SP\_2021\_58121\_70196.jpg

View of crossing from WS. WS blocked by sediment. 2 slide gates part of structure design.

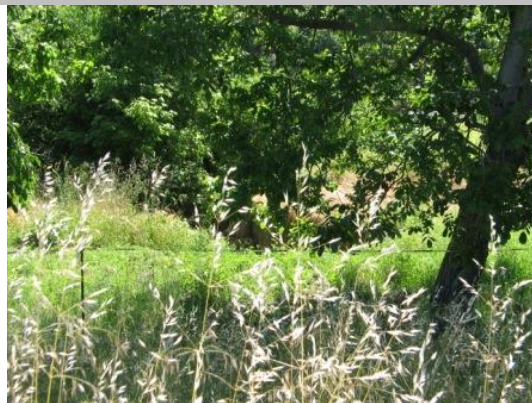
Photo 1 of 1 : SP\_2021\_MA0001\_297\_18\_20210224\_00008.jpg

View of the erosion along the waterside of the levee.

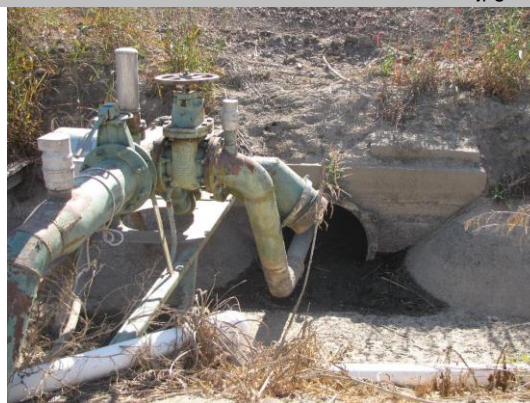
Photo 3 of 3 : UCIP\_SP\_2021\_51903\_70350.jpg

6-inch irrigation pipe through crossing at LS. Flap gate missing.

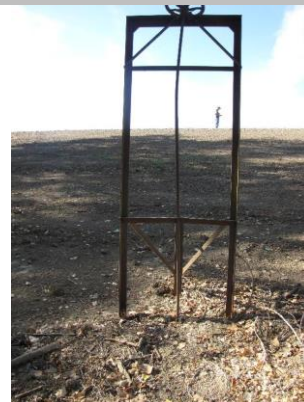
Photo 2 of 2 : UCIP\_SP\_2021\_58141\_70380.jpg

WS-Slide gate buried-non-functional.

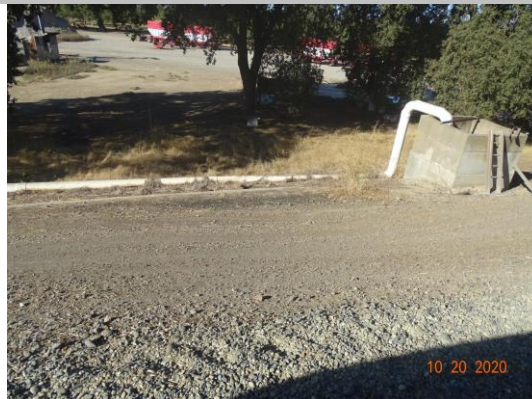
Photo 1 of 1 : SP\_2021\_MA0001\_297\_128\_20210224\_00031.jpg

View of the concrete pipe that runs along the landside toe. Fall 2020.

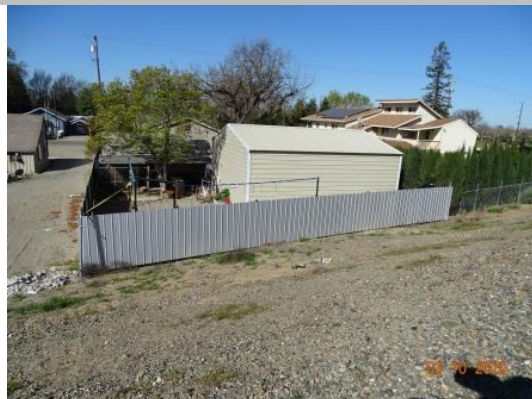
Photo 1 of 1 : SP\_2021\_MA0001\_297\_47\_20210224\_00011.jpg

View of the fence along the landside toe. Spring 2020.
