**Flood Control Project Maintenance
Levee Inspections
LMA District Cover Sheet**

Sutter Maintenance Yard Maintenance Area 0001

Waterway			Bank	Unit Miles
Unit No. 01 Sacramento River			Right	16.76
	Spring (March - May)	Summer (June - August)	(September - November) Fall	Winter (December - February)
Unit Maintenance Rating (Fall Only)				
Date of Inspection	4/5/2022 - 4/5/2022			
DWR Inspector	Makar Sokol			
Accompanied By	Gregg Ahlers DWR Sutter Yard

Levee Inspection Report By Mile - Spring 2022

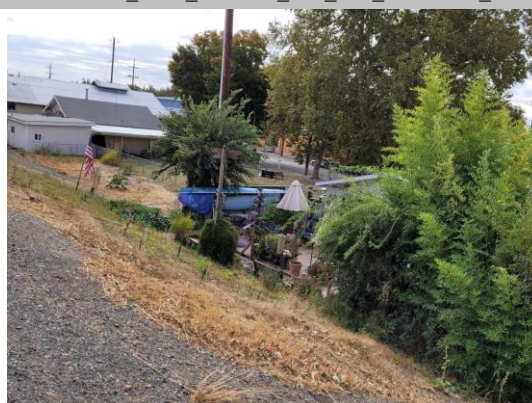
Photo 1 of 1 : SP_2022_MA0001_297_106_20220307_00029.jpg

View of the irrigation system on the landside slope. Fall 2021.

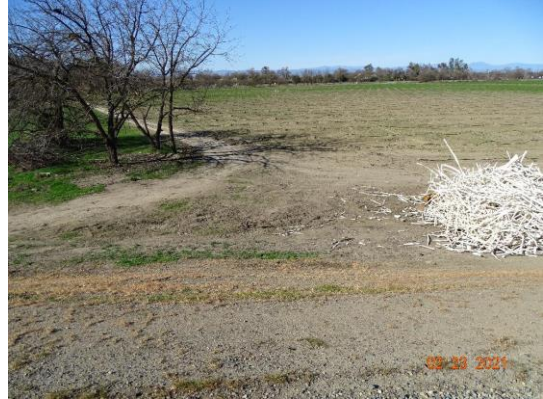
Photo 3 of 3 : UCIP_SP_2022_62866_91138.jpg

FS_ID:62866
DS_ID:16486
EP_NO: 15617
Repair Type: Non-Urgent
Crossing Status: Not Found
UCIP Comments: 02/23/2021 Record is Non-Urgent. Crossing not found. Irrigation PVC pipe debris pile on landside. (O.Yakimov - DWR UCIP)
06/01/2016 DELETE record not through levees. (A. Freitag - DWR Sutter Yard)04/25/2016 Unable to locate. (A. Freitag - DWR Sutter Yard)04/20/2015 Unable to locate. (A. Freitag - DWR Sutter Yard)06/18/2014 Unable to locate. (A. Freitag - DWR Sutter Yard)12/17/2013 Unable to locate. (A. Freitag - DWR Sutter Yard)07/18/2013 Same as last inspection. Unable to locate.
FIELD_STRUCT_DESC: *NOT THROUGH LEVEE* A portable irrigation pump on the right bank of the Sacramento River during the irrigation season. (Installation of portable irrigation pump authorized under Permit No. 15617, 1991 - Nancy Ward).
FS Date: 2/23/2021 8:56:22 AM

Land-Side: View of levee slope looking from crown. PVC pipe debris at levee toe

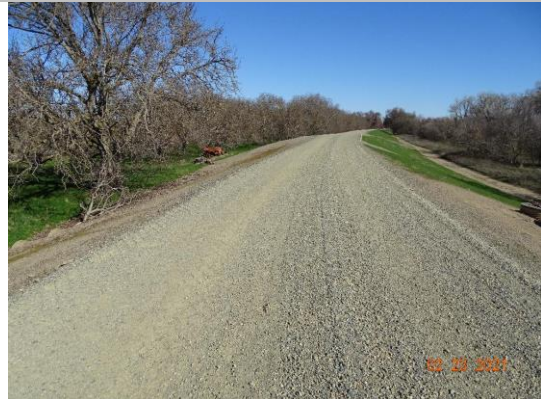
Photo 1 of 3 : UCIP_SP_2022_62869_91150.jpg

FS_ID:62869
DS_ID:16430
EP_NO: 9487
Repair Type: Urgent
Crossing Status: Found
UCIP Comments: 02/23/2021 Record updated from Non-Urgent to Urgent. DMP internal video inspection has found pipe integrity issues. LOF of crossing is between 5 and 6. Crossing will be monitored until funding becomes available to address the issues. No permit has been identified authorizing pipe. Need to have CVFPB review ABO and determine current owner. (O.Yakimov - DWR UCIP)
05/03/2017 WS end still partially plugged. (A. Freitag - DWR Sutter Yard)
10/24/2016 WS end is till partially plugged. (A. Freitag - DWR Sutter Yard)04/25/2016 WS pipe end is still plugged with soil. Rest of the pipe appeared to be in good condition. (A. Freitag - DWR Sutter Yard)04/20/2015 WS pipe end is plugged about 50% by soil. (A. Freitag - DWR Sutter Yard)06/18/2014 Same as last inspection. (A. Freitag - DWR Sutter Yard)12/17/2013 Same as last inspection. (A. Freitag - DWR Sutter Yard)07/18/2013 WS pipe end has been reformed but is still clogged about 50% by sediment.10/18/2012 Remove dirt and debris in riser. Outlet deformed and blocked over 50%. Debris-round concrete section on landward side. This crossing was listed in the USACE Periodic Inspections as ID#

Top of Levee: View of levee crown looking upstream

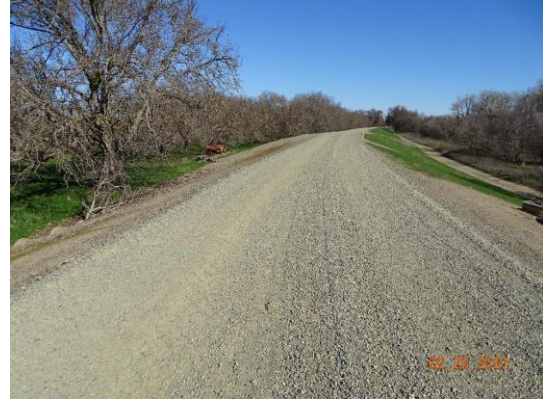
Photo 1 of 3 : UCIP_SP_2022_62871_91162.jpg

FS_ID:62871
DS_ID:17565
EP_NO: 9487
Repair Type: Urgent
Crossing Status: Found
UCIP Comments: 02/23/2021 Record updated from Non-Urgent to Urgent. DMP internal video inspection has found pipe integrity issues. LOF of crossing is between 5 and 6. Crossing will be monitored until funding becomes available to address the issues. No permit has been identified authorizing pipe. Need to have CVFPB review ABO and determine current owner. (O.Yakimov - DWR UCIP)
05/03/2017 WS end still partially plugged. (A. Freitag - DWR Sutter Yard)10/24/2016 WS pipe end still plugged. (A. Freitag - DWR Sutter Yard)04/25/2016 WS pipe end still plugged with soil. rest of pipe appears in good condition. (A. Freitag - DWR Sutter Yard)04/20/2015 WS pipe end plugged about 50% by soil. (A. Freitag - DWR Sutter Yard)06/18/2014 Same as last inspection. (A. Freitag - DWR Sutter Yard)12/17/2013 Same as last inspection. (A. Freitag - DWR Sutter Yard)07/18/2013 WS pipe end has been reformed but is still partially blocked with dirt and debris.10/18/2012 WS-remove dirt and debris in riser. Outlet deformed and blocked over 50%. Burrow activity near outlet on waterward slope. Debris around concrete section on landward side. This crossing was listed in the USACE Periodic Inspections as ID# USACE_CESPK_MA1C_2010_p_0116 for crossing outlet deformed and clogged with dirt. (O. Magana - DWR UCIP)

Top of Levee: View of levee crown looking upstream

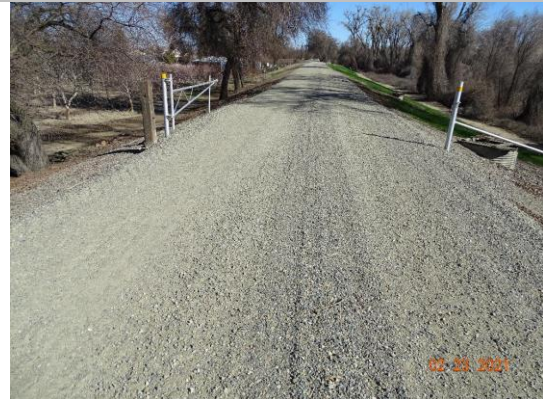
Photo 1 of 3 : UCIP_SP_2022_62872_91171.jpg

FS_ID:62872
DS_ID:16429
EP_NO: 9472
Repair Type: Urgent
Crossing Status: Found
UCIP Comments: 02/23/2021 Record updated from Non-Urgent to Urgent. DMP internal video inspection has found pipe integrity issues. LOF of crossing is between 5 and 6. Crossing will be monitored until funding becomes available to address the issues. No permit has been identified authorizing pipe. Need to have CVFPB review ABO and determine current owner. Crossing appears abandoned. Soil blocks more than 80% of pipe end at landside toe. (O.Yakimov - DWR UCIP) 05/03/2017 LS inlet partially plugged with soil. Some debris still present inside riser. (A. Freitag - DWR Sutter Yard)10/24/2016 Debris still inside of riser. (A. Freitag - DWR Sutter Yard)04/25/2016 Pipe still inside of riser and LS end plugged about 50% by soil. (A. Freitag - DWR Sutter Yard)04/20/2015 Same as last inspection. (A. Freitag - DWR Sutter Yard)06/18/2014 Same as last inspection. (A. Freitag - DWR Sutter Yard)12/17/2013 Same as last inspection. (A. Freitag - DWR Sutter Yard)07/18/2013 Same as last inspection. (A. Freitag - DWR Sutter Yard)10/18/2012 Remove debris from riser. Landward inlet is blocked by over 50%. This crossing was listed in the USACE Periodic Inspections as ID# USACE_CESPK_MA1C_2010_p_0128 for sediment build up at inlet (landward side) and debris inside riser. (O. Magana - DWR UCIP) FIELD_STRUCT_DESC: 54-inch corrugated metal drainage pipe through the levee, approximately 12-15 feet below the crown. Slide gate in corrugated metal pipe (CMP) riser on the waterside (WS) slope. Pipe daylights at landside toe. This pipe crosses the levee at angle. (54-inch pipe [HLM 2.29] authorized under Automatic Board Order (ABO) issued as Permit No. 9472, 1974 - Ballard). [Additional Reference(s): DWR Levee Log, 1992 (HLM 2.29). USACE Sacramento O&M Manual, Unit 137, August 1955, Revised 29 December 2016, (STA 120+00), listed as 54-inch pipe].

Top of Levee: View of levee crown looking upstream

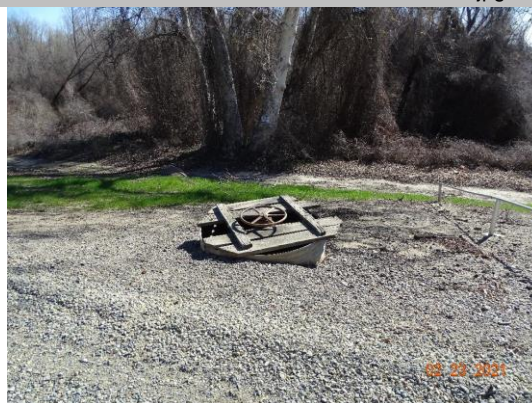
Photo 3 of 3 : UCIP_SP_2022_62872_91174.jpg

Water-Side: View of levee slope looking from crown. CMP riser on levee slope

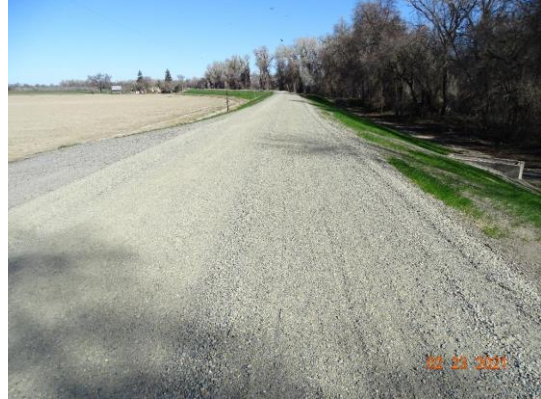
Photo 1 of 3 : UCIP_SP_2022_62892_91308.jpg

FS_ID:62892
DS_ID:16416
EP_NO: 9474
Repair Type: Urgent
Crossing Status: Found
UCIP Comments: 02/23/2021 Record updated from Non-Urgent to Urgent. Missing slide gate on pipe in concrete box on waterside slope creates flood threat to landside. Crossing appears abandoned. Concrete box on waterside filled with soil, soil deposits inside and around pipe end on landside. No permit has been identified authorizing pipe. Need to have CVFPB review ABO and determine current owner. (O.Yakimov - DWR UCIP)
05/03/2017 Appears abandoned- WS vault full of soil. Needs to be abandoned properly. (A. Freitag - DWR Sutter Yard)10/24/2016 Appears to be abandoned. WS vault full of soil to help prevent water from flowing through during high water season. (A. Freitag - DWR Sutter Yard)04/25/2016 Concrete box was filled with dirt to help prevent water from through during high water times. (A. Freitag - DWR Sutter Yard)04/20/2015 Positive closure device is missing and water cannot be prevented from flowing through pipe during high water. (A. Freitag - DWR Sutter Yard)06/18/2014 Same as last inspection. (A. Freitag - DWR Sutter Yard)12/17/2013 Same as last inspection. (A. Freitag - DWR Sutter Yard)07/18/2013 Same as last inspection. (A. Freitag - DWR Sutter Yard)10/18/2012 During high water flow goes through levee. Missing positive closure device on waterward side. This structure appears abandoned-slide gates have been removed. Crossing needs to be properly abandoned. This crossing was listed in the USACE Periodic Inspection as ID# USACE_CESPK_MA1C_2010_p_0169 for concrete box partially filled with dirt. (O. Magana - DWR UCIP)

Top of Levee: View of levee crown looking upstream

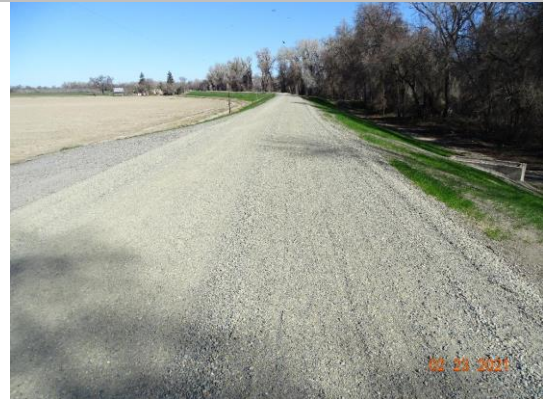
Photo 1 of 3 : UCIP_SP_2022_62894_91323.jpg

FS_ID:62894
DS_ID:17567
EP_NO: 9474
Repair Type: Urgent
Crossing Status: Found
UCIP Comments: 02/23/2021 Record updated from Non-Urgent to Urgent. Missing slide gate on pipe in concrete box on waterside slope creates flood threat to landside. Crossing appears abandoned. Concrete box on waterside filled with soil, soil deposits inside and around pipe end on landside. No permit has been identified authorizing pipe. Need to have CVFPB review ABO and determine current owner. (O.Yakimov - DWR UCIP)
05/03/2017 Appears abandoned- WS vault full of soil. Needs to be abandoned properly. (A. Freitag - DWR Sutter Yard)10/24/2016 Appears to be abandoned. WS vault full of soil to help prevent water from flowing through during high water season. (A. Freitag - DWR Sutter Yard)04/25/2016 Concrete box on WS was filled with soil to help prevent water form flowing through during times of high water. (A. Freitag - DWR Sutter Yard)04/20/2015 Positive closure device is missing and water cannot be prevented from flowing through pipe during high water. (A. Freitag - DWR Sutter Yard)06/18/2014 Same as last inspection. (A. Freitag - DWR Sutter Yard)12/17/2013 Same as last inspection. (A. Freitag - DWR Sutter Yard)07/18/2013 Same as last inspection. (A. Freitag - DWR Sutter Yard)10/18/2015 During high water flow goes through levee. Missing positive closure device on waterward side. This structure appears abandoned-slide gates have been removed. Crossing needs to be properly abandoned. This crossing was listed in the USACE Periodic Inspection as ID# USACE_CESPK_MA1C_2010_p_0169 for concrete box partially filled with dirt. (O. Magana - DWR UCIP)

Top of Levee: View of levee crown looking upstream

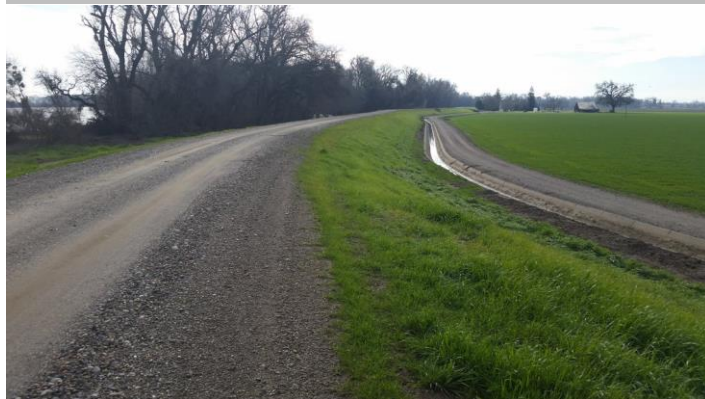
Photo 1 of 1 : SP_2022_MA0001_297_5_20220307_00002.jpg

View of the concrete lined ditch along the landside toe.

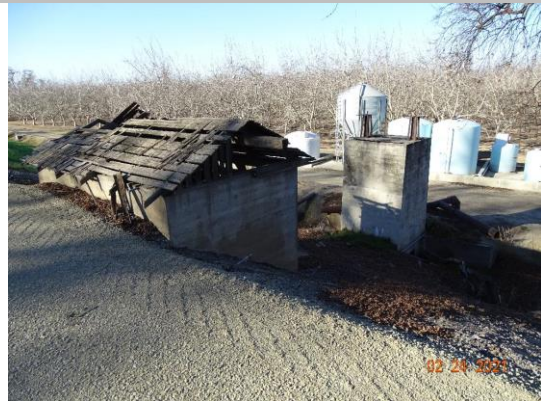
Photo 3 of 3 : UCIP_SP_2022_62919_91497.jpg

Land-Side: View of levee slope looking from crown. Abandoned pumphouse on levee shoulder

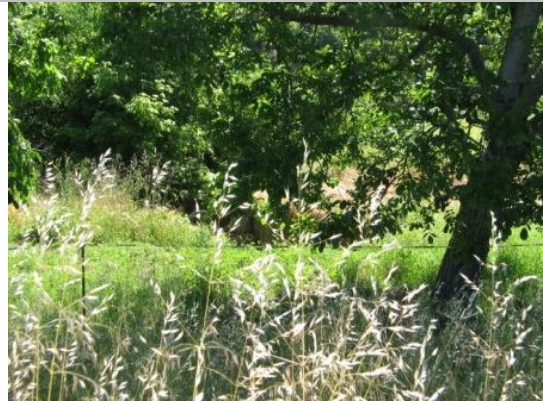
Photo 1 of 1 : SP_2022_MA0001_297_18_20220307_00009.jpg

View of the erosion along the waterside of the levee.

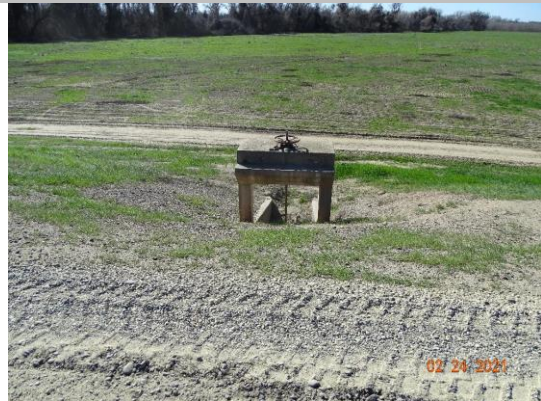
Photo 3 of 3 : UCIP_SP_2022_62947_91656.jpg

Water-Side: View of levee slope looking from crown. Screw gate on levee slope
