**Flood Control Project Maintenance
Levee Inspections
LMA District Cover Sheet**

**Flood Control Project Maintenance
Levee Inspections
Unit Cover Sheet**

Waterway			Bank	Unit Miles
Unit No. 01 Sacramento River			Right	16.76
	Spring (March - May)	Summer (June - August)	(September - November) Fall	Winter (December - February)
Unit Maintenance Rating (Fall Only)				
Date of Inspection	4/11/2023 - 4/11/2023			
DWR Inspector	Makar Sokol			
Accompanied By	Gregg Ahlers DWR Sutter Yard

Levee Inspection Report By Mile - Spring 2023

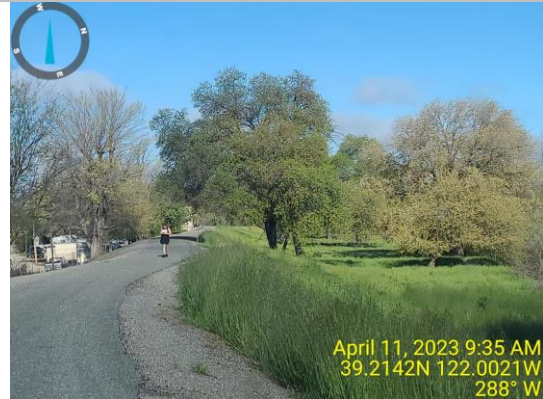
Photo 1 of 1 : SP_2023_MA0001_297_38_20230414_00104.jpg

View of the vegetation along the waterside slope. Spring 2023.

LM Start	0.01	Rating **	N	Issue No.	92
LM End	0.01	Issue Type +	Ma	Location *	LS
Category	Earthen Levee			GPS Latitude/Longitude	
				Start	End
Item	Trim / Thin Trees			39.214000°	39.214000°
				-122.001077°	-122.001077°
DWR ID	DWR_MA0001_01_f_2016_92				
Comment Code					
T5 : Tree stumps.					
Inspector Comment

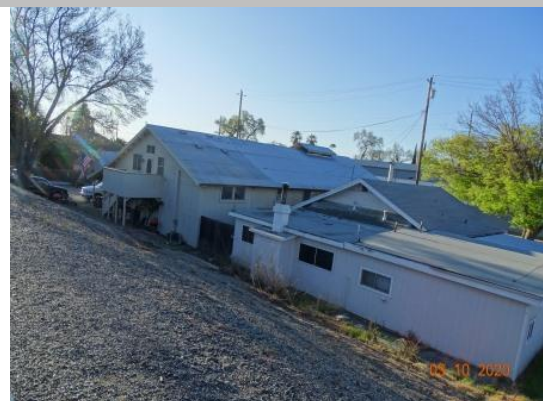
Photo 1 of 1 : SP_2023_MA0001_297_2_20230410_00001.jpg

View of the buildings along the landside toe. Spring 2020.

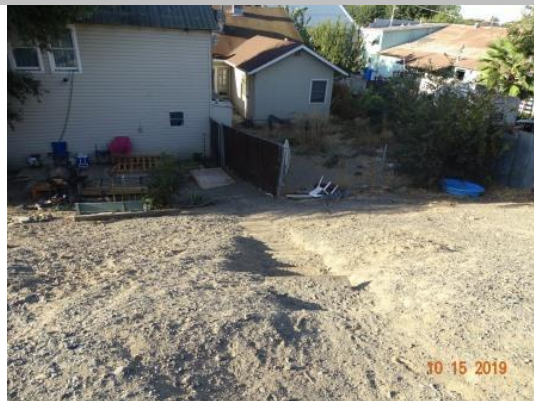
Photo 2 of 2 : SP_2023_MA0001_297_63_20230410_00016.jpg

View of the wooden stairs cut into the landside slope. Fall 2019.

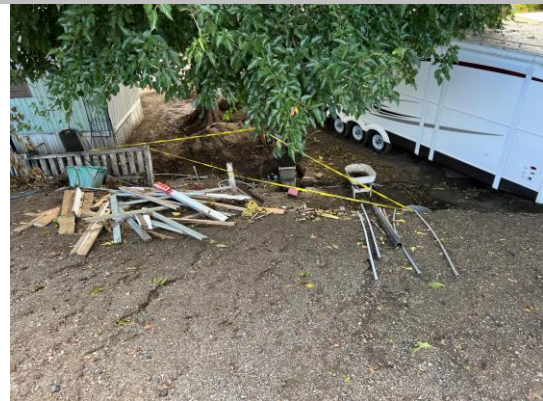
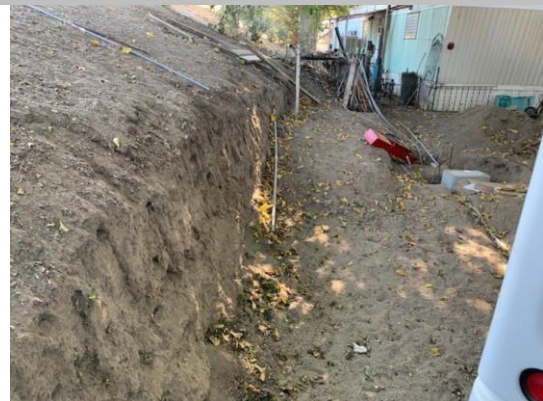
View of a vertical cut into the landside levee slope. Fall 2022.

LM Start	0.19	Rating **	U	Issue No.	85 (cont)
LM End	0.19	Issue Type +	En	Location *	LS

Another view of a vertical cut into the landside levee slope. Fall 2022.

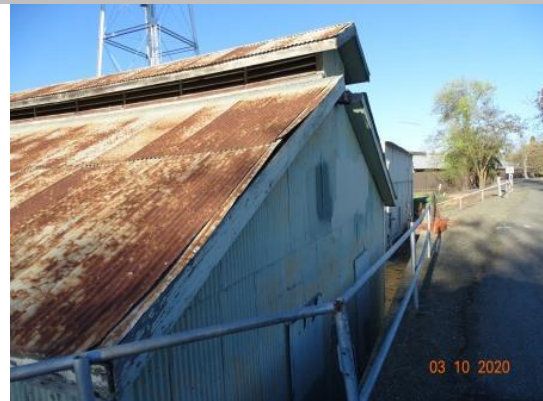
Photo 1 of 1 : SP_2023_MA0001_297_7_20230410_00005.jpg

View of the buildings along the landside toe. Spring 2020.

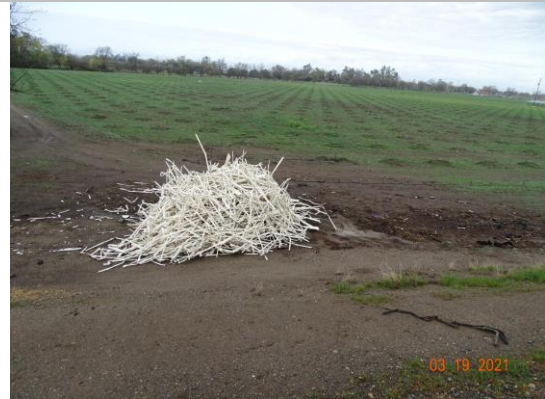
Photo 1 of 1 : SP_2023_MA0001_297_62_20230410_00014.jpg

View of the pile of PVC pipes at the landside toe. Spring 2021.

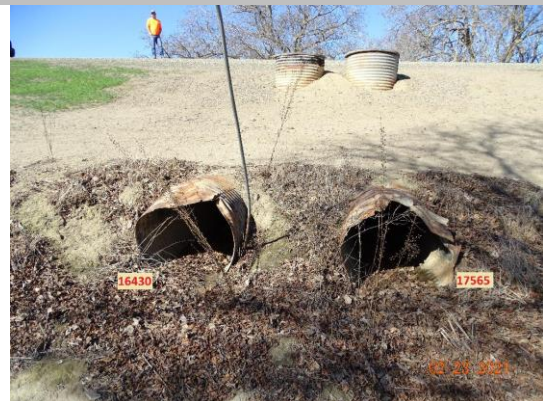
Photo 3 of 3 : UCIP_SP_2023_62869_91154.jpg

Comment Code					
Inspector Comment					
DS_ID:16430 FS_ID:62869 EP_NO: 9487 Repair Type: Urgent EVAL Issue: 1, Pipe Integrity Crossing Status: Found UCIP Comments: 02/23/2021 Record updated from Non-Urgent to Urgent. DMP internal video inspection has found pipe integrity issues. LOF of crossing is between 5 and 6. Crossing will be monitored until funding becomes available to address the issues. No permit has been identified authorizing pipe. Need to have CVFPB review ABO and determine current owner. (O.Yakimov - DWR UCIP) 05/03/2017 WS end still partially plugged. (A. Freitag - DWR Sutter Yard) 10/24/2016 WS end is till partially plugged. (A. Freitag - DWR Sutter Yard)04/25/2016 WS pipe end is still plugged with soil. Rest of the pipe appeared to be in good condition. (A. Freitag - DWR Sutter Yard)04/20/2015 WS pipe end is plugged about 50% by soil. (A. Freitag - DWR Sutter Yard)06/18/2014 Same as last inspection. (A. Freitag - DWR Sutter Yard)12/17/2013 Same as last inspection. (A. Freitag - DWR Sutter Yard)07/18/2013 WS pipe end has been reformed but is still clogged about 50% by sediment.10/18/2012 Remove dirt and debris in riser. Outlet deformed and blocked over 50%. Debris-round concrete section on landward side. This crossing was listed in the USACE Periodic Inspections as ID# USACE_CESPK_MA1C_2010_p_0116 for crossing outlet deformed and clogged with dirt. (O. Magana - DWR UCIP) FIELD_STRUCT_DESC: 1 of 2: 36-inch corrugated metal drainage pipe through the levee, approximately 12-15 feet below the crown. Slide gates in corrugated metal pipe (CMP) riser located on the waterside (WS) slope. Pipe daylights on the landside (LS). (36-inch pipe [HLM 1.97] authorized under Automatic Board Order (ABO) issued as Permit No. 9487, 1974 - Jimeno Rancho). [Additional Reference(s): DWR Levee Log, 1992 (HLM 1.97).USACE Sacramento O&M Manual, Unit 137, August 1955, Revised 29 December 2016, (STA 103+18), listed as 36-inch pipe]. FS Date: 2/23/2021 9:20:38 AM

Water-Side: View of levee slope looking towards crown. Pipe end at levee toe

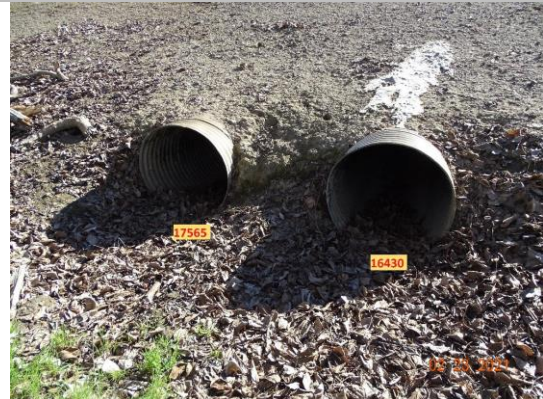
Photo 2 of 3 : UCIP_SP_2023_62871_91165.jpg

Comment Code					
Inspector Comment					
DS_ID:17565 FS_ID:62871 EP_NO: 9487 Repair Type: Urgent EVAL Issue: 1, Pipe Integrity Crossing Status: Found UCIP Comments: 02/23/2021 Record updated from Non-Urgent to Urgent. DMP internal video inspection has found pipe integrity issues. LOF of crossing is between 5 and 6. Crossing will be monitored until funding becomes available to address the issues. No permit has been identified authorizing pipe. Need to have CVFPB review ABO and determine current owner. (O.Yakimov - DWR UCIP) 05/03/2017 Ws end still partially plugged. (A. Freitag - DWR Sutter Yard)10/24/2016 Ws pipe end still plugged. (A. Freitag - DWR Sutter Yard)04/25/2016 WS pipe end still plugged with soil. rest of pipe appears in good condition. (A. Freitag - DWR Sutter Yard)04/20/2015 WS pipe end plugged about 50% by soil. (A. Freitag - DWR Sutter Yard)06/18/2014 Same as last inspection. (A. Freitag - DWR Sutter Yard)12/17/2013 Same as last inspection. (A. Freitag - DWR Sutter Yard)07/18/2013 WS pipe end has been reformed but is still partially blocked with dirt and debris.10/18/2012 WS-remove dirt and debris in riser. Outlet deformed and blocked over 50%. Burrow activity near outlet on waterward slope. Debris around concrete section on landward side. This crossing was listed in the USACE Periodic Inspections as ID# USACE_CESPK_MA1C_2010_p_0116 for crossing outlet deformed and clogged with dirt. (O. Magana - DWR UCIP) FIELD_STRUCT_DESC: 2 of 2: 36-inch corrugated metal drainage pipe through the levee, approximately 12-15 feet below the crown. Slide gates in corrugated metal pipe (CMP) riser on the waterside (WS) slope. Pipe daylights on the landside (LS). (36-inch pipe [HLM 1.97] authorized under Automatic Board Order (ABO) issued as Permit No. 9487, 1974 - Jimeno Rancho) [Additional Reference(s): DWR Levee Log, 1992 (HLM 1.97).USACE Sacramento O&M Manual, Unit 137, August 1955, Revised 29 December 2016, (STA 103+18), listed as 36-inch pipe]. FS Date: 2/23/2021 9:23:26 AM

Land-Side: Pipe end at levee toe

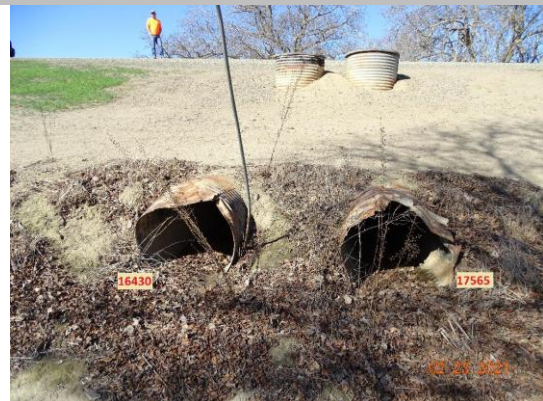
Photo 3 of 3 : UCIP_SP_2023_62871_91167.jpg

Water-Side: Pipe end at levee toe

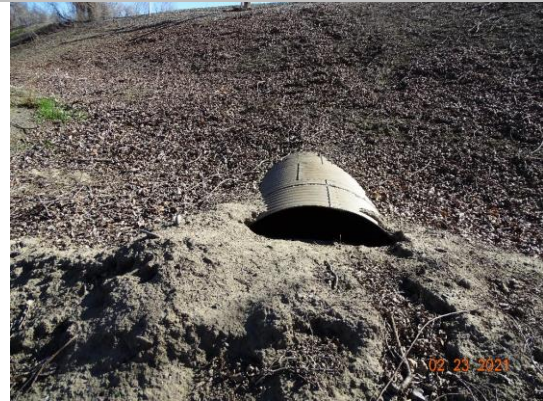
Photo 2 of 3 : UCIP_SP_2023_62872_91173.jpg

Comment Code					
Inspector Comment					
DS_ID:16429 FS_ID:62872 EP_NO: 9472 Repair Type: Urgent EVAL Issue: 1, Pipe Integrity Crossing Status: Found UCIP Comments: 02/23/2021 Record updated from Non-Urgent to Urgent. DMP internal video inspection has found pipe integrity issues. LOF of crossing is between 5 and 6. Crossing will be monitored until funding becomes available to address the issues. No permit has been identified authorizing pipe. Need to have CVFPB review ABO and determine current owner. Crossing appears abandoned. Soil blocks more than 80% of pipe end at landside toe. (O.Yakimov - DWR UCIP) 05/03/2017 LS inlet partially plugged with soil. Some debris still present inside riser. (A. Freitag - DWR Sutter Yard)10/24/2016 Debris still inside of riser. (A. Freitag - DWR Sutter Yard)04/25/2016 Pipe still inside of riser and LS end plugged about 50% by soil. (A. Freitag - DWR Sutter Yard)04/20/2015 Same as last inspection. (A. Freitag - DWR Sutter Yard)06/18/2014 Same as last inspection. (A. Freitag - DWR Sutter Yard)12/17/2013 Same as last inspection. (A. Freitag - DWR Sutter Yard)07/18/2013 Same as last inspection. (A. Freitag - DWR Sutter Yard)10/18/2012 Remove debris from riser. Landward inlet is blocked by over 50%. This crossing was listed in the USACE Periodic Inspections as ID# USACE_CESPK_MA1C_2010_p_0128 for sediment build up at inlet (landward side) and debris inside riser. (O. Magana - DWR UCIP) FIELD_STRUCT_DESC: 54-inch corrugated metal drainage pipe through the levee, approximately 12-15 feet below the crown. Slide gate in corrugated metal pipe (CMP) riser on the waterside (WS) slope. Pipe daylights at landside toe. This pipe crosses the levee at angle. (54-inch pipe [HLM 2.29] authorized under Automatic Board Order (ABO) issued as Permit No. 9472, 1974 - Ballard). [Additional Reference(s): DWR Levee Log, 1992 (HLM 2.29). USACE Sacramento O&M Manual, Unit 137, August 1955, Revised 29 December 2016, (STA 120+00), listed as 54-inch pipe]. FS Date: 2/23/2021 9:25:10 AM

Land-Side: Pipe inlet blocked with soil

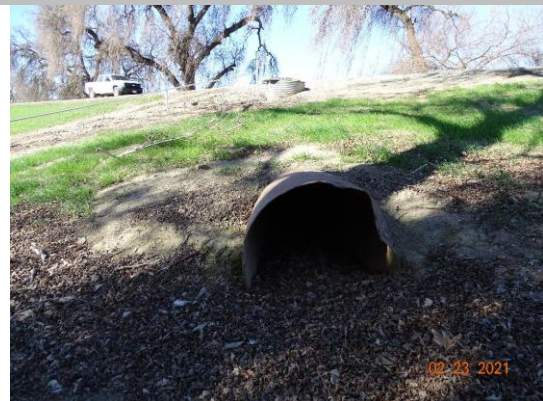
Photo 3 of 3 : UCIP_SP_2023_62872_91169.jpg

Water-Side: Pipe end at levee toe

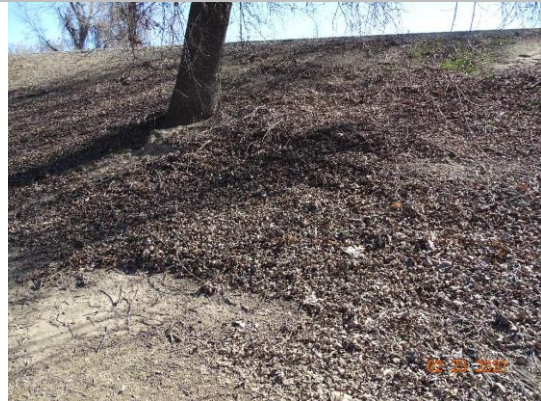
Photo 3 of 3 : UCIP_SP_2023_62873_91179.jpg

Comment Code					
Inspector Comment					
DS_ID:16428 FS_ID:62873 EP_NO: 9467 Repair Type: Non-Urgent EVAL Issue: Crossing Status: Found UCIP Comments: 02/23/2021 Record remains Non-Urgent. Geophysical study indicates possible presence of pipe through levee. Owner needs to coordinate with the CVFPB to remove or abandon crossing according to Title 23 requirements. Crossing appears abandoned. Pipe ends on both slopes are buried in soil. No permit has been identified authorizing pipe. Need to have CVFPB review ABO and determine current owner. (O.Yakimov - DWR UCIP) 05/03/2017 Abanoned- needs to be done so properly. (A. Freitag - DWR Sutter Yard)10/24/2016 Abandoned. (A. Freitag - DWR Sutter Yard)04/25/2016 Abandoned crossing. Unable to locate any WS and LS pipe ends. (A. Freitag - DWR Sutter Yard)04/20/2015 Same as last inspection. (A. Freitag - DWR Sutter Yard)06/18/2014 Same as last inspection. (A. Freitag - DWR Sutter Yard)12/17/2013 Same as last inspection. (A. Freitag - DWR Sutter Yard)07/18/2013 Same as last inspection. (A. Freitag - DWR Sutter Yard)10/18/2012 Only riser visible. Debris and sediment blocking gate. Gate inside riser is buried and non-functional. If crossing is abandoned, owner needs to properly abandon. This crossing was listed in the USACE Periodic Inspections as ID# USACE_CESPK_MA1C_2010_p_0132 no culvert through the levee is visible here. (O. Magana - DWR UCIP) FIELD_STRUCT_DESC: 24-inch corrugated metal drainage pipe through the levee, approximately 12-15 feet below the crown. Slide gate in CM pipe riser on the waterside (WS) slope. No signs of inlet visible on the landside (LS). (24-inch pipe [HLM 2.31] authorized under Automatic Board Order (ABO) issued as Permit No. 9467, 1974 - Lovell E. Spurgeon). [Additional Reference(s): DWR Levee Log, 1992 (HLM 2.31). USACE Sacramento O&M Manual, Unit 137, August 1955, Revised 29 December 2016, (STA 120+60), listed as 24-inch pipe]. FS Date: 2/23/2021 9:30:51 AM

Land-Side: View of levee slope looking from toe. Pipe end not found

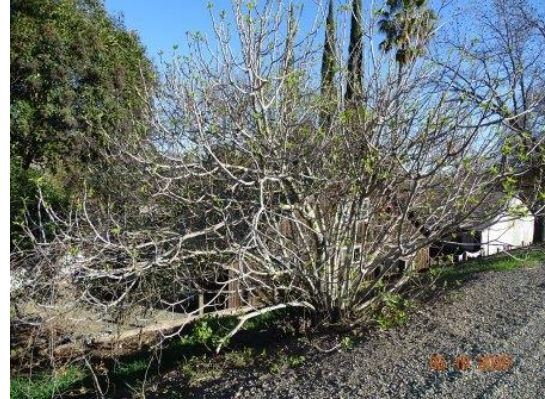
Photo 1 of 1 : SP_2023_MA0001_297_88_20230410_00023.jpg

View of the fig tree on the landside shoulder. Spring 2020.

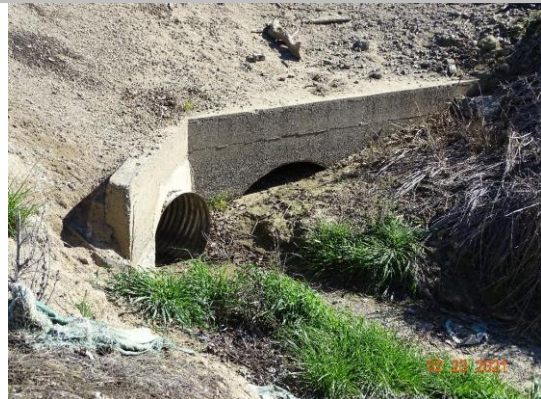
Photo 3 of 3 : UCIP_SP_2023_62892_91307.jpg

DS_ID:16416
FS_ID:62892
EP_NO: 9474
Repair Type: Urgent
EVAL Issue: 3a, Flood Risk
Crossing Status: Found
UCIP Comments: 02/23/2021 Record updated from Non-Urgent to Urgent. Missing slide gate on pipe in concrete box on waterside slope creates flood threat to landside. Crossing appears abandoned. Concrete box on waterside filled with soil, soil deposits inside and around pipe end on landside. No permit has been identified authorizing pipe. Need to have CVFPB review ABO and determine current owner. (O.Yakimov - DWR UCIP)
05/03/2017 Appears abandoned- WS vault full of soil. Needs to be abandoned properly. (A. Freitag - DWR Sutter Yard)10/24/2016 Appears to be abandoned. WS vault full of soil to help prevent water from flowing through during high water season. (A. Freitag - DWR Sutter Yard)04/25/2016 Concrete box was filled with dirt to help prevent water from through during high water times. (A. Freitag - DWR Sutter Yard)04/20/2015 Positive closure device is missing and water cannot be prevented from flowing through pipe during high water. (A. Freitag - DWR Sutter Yard)06/18/2014 Same as last inspection. (A. Freitag - DWR Sutter Yard)12/17/2013 Same as last inspection. (A. Freitag - DWR Sutter Yard)07/18/2013 Same as last inspection. (A. Freitag - DWR Sutter Yard)10/18/2012 During high water flow goes through levee. Missing positive closure device on waterward side. This structure appears abandoned-slide gates have been removed. Crossing needs to be properly abandoned. This crossing was listed in the USACE Periodic Inspection as ID# USACE_CESPK_MA1C_2010_p_0169 for concrete box partially filled with dirt. (O. Magana - DWR UCIP)

Land-Side: View of headwall and pipe end partially blocked with soil

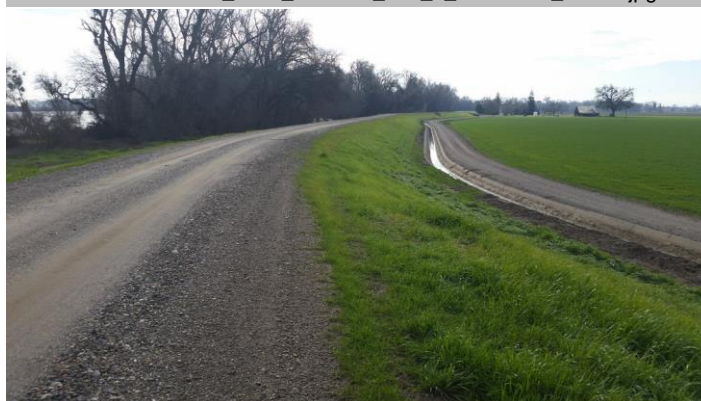
Photo 1 of 1 : SP_2023_MA0001_297_5_20230410_00002.jpg

View of the concrete lined ditch along the landside toe.

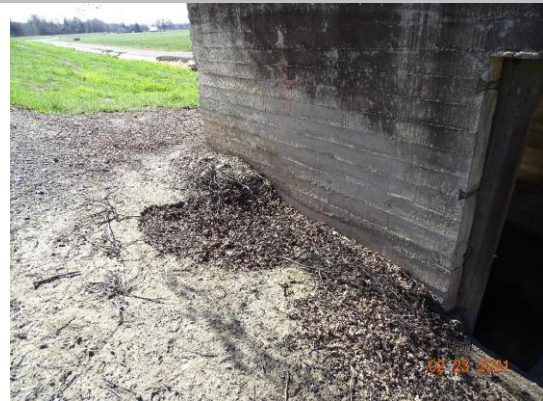
Photo 3 of 3 : UCIP_SP_2023_62897_91347.jpg

DS_ID:16436
FS_ID:62897
EP_NO: 4213
Repair Type: Urgent
EVAL Issue: 2b, Levee Integrity
Crossing Status: Found
UCIP Comments: 02/23/2021 Record remains Urgent. Existing sinkhole in pipe alignment at pumphouse wall measures 5 feet in diameter and about 1 foot deep. Recommend owner perform pipe integrity test. (O.Yakimov - DWR UCIP)
10/01/2018 Sinkhole near concrete structure on the LS was filled with soil and debris. Flow meter at the WS shoulder and a manometer on the pipe on the LS shoulder was installed. Video inspection is recommended to determine pipe integrity through levee. (O.Yakimov - DWR UCIP)05/03/2017 Sinkhole still present next to concrete structure on LS. (A. Freitag - DWR Sutter Yard)10/24/2016 Pump is on WS. Sinkhole still present over pipe alignment next to the concrete building. (A. Freitag - DWR Sutter Yard)04/25/2016 No repairs have been made since last inspection. Sink holes are still present above pipe next to concrete building on LS. (A. Freitag - DWR Sutter Yard)04/20/2015 Sink hole over pipe alignment on LS up against the concrete building. Need to dig up pipe and see if its leaking. (A. Freitag - DWR Sutter Yard)06/23/2014 Same as last inspection. (A. Freitag - DWR Sutter Yard)06/18/2014 Same as last inspection. (A. Freitag - DWR Sutter Yard)12/17/2013 Same as last inspection. (A. Freitag - DWR Sutter Yard)07/18/2013 Same as last inspection. (A. Freitag - DWR Sutter Yard)10/19/2012 Recommend adding door to LS concrete structure. Riser located on landward side is damaged. This crossing was listed in the USACE Periodic Inspection as ID# USACE_CESPK_MA1C_2010_p_0194 no issues logged. (O. Magana - DWR UCIP)

Land-Side: View of sinkhole filled with leaves at pumphouse wall

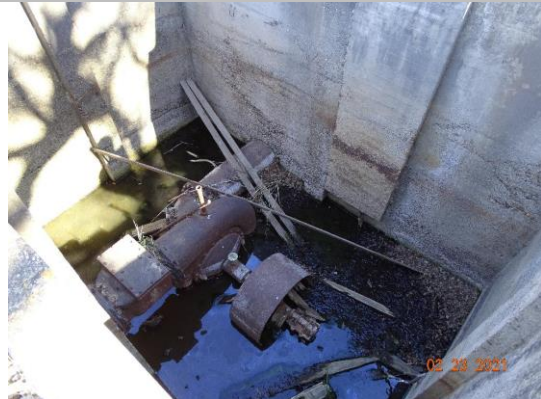
Photo 1 of 3 : UCIP_SP_2023_62898_91353.jpg

DS_ID:16424
FS_ID:62898
EP_NO: 9490
Repair Type: Non-Urgent
EVAL Issue: 4b, Safety Issue
Crossing Status: Found
UCIP Comments: 02/23/2021 Record remains Non-Urgent. Crossing appears abandoned. Abandoned pump located inside of concrete distribution box at landside levee toe. Concrete box open at ground level creates fall hazard. Pipe not found on waterside. No permit has been identified authorizing pipe. Need to have CVFPB review ABO and determine current owner. (O.Yakimov - DWR UCIP)
05/03/2017 Abandoned- Needs to be done properly. (A. Freitag - DWR Sutter Yard)10/24/2016 Abandoned. Needs a cover made for the LS distribution box. (A. Freitag - DWR Sutter Yard)04/25/2016 ABANDONED crossing and should be abandoned properly. Concrete distribution box on LS is opened on top and could pose a safety hazard with falling. (A. Freitag - DWR Sutter Yard)04/20/2015 Same as last inspection. (A. Freitag - DWR Sutter Yard) 06/18/2014 Same as last inspection. (A. Freitag - DWR Sutter Yard)12/17/2013 Same as last inspection. (A. Freitag - DWR Sutter Yard)07/18/2013 Same as last inspection. (A. Freitag - DWR Sutter Yard)10/19/2012 Crossing needs to be properly abandoned. This crossing was listed in the USACE Periodic Inspection as ID#

Land-Side: Abandoned pipe and pump inside of concrete box

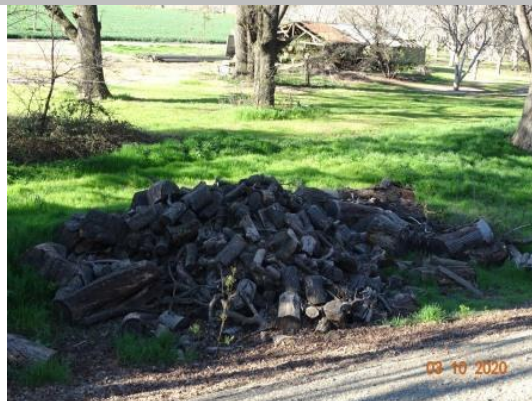
Photo 1 of 1 : SP_2023_MA0001_297_102_20230410_00028.jpg

View of the pile of firewood at the landside toe. Spring 2020.

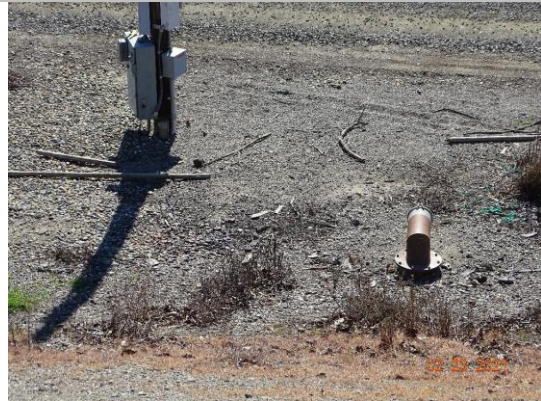
Photo 2 of 3 : UCIP_SP_2023_62908_91427.jpg

Land-Side: Capped pipe at levee toe

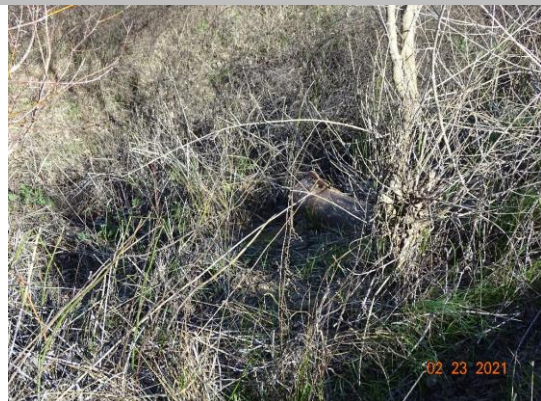
Photo 3 of 3 : UCIP_SP_2023_62908_91429.jpg

Water-Side: View of pipe end open at riverbank

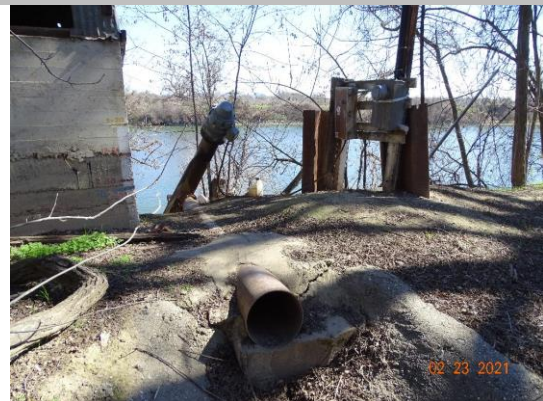
Photo 3 of 3 : UCIP_SP_2023_62910_91438.jpg

Water-Side: Abandoned pumphouse, slant pump at riverbank

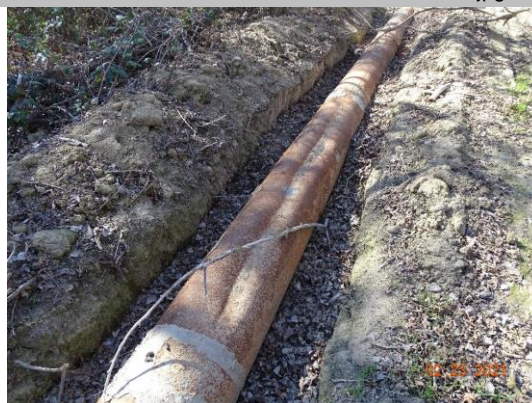
Photo 3 of 3 : UCIP_SP_2023_62912_91456.jpg

Water-Side: Damaged pipe in the trench likely due to excavation

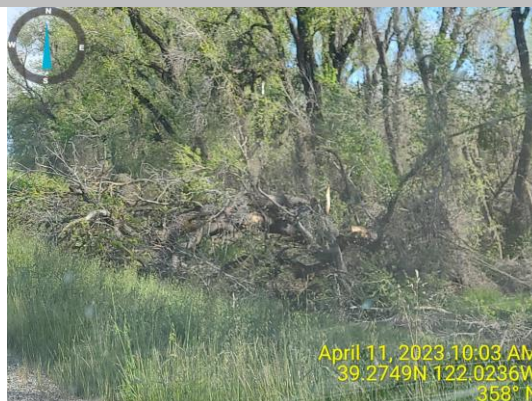
Photo 1 of 1 : SP_2023_MA0001_297_41_20230414_00105.jpg

View of a fallen tree on the waterside slope and toe. Spring 2023.

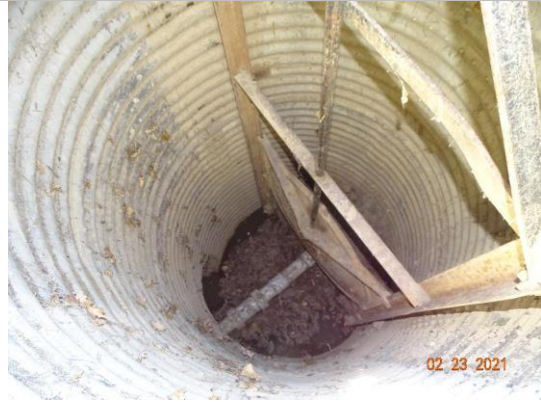
Photo 2 of 3 : UCIP_SP_2023_62913_91463.jpg

Water-Side: Screw gate and PVC pipe inside CMP riser

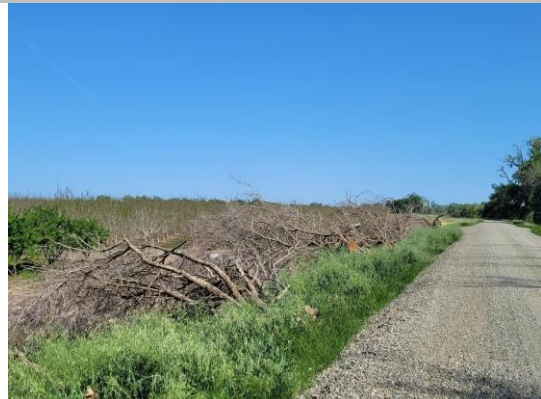
Photo 1 of 1 : SP_2023_MA0001_297_115_20230410_00030.jpg

View of the prunings along the landside slope and toe. Spring 2022.

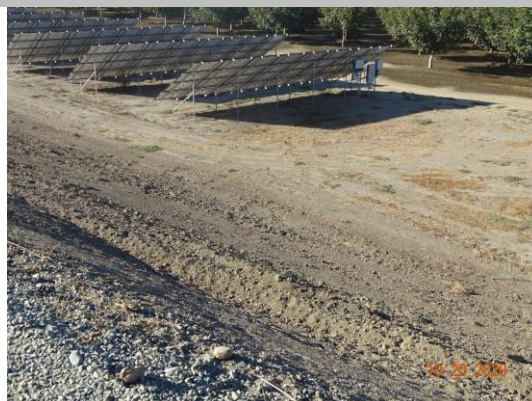
Photo 1 of 1 : SP_2023_MA0001_297_77_20230410_00018.jpg

View of the vehicle erosion along the landside slope. Fall 2020.

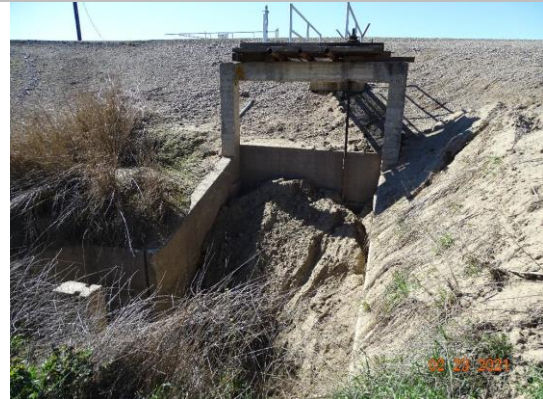
Photo 2 of 3 : UCIP_SP_2023_62915_91474.jpg

Water-Side: Concrete headwall on levee slope. Missing slide gate, pipe buried under soil

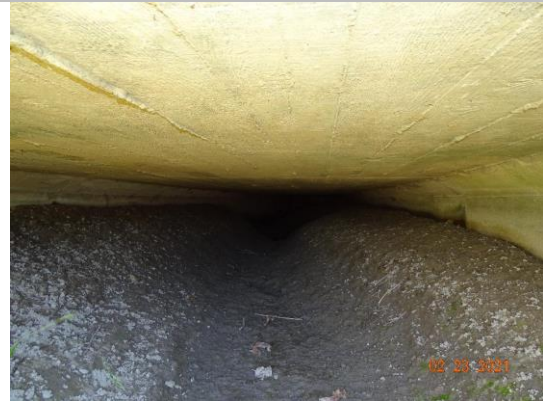
Photo 3 of 3 : UCIP_SP_2023_62915_91470.jpg

Land-Side: Concrete box culvert filled with soil

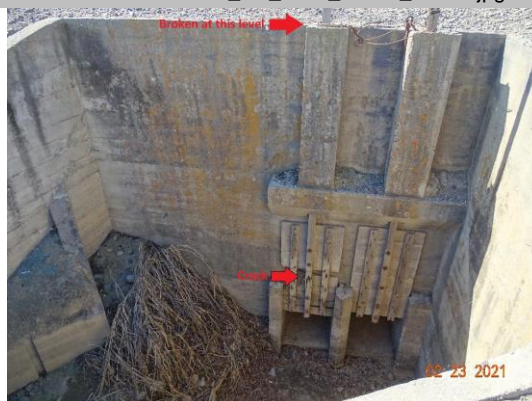
Photo 2 of 3 : UCIP_SP_2023_62917_91483.jpg

Water-Side: View in concret vault on levee slope. Broken wood stem

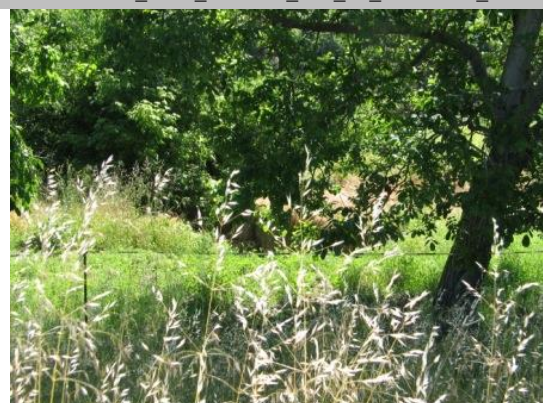
Photo 1 of 1 : SP_2023_MA0001_297_18_20230410_00009.jpg

View of the erosion along the waterside of the levee.

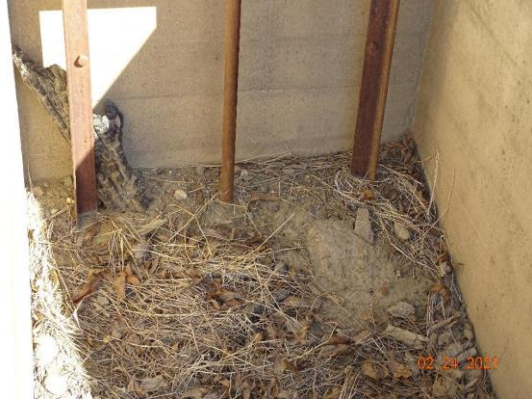
Photo 1 of 3 : UCIP_SP_2023_62947_91658.jpg

Water-Side: Screw gate burried in soil

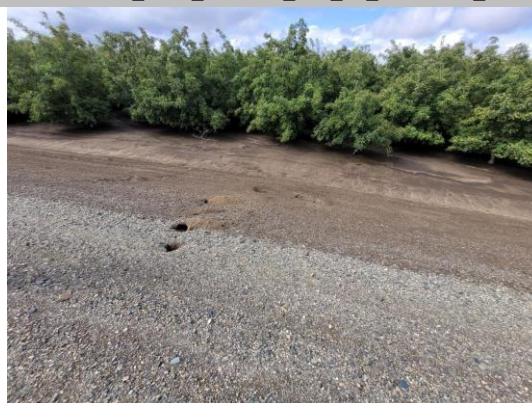
Photo 1 of 1 : SP_2023_MA0001_297_84_20230410_00019.jpg

View of the rodent activity along the landside slope. Fall 2022.

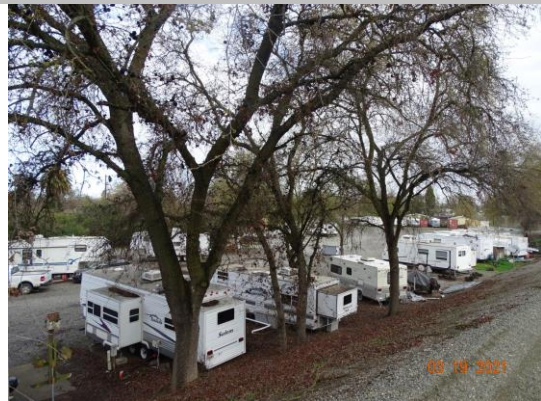
Photo 1 of 1 : SP_2023_MA0001_297_86_20230410_00022.jpg

View of the mobile homes along the landside toe. Spring 2021.

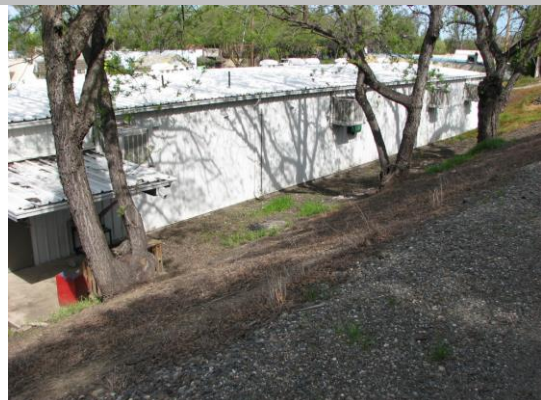
Photo 1 of 1 : SP_2023_MA0001_297_91_20230410_00026.jpg

View of a building obstructing access.

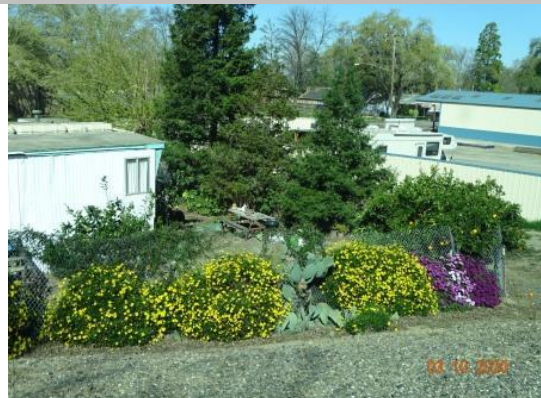
Photo 1 of 1 : SP_2023_MA0001_297_74_20230410_00017.jpg

View of the landscaping along the landside slope and toe. Spring 2020.

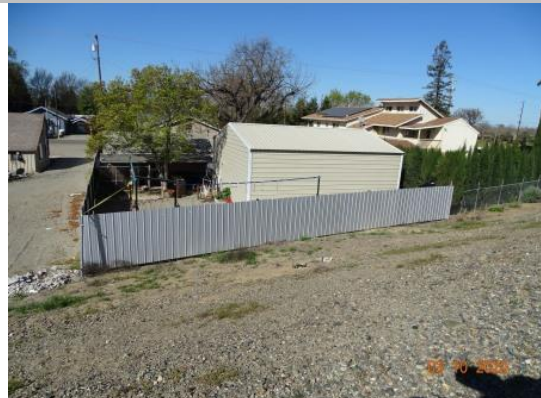
Photo 1 of 1 : SP_2023_MA0001_297_47_20230410_00012.jpg

View of the fence along the landside toe. Spring 2020.
