Flood Control Project Maintenance  
Levee Inspections  
LMA District Cover Sheet

Sutter Maintenance Yard Maintenance Area 0001

**Flood Control Project Maintenance  
Levee Inspections**

**Levee Inspection Report By Mile - Spring 2024**

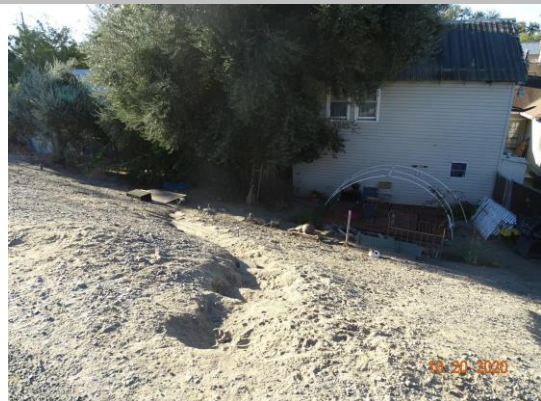
Photo 1 of 2 : SP\_2024\_MA0001\_297\_63\_20240212\_00013.jpg

View of one of the stairs cut into the landside slope. Fall 2020.

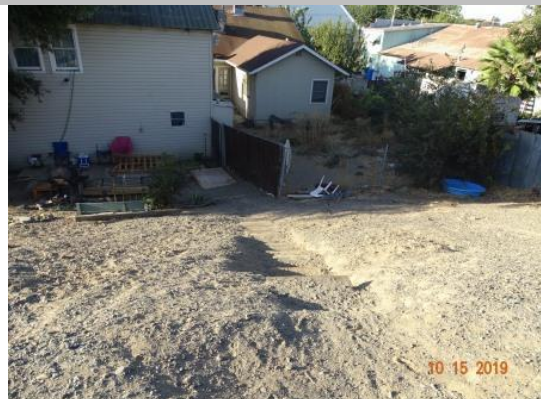
Photo 2 of 2 : SP\_2024\_MA0001\_297\_63\_20240212\_00014.jpg

View of the wooden stairs cut into the landside slope. Fall 2019.

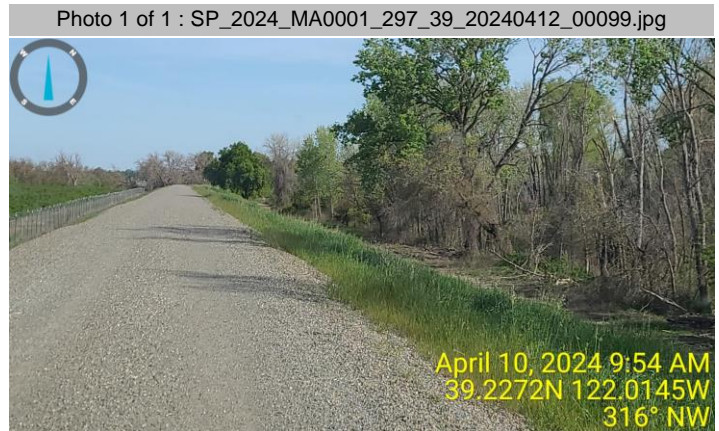
LM Start	1.29	Rating **	M	Issue No.	39
LM End	3.69	Issue Type +	Ma	Location *	WS
Category	Earthen Levee			GPS Latitude/Longitude	
				Start	End
Item	Vegetation			39.223352°	39.255962°
				-122.015893°	-122.009714°
DWR ID	DWR_MA0001_01_s_2024_39				
Comment Code					
V1 : Control annual grass and weeds on the levee slopes and easements.					
Inspector Comment

View of the vegetation along the waterside slope. Spring 2024.

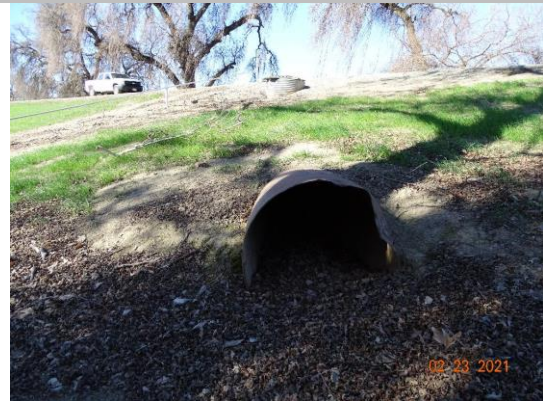
Photo 3 of 3 : UCIP\_SP\_2024\_62872\_91169.jpg

Comment Code					
Inspector Comment					
DS_ID:16429 FS_ID:62872 EP_NO: 9472 Repair Type: Urgent EVAL Issue: 1, Pipe Integrity Crossing Status: Found UCIP Comments: 02/23/2021 Record updated from Non-Urgent to Urgent. DMP internal video inspection has found pipe integrity issues. LOF of crossing is between 5 and 6. Crossing will be monitored until funding becomes available to address the issues. No permit has been identified authorizing pipe. Need to have CVFPB review ABO and determine current owner. Crossing appears abandoned. Soil blocks more than 80% of pipe end at landside toe. (O.Yakimov - DWR UCIP) 05/03/2017 LS inlet partially plugged with soil. Some debris still present inside riser. (A. Freitag - DWR Sutter Yard)10/24/2016 Debris still inside of riser. (A. Freitag - DWR Sutter Yard)04/25/2016 Pipe still inside of riser and LS end plugged about 50% by soil. (A. Freitag - DWR Sutter Yard)04/20/2015 Same as last inspection. (A. Freitag - DWR Sutter Yard)06/18/2014 Same as last inspection. (A. Freitag - DWR Sutter Yard)12/17/2013 Same as last inspection. (A. Freitag - DWR Sutter Yard)07/18/2013 Same as last inspection. (A. Freitag - DWR Sutter Yard)10/18/2012 Remove debris from riser. Landward inlet is blocked by over 50%. This crossing was listed in the USACE Periodic Inspections as ID# USACE_CESPK_MA1C_2010_p_0128 for sediment build up at inlet (landward side) and debris inside riser. (O. Magana - DWR UCIP) FIELD_STRUCT_DESC: 54-inch corrugated metal drainage pipe through the levee, approximately 12-15 feet below the crown. Slide gate in corrugated metal pipe (CMP) riser on the waterside (WS) slope. Pipe daylights at landside toe. This pipe crosses the levee at angle. (54-inch pipe [HLM 2.29] authorized under Automatic Board Order (ABO) issued as Permit No. 9472, 1974 - Ballard). [Additional Reference(s): DWR Levee Log, 1992 (HLM 2.29). USACE Sacramento O&M Manual, Unit 137, August 1955, Revised 29 December 2016, (STA 120+00), listed as 54-inch pipe]. FS Date: 2/23/2021 9:25:10 AM

Water-Side: Pipe end at levee toe

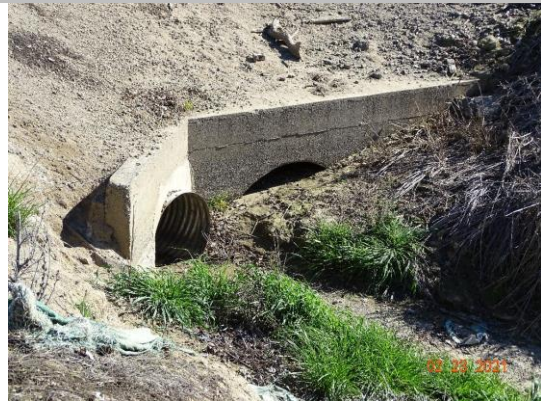
Photo 3 of 3 : UCIP\_SP\_2024\_62892\_91307.jpg

DS\_ID:16416  
FS\_ID:62892  
EP\_NO: 9474  
Repair Type: Urgent  
EVAL Issue: 3a, Flood Risk  
Crossing Status: Found  
UCIP Comments: 02/23/2021 Record updated from Non-Urgent to Urgent. Missing slide gate on pipe in concrete box on waterside slope creates flood threat to landside. Crossing appears abandoned. Concrete box on waterside filled with soil, soil deposits inside and around pipe end on landside. No permit has been identified authorizing pipe. Need to have CVFPB review ABO and determine current owner. (O.Yakimov - DWR UCIP)  
05/03/2017 Appears abandoned- WS vault full of soil. Needs to be abandoned properly. (A. Freitag - DWR Sutter Yard)10/24/2016 Appears to be abandoned. WS vault full of soil to help prevent water from flowing through during high water season. (A. Freitag - DWR Sutter Yard)04/25/2016 Concrete box was filled with dirt to help prevent water from through during high water times. (A. Freitag - DWR Sutter Yard)04/20/2015 Positive closure device is missing and water cannot be prevented from flowing through pipe during high water. (A. Freitag - DWR Sutter Yard)06/18/2014 Same as last inspection. (A. Freitag - DWR Sutter Yard)12/17/2013 Same as last inspection. (A. Freitag - DWR Sutter Yard)07/18/2013 Same as last inspection. (A. Freitag - DWR Sutter Yard)10/18/2012 During high water flow goes through levee. Missing positive closure device on waterward side. This structure appears abandoned-slide gates have been removed. Crossing needs to be properly abandoned. This crossing was listed in the USACE Periodic Inspection as ID# USACE\_CESPK\_MA1C\_2010\_p\_0169 for concrete box partially filled with dirt. (O. Magana - DWR UCIP)

Land-Side: View of headwall and pipe end partially blocked with soil

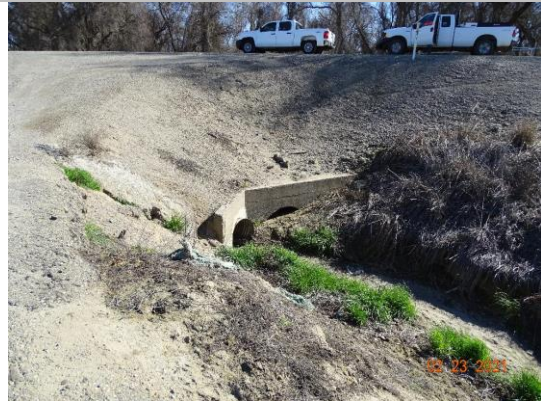
Photo 3 of 3 : UCIP\_SP\_2024\_62894\_91321.jpg

Comment Code					
Inspector Comment					
DS_ID:17567 FS_ID:62894 EP_NO: 9474 Repair Type: Urgent EVAL Issue: 3a, Flood Risk Crossing Status: Found UCIP Comments: 02/23/2021 Record updated from Non-Urgent to Urgent. Missing slide gate on pipe in concrete box on waterside slope creates flood threat to landside. Crossing appears abandoned. Concrete box on waterside filled with soil, soil deposits inside and around pipe end on landside. No permit has been identified authorizing pipe. Need to have CVFPB review ABO and determine current owner. (O.Yakimov - DWR UCIP) 05/03/2017 Appears abandoned- WS vault full of soil. Needs to be abandoned properly. (A. Freitag - DWR Sutter Yard)10/24/2016 Appears to be abandoned. WS vault full of soil to help prevent water from flowing through during high water season. (A. Freitag - DWR Sutter Yard)04/25/2016 Concrete box on WS was filled with soil to help prevent water form flowing through during times of high water. (A. Freitag - DWR Sutter Yard)04/20/2015 Positive closure device is missing and water cannot be prevented from flowing through pipe during high water. (A. Freitag - DWR Sutter Yard)06/18/2014 Same as last inspection. (A. Freitag - DWR Sutter Yard)12/17/2013 Same as last inspection. (A. Freitag - DWR Sutter Yard)07/18/2013 Same as last inspection. (A. Freitag - DWR Sutter Yard)10/18/2015 During high water flow goes through levee. Missing positive closure device on waterward side. This structure appears abandoned-slide gates have been removed. Crossing needs to be properly abandoned. This crossing was listed in the USACE Periodic Inspection as ID# USACE_CESPK_MA1C_2010_p_0169 for concrete box partially filled with dirt. (O. Magana - DWR UCIP) FIELD_STRUCT_DESC: 60-inch reinforced concrete irrigation pipe through the levee, approximately 12-15 feet below the crown. Culvert constructed with wing walls and gates. Crossing goes through the levee at an angle. Slide gates in concrete well at the waterside (WS) toe. (60-inch pipe [HLM 2.89] authorized under Automatic Board Order (ABO) issued as Permit No. 9474, 1974 - George R. Zumwalt, et al). [Additional Reference(s): DWR Levee Log, 1992 (HLM 2.89). USACE Sacramento O&M Manual, Unit 137, August 1955, Revised 29 December 2016, (STA 150+06), listed as 5-foot by 5-foot concrete culvert with hand-operated slide gate]. FS Date: 2/23/2021 2:01:03 PM

Land-Side: Headwall at the toe. Irrigation ditch starts at pipe outfall

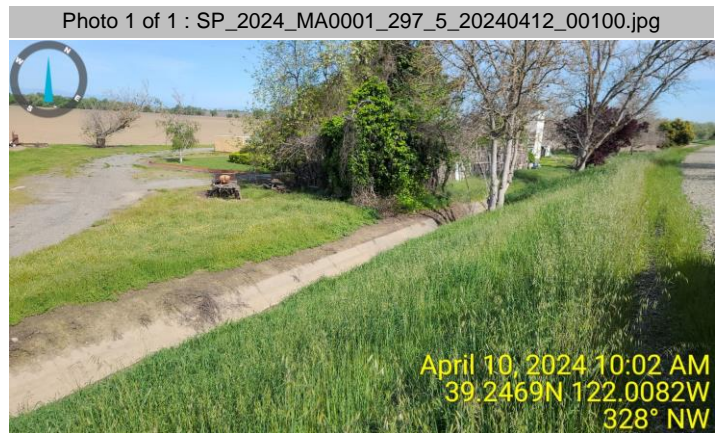
LM Start	3.05	Rating **	U	Issue No.	5
LM End	3.70	Issue Type +	En	Location *	LS
Category	Earthen Levee			GPS Latitude/Longitude	
				Start	End
Item	Encroachments			39.246813°	39.255976°
				-122.008155°	-122.009794°
DWR ID	DWR_MA0001_01_s_2012_5				
Comment Code					
DT : Ditch					
Inspector Comment

View of the concrete lined ditch along the landside toe. Spring 2024.

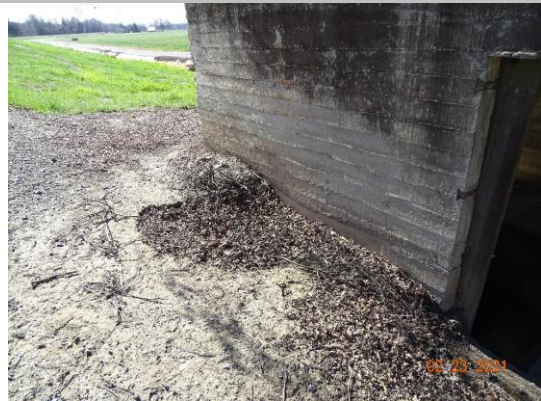
Photo 3 of 3 : UCIP\_SP\_2024\_62897\_91347.jpg

DS\_ID:16436  
FS\_ID:62897  
EP\_NO: 4213  
Repair Type: Urgent  
EVAL Issue: 2b, Levee Integrity  
Crossing Status: Found  
UCIP Comments: 02/23/2021 Record remains Urgent. Existing sinkhole in pipe alignment at pumphouse wall measures 5 feet in diameter and about 1 foot deep. Recommend owner perform pipe integrity test. (O.Yakimov - DWR UCIP)  
10/01/2018 Sinkhole near concrete structure on the LS was filled with soil and debris. Flow meter at the WS shoulder and a manometer on the pipe on the LS shoulder was installed. Video inspection is recommended to determine pipe integrity through levee. (O.Yakimov - DWR UCIP)05/03/2017 Sinkhole still present next to concrete structure on LS. (A. Freitag - DWR Sutter Yard)10/24/2016 Pump is on WS. Sinkhole still present over pipe alignment next to the concrete building. (A. Freitag - DWR Sutter Yard)04/25/2016 No repairs have been made since last inspection. Sink holes are still present above pipe next to concrete building on LS. (A. Freitag - DWR Sutter Yard)04/20/2015 Sink hole over pipe alignment on LS up against the concrete building. Need to dig up pipe and see if its leaking. (A. Freitag - DWR Sutter Yard)06/23/2014 Same as last inspection. (A. Freitag - DWR Sutter Yard)06/18/2014 Same as last inspection. (A. Freitag - DWR Sutter Yard)12/17/2013 Same as last inspection. (A. Freitag - DWR Sutter Yard)07/18/2013 Same as last inspection. (A. Freitag - DWR Sutter Yard)10/19/2012 Recommend adding door to LS concrete structure. Riser located on landward side is damaged. This crossing was listed in the USACE Periodic Inspection as ID# USACE\_CESPK\_MA1C\_2010\_p\_0194 no issues logged. (O. Magana - DWR UCIP)

Land-Side: View of sinkhole filled with leaves at pumphouse wall

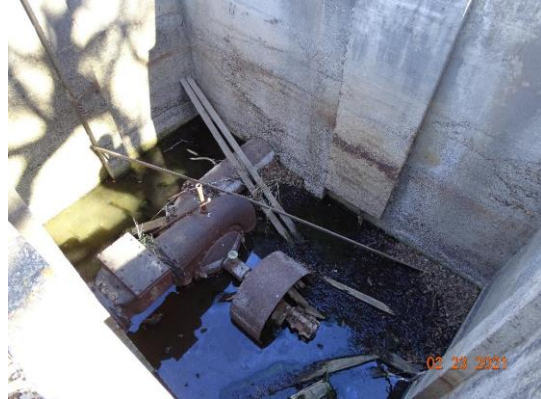
Photo 1 of 3 : UCIP\_SP\_2024\_62898\_91353.jpg

DS\_ID:16424  
FS\_ID:62898  
EP\_NO: 9490  
Repair Type: Non-Urgent  
EVAL Issue: 4b, Safety Issue  
Crossing Status: Found  
UCIP Comments: 02/23/2021 Record remains Non-Urgent. Crossing appears abandoned. Abandoned pump located inside of concrete distribution box at landside levee toe. Concrete box open at ground level creates fall hazard. Pipe not found on waterside. No permit has been identified authorizing pipe. Need to have CVFPB review ABO and determine current owner. (O.Yakimov - DWR UCIP)  
05/03/2017 Abandoned- Needs to be done properly. (A. Freitag - DWR Sutter Yard)10/24/2016 Abandoned. Needs a cover made for the LS distribution box. (A. Freitag - DWR Sutter Yard)04/25/2016 ABANDONED crossing and should be abandoned properly. Concrete distribution box on LS is opened on top and could pose a safety hazard with falling. (A. Freitag - DWR Sutter Yard)04/20/2015 Same as last inspection. (A. Freitag - DWR Sutter Yard) 06/18/2014 Same as last inspection. (A. Freitag - DWR Sutter Yard)12/17/2013 Same as last inspection. (A. Freitag - DWR Sutter Yard)07/18/2013 Same as last inspection. (A. Freitag - DWR Sutter Yard)10/19/2012 Crossing needs to be properly abandoned. This crossing was listed in the USACE Periodic Inspection as ID#

Land-Side: Abandoned pipe and pump inside of concrete box

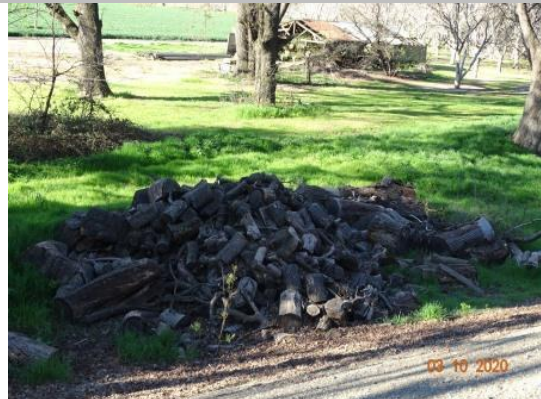
Photo 1 of 1 : SP\_2024\_MA0001\_297\_102\_20240212\_00023.jpg

View of the pile of firewood at the landside toe. Spring 2020.

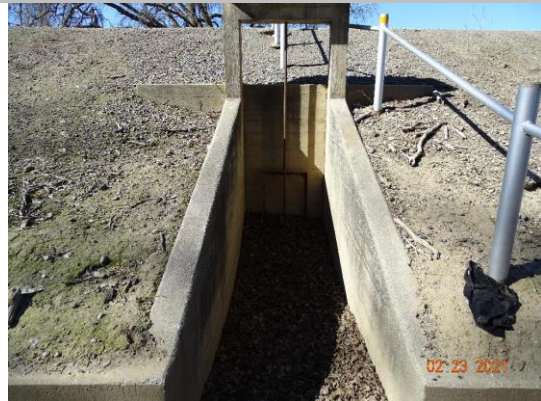
Photo 3 of 3 : UCIP\_SP\_2024\_62902\_91395.jpg

Water-Side: U-shaped headwall and screw gate in debris on levee slope

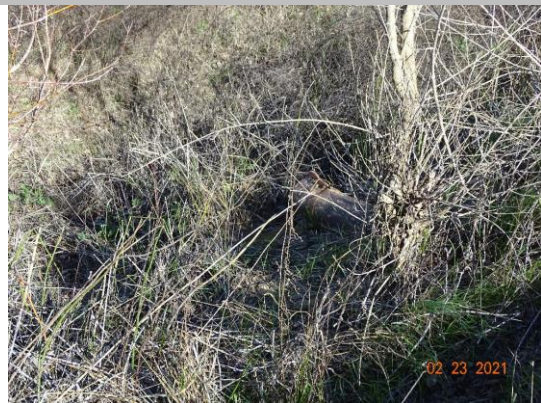
Photo 3 of 3 : UCIP\_SP\_2024\_62908\_91429.jpg

Water-Side: View of pipe end open at riverbank

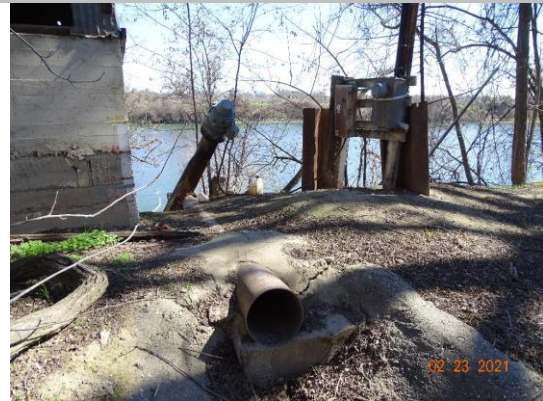
Photo 3 of 3 : UCIP\_SP\_2024\_62910\_91438.jpg

Water-Side: Abandoned pumphouse, slant pump at riverbank

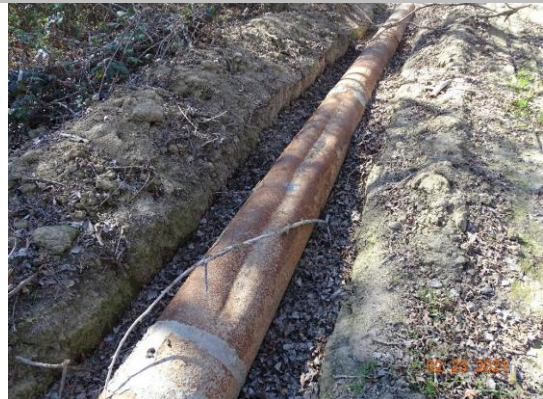
Photo 3 of 3 : UCIP\_SP\_2024\_62912\_91456.jpg

Water-Side: Damaged pipe in the trench likely due to excavation

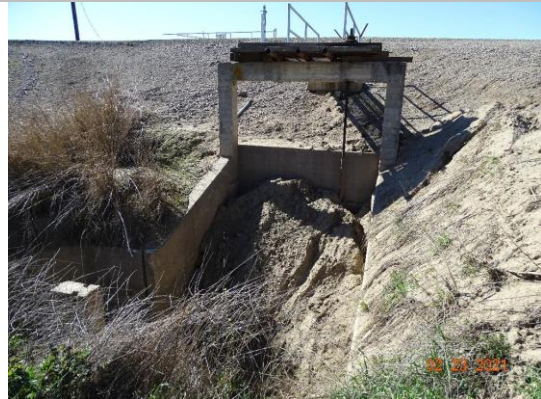
Photo 2 of 3 : UCIP\_SP\_2024\_62915\_91474.jpg

Water-Side: Concrete headwall on levee slope. Missing slide gate, pipe buried under soil

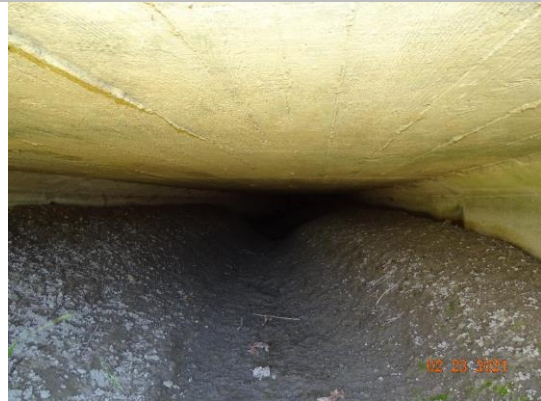
Photo 3 of 3 : UCIP\_SP\_2024\_62915\_91470.jpg

Land-Side: Concrete box culvert filled with soil

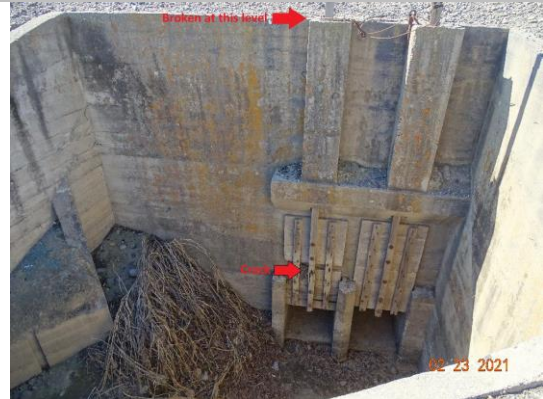
Photo 2 of 3 : UCIP\_SP\_2024\_62917\_91483.jpg

Water-Side: View in concret vault on levee slope. Broken wood stem

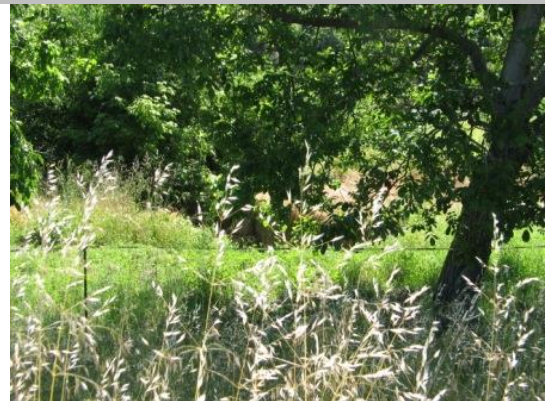
Photo 1 of 1 : SP\_2024\_MA0001\_297\_18\_20240212\_00009.jpg

View of the erosion along the waterside of the levee.

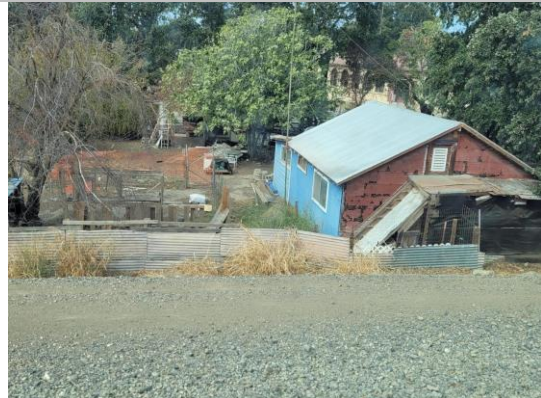
Photo 1 of 1 : SP\_2024\_MA0001\_297\_89\_20240212\_00020.jpg

View of the building and corrugated metal fence along the landside slope. Fall 2021.

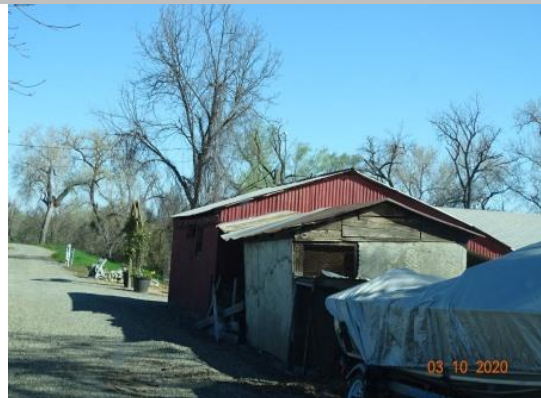
Photo 1 of 1 : SP\_2024\_MA0001\_297\_14\_20240212\_00008.jpg

View of the building on the waterside slope. Spring 2020.

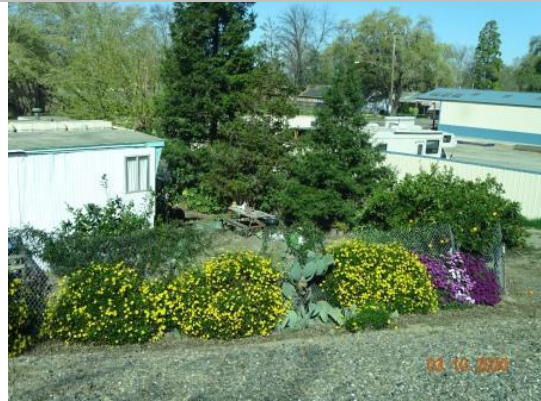
Photo 1 of 1 : SP\_2024\_MA0001\_297\_74\_20240212\_00015.jpg

View of the landscaping along the landside slope and toe. Spring 2020.

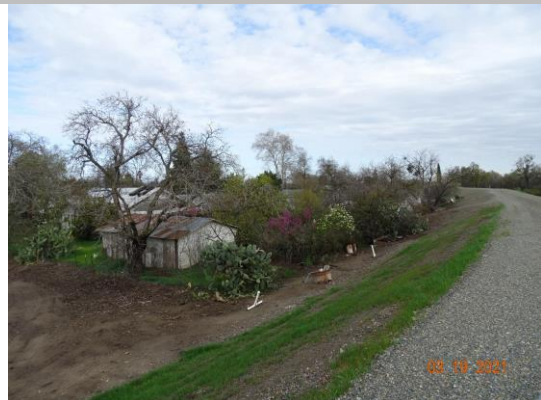
Photo 1 of 1 : SP\_2024\_MA0001\_297\_134\_20240212\_00026.jpg

View of the landscaping and fruit trees along the landside toe. Spring 2021.

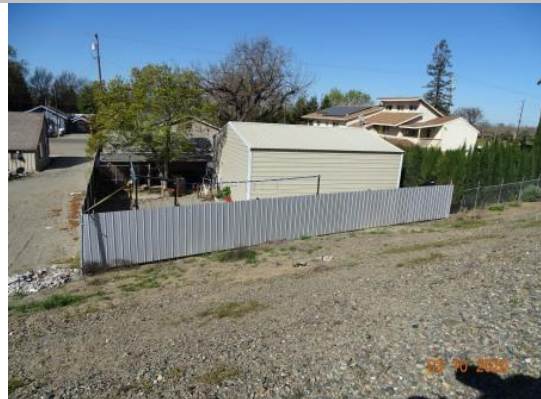
Photo 1 of 1 : SP\_2024\_MA0001\_297\_47\_20240212\_00012.jpg

View of the fence along the landside toe. Spring 2020.

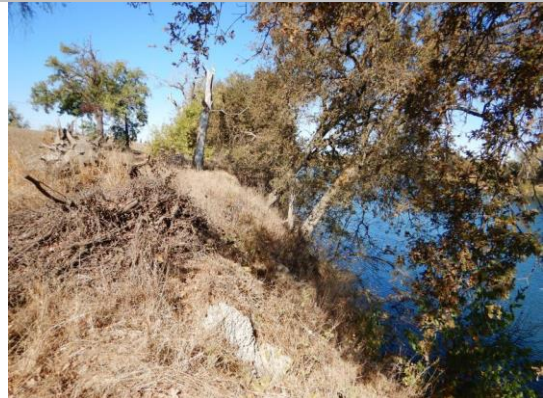
Photo 2 of 2 : SP\_2024\_MA0001\_297\_9\_20240212\_00007.jpg

USACE 2018 Erosion Photo #2
