**Flood Control Project Maintenance
Levee Inspections**

Maintenance Issue Types Only, Levee Inspection Report By Mile - Spring 2015

Sutter Maintenance Yard Maintenance Area 0001

Waterway	Bank	Unit Miles	Inspection Start/End	Inspector
Unit No. 01 Sacramento River	Right	16.76	03/13/2015 03/13/2015	Bob Duffey

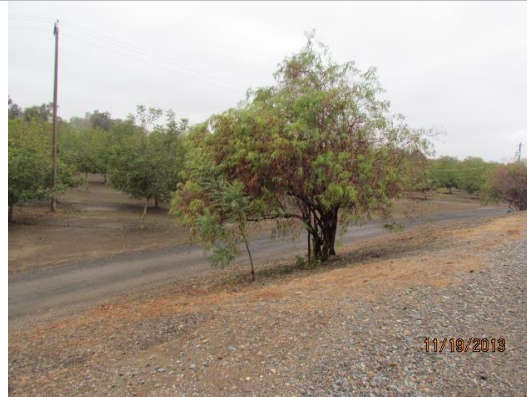
Photo 1 of 1 : SP_2015_MA0001_297_50_20150310_00015.jpg

LM Start	3.88	Rating **	M	Issue No.	50
LM End	3.88	Issue Type +	Ma	Location *	LS
Category	Earthen Levee			GPS Latitude/Longitude	
				Start	End
Item	Vegetation			39.257125 °	39.257125 °
				-122.012648 °	-122.012648 °
DWR ID	DWR_MA0001_01_f_2013_50				
Action/Comments					
Elderberries are blocking visibility and flood fight capability.

View of the elderberry on the landside slope.

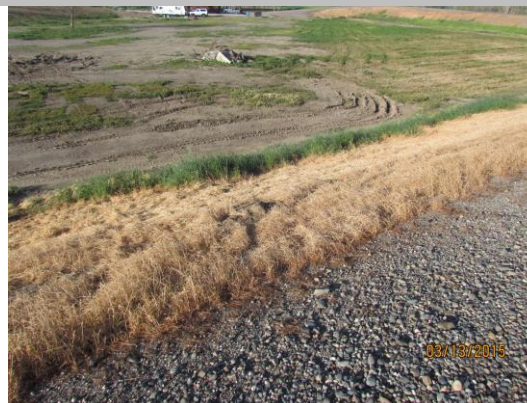
Photo 1 of 1 : SP_2015_MA0001_297_73_20150406_00022.jpg

View of the rodent hole along the landside slope.

LM Start	4.67	Rating **	A/W	Issue No.	73
LM End	4.67	Issue Type +	Ma	Location *	LS
Category	Earthen Levee			GPS Latitude/Longitude	
				Start	End
Item	Animal Control			39.266557 °	39.266557 °
				-122.011208 °	-122.011208 °
DWR ID	DWR_MA0001_01_s_2015_73				
Action/Comments					
Exterminate rodents and backfill and compact or grout burrows.

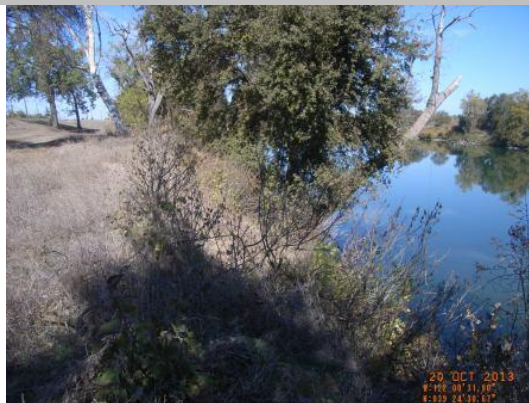
Photo 1 of 2 : SP_2015_MA0001_297_1_20150310_00001.jpg

LM Start	16.35	Rating **	M	Issue No.	1
LM End	16.58	Issue Type +	Ma	Location *	WS
Category	Supplemental			GPS Latitude/Longitude	
				Start	End
Item	USACE Erosion Survey			39.407837 °	39.411111 °
				-122.008763 °	-122.009238 °
DWR ID	DWR_MA0001_01_f_2014_1				
Action/Comments					
Inspector Comments: Erosion site added in 1997 and removed in 2005. 2009 - Site added back in, hard toe with slow moving erosion. Potential geotechnical failure. 2011 - Site extended downstream. 2013: No observed changes. [2013 Site ID: SAC_164-3_R]

USACE 2013 Photo #1

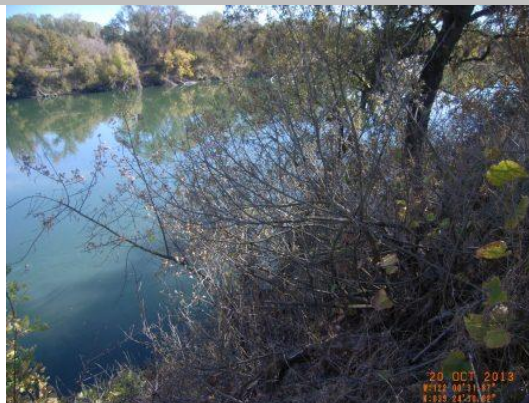
Photo 2 of 2 : SP_2015_MA0001_297_1_20150310_00002.jpg

LM Start	16.35	Rating **	M	Issue No.	1 (cont)
LM End	16.58	Issue Type +	Ma	Location *	WS

USACE 2013 Photo #2
