**Flood Control Project Maintenance
Levee Inspections**

Maintenance Issue Types Only, Levee Inspection Report By Mile - Spring 2016

Sutter Maintenance Yard Maintenance Area 0001

Waterway	Bank	Unit Miles	Inspection Start/End	Inspector
Unit No. 01 Sacramento River	Right	16.76	03/24/2016 03/24/2016	Keith Millard

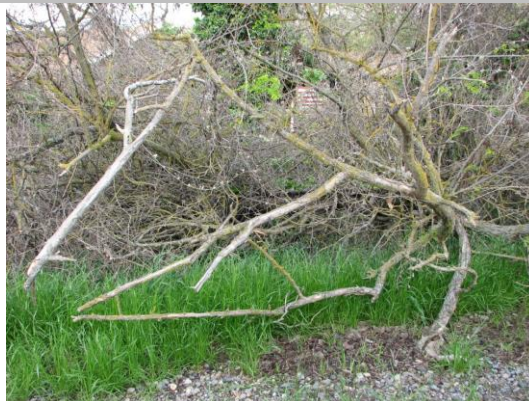
Photo 1 of 1 : SP_2016_MA0001_297_81_20160405_00144.jpg

LM Start	3.09	Rating **	U	Issue No.	81
LM End	3.09	Issue Type +	Ma	Location *	LS
Category	Earthen Levee			GPS Latitude/Longitude	
				Start	End
Item	Trim / Thin Trees			39.247332 °	39.247332 °
				-122.008164 °	-122.008164 °
DWR ID	DWR_MA0001_01_s_2016_81				
Comment Code					
T3 : Trim and thin trees to allow visibility of the ground and room to flood fight.					
Inspector Comment					
downed tree covering LS slope.

Downed tree obstructing access

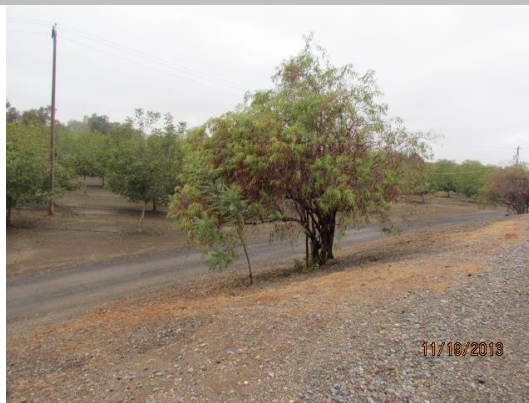
Photo 1 of 1 : SP_2016_MA0001_297_50_20160316_00016.jpg

LM Start	3.88	Rating **	M	Issue No.	50
LM End	3.88	Issue Type +	Ma	Location *	LS
Category	Earthen Levee			GPS Latitude/Longitude	
				Start	End
Item	Vegetation			39.257125 °	39.257125 °
				-122.012648 °	-122.012648 °
DWR ID	DWR_MA0001_01_f_2013_50				
Comment Code					
V4 : Elderberries are blocking visibility and flood fight capability.					
Inspector Comment

View of the elderberry on the landside slope.

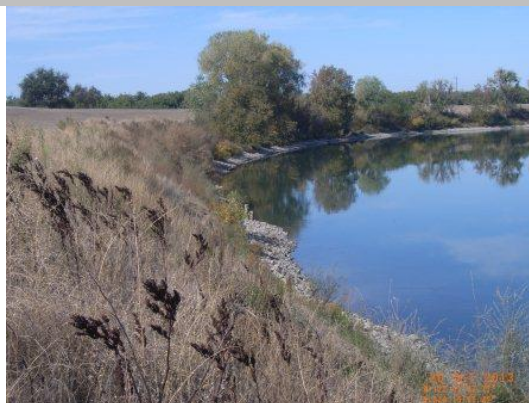
Photo 1 of 1 : SP_2016_MA0001_297_3_20160316_00002.jpg

LM Start	4.86	Rating **	M	Issue No.	3
LM End	5.26	Issue Type +	Ma	Location *	WS
Category	Supplemental			GPS Latitude/Longitude	
				Start	End
Item	2015 USACE Erosion Survey, DRAFT			39.265730 °	39.266315 °
				-122.014925 °	-122.020682 °
DWR ID	DWR_MA0001_01_s_2016_3				
Comment Code					
Inspector Comment					
2009 - Slump in the middle of the section has left a vertical section on the bank. 2010 - Old cobble site unraveling, site extended downstream. 2015: Last observed in 2013. [2015 Site ID: SAC_151-0_R]

USACE 2013 Photo #1

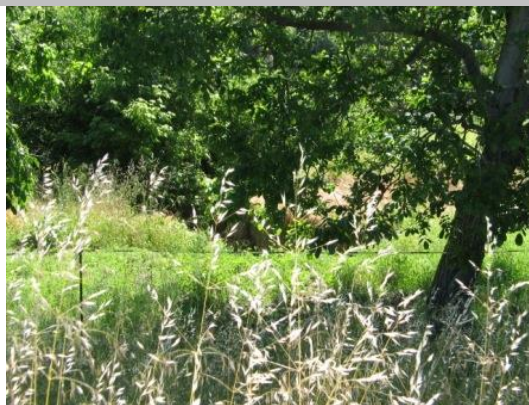
Photo 1 of 1 : SP_2016_MA0001_297_18_20160316_00009.jpg

LM Start	10.13	Rating **	M	Issue No.	18
LM End	10.13	Issue Type +	Ma	Location *	WS
Category	Earthen Levee			GPS Latitude/Longitude	
				Start	End
Item	Erosion / Bank Caving			39.328697 °	39.328697 °
				-122.029262 °	-122.029262 °
DWR ID	DWR_MA0001_01_s _ 2012_18				
Comment Code					
E1 : Note and monitor erosion site.					
Inspector Comment					
Monitor the erosion site.

View of the erosion along the waterside of the levee.

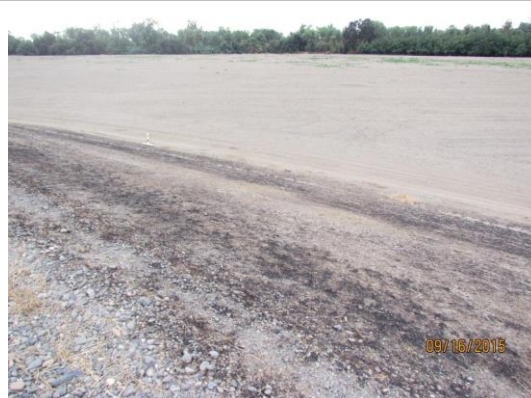
Photo 1 of 1 : SP_2016_MA0001_297_78_20160316_00021.jpg

LM Start	12.27	Rating **	A/W	Issue No.	78
LM End	12.27	Issue Type +	Ma	Location *	WS
Category	Earthen Levee			GPS Latitude/Longitude	
				Start	End
Item	Animal Control			39.357497 °	39.357497 °
				-122.026093 °	-122.026093 °
DWR ID	DWR_MA0001_01_f_2015_78				
Comment Code					
A1 : Exterminate rodents and backfill and compact or grout burrows.					
Inspector Comment

View of the rodent holes along the waterside slope.

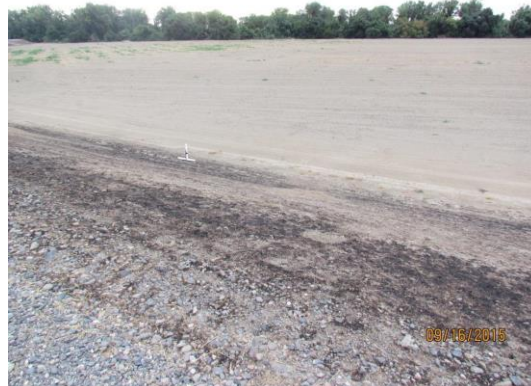
Photo 1 of 1 : SP_2016_MA0001_297_79_20160316_00022.jpg

LM Start	12.49	Rating **	A/W	Issue No.	79
LM End	12.49	Issue Type +	Ma	Location *	WS
Category	Earthen Levee			GPS Latitude/Longitude	
				Start	End
Item	Animal Control			39.359500 °	39.359500 °
				-122.022980 °	-122.022980 °
DWR ID	DWR_MA0001_01_f_2015_79				
Comment Code					
A3 : No rodents visible, but rodent burrows visible; need to backfill and compact or grout burrows.					
Inspector Comment

View of the rodent holes along the waterside slope.

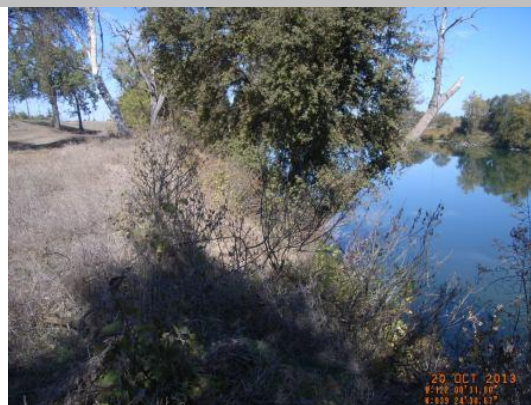
Photo 1 of 2 : SP_2016_MA0001_297_9_20160316_00006.jpg

LM Start	16.35	Rating **	M	Issue No.	9
LM End	16.58	Issue Type +	Ma	Location *	WS
Category	Supplemental			GPS Latitude/Longitude	
				Start	End
Item	2015 USACE Erosion Survey, DRAFT			39.407837 °	39.411111 °
				-122.008763 °	-122.009238 °
DWR ID	DWR_MA0001_01_s_2016_9				
Comment Code					
Inspector Comment					
Erosion site added in 1997 and removed in 2005. 2009 - Site added back in, hard toe with slow moving erosion. Potential geotechnical failure. 2011 - Site extended downstream. 2015: Last observed in 2013. [2015 Site ID: SAC_164-3_R]

USACE 2013 Photo #1

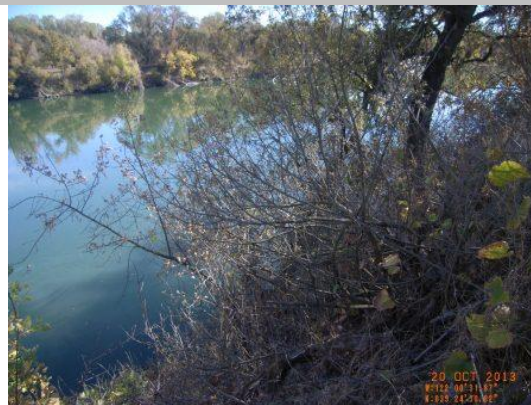
Photo 2 of 2 : SP_2016_MA0001_297_9_20160316_00007.jpg

LM Start	16.35	Rating **	M	Issue No.	9 (cont)
LM End	16.58	Issue Type +	Ma	Location *	WS

USACE 2013 Photo #2
