**Flood Control Project Maintenance  
Levee Inspections**

**Maintenance Issue Types Only, Levee Inspection Report By Mile - Spring 2020**

**Sutter Maintenance Yard Maintenance Area 0001**

Waterway	Bank	Unit Miles	Inspection Start/End	Inspector
Unit No. 01 Sacramento River	Right	16.76	03/10/2020 03/10/2020	Makar Sokol

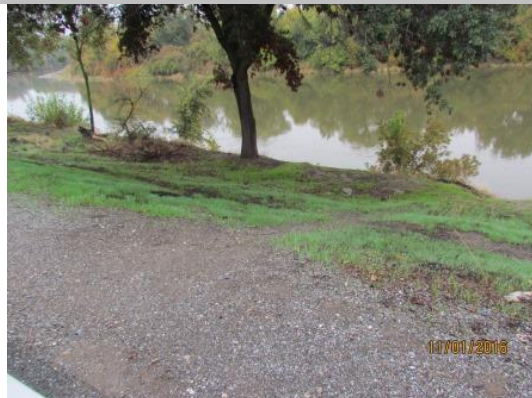
Photo 1 of 1 : SP\_2020\_MA0001\_297\_98\_20200226\_00025.jpg

LM Start	0.38	Rating **	A/W	Issue No.	98
LM End	0.38	Issue Type +	Ma	Location *	WS
Category	Earthen Levee			GPS Latitude/Longitude	
				Start	End
Item	Slope Stability			39.215878 °	39.215878 °
				-122.007278 °	-122.007278 °
DWR ID	DWR_MA0001_01_f_2016_98				
Comment Code					
S2 : Repair the levee slope damaged by foot traffic and prevent access where possible.					
Inspector Comment

View of the slope instability along the waterside slope.

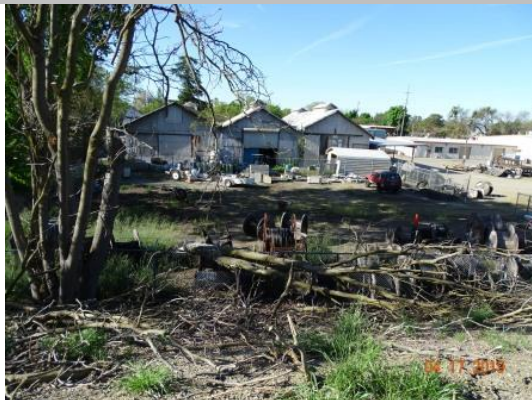
Photo 1 of 1 : SP\_2020\_MA0001\_297\_79\_20200226\_00016.jpg

LM Start	0.87	Rating **	M	Issue No.	79
LM End	0.87	Issue Type +	Ma	Location *	LS
Category	Earthen Levee			GPS Latitude/Longitude	
				Start	End
Item	Encroachments			39.217717 °	39.217717 °
				-122.015717 °	-122.015717 °
DWR ID	DWR_MA0001_01_s_2019_79				
Comment Code					
TR : Tree or limb					
Inspector Comment

View of the tree branches and limbs at the landside toe. Spring 2019.

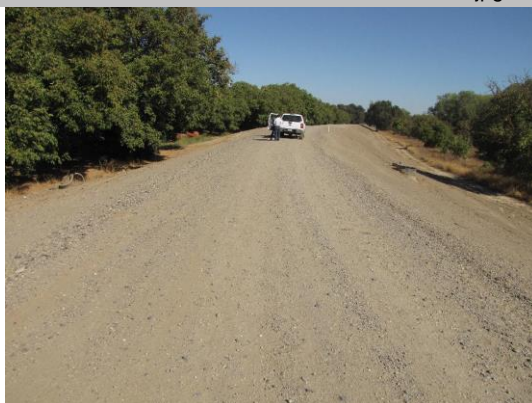
Photo 1 of 3 : UCIP\_SP\_2020\_51852\_70064.jpg

Comment Code					
Inspector Comment					
DS_ID:16430 FS_ID:51852 EP_NO: 9487 Repair Type: Non-Urgent Crossing Status: Found UCIP Comments: 5/3/2017 WS end still partially plugged. (DWR Sutter Yard- A Freitag)10/24/2016 Ws end is till partially plugged.(DWR Sutter Yard- A Freitag)4/25/2016 WS pipe end is still plugged with soil. Rest of the pipe appeared to be in good condition.4/20/2015 WS pipe end is plugged about 50% by soil.6/18/2014 Same as last inspection.12/17/2013 Same as last inspection.7/18/2013 WS pipe end has been reformed but is still clogged about 50% by sediment.10/18/2012 Remove dirt and debris in riser. Outlet deformed and blocked over 50%. Debris-round concrete section on landward side. This crossing was listed in the USACE Periodic Inspections as ID# USACE_CESPK_MA1C_2010_p_0116 for crossing outlet deformed and clogged with dirt. FIELD_STRUCT_DESC: 1 of 2: 36-inch corrugated metal drainage pipe through the levee, approximately 12-15 feet below the crown. Slide gates in corrugated metal pipe (CMP) riser located on the waterside (WS) slope. Pipe daylights on the landside (LS). (36-inch pipe [HLM 1.97] authorized under Automatic Board Order (ABO) issued as Permit No. 9487, 1974 - Jimeno Rancho) [Additional Reference(s): DWR Levee Log, 1992. USACE Sacramento O&M Manual 137, August 1955, (Station 103+18)]. FS Date: 5/19/2017 1:20:29 PM

Overview of levee crown and slopes looking upstream towards crossing.

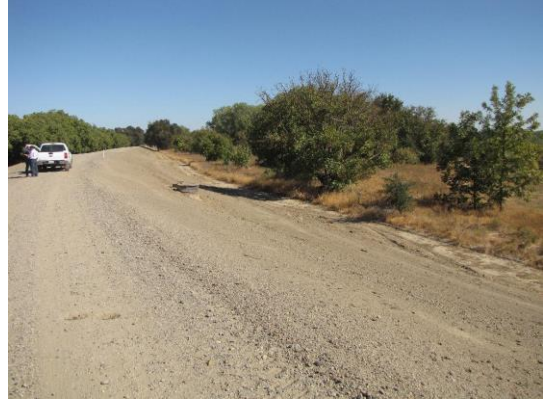
Photo 2 of 3 : UCIP\_SP\_2020\_51852\_70063.jpg

View of WS looking upstream at CMP riser on slope.

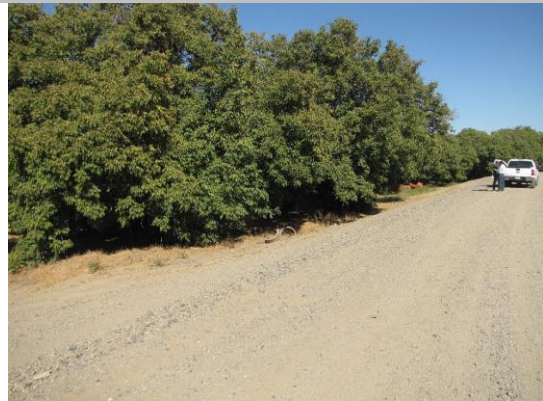
Photo 3 of 3 : UCIP\_SP\_2020\_51852\_70062.jpg

View of LS looking upstream at crossing.

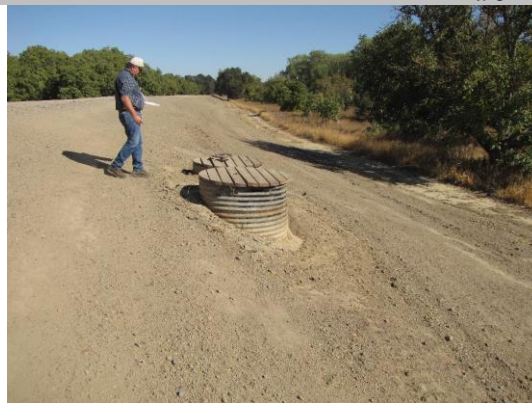
Photo 2 of 3 : UCIP\_SP\_2020\_51853\_70074.jpg

View of CMP risers located on WS slope.

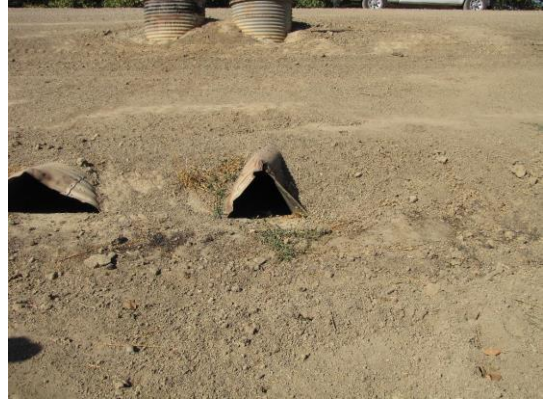
Photo 3 of 3 : UCIP\_SP\_2020\_51853\_70073.jpg

CMP pipe outlet deformed with over 50 percent blockage.

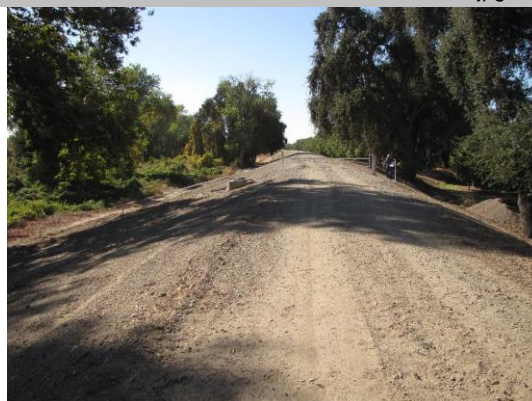
Photo 1 of 3 : UCIP\_SP\_2020\_51854\_70078.jpg

Comment Code						
Inspector Comment						
DS_ID:16429 FS_ID:51854 EP_NO: 9472 Repair Type: Non-Urgent Crossing Status: Found UCIP Comments: 5/3/2017 LS inlet partially plugged with soil. Some debris still present inside riser. (DWR Sutter Yard-AFreitag)10/24/2016 Debris still inside of riser.(DWR Sutter Yard-AFreitag)4/25/2016 Pipe still inside of riser and LS end plugged about 50% by soil.4/20/2015 Same as last inspection.6/18/2014 Same as last inspection.12/17/2013 Same as last inspection.7/18/2013 Same as last inspection.10/18/12 Remove debris from riser. Landward inlet is blocked by over 50%. This crossing was listed in the USACE Periodic Inspections as ID# USACE_CESPK_MA1C_2010_p_0128 for sediment build up at inlet (landward side) and debris inside riser. FIELD_STRUCT_DESC: 54-inch corrugated metal drainage pipe through the levee, approximately 12-15 feet below the crown. Slide gate in corrugated metal pipe (CMP) riser on the waterside (WS) slope. 48-inch CMP at landside (LS) slope. This crossing crosses the levee at an angle. (54-inch pipe [HLM 2.29] authorized under Automatic Board Order (ABO) issued as Permit No. 9472, 1974 - Ballard) ) [Additional Reference(s): DWR Levee Log, 1992. USACE Sacramento O&M Manual 137, August 1955, (Station 120+00)]. FS Date: 5/19/2017 1:23:34 PM

View of levee crown looking downstream at crossing. CMP riser located on WS shoulder.

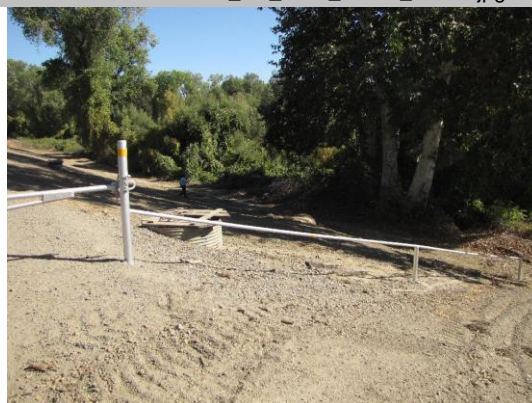
Photo 2 of 3 : UCIP\_SP\_2020\_51854\_70079.jpg

View of WS looking at slope and channel.

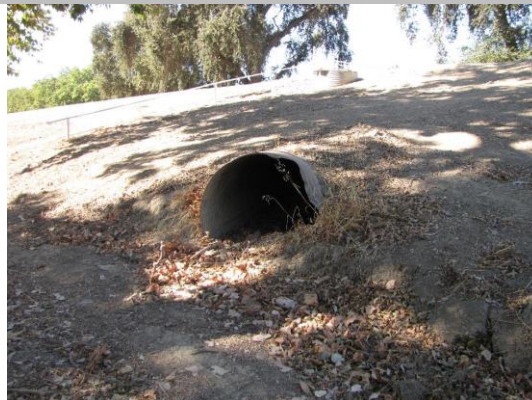
Photo 3 of 3 : UCIP\_SP\_2020\_51854\_70077.jpg

View of outlet located at WS toe.

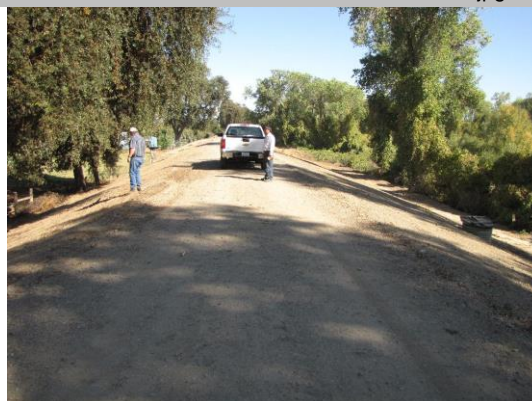
Photo 1 of 3 : UCIP\_SP\_2020\_51855\_70085.jpg

DS\_ID:16428  
 FS\_ID:51855  
 EP\_NO: 9467  
 Repair Type: Non-Urgent  
 Crossing Status: Found  
 UCIP Comments: 5/3/2017 Abandoned- needs to be done so properly.  
 (DWR Sutter Yard- A Freitag)10/24/2016 Abandoned.(DWR Sutter Yard- A Freitag)4/25/2016 Abandoned crossing. Unable to locate any WS and LS pipe ends.4/20/2015 Same as last inspection.6/18/2014 Same as last inspection.12/17/2013 Same as last inspection.7/18/2013 Same as last inspection.10/18/2012 Only riser visible. Debris and sediment blocking gate. Gate inside riser is buried and non-functional. If crossing is abandoned, owner needs to properly abandon. This crossing was listed in the USACE Periodic Inspections as ID# USACE\_CESPK\_MA1C\_2010\_p\_0132 no culvert through the levee is visible here.  
 FIELD\_STRUCT\_DESC: \*ABANDONED\* 24-inch corrugated metal drainage pipe through the levee, approximately 12-15 feet below the crown. Slide gate in CM pipe riser on the waterside (WS) slope. No signs of inlet visible on the landside (LS). (24-inch pipe [HLM 2.31] authorized under Automatic Board Order (ABO) issued as Permit No. 9467, 1974 - Lovell E. Spurgeon) [Additional Reference(s): DWR Levee Log, 1992. USACE Sacramento O&M Manual 137, August 1955, (Station 120+60)].

Overview of levee crown looking upstream at crossing.

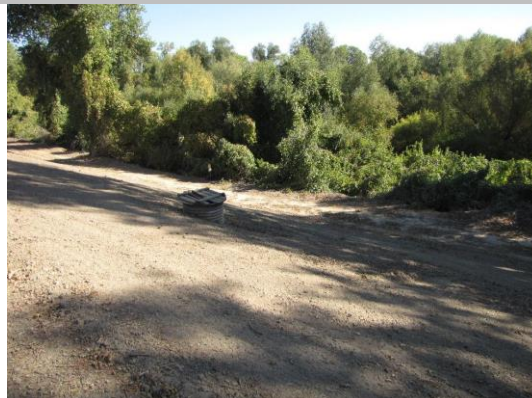
Photo 2 of 3 : UCIP\_SP\_2020\_51855\_70084.jpg

View of WS slope and toe.

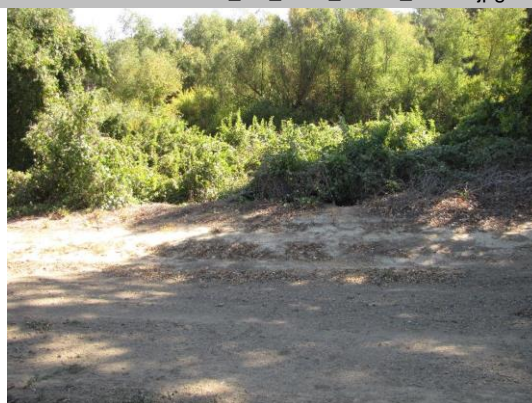
Photo 3 of 3 : UCIP\_SP\_2020\_51855\_70083.jpg

Unable to locate WS outlet.

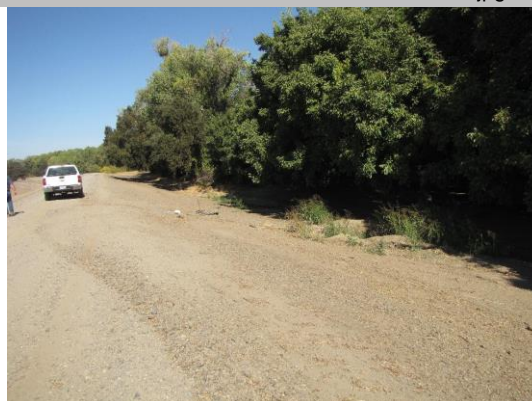
Photo 2 of 3 : UCIP\_SP\_2020\_51859\_70109.jpg

View of WS looking upstream.

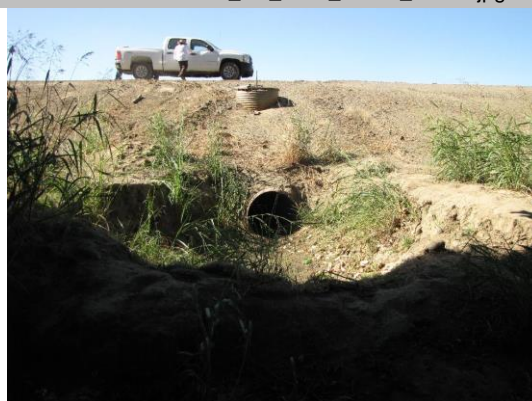
Photo 3 of 3 : UCIP\_SP\_2020\_51859\_70111.jpg

View of WS slope, riser with slide gate, and outlet.

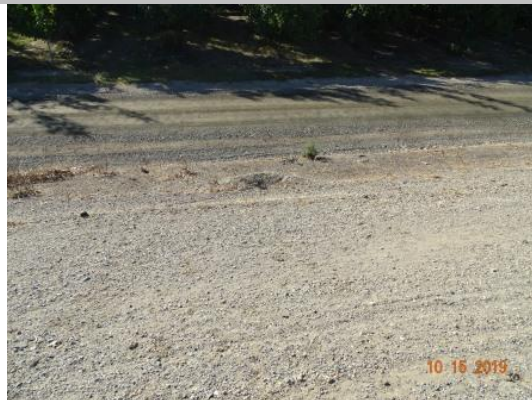
Photo 1 of 1 : SP\_2020\_MA0001\_297\_80\_20200226\_00017.jpg

View of the rodent activity at the landside toe. Fall 2019.

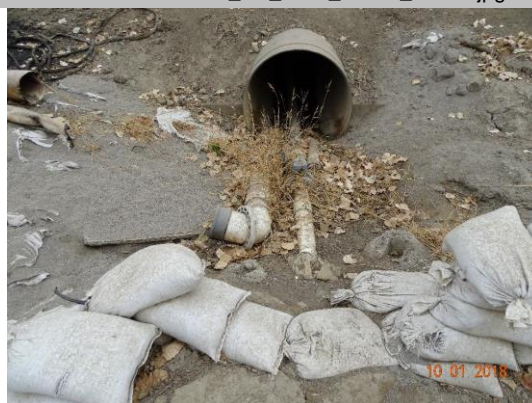
Photo 3 of 3 : UCIP\_SP\_2020\_53049\_78244.jpg

Pipe at LS toe.

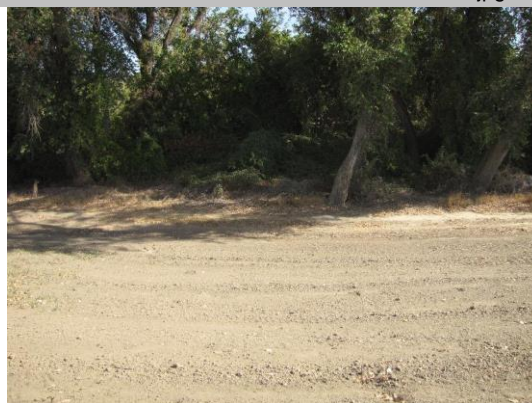
Photo 1 of 3 : UCIP\_SP\_2020\_51874\_70181.jpg

Comment Code						
Inspector Comment						
DS_ID:16425 FS_ID:51874 EP_NO: N/A Repair Type: Non-Urgent Crossing Status: Found UCIP Comments: 5/3/2017 Abandoned- needs to be done properly. (DWR Sutter Yard- AFreitag)10/24/2016 Abandoned(DWR Sutter Yard- AFreitag)4/25/2016 Abandoned crossing.4/20/2015 Same as last inspection.6/23/2014 Same as last inspection.12/17/2013 Same as last inspection.7/18/2013 Same as last inspection.10/19/2012 Need to be properly abandoned concrete structure; plate covers concrete box; Concrete headwall damaged. This crossing was listed in the USACE Periodic Inspection as ID# USACE_CESPK_MA1C_2010_p_0262 for damage to concrete structure (vertical 2 inch wide cracks and spalling visible). FIELD_STRUCT_DESC: *ABANDONED* 72-inch corrugated metal (precast concrete) drainage pipe through the levee at an unknown depth below the crown. Structure is blocked on the waterside (WS) end with 3-foot concrete plug installed in 1980. Slide gate in concrete well on the landside (LS) shoulder. Concrete headwall at both toes. WS headwall not found. [Additional Reference(s): DWR Levee Log, 1992. USACE Sacramento O&M Manual 137, August 1955, (Station 339+74)]. FS Date: 5/23/2017 10:13:24 AM

View of WS no structure features visible.

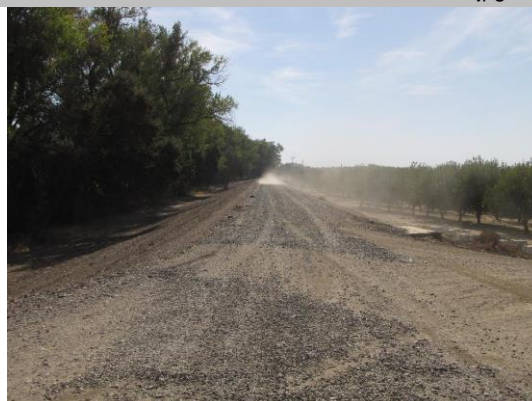
Photo 2 of 3 : UCIP\_SP\_2020\_51874\_70180.jpg

Overview of levee crown looking downstream at crossing.

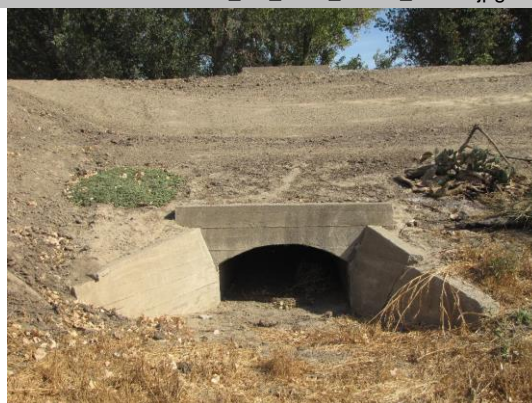
Photo 3 of 3 : UCIP\_SP\_2020\_51874\_70179.jpg

View of structure located in LS.

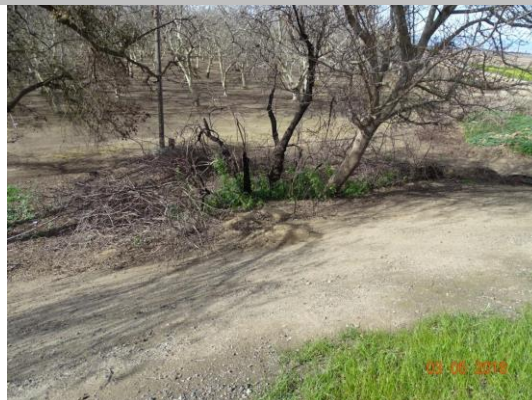
Photo 1 of 1 : SP\_2020\_MA0001\_297\_69\_20200226\_00013.jpg

LM Start	11.01	Rating **	M	Issue No.	69
LM End	11.01	Issue Type +	Ma	Location *	LS
Category	Earthen Levee			GPS Latitude/Longitude	
				Start	End
Item	Animal Control			39.340803 °	39.340803 °
				-122.032868 °	-122.032868 °
DWR ID	DWR_MA0001_01_s_2018_69				
Comment Code					
A3 : No rodents visible, but rodent burrows visible; need to backfill and compact or grout burrows.					
Inspector Comment

View of the rodent holes along the landside slope.

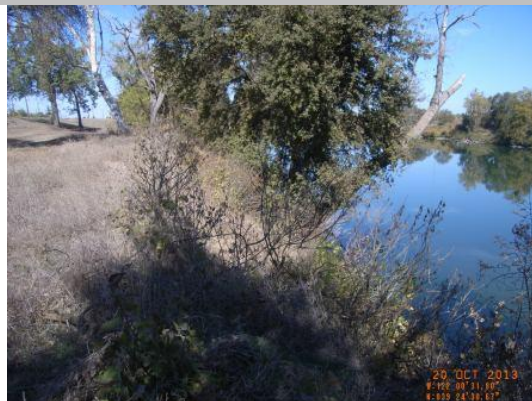
Photo 1 of 2 : SP\_2020\_MA0001\_297\_9\_20200226\_00005.jpg

LM Start	16.35	Rating **	A/W	Issue No.	9
LM End	16.58	Issue Type +	Ma	Location *	WS
Category	Supplemental			GPS Latitude/Longitude	
				Start	End
Item	2017 USACE Erosion Survey			39.407837 °	39.411111 °
				-122.008763 °	-122.009238 °
DWR ID	DWR_ST0010_02_f_2022_7				
Comment Code					
Inspector Comment					
2017 Site ID: SAC 164.3 R					
Status: Eroding					
2017 Field Notes: New erosion along entire site.					
Site History: Erosion site added in 1997 and removed in 2005. 2009 -					
Site added back in, hard toe with slow moving erosion. Potential					
geotechnical failure. 2011 - Site extended downstream.
