**Flood Control Project Maintenance
Levee Inspections**

Maintenance Issue Types Only, Levee Inspection Report By Mile - Spring 2021

Sutter Maintenance Yard Maintenance Area 0001

Waterway	Bank	Unit Miles	Inspection Start/End	Inspector
Unit No. 01 Sacramento River	Right	16.76	03/19/2021 03/19/2021	Makar Sokol

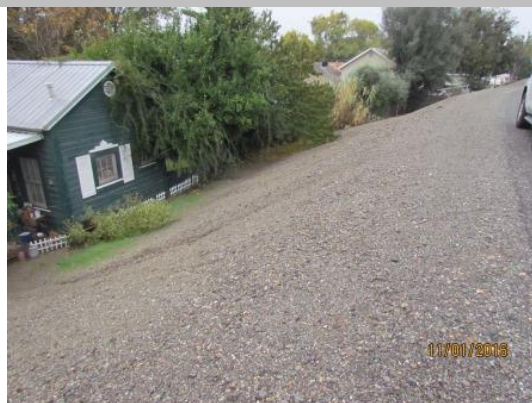
Photo 1 of 1 : SP_2021_MA0001_297_94_20210224_00026.jpg

LM Start	0.09	Rating **	A/W	Issue No.	94
LM End	0.09	Issue Type +	Ma	Location *	LS
Category	Earthen Levee			GPS Latitude/Longitude	
				Start	End
Item	Slope Stability			39.214217 °	39.214217 °
				-122.002378 °	-122.002378 °
DWR ID	DWR_MA0001_01_f_2016_94				
Comment Code					
S2 : Repair the levee slope damaged by foot traffic and prevent access where possible.					
Inspector Comment

View of the slope instability along the landside slope.

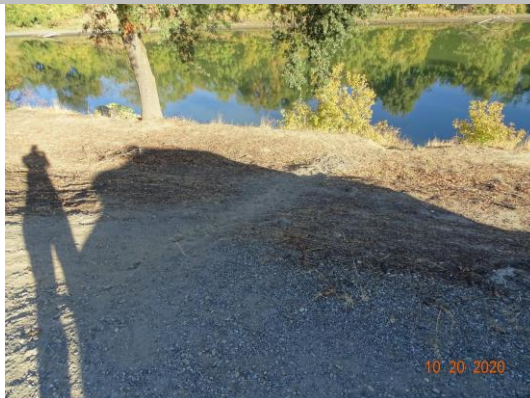
Photo 1 of 1 : SP_2021_MA0001_297_98_20210224_00027.jpg

LM Start	0.38	Rating **	A/W	Issue No.	98
LM End	0.38	Issue Type +	Ma	Location *	WS
Category	Earthen Levee			GPS Latitude/Longitude	
				Start	End
Item	Slope Stability			39.215878 °	39.215878 °
				-122.007278 °	-122.007278 °
DWR ID	DWR_MA0001_01_f_2020_98				
Comment Code					
S2 : Repair the levee slope damaged by foot traffic and prevent access where possible.					
Inspector Comment

View of the slope instability along the waterside slope. Fall 2020.

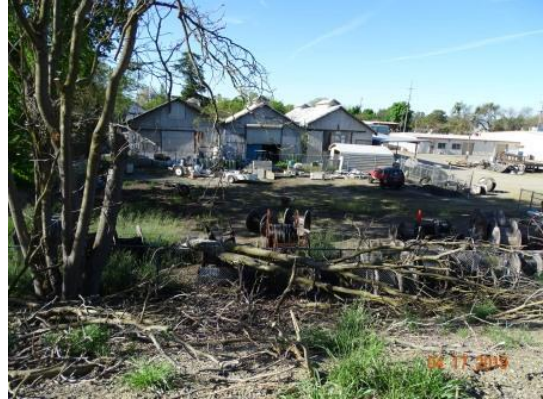
Photo 1 of 1 : SP_2021_MA0001_297_79_20210224_00019.jpg

LM Start	0.87	Rating **	M	Issue No.	79
LM End	0.87	Issue Type +	Ma	Location *	LS
Category	Earthen Levee			GPS Latitude/Longitude	
				Start	End
Item	Encroachments			39.217717 °	39.217717 °
				-122.015717 °	-122.015717 °
DWR ID	DWR_MA0001_01_s_2019_79				
Comment Code					
TR : Tree or limb					
Inspector Comment

View of the tree branches and limbs at the landside toe. Spring 2019.

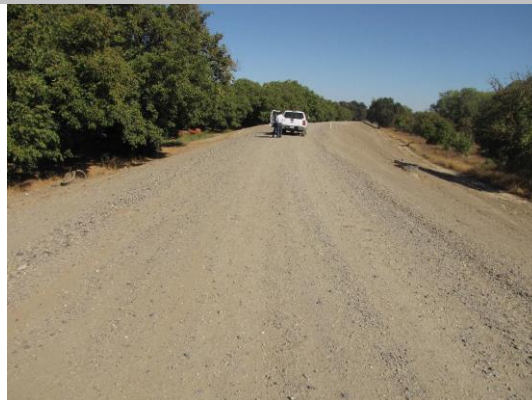
Photo 1 of 3 : UCIP_SP_2021_58090_70064.jpg

Comment Code						
Inspector Comment						
FS_ID:58090 DS_ID:16430 EP_NO: 9487 Repair Type: Non-Urgent Crossing Status: Found UCIP Comments: 05/03/2017 WS end still partially plugged. (A. Freitag - DWR Sutter Yard)10/24/2016 Ws end is till partially plugged. (A. Freitag - DWR Sutter Yard)04/25/2016 WS pipe end is still plugged with soil. Rest of the pipe appeared to be in good condition. (A. Freitag - DWR Sutter Yard)04/20/2015 WS pipe end is plugged about 50% by soil. (A. Freitag - DWR Sutter Yard)06/18/2014 Same as last inspection. (A. Freitag - DWR Sutter Yard)12/17/2013 Same as last inspection. (A. Freitag - DWR Sutter Yard)07/18/2013 WS pipe end has been reformed but is still clogged about 50% by sediment.10/18/2012 Remove dirt and debris in riser. Outlet deformed and blocked over 50%. Debris-round concrete section on landward side. This crossing was listed in the USACE Periodic Inspections as ID# USACE_CESPK_MA1C_2010_p_0116 for crossing outlet deformed and clogged with dirt. (O. Magana - DWR UCIP) FIELD_STRUCT_DESC: 1 of 2: 36-inch corrugated metal drainage pipe through the levee, approximately 12-15 feet below the crown. Slide gates in corrugated metal pipe (CMP) riser located on the waterside (WS) slope. Pipe daylights on the landside (LS). (36-inch pipe [HLM 1.97] authorized under Automatic Board Order (ABO) issued as Permit No. 9487, 1974 - Jimeno Rancho) [Additional Reference(s): DWR Levee Log, 1992. USACE Sacramento O&M Manual 137, August 1955, (Station 103+18)]. FS Date: 5/19/2017 1:20:00 PM

Overview of levee crown and slopes looking upstream towards crossing.

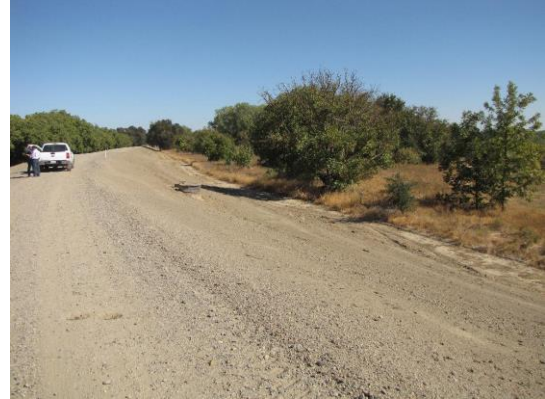
Photo 2 of 3 : UCIP_SP_2021_58090_70063.jpg

View of WS looking upstream at CMP riser on slope.

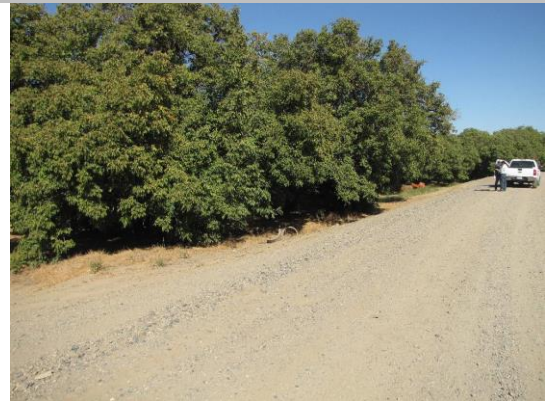
Photo 3 of 3 : UCIP_SP_2021_58090_70062.jpg

View of LS looking upstream at crossing.

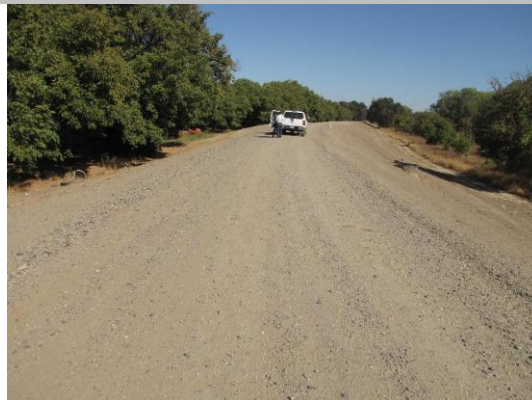
Photo 1 of 3 : UCIP_SP_2021_58092_70071.jpg

Comment Code						
Inspector Comment						
FS_ID:58092 DS_ID:17565 EP_NO: 9487 Repair Type: Non-Urgent Crossing Status: Found UCIP Comments: 05/03/2017 Ws end still partially plugged. (A. Freitag - DWR Sutter Yard)10/24/2016 Ws pipe end still plugged. (A. Freitag - DWR Sutter Yard)04/25/2016 WS pipe end still plugged with soil. rest of pipe appears in good condition. (A. Freitag - DWR Sutter Yard)04/20/2015 WS pipe end plugged about 50% by soil. (A. Freitag - DWR Sutter Yard)06/18/2014 Same as last inspection. (A. Freitag - DWR Sutter Yard)12/17/2013 Same as last inspection. (A. Freitag - DWR Sutter Yard)07/18/2013 WS pipe end has been reformed but is still partially blocked with dirt and debris.10/18/2012 WS-remove dirt and debris in riser. Outlet deformed and blocked over 50%. Burrow activity near outlet on waterward slope. Debris around concrete section on landward side. This crossing was listed in the USACE Periodic Inspections as ID# USACE_CESPK_MA1C_2010_p_0116 for crossing outlet deformed and clogged with dirt. (O. Magana - DWR UCIP) FIELD_STRUCT_DESC: 2 of 2: 36-inch corrugated metal drainage pipe through the levee, approximately 12-15 feet below the crown. Slide gates in corrugated metal pipe (CMP) riser on the waterside (WS) slope. Pipe daylights on the landside (LS). (36-inch pipe [HLM 1.97] authorized under Automatic Board Order (ABO) issued as Permit No. 9487, 1974 - Jimeno Rancho) [Additional Reference(s): DWR Levee Log, 1992. USACE Sacramento O&M Manual 137, August 1955, (Station 103+18)]. FS Date: 5/19/2017 1:21:00 PM

View of levee crown and slopes looking upstream at crossing.

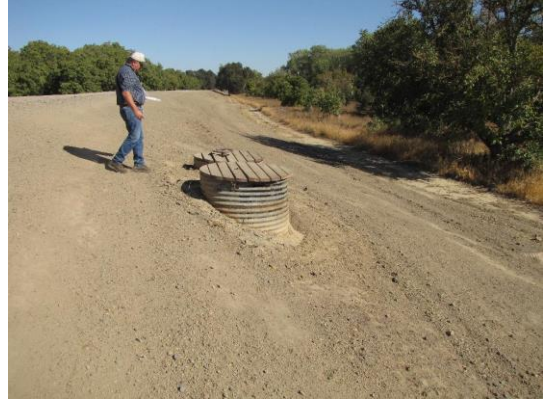
Photo 2 of 3 : UCIP_SP_2021_58092_70074.jpg

View of CMP risers located on WS slope.

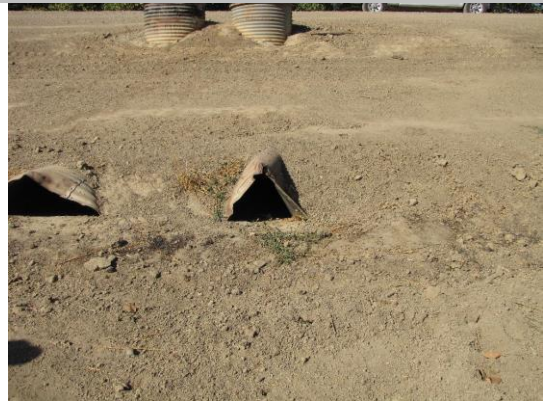
Photo 3 of 3 : UCIP_SP_2021_58092_70073.jpg

CMP pipe outlet deformed with over 50 percent blockage.

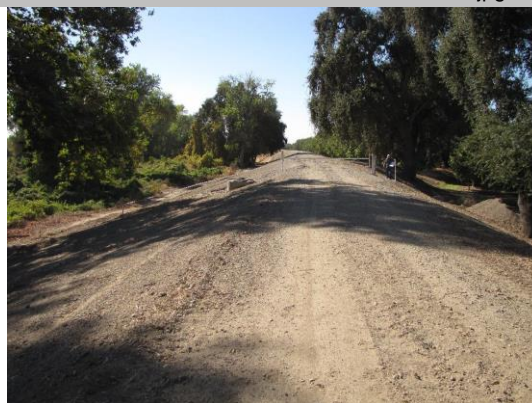
Photo 1 of 3 : UCIP_SP_2021_58093_70078.jpg

FS_ID:58093
DS_ID:16429
EP_NO: 9472
Repair Type: Non-Urgent
Crossing Status: Found
UCIP Comments: 05/03/2017 LS inlet partially plugged with soil. Some debris still present inside riser. (A. Freitag - DWR Sutter Yard)10/24/2016 Debris still inside of riser. (A. Freitag - DWR Sutter Yard)04/25/2016 Pipe still inside of riser and LS end plugged about 50% by soil. (A. Freitag - DWR Sutter Yard)04/20/2015 Same as last inspection. (A. Freitag - DWR Sutter Yard)06/18/2014 Same as last inspection. (A. Freitag - DWR Sutter Yard)12/17/2013 Same as last inspection. (A. Freitag - DWR Sutter Yard)07/18/2013 Same as last inspection. (A. Freitag - DWR Sutter Yard)10/18/2012 Remove debris from riser. Landward inlet is blocked by over 50%. This crossing was listed in the USACE Periodic Inspections as ID# USACE_CESPK_MA1C_2010_p_0128 for sediment build up at inlet (landward side) and debris inside riser. (O. Magana - DWR UCIP) FIELD_STRUCT_DESC: 54-inch corrugated metal drainage pipe through the levee, approximately 12-15 feet below the crown. Slide gate in corrugated metal pipe (CMP) riser on the waterside (WS) slope. 48-inch CMP at landside (LS) slope. This crossing crosses the levee at an angle. (54-inch pipe [HLM 2.29] authorized under Automatic Board Order (ABO) issued as Permit No. 9472, 1974 - Ballard) [Additional Reference(s): DWR Levee Log, 1992. USACE Sacramento O&M Manual 137, August 1955, (Station 120+00)].

View of levee crown looking downstream at crossing. CMP riser located on WS shoulder.

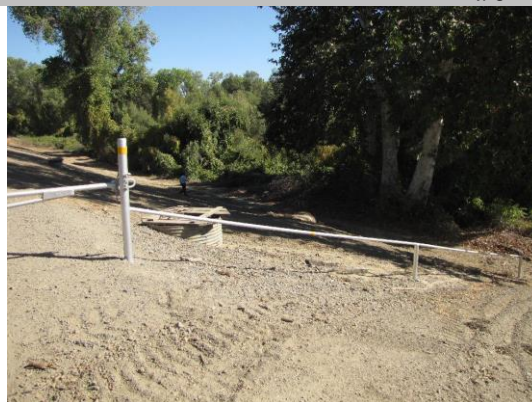
Photo 2 of 3 : UCIP_SP_2021_58093_70079.jpg

View of WS looking at slope and channel.

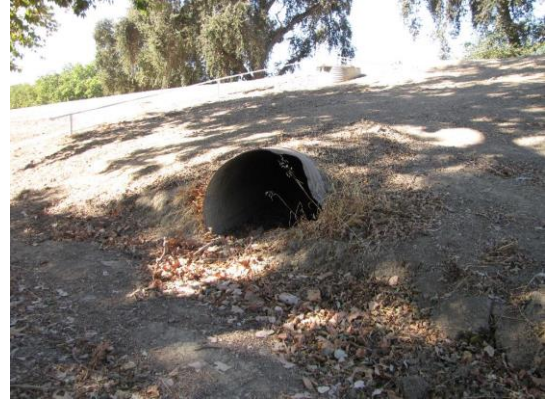
Photo 3 of 3 : UCIP_SP_2021_58093_70077.jpg

View of outlet located at WS toe.

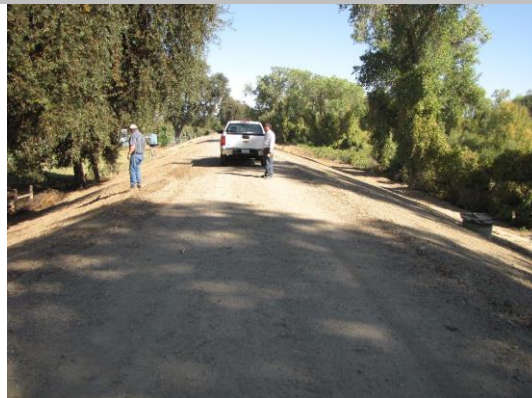
Photo 1 of 3 : UCIP_SP_2021_58095_70085.jpg

Comment Code						
Inspector Comment						
FS_ID:58095 DS_ID:16428 EP_NO: 9467 Repair Type: Non-Urgent Crossing Status: Found UCIP Comments: 05/03/2017 Abandoned- needs to be done so properly. (A. Freitag - DWR Sutter Yard)10/24/2016 Abandoned. (A. Freitag - DWR Sutter Yard)04/25/2016 Abandoned crossing. Unable to locate any WS and LS pipe ends. (A. Freitag - DWR Sutter Yard)04/20/2015 Same as last inspection. (A. Freitag - DWR Sutter Yard)06/18/2014 Same as last inspection. (A. Freitag - DWR Sutter Yard)12/17/2013 Same as last inspection. (A. Freitag - DWR Sutter Yard)07/18/2013 Same as last inspection. (A. Freitag - DWR Sutter Yard)10/18/2012 Only riser visible. Debris and sediment blocking gate. Gate inside riser is buried and non-functional. If crossing is abandoned, owner needs to properly abandon. This crossing was listed in the USACE Periodic Inspections as ID# USACE_CESPK_MA1C_2010_p_0132 no culvert through the levee is visible here. (O. Magana - DWR UCIP) FIELD_STRUCT_DESC: *ABANDONED* 24-inch corrugated metal drainage pipe through the levee, approximately 12-15 feet below the crown. Slide gate in CM pipe riser on the waterside (WS) slope. No signs of inlet visible on the landside (LS). (24-inch pipe [HLM 2.31] authorized under Automatic Board Order (ABO) issued as Permit No. 9467, 1974 - Lovell E. Spurgeon) [Additional Reference(s): DWR Levee Log, 1992. USACE Sacramento O&M Manual 137, August 1955, (Station 120+60)]. FS Date: 5/19/2017 1:48:00 PM

Overview of levee crown looking upstream at crossing.

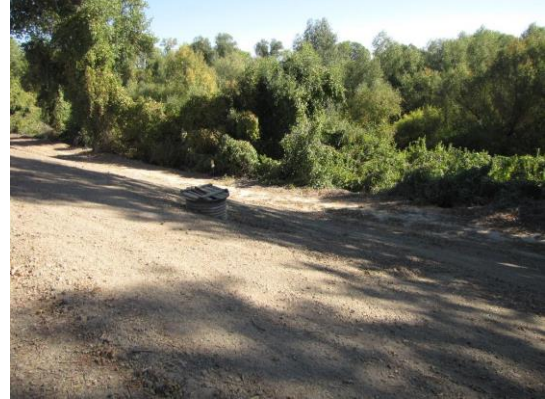
Photo 2 of 3 : UCIP_SP_2021_58095_70084.jpg

View of WS slope and toe.

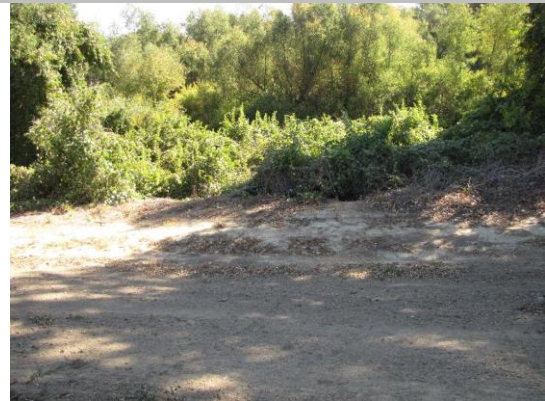
Photo 3 of 3 : UCIP_SP_2021_58095_70083.jpg

Unable to locate WS outlet.

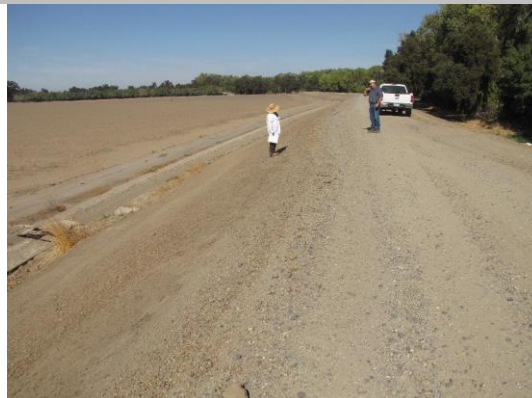
Photo 1 of 3 : UCIP_SP_2021_58101_70110.jpg

Comment Code						
Inspector Comment						
FS_ID:58101 DS_ID:16426 EP_NO: 9490 Repair Type: Non-Urgent Crossing Status: Found UCIP Comments: 05/03/2017 Sediment build up in WS pipe end. WS slide gate stem bent but it does not affect its operation. (A. Freitag - DWR Sutter Yard)10/24/2016 WS slide gate stem is still bent. (A. Freitag - DWR Sutter Yard)04/25/2016 WS slide gate is slightly bent. Rest of crossing appears to be in good condition. (A. Freitag - DWR Sutter Yard) 04/20/2015 LS inlet still has some minor sediment build up. Needs to be cleaned. (A. Freitag - DWR Sutter Yard)06/18/2014 Same as last inspection. (A. Freitag - DWR Sutter Yard)12/17/2013 Same as last inspection. (A. Freitag - DWR Sutter Yard)07/18/2013 WS slide gate looks to be in good condition but stem is slightly bent. Not sure if bend will hinder gates operation or not. LS inlet is still blocked by minor sediment build up.10/18/2012 LS pipe slightly deformed and sediment build up blocking about 30% of opening; need to check the condition of the slide gate-need photo. Metal marker down. This crossing was listed in the USACE Periodic Inspection as ID# USACE_CESPK_MA1C_2010_p_0187 for sediment build up at landward toe. (O. Magana - DWR UCIP) FIELD_STRUCT_DESC: 36-inch corrugated metal drainage pipe through the levee, approximately 12-15 feet below the crown. Slide gate in corrugated metal pipe (CMP) riser on the waterside (WS) slope. (36-inch pipe [HLM 3.78] authorized under Automatic Board Order (ABO) issued as Permit No. 9490, 1955 - Charles & Virginia Yerxa) [Additional Reference(s): DWR Levee Log, 1992. USACE Sacramento O&M Manual 137, August 1955, (Station 177+67)]. FS Date: 5/19/2017 1:53:00 PM

View of LS looking upstream.

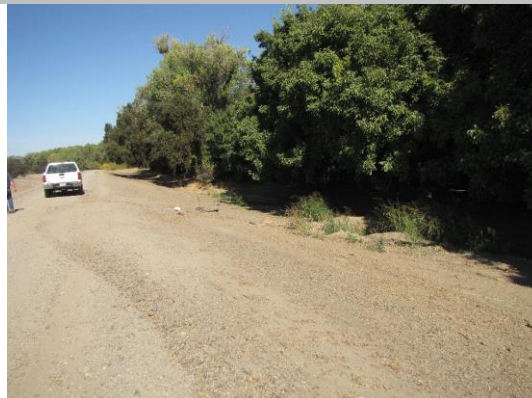
Photo 2 of 3 : UCIP_SP_2021_58101_70109.jpg

View of WS looking upstream.

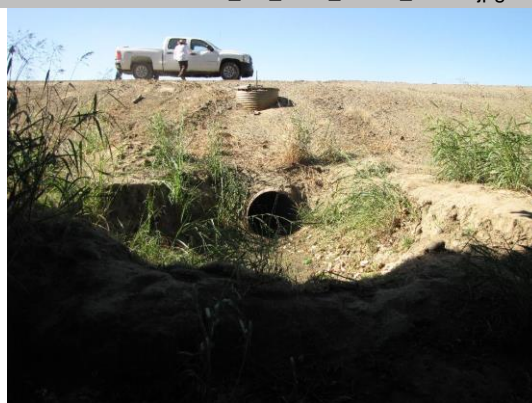
Photo 3 of 3 : UCIP_SP_2021_58101_70111.jpg

View of WS slope, riser with slide gate, and outlet.

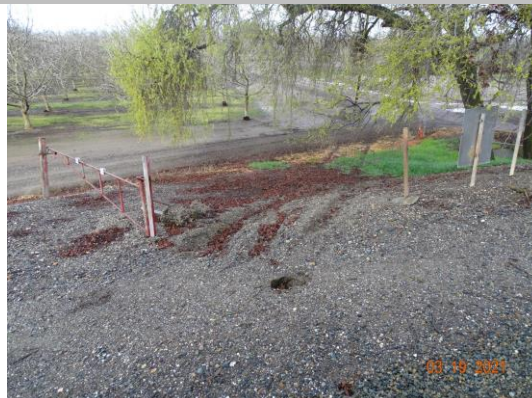
Photo 1 of 1 : SP_2021_MA0001_297_65_20210322_00144.jpg

LM Start	3.94	Rating **	M	Issue No.	65
LM End	3.94	Issue Type +	Ma	Location *	LS
Category	Earthen Levee			GPS Latitude/Longitude	
				Start	End
Item	Slope Stability			39.257893 °	39.257893 °
				-122.013201 °	-122.013201 °
DWR ID	DWR_MA0001_01_s_2021_65				
Comment Code					
S3 : Repair the levee slope damaged by vehicle traffic and prevent access where possible.					
Inspector Comment

View of the slope stability issue caused by vehicle tires. Spring 2021.

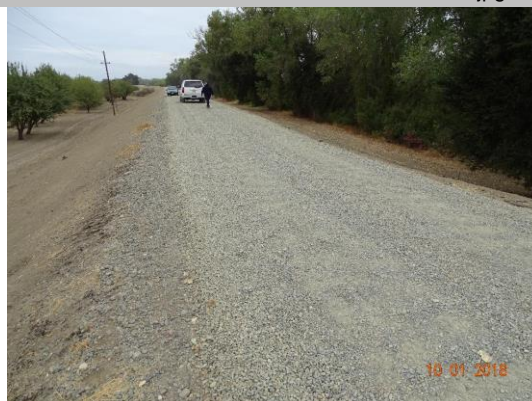
Photo 1 of 3 : UCIP_SP_2021_58116_78240.jpg

UCIP Comments: 10/01/2018 PVC pipe underneath the slide gate that is located inside CMP riser on WS shoulder was restored and blocks gate from closing. Sediment built up at the bottom of CMP riser. PVC pipe needs to be removed in order to properly close slide gate. (O.Yakimov - DWR UCIP)05/03/2017 Pipe leaked during the Jan/Feb 2017 high water event. Sand bags were placed at both the LS and WS outlets as well as down inside the standpipe to slow the water flow. The 5inch pvc was cut away but the slide gate could still not close fully. Suspect sediment build up was in the bottom of the stand pipe was blocking the gate. Inside of pipe should be cleaned out. (A. Freitag - DWR Sutter Yard)10/24/2016 Pvc was back running through the crossing and blocking the screwgate. photo attached. (A. Freitag - DWR Sutter Yard)09/28/2016 Crossing has been downgraded from Urgent to Non-Urgent 5-inch PVC pipe was cut to allow the slide gate to close. Need to contact owner to remove unauthorized pipe to comply with Title 23. (O. Magana - DWR UCIP)04/25/2016 5 inch pvc pipe running through crossing has been cut out to allow the slide gate to close. (A. Freitag - DWR Sutter Yard)04/20/2015 5inch pvc is still present blocking slide gate from closing. WS end of pipe has been exposed so there is no way to stop water from flowing through pipe during highwater times. (A. Freitag - DWR Sutter Yard)06/23/2014 Same as last inspection. There is no way to stop water from flowing through pipe during high water times. (A. Freitag - DWR Sutter Yard)12/17/2013 Same as last inspection. (A. Freitag - DWR Sutter Yard)07/18/2013 Same as last inspection. (A. Freitag - DWR Sutter Yard)10/19/2012 Unauthorized 5 inch PVC pipe running through 36 inch crossing. 5 inch PVC crossing prevents slide gate from closing during high water. Debris and sediment inside riser. This crossing was listed in the USACE Periodic Inspection as ID# USACE_CESPK_MA1C_2010_p_0258 for 5 inch PVC pipe running through culvert. (O. Magana - DWR UCIP) FIELD_STRUCT_DESC: 36-inch steel (not corrugated metal, as referenced in O&M manual) drainage pipe through the levee, approximately 14-16 feet below levee crown. Slide gate in corrugated metal pipe (CMP) riser on the waterside (WS) slope. Pipe also visible on the landside (LS). [Additional Reference(s): DWR Levee Log, 1992. USACE Sacramento O&M Manual 137, August 1955, (Station 331+31)]. FS Date: 10/1/2018 2:59:00 PM

View of levee crown at crossing.

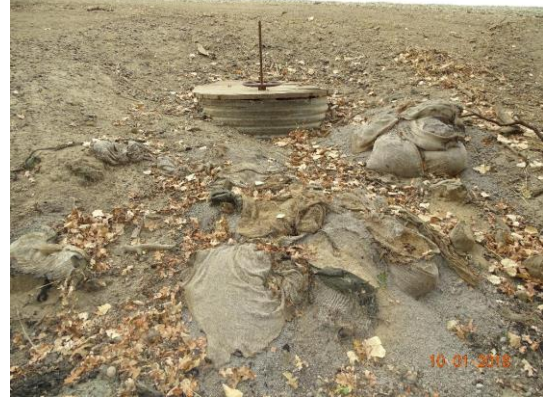
Photo 2 of 3 : UCIP_SP_2021_58116_78243.jpg

View of CMP riser at WS shoulder.

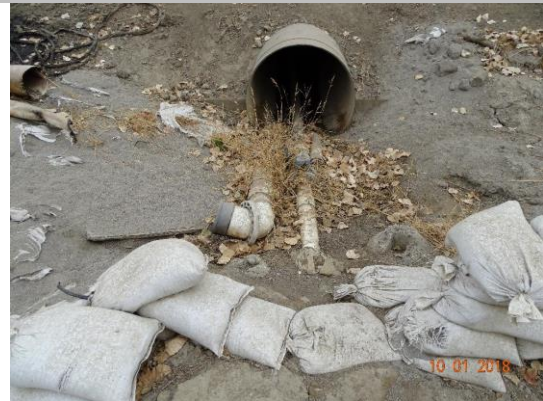
Photo 3 of 3 : UCIP_SP_2021_58116_78244.jpg

Pipe at LS toe.

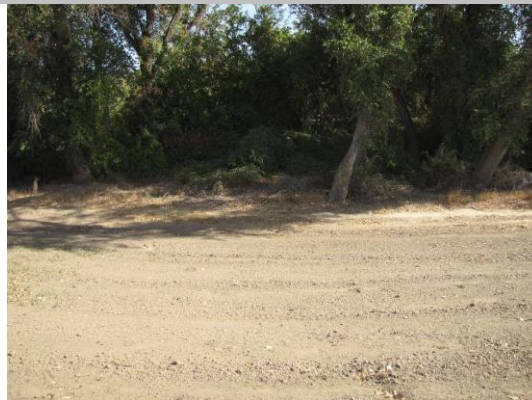
Photo 1 of 3 : UCIP_SP_2021_58119_70181.jpg

FS_ID:58119
DS_ID:16425
EP_NO: N/A
Repair Type: Non-Urgent
Crossing Status: Found
UCIP Comments: 05/03/2017 Abandoned- needs to be done properly. (A. Freitag - DWR Sutter Yard)10/24/2016 Abandoned. (A. Freitag - DWR Sutter Yard)04/25/2016 Abandoned crossing. (A. Freitag - DWR Sutter Yard)04/20/2015 Same as last inspection. (A. Freitag - DWR Sutter Yard)06/23/2014 Same as last inspection. (A. Freitag - DWR Sutter Yard)12/17/2013 Same as last inspection. (A. Freitag - DWR Sutter Yard)07/18/2013 Same as last inspection. (A. Freitag - DWR Sutter Yard)10/19/2012 Need to be properly abandoned concrete structure; plate covers concrete box; Concrete headwall damaged. This crossing was listed in the USACE Periodic Inspection as ID# USACE_CESPK_MA1C_2010_p_0262 for damage to concrete structure (vertical 2 inch wide cracks and spalling visible). (O. Magana - DWR UCIP)
FIELD_STRUCT_DESC: *ABANDONED* 72-inch corrugated metal (precast concrete) drainage pipe through the levee at an unknown depth below the crown. Structure is blocked on the waterside (WS) end with 3-foot concrete plug installed in 1980. Slide gate in concrete well on the landside (LS) shoulder. Concrete headwall at both toes. WS headwall not found. [Additional Reference(s): DWR Levee Log, 1992. USACE Sacramento O&M Manual 137, August 1955, (Station 339+74)].

View of WS no structure features visible.

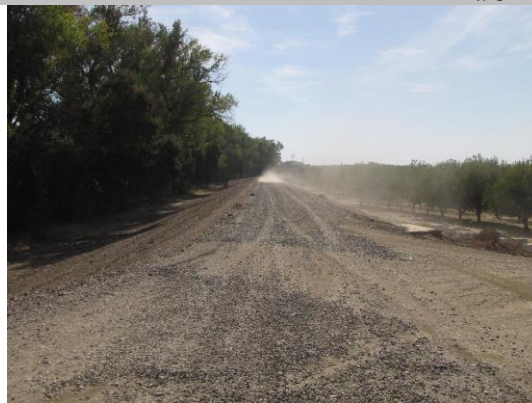
Photo 2 of 3 : UCIP_SP_2021_58119_70180.jpg

Overview of levee crown looking downstream at crossing.

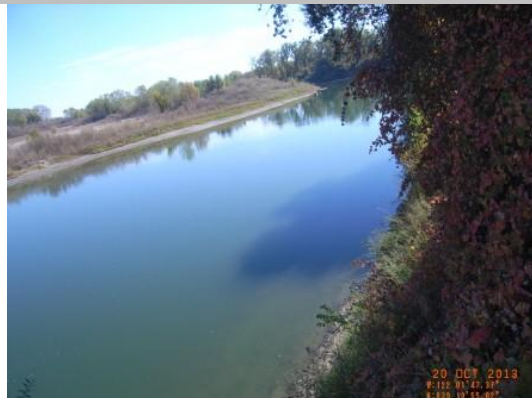
Photo 1 of 1 : SP_2021_MA0001_297_6_20210224_00003.jpg

LM Start	10.32	Rating **	A/W	Issue No.	6
LM End	10.41	Issue Type +	Ma	Location *	WS
Category	Supplemental			GPS Latitude/Longitude	
				Start	End
Item	2017 USACE Erosion Survey			39.331447 °	39.332716 °
				-122.029440 °	-122.029953 °
DWR ID	DWR_ST0003_01_f_2018_1				
Comment Code					
Inspector Comment					
2017 Site ID: SAC 157.7 R					
Status: Eroding					
2017 Field Notes: Vertical face of clay sand bank, new tree popout.					
Bank continues to erode.					
Site History: 2004 - Slowly eroding but near vertical with no vegetation to hold it. 2005 - Erosion is close to levee toe but not into the levee section yet. 2010 - Some new toe scour.

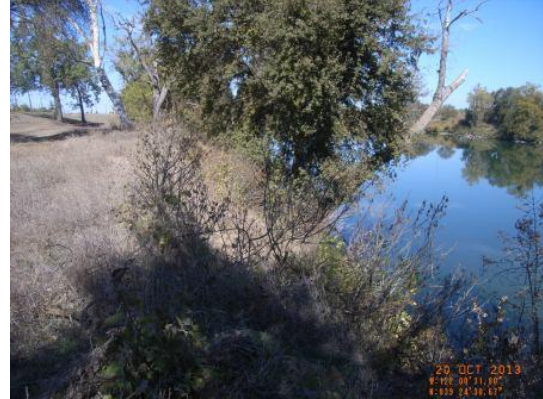
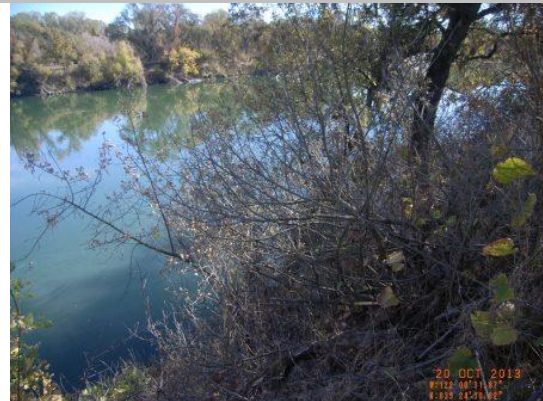
LM Start	16.35	Rating **	A/W	Issue No.	9
LM End	16.58	Issue Type +	Ma	Location *	WS
Category	Supplemental			GPS Latitude/Longitude	
				Start	End
Item	2017 USACE Erosion Survey			39.407837 °	39.411111 °
				-122.008763 °	-122.009238 °
DWR ID	DWR_ST0010_02_f_2022_7				
Comment Code					
Inspector Comment					
2017 Site ID: SAC 164.3 R					
Status: Eroding					
2017 Field Notes: New erosion along entire site.					
Site History: Erosion site added in 1997 and removed in 2005. 2009 - Site added back in, hard toe with slow moving erosion. Potential geotechnical failure. 2011 - Site extended downstream.
