**Flood Control Project Maintenance
Levee Inspections**

Maintenance Issue Types Only, Levee Inspection Report By Mile - Spring 2022

Sutter Maintenance Yard Maintenance Area 0001

Waterway	Bank	Unit Miles	Inspection Start/End	Inspector
Unit No. 01 Sacramento River	Right	16.76	04/05/2022 04/05/2022	Makar Sokol

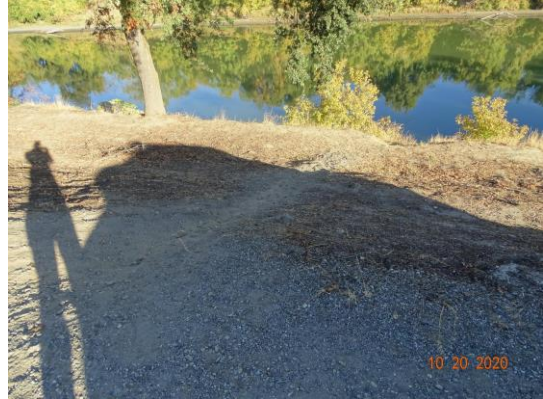
Photo 1 of 1 : SP_2022_MA0001_297_98_20220307_00026.jpg

LM Start	0.38	Rating **	M	Issue No.	98
LM End	0.38	Issue Type +	Ma	Location *	WS
Category	Earthen Levee			GPS Latitude/Longitude	
				Start	End
Item	Erosion / Foot Traffic			39.215878 °	39.215878 °
				-122.007278 °	-122.007278 °
DWR ID	DWR_MA0001_01_f _ 2020_98				
Comment Code					
E3 : Repair the levee slope damaged by foot traffic and prevent access where possible.					
Inspector Comment

View of the slope instability along the waterside slope. Fall 2020.

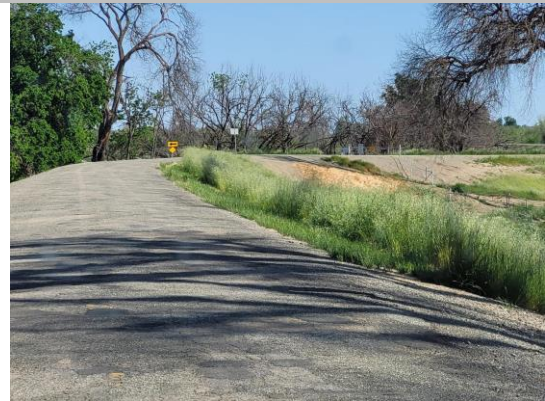
Photo 1 of 1 : SP_2022_MA0001_297_83_20220417_00192.jpg

LM Start	1.21	Rating **	M	Issue No.	83
LM End	16.55	Issue Type +	Ma	Location *	WS
Category	Earthen Levee			GPS Latitude/Longitude	
				Start	End
Item	Vegetation			39.222175 °	39.410651 °
				-122.015752 °	-122.009720 °
DWR ID	DWR_MA0001_01_s_2022_83				
Comment Code					
V1 : Control annual grass and weeds on the levee slopes and easements.					
Inspector Comment

View of the vegetation along the waterside slope. Spring 2022.

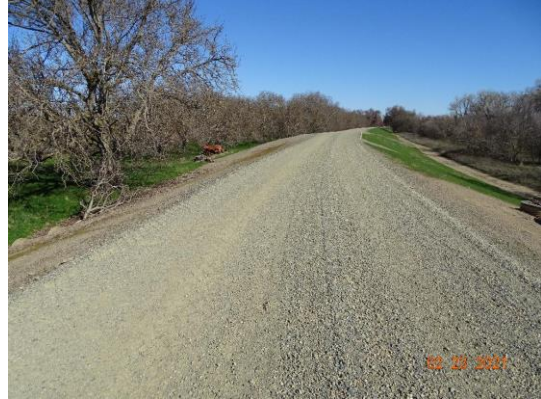
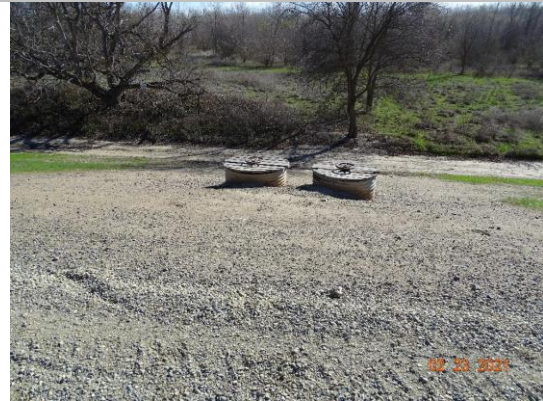
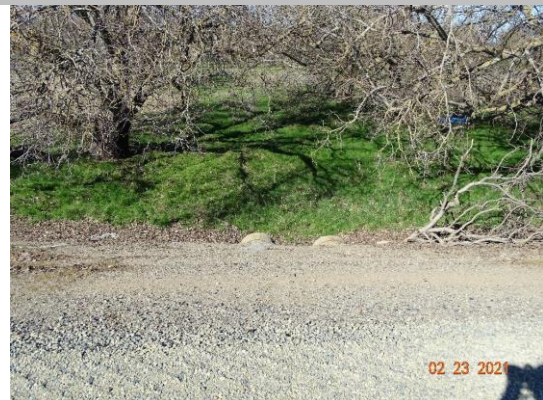
FS_ID:62869
DS_ID:16430
EP_NO: 9487
Repair Type: Urgent
Crossing Status: Found
UCIP Comments: 02/23/2021 Record updated from Non-Urgent to Urgent. DMP internal video inspection has found pipe integrity issues. LOF of crossing is between 5 and 6. Crossing will be monitored until funding becomes available to address the issues. No permit has been identified authorizing pipe. Need to have CVFPB review ABO and determine current owner. (O.Yakimov - DWR UCIP)
05/03/2017 WS end still partially plugged. (A. Freitag - DWR Sutter Yard)
10/24/2016 WS end is till partially plugged. (A. Freitag - DWR Sutter Yard)04/25/2016 WS pipe end is still plugged with soil. Rest of the pipe appeared to be in good condition. (A. Freitag - DWR Sutter Yard)04/20/2015 WS pipe end is plugged about 50% by soil. (A. Freitag - DWR Sutter Yard)06/18/2014 Same as last inspection. (A. Freitag - DWR Sutter Yard)12/17/2013 Same as last inspection. (A. Freitag - DWR Sutter Yard)07/18/2013 WS pipe end has been reformed but is still clogged about 50% by sediment.10/18/2012 Remove dirt and debris in riser. Outlet deformed and blocked over 50%. Debris-round concrete section on landward side. This crossing was listed in the USACE Periodic Inspections as ID# USACE_CESPK_MA1C_2010_p_0116 for crossing outlet deformed and clogged with dirt. (O. Magana - DWR UCIP)

FIELD_STRUCT_DESC: 1 of 2: 36-inch corrugated metal drainage pipe through the levee, approximately 12-15 feet below the crown. Slide gates in corrugated metal pipe (CMP) riser located on the waterside (WS) slope. Pipe daylights on the landside (LS). (36-inch pipe [HLM 1.97] authorized under Automatic Board Order (ABO) issued as Permit No. 9487, 1974 - Jimeno Rancho). [Additional Reference(s): DWR Levee Log, 1992 (HLM 1.97).USACE Sacramento O&M Manual, Unit 137, August 1955, Revised 29 December 2016, (STA 103+18), listed as 36-inch pipe].
FS Date: 2/23/2021 9:20:38 AM

Top of Levee: View of levee crown looking upstream

Water-Side: View of levee slope looking from crown

Land-Side: View of levee slope looking from crown

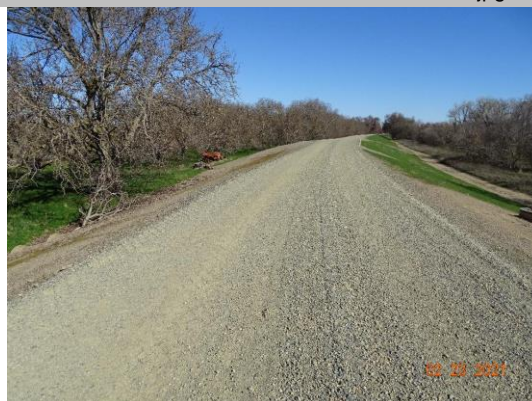
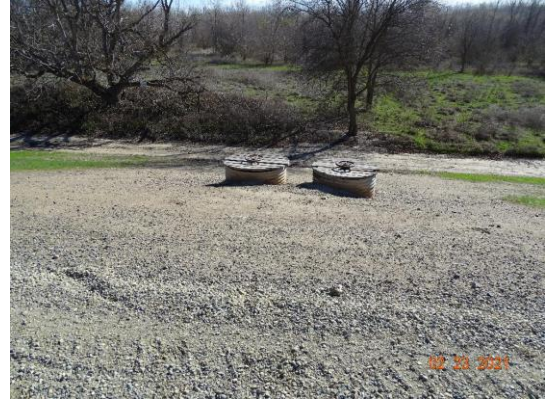
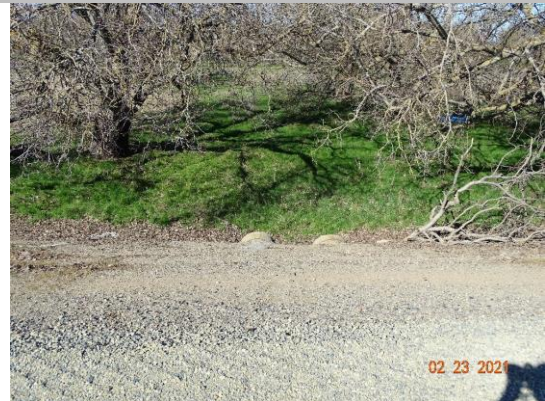
FS_ID:62871
DS_ID:17565
EP_NO: 9487
Repair Type: Urgent
Crossing Status: Found
UCIP Comments: 02/23/2021 Record updated from Non-Urgent to Urgent. DMP internal video inspection has found pipe integrity issues. LOF of crossing is between 5 and 6. Crossing will be monitored until funding becomes available to address the issues. No permit has been identified authorizing pipe. Need to have CVFPB review ABO and determine current owner. (O.Yakimov - DWR UCIP)
05/03/2017 Ws end still partially plugged. (A. Freitag - DWR Sutter Yard)10/24/2016 Ws pipe end still plugged. (A. Freitag - DWR Sutter Yard)04/25/2016 WS pipe end still plugged with soil. rest of pipe appears in good condition. (A. Freitag - DWR Sutter Yard)04/20/2015 WS pipe end plugged about 50% by soil. (A. Freitag - DWR Sutter Yard)06/18/2014 Same as last inspection. (A. Freitag - DWR Sutter Yard)12/17/2013 Same as last inspection. (A. Freitag - DWR Sutter Yard)07/18/2013 WS pipe end has been reformed but is still partially blocked with dirt and debris.10/18/2012 WS-remove dirt and debris in riser. Outlet deformed and blocked over 50%. Burrow activity near outlet on waterward slope. Debris around concrete section on landward side. This crossing was listed in the USACE Periodic Inspections as ID# USACE_CESPK_MA1C_2010_p_0116 for crossing outlet deformed and clogged with dirt. (O. Magana - DWR UCIP)

FIELD_STRUCT_DESC: 2 of 2: 36-inch corrugated metal drainage pipe through the levee, approximately 12-15 feet below the crown. Slide gates in corrugated metal pipe (CMP) riser on the waterside (WS) slope. Pipe daylights on the landside (LS). (36-inch pipe [HLM 1.97] authorized under Automatic Board Order (ABO) issued as Permit No. 9487, 1974 - Jimeno Rancho) [Additional Reference(s): DWR Levee Log, 1992 (HLM 1.97).USACE Sacramento O&M Manual, Unit 137, August 1955, Revised 29 December 2016, (STA 103+18), listed as 36-inch pipe].
FS Date: 2/23/2021 9:23:26 AM

Top of Levee: View of levee crown looking upstream

Water-Side: View of levee slope looking from crown. CMP riser on levee slope

Land-Side: View of levee slope looking from crown

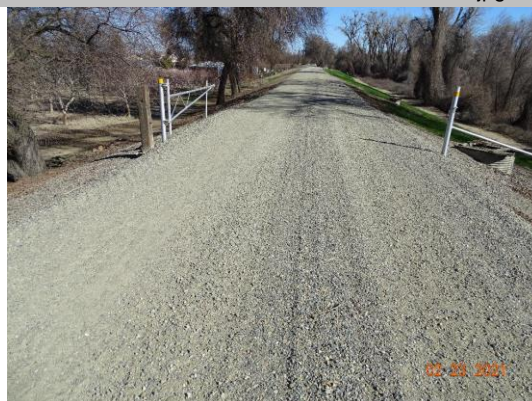
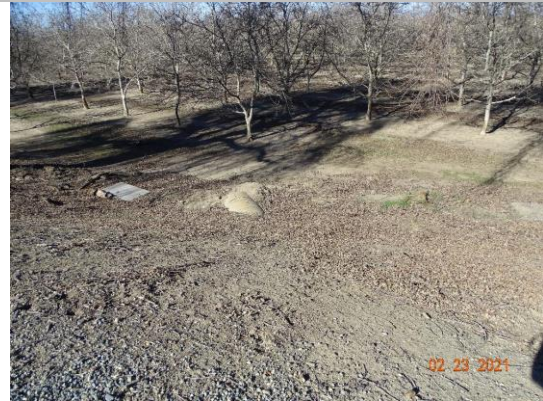
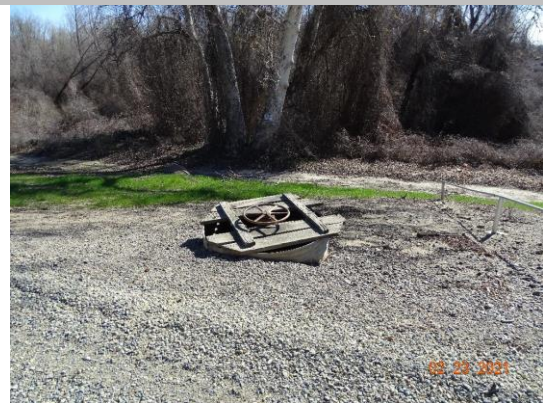
FS_ID:62872
DS_ID:16429
EP_NO: 9472
Repair Type: Urgent
Crossing Status: Found
UCIP Comments: 02/23/2021 Record updated from Non-Urgent to Urgent. DMP internal video inspection has found pipe integrity issues. LOF of crossing is between 5 and 6. Crossing will be monitored until funding becomes available to address the issues. No permit has been identified authorizing pipe. Need to have CVFPB review ABO and determine current owner. Crossing appears abandoned. Soil blocks more than 80% of pipe end at landside toe. (O.Yakimov - DWR UCIP) 05/03/2017 LS inlet partially plugged with soil. Some debris still present inside riser. (A. Freitag - DWR Sutter Yard)10/24/2016 Debris still inside of riser. (A. Freitag - DWR Sutter Yard)04/25/2016 Pipe still inside of riser and LS end plugged about 50% by soil. (A. Freitag - DWR Sutter Yard)04/20/2015 Same as last inspection. (A. Freitag - DWR Sutter Yard)06/18/2014 Same as last inspection. (A. Freitag - DWR Sutter Yard)12/17/2013 Same as last inspection. (A. Freitag - DWR Sutter Yard)07/18/2013 Same as last inspection. (A. Freitag - DWR Sutter Yard)10/18/2012 Remove debris from riser. Landward inlet is blocked by over 50%. This crossing was listed in the USACE Periodic Inspections as ID# USACE_CESPK_MA1C_2010_p_0128 for sediment build up at inlet (landward side) and debris inside riser. (O. Magana - DWR UCIP) FIELD_STRUCT_DESC: 54-inch corrugated metal drainage pipe through the levee, approximately 12-15 feet below the crown. Slide gate in corrugated metal pipe (CMP) riser on the waterside (WS) slope. Pipe daylights at landside toe. This pipe crosses the levee at angle. (54-inch pipe [HLM 2.29] authorized under Automatic Board Order (ABO) issued as Permit No. 9472, 1974 - Ballard). [Additional Reference(s): DWR Levee Log, 1992 (HLM 2.29). USACE Sacramento O&M Manual, Unit 137, August 1955, Revised 29 December 2016, (STA 120+00), listed as 54-inch pipe].

Top of Levee: View of levee crown looking upstream

Land-Side: View of levee crown looking from crown

Water-Side: View of levee slope looking from crown. CMP riser on levee slope

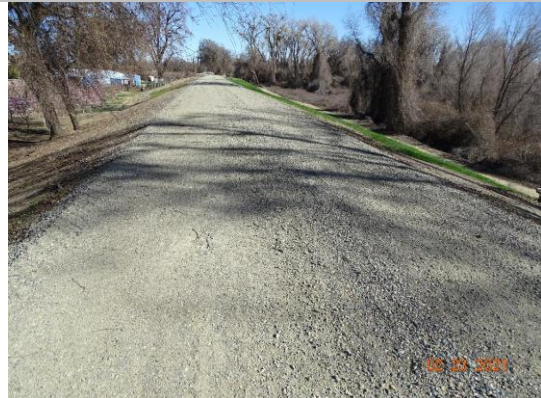
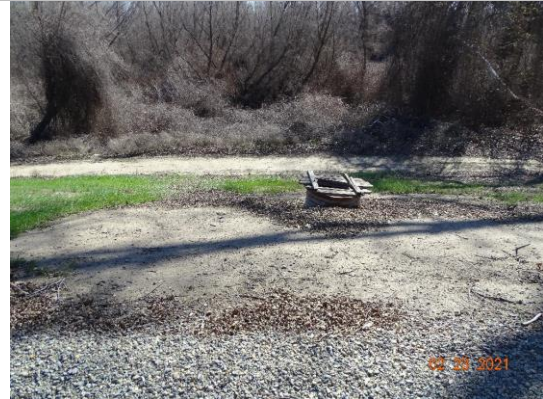
FS_ID:62873
DS_ID:16428
EP_NO: 9467
Repair Type: Non-Urgent
Crossing Status: Found
UCIP Comments: 02/23/2021 Record remains Non-Urgent. Geophysical study indicates possible presence of pipe through levee. Owner needs to coordinate with the CVFPB to remove or abandon crossing according to Title 23 requirements. Crossing appears abandoned. Pipe ends on both slopes are buried in soil. No permit has been identified authorizing pipe. Need to have CVFPB review ABO and determine current owner. (O.Yakimov - DWR UCIP)
05/03/2017 Abandoned- needs to be done so properly. (A. Freitag - DWR Sutter Yard)10/24/2016 Abandoned. (A. Freitag - DWR Sutter Yard)04/25/2016 Abandoned crossing. Unable to locate any WS and LS pipe ends. (A. Freitag - DWR Sutter Yard)04/20/2015 Same as last inspection. (A. Freitag - DWR Sutter Yard)06/18/2014 Same as last inspection. (A. Freitag - DWR Sutter Yard)12/17/2013 Same as last inspection. (A. Freitag - DWR Sutter Yard)07/18/2013 Same as last inspection. (A. Freitag - DWR Sutter Yard)10/18/2012 Only riser visible. Debris and sediment blocking gate. Gate inside riser is buried and non-functional. If crossing is abandoned, owner needs to properly abandon. This crossing was listed in the USACE Periodic Inspections as ID# USACE_CESPK_MA1C_2010_p_0132 no culvert through the levee is visible here. (O. Magana - DWR UCIP)

FIELD_STRUCT_DESC: 24-inch corrugated metal drainage pipe through the levee, approximately 12-15 feet below the crown. Slide gate in CM pipe riser on the waterside (WS) slope. No signs of inlet visible on the landside (LS). (24-inch pipe [HLM 2.31] authorized under Automatic Board Order (ABO) issued as Permit No. 9467, 1974 - Lovell E. Spurgeon). [Additional Reference(s): DWR Levee Log, 1992 (HLM 2.31). USACE Sacramento O&M Manual, Unit 137, August 1955, Revised 29 December 2016, (STA 120+60), listed as 24-inch pipe].
FS Date: 2/23/2021 9:30:51 AM

Top of Levee: View of levee crown looking upstream

Land-Side: View of levee slope looking from crown

Water-Side: View of levee slope looking from crown. CMP riser on levee slope

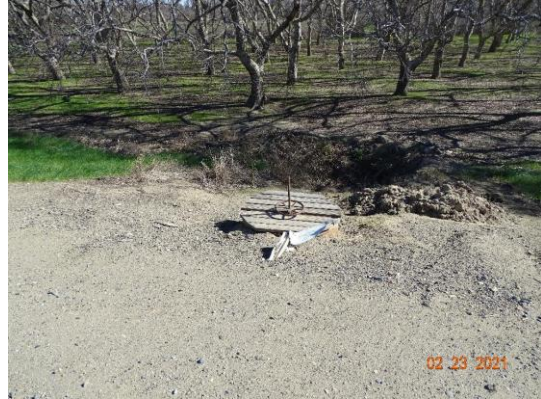
Photo 2 of 3 : UCIP_SP_2022_62896_91331.jpg

Water-Side: CMP riser on levee slope

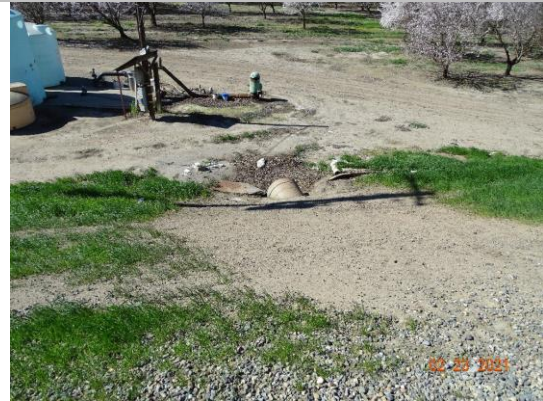
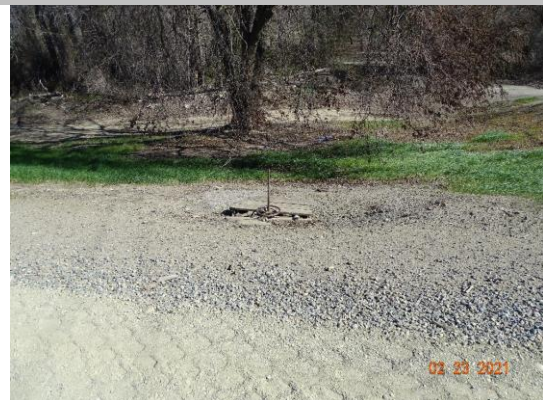
FS_ID:62913
DS_ID:16446
EP_NO: N/A
Repair Type: Urgent
Crossing Status: Found
UCIP Comments: 02/23/2021 Record remains Urgent. 4-inch PVC sleeved through 36-inch steel pipe through levee. Screw gate can't be closed due to the PVC pipe. No permit has been identified authorizing pipe. (O.Yakimov - DWR UCIP)
10/01/2018 PVC pipe underneath the slide gate that is located inside CMP riser on WS shoulder was restored and blocks gate from closing. Sediment built up at the bottom of CMP riser. PVC pipe needs to be removed in order to properly close slide gate. (O.Yakimov - DWR UCIP)05/03/2017 Pipe leaked during the Jan/Feb 2017 high water event. Sand bags were placed at both the LS and WS outlets as well as down inside the standpipe to slow the water flow. The 5inch pvc was cut away but the slide gate could still not close fully. Suspect sediment build up was in the bottom of the stand pipe was blocking the gate. Inside of pipe should be cleaned out. (A. Freitag - DWR Sutter Yard)10/24/2016 Pvc was back running through the crossing and blocking the screwgate. photo attached. (A. Freitag - DWR Sutter Yard)09/28/2016 Crossing has been downgraded from Urgent to Non-Urgent 5-inch PVC pipe was cut to allow the slide gate to close. Need to contact owner to remove unauthorized pipe to comply with Title 23. (O. Magana - DWR UCIP)04/25/2016 5 inch pvc pipe running through crossing has been cut out to allow the slide gate to close. (A. Freitag - DWR Sutter Yard)04/20/2015 5inch pvc is still present blocking slide gate from closing. WS end of pipe has been exposed so there is no way to stop water from flowing through pipe during highwater times. (A. Freitag - DWR Sutter Yard)06/23/2014 Same as last inspection. There is no way to stop water from flowing through pipe during high water times. (A. Freitag - DWR Sutter Yard)12/17/2013 Same as last inspection. (A. Freitag - DWR Sutter Yard)07/18/2013 Same as last inspection. (A. Freitag - DWR Sutter Yard)10/19/2012 Unauthorized 5 inch PVC pipe running through 36 inch crossing. 5 inch PVC crossing prevents slide gate from closing during high water. Debris and sediment inside riser. This crossing was listed in the USACE Periodic Inspection as ID# USACE_CESPK_MA1C_2010_p_0258 for 5 inch PVC pipe running through culvert. (O. Magana - DWR UCIP)

FIELD_STRUCT_DESC: 36-inch steel (not corrugated metal, as referenced in O&M manual) drainage pipe through the levee, approximately 14-16 feet below levee crown. Slide gate in corrugated metal pipe (CMP) riser on the waterside (WS) slope. Pipe also visible on the landside (LS). [Additional Reference(s): DWR Levee Log, 1992 (HLM 6.38). USACE Sacramento O&M Manual, Unit 137, August 1955, Revised 29 December 2016, (STA 331+31), listed as 36-inch pipe].
FS Date: 2/23/2021 3:47:40 PM

Top of Levee: View of levee crown looking upstream

Land-Side: View of levee slope looking from crown

Water-Side: View of levee slope looking from crown

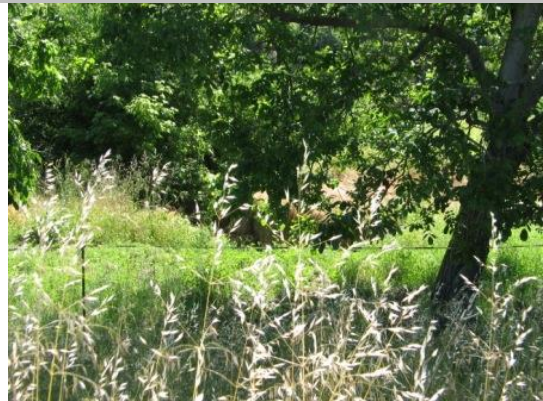
Photo 1 of 1 : SP_2022_MA0001_297_18_20220307_00009.jpg

View of the erosion along the waterside of the levee.

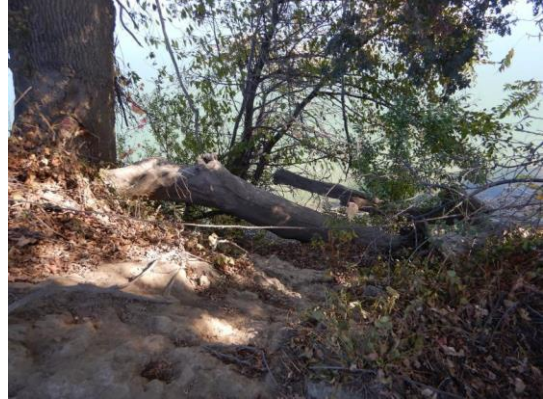
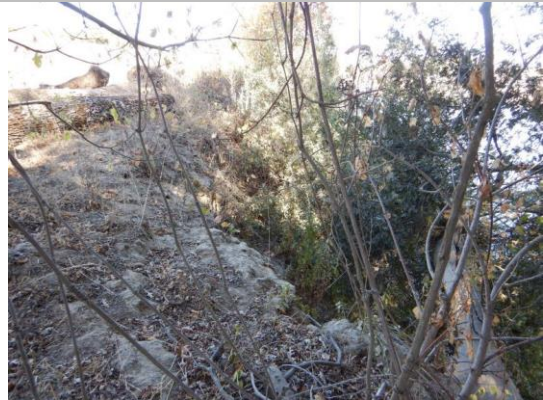
USACE 2018 Erosion Photo #1

USACE 2018 Erosion Photo #2

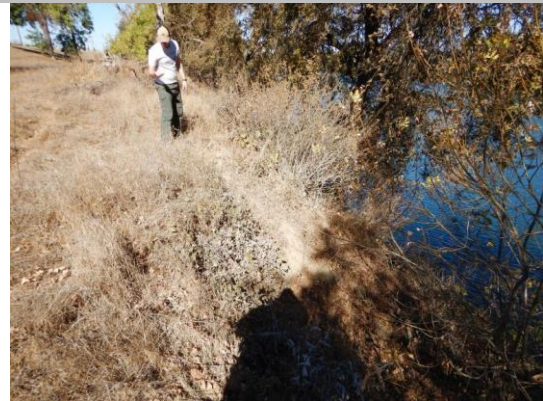
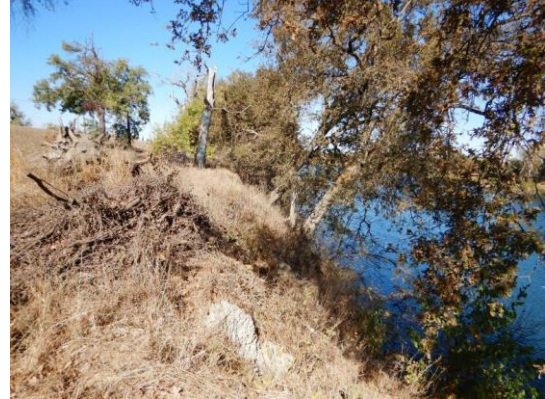
LM Start	16.35	Rating **	A/W	Issue No.	9
LM End	16.58	Issue Type +	Ma	Location *	WS
Category	Supplemental			GPS Latitude/Longitude	
				Start	End
Item	2018 USACE Erosion Survey			39.407837 °	39.411111 °
				-122.008763 °	-122.009238 °
DWR ID	DWR_MA0001_01_s_2022_9				
Comment Code					
Inspector Comment					
2018 Site ID: SAC 164.3 R					
Status: Eroding					
2018 Field Notes: Minor new erosion throughout site.					
Site History: Erosion site added in 1997 and removed in 2005. 2009 -					
Site added back in, hard toe with slow moving erosion. Potential					
geotechnical failure. 2011 - Site extended downstream. 2017 - New					
erosion along entire site.

USACE 2018 Erosion Photo #1

USACE 2018 Erosion Photo #2
