**Flood Control Project Maintenance  
Levee Inspections**

**Maintenance Issue Types Only, Levee Inspection Report By Mile - Spring 2023**

**Sutter Maintenance Yard Maintenance Area 0001**

Waterway	Bank	Unit Miles	Inspection Start/End	Inspector
Unit No. 01 Sacramento River	Right	16.76	04/11/2023 04/11/2023	Makar Sokol

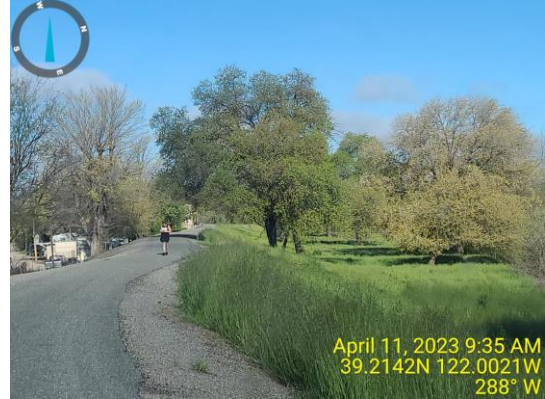
Photo 1 of 1 : SP\_2023\_MA0001\_297\_38\_20230414\_00104.jpg

LM Start	0.00	Rating **	U	Issue No.	38
LM End	0.48	Issue Type +	Ma	Location *	WS
Category	Earthen Levee			GPS Latitude/Longitude	
				Start	End
Item	Vegetation			39.213909°	39.215782°
				-122.000923°	-122.009235°
DWR ID	DWR_MA0001_01_s_2023_38				
Comment Code					
V1 : Control annual grass and weeds on the levee slopes and easements.					
Inspector Comment

View of the vegetation along the waterside slope. Spring 2023.

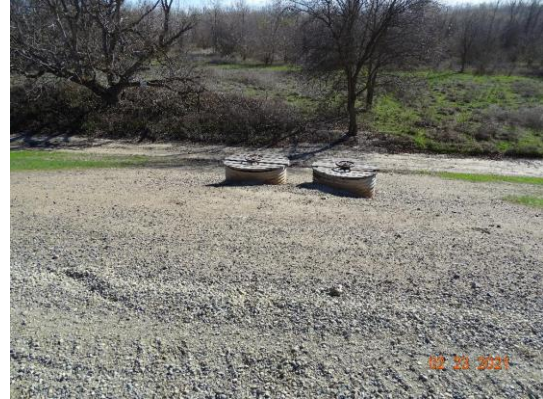
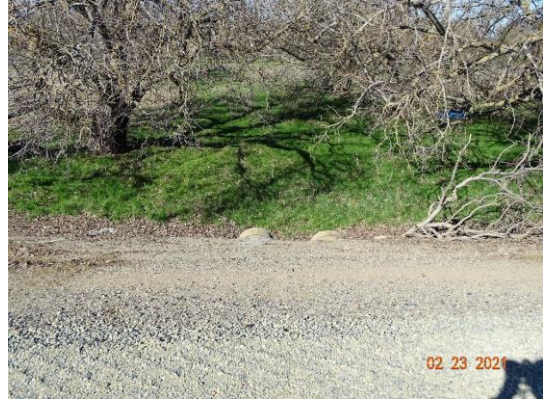
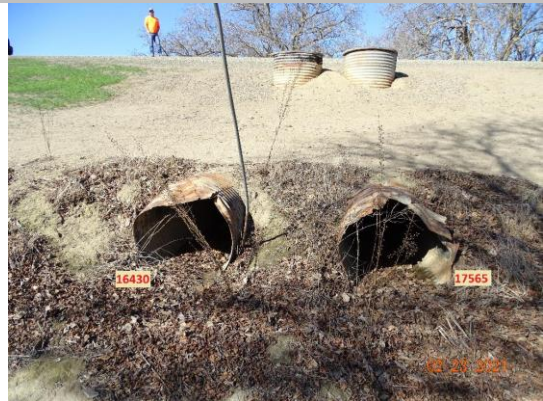
Comment Code					
Inspector Comment					
DS_ID:16430 FS_ID:62869 EP_NO: 9487 Repair Type: Urgent EVAL Issue: 1, Pipe Integrity Crossing Status: Found UCIP Comments: 02/23/2021 Record updated from Non-Urgent to Urgent. DMP internal video inspection has found pipe integrity issues. LOF of crossing is between 5 and 6. Crossing will be monitored until funding becomes available to address the issues. No permit has been identified authorizing pipe. Need to have CVFPB review ABO and determine current owner. (O.Yakimov - DWR UCIP) 05/03/2017 WS end still partially plugged. (A. Freitag - DWR Sutter Yard) 10/24/2016 WS end is till partially plugged. (A. Freitag - DWR Sutter Yard)04/25/2016 WS pipe end is still plugged with soil. Rest of the pipe appeared to be in good condition. (A. Freitag - DWR Sutter Yard)04/20/2015 WS pipe end is plugged about 50% by soil. (A. Freitag - DWR Sutter Yard)06/18/2014 Same as last inspection. (A. Freitag - DWR Sutter Yard)12/17/2013 Same as last inspection. (A. Freitag - DWR Sutter Yard)07/18/2013 WS pipe end has been reformed but is still clogged about 50% by sediment.10/18/2012 Remove dirt and debris in riser. Outlet deformed and blocked over 50%. Debris-round concrete section on landward side. This crossing was listed in the USACE Periodic Inspections as ID# USACE_CESPK_MA1C_2010_p_0116 for crossing outlet deformed and clogged with dirt. (O. Magana - DWR UCIP) FIELD_STRUCT_DESC: 1 of 2: 36-inch corrugated metal drainage pipe through the levee, approximately 12-15 feet below the crown. Slide gates in corrugated metal pipe (CMP) riser located on the waterside (WS) slope. Pipe daylights on the landside (LS). (36-inch pipe [HLM 1.97] authorized under Automatic Board Order (ABO) issued as Permit No. 9487, 1974 - Jimeno Rancho). [Additional Reference(s): DWR Levee Log, 1992 (HLM 1.97).USACE Sacramento O&M Manual, Unit 137, August 1955, Revised 29 December 2016, (STA 103+18), listed as 36-inch pipe]. FS Date: 2/23/2021 9:20:38 AM

Water-Side: View of levee slope looking from crown

Land-Side: View of levee slope looking from crown

Water-Side: View of levee slope looking towards crown. Pipe end at levee toe

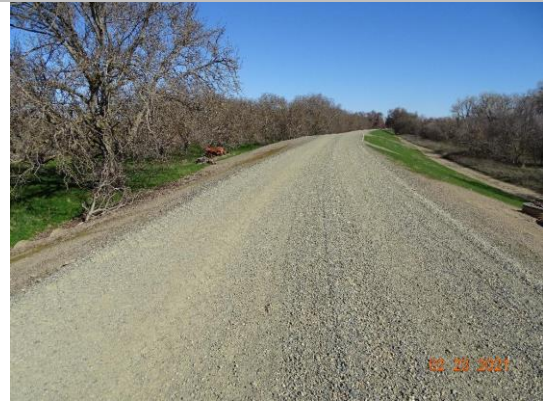
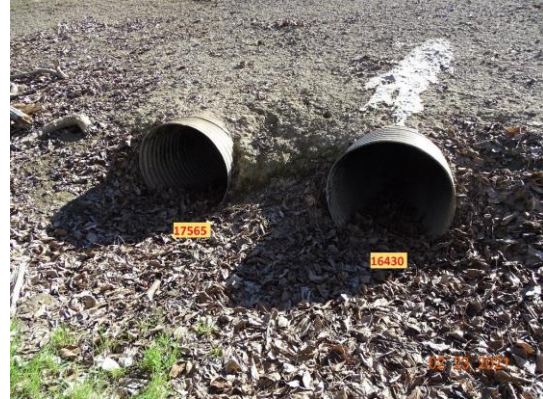
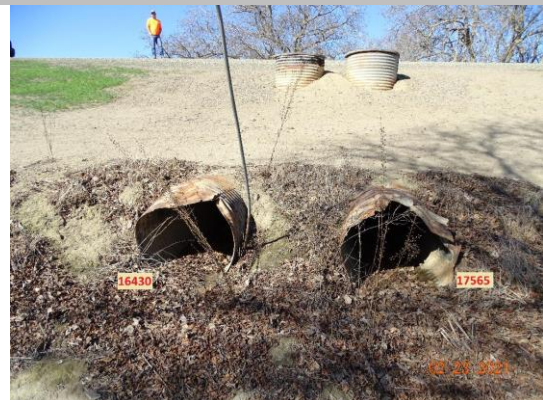
DS\_ID:17565  
FS\_ID:62871  
EP\_NO: 9487  
Repair Type: Urgent  
EVAL Issue: 1, Pipe Integrity  
Crossing Status: Found  
UCIP Comments: 02/23/2021 Record updated from Non-Urgent to Urgent. DMP internal video inspection has found pipe integrity issues. LOF of crossing is between 5 and 6. Crossing will be monitored until funding becomes available to address the issues. No permit has been identified authorizing pipe. Need to have CVFPB review ABO and determine current owner. (O.Yakimov - DWR UCIP)  
05/03/2017 Ws end still partially plugged. (A. Freitag - DWR Sutter Yard)10/24/2016 Ws pipe end still plugged. (A. Freitag - DWR Sutter Yard)04/25/2016 WS pipe end still plugged with soil. rest of pipe appears in good condition. (A. Freitag - DWR Sutter Yard)04/20/2015 WS pipe end plugged about 50% by soil. (A. Freitag - DWR Sutter Yard)06/18/2014 Same as last inspection. (A. Freitag - DWR Sutter Yard)12/17/2013 Same as last inspection. (A. Freitag - DWR Sutter Yard)07/18/2013 WS pipe end has been reformed but is still partially blocked with dirt and debris.10/18/2012 WS-remove dirt and debris in riser. Outlet deformed and blocked over 50%. Burrow activity near outlet on waterward slope. Debris around concrete section on landward side. This crossing was listed in the USACE Periodic Inspections as ID# USACE\_CESPK\_MA1C\_2010\_p\_0116 for crossing outlet deformed and clogged with dirt. (O. Magana - DWR UCIP)

Top of Levee: View of levee crown looking upstream

Land-Side: Pipe end at levee toe

Water-Side: Pipe end at levee toe

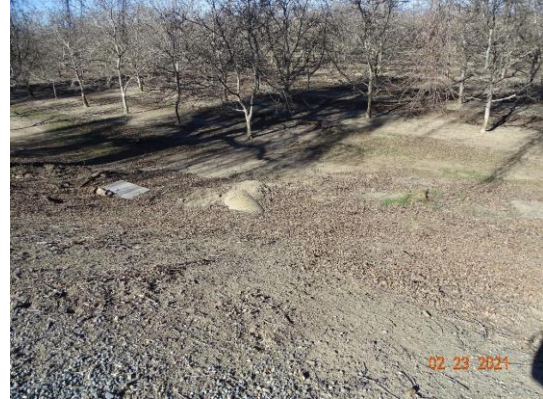
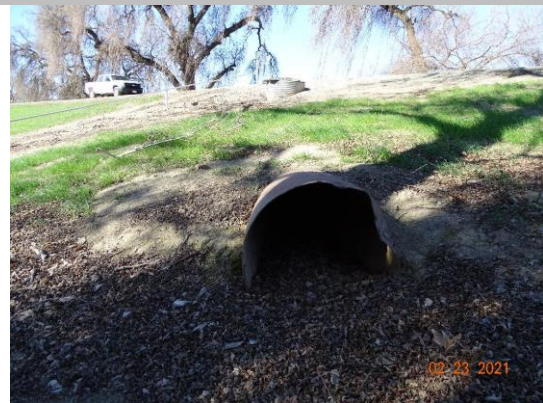
DS\_ID:16429  
FS\_ID:62872  
EP\_NO: 9472  
Repair Type: Urgent  
EVAL Issue: 1, Pipe Integrity  
Crossing Status: Found  
UCIP Comments: 02/23/2021 Record updated from Non-Urgent to Urgent. DMP internal video inspection has found pipe integrity issues. LOF of crossing is between 5 and 6. Crossing will be monitored until funding becomes available to address the issues. No permit has been identified authorizing pipe. Need to have CVFPB review ABO and determine current owner. Crossing appears abandoned. Soil blocks more than 80% of pipe end at landside toe. (O.Yakimov - DWR UCIP) 05/03/2017 LS inlet partially plugged with soil. Some debris still present inside riser. (A. Freitag - DWR Sutter Yard)10/24/2016 Debris still inside of riser. (A. Freitag - DWR Sutter Yard)04/25/2016 Pipe still inside of riser and LS end plugged about 50% by soil. (A. Freitag - DWR Sutter Yard)04/20/2015 Same as last inspection. (A. Freitag - DWR Sutter Yard)06/18/2014 Same as last inspection. (A. Freitag - DWR Sutter Yard)12/17/2013 Same as last inspection. (A. Freitag - DWR Sutter Yard)07/18/2013 Same as last inspection. (A. Freitag - DWR Sutter Yard)10/18/2012 Remove debris from riser. Landward inlet is blocked by over 50%. This crossing was listed in the USACE Periodic Inspections as ID# USACE\_CESPK\_MA1C\_2010\_p\_0128 for sediment build up at inlet (landward side) and debris inside riser. (O. Magana - DWR UCIP)

Land-Side: View of levee crown looking from crown

Land-Side: Pipe inlet blocked with soil

Water-Side: Pipe end at levee toe

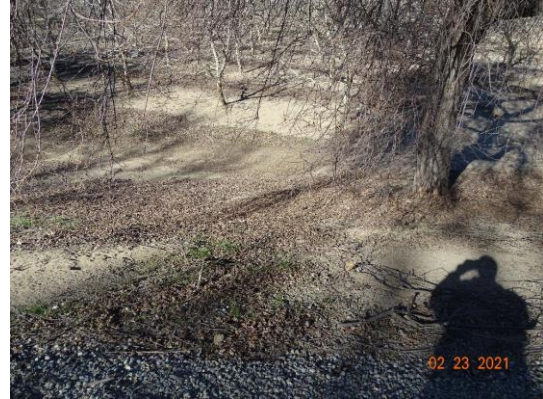
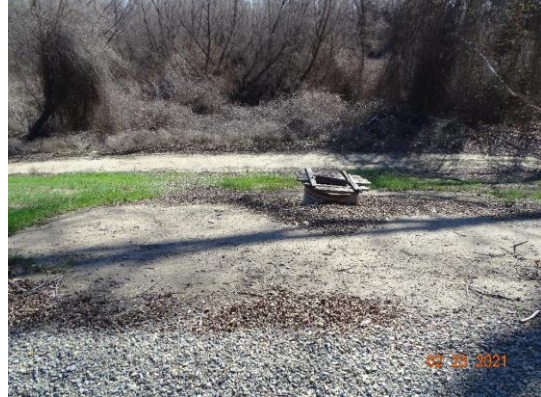
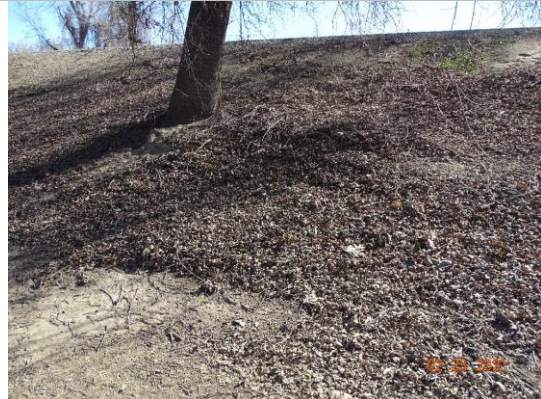
Comment Code					
Inspector Comment					
DS_ID:16428 FS_ID:62873 EP_NO: 9467 Repair Type: Non-Urgent EVAL Issue: Crossing Status: Found UCIP Comments: 02/23/2021 Record remains Non-Urgent. Geophysical study indicates possible presence of pipe through levee. Owner needs to coordinate with the CVFPB to remove or abandon crossing according to Title 23 requirements. Crossing appears abandoned. Pipe ends on both slopes are buried in soil. No permit has been identified authorizing pipe. Need to have CVFPB review ABO and determine current owner. (O.Yakimov - DWR UCIP) 05/03/2017 Abanoned- needs to be done so properly. (A. Freitag - DWR Sutter Yard)10/24/2016 Abandoned. (A. Freitag - DWR Sutter Yard)04/25/2016 Abandoned crossing. Unable to locate any WS and LS pipe ends. (A. Freitag - DWR Sutter Yard)04/20/2015 Same as last inspection. (A. Freitag - DWR Sutter Yard)06/18/2014 Same as last inspection. (A. Freitag - DWR Sutter Yard)12/17/2013 Same as last inspection. (A. Freitag - DWR Sutter Yard)07/18/2013 Same as last inspection. (A. Freitag - DWR Sutter Yard)10/18/2012 Only riser visible. Debris and sediment blocking gate. Gate inside riser is buried and non-functional. If crossing is abandoned, owner needs to properly abandon. This crossing was listed in the USACE Periodic Inspections as ID# USACE_CESPK_MA1C_2010_p_0132 no culvert through the levee is visible here. (O. Magana - DWR UCIP) FIELD_STRUCT_DESC: 24-inch corrugated metal drainage pipe through the levee, approximately 12-15 feet below the crown. Slide gate in CM pipe riser on the waterside (WS) slope. No signs of inlet visible on the landside (LS). (24-inch pipe [HLM 2.31] authorized under Automatic Board Order (ABO) issued as Permit No. 9467, 1974 - Lovell E. Spurgeon). [Additional Reference(s): DWR Levee Log, 1992 (HLM 2.31). USACE Sacramento O&M Manual, Unit 137, August 1955, Revised 29 December 2016, (STA 120+60), listed as 24-inch pipe]. FS Date: 2/23/2021 9:30:51 AM

Land-Side: View of levee slope looking from crown

Water-Side: View of levee slope looking from crown. CMP riser on levee slope

Land-Side: View of levee slope looking from toe. Pipe end not found

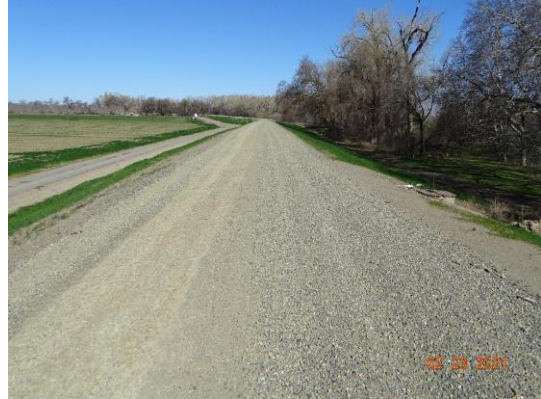
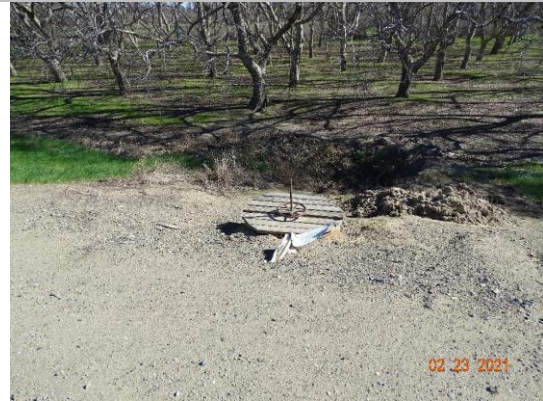
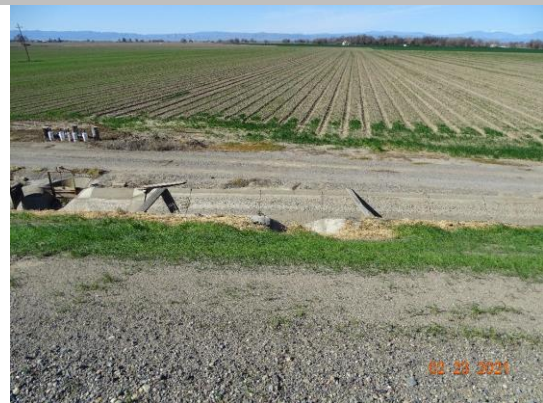
Comment Code					
Inspector Comment					
DS_ID:16426 FS_ID:62896 EP_NO: 9490 Repair Type: Non-Urgent EVAL Issue: Crossing Status: Found UCIP Comments: 02/23/2021 Record remains Non-Urgent. No permit has been identified authorizing pipe. Need to have CVFPB review ABO and determine current owner. Bent stem has been repaired, pipe inlet and outfall cleared from sediment. (O.Yakimov - DWR UCIP) 05/03/2017 Sediment build up in WS pipe end. WS slide gate stem bent but it does not affect its operation. (A. Freitag - DWR Sutter Yard)10/24/2016 WS slide gate stem is still bent. (A. Freitag - DWR Sutter Yard)04/25/2016 WS slide gate is slightly bent. Rest of crossing appears to be in good condition. (A. Freitag - DWR Sutter Yard) 04/20/2015 LS inlet still has some minor sediment build up. Needs to be cleaned. (A. Freitag - DWR Sutter Yard)06/18/2014 Same as last inspection. (A. Freitag - DWR Sutter Yard)12/17/2013 Same as last inspection. (A. Freitag - DWR Sutter Yard)07/18/2013 WS slide gate looks to be in good condition but stem is slightly bent. Not sure if bend will hinder gates operation or not. LS inlet is still blocked by minor sediment build up.10/18/2012 LS pipe slightly deformed and sediment build up blocking about 30% of opening; need to check the condition of the slide gate-need photo. Metal marker down. This crossing was listed in the USACE Periodic Inspection as ID# USACE_CESPK_MA1C_2010_p_0187 for sediment build up at landward toe. (O. Magana - DWR UCIP) FIELD_STRUCT_DESC: 36-inch corrugated metal drainage pipe through the levee, approximately 12-15 feet below the crown. Slide gate in corrugated metal pipe (CMP) riser on the waterside (WS) slope. (36-inch pipe [HLM 3.78] authorized under Automatic Board Order (ABO) issued as Permit No. 9490, 1955 - Charles & Virginia Yerxa). [Additional Reference(s): DWR Levee Log, 1992 (HLM 3.39). USACE Sacramento O&M Manual, Unit 137, August 1955, Revised 29 December 2016, (STA 177+67), listed as 36-inch pipe]. FS Date: 2/23/2021 2:05:19 PM

Top of Levee: View of levee crown looking upstream

Water-Side: CMP riser on levee slope

Land-Side: View of levee slope looking from crown

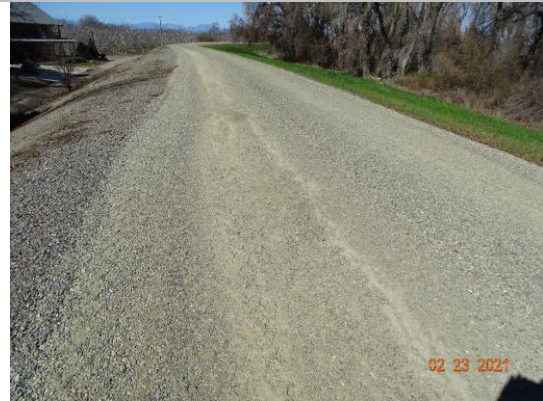
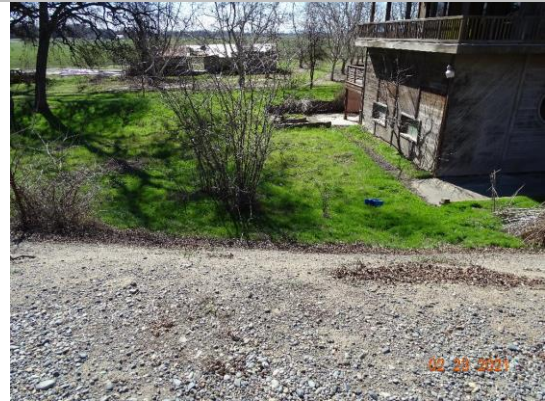
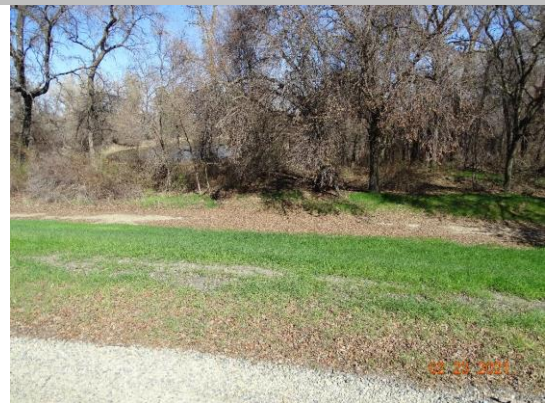
Comment Code					
Inspector Comment					
DS_ID:17659 FS_ID:62900 EP_NO: N/A Repair Type: Non-Urgent EVAL Issue: Crossing Status: Not Found UCIP Comments: 02/23/2021 Record remains Non-Urgent. Crossing not found. Geophysical results did not confirm presence of pipe through levee. Record will remain in UCIP's inspection records until future Levee Improvement Project can confirm no crossing was found through the levee. No permit has been identified authorizing pipe. Updated coordinates of crossing to match location to O&M (STA 198+00). (O.Yakimov - DWR UCIP) 05/03/2017 Unable to locate. (A. Freitag - DWR Sutter Yard) 10/24/2016 Unable to locate. (A. Freitag - DWR Sutter Yard) 04/25/2016 Unable to locate. (A. Freitag - DWR Sutter Yard) 04/20/2015 Same as last inspection. (A. Freitag - DWR Sutter Yard) 06/18/2014 Same as last inspection. (A. Freitag - DWR Sutter Yard) 12/17/2013 Same as last inspection. (A. Freitag - DWR Sutter Yard) 07/18/2013 Same as last inspection. (A. Freitag - DWR Sutter Yard) 10/19/2012 USA flag markers show some type of alignment on LS. Unable to determine if crossing still exists at this location. (O. Magana - DWR UCIP) FIELD_STRUCT_DESC: 18-inch steel drainage pipe through the levee at an unknown depth below the crown. Automatic drainage gate on the outlet end of the pipe. [Additional Reference(s): USACE Sacramento O&M Manual, Unit 137, August 1955, Revised 29 December 2016, (STA 198+00), listed as 18-inch pipe]. FS Date: 2/23/2021 2:19:54 PM

Top of Levee: View of levee crown looking upstream

Land-Side: View of levee slope looking from crown

Water-Side: View of levee slope looking from crown

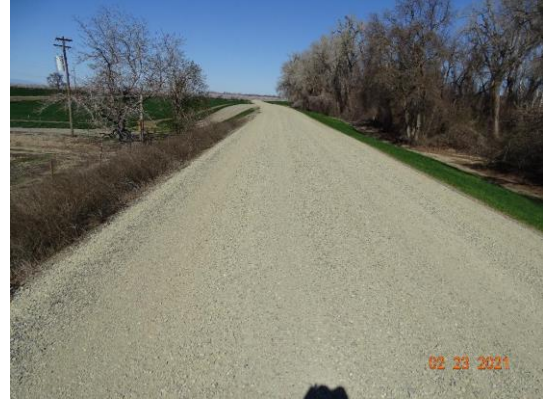
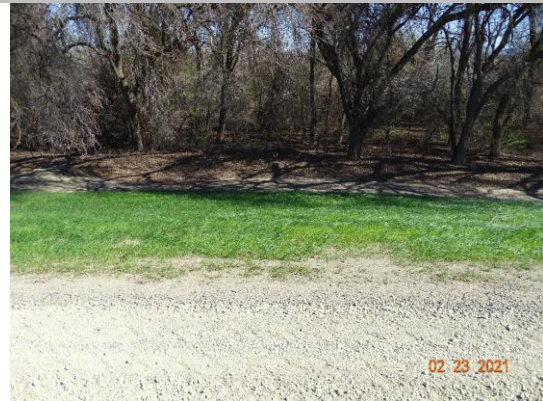
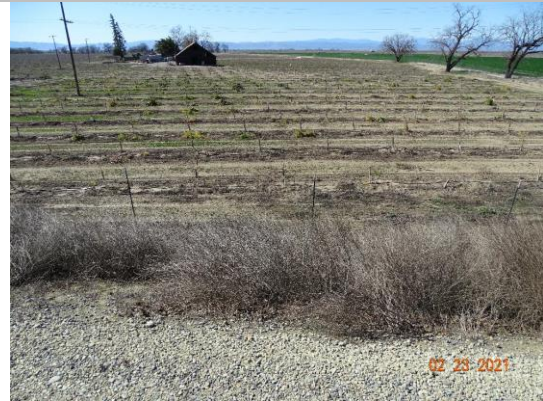
Comment Code						
Inspector Comment						
DS_ID:17658 FS_ID:62911 EP_NO: N/A Repair Type: Non-Urgent EVAL Issue: Crossing Status: Not Found UCIP Comments: 02/23/2021 Record is Non-Urgent. Crossing not found. Geophysical results did not confirm presence of pipe through levee. Record will remain in UCIP's inspection records until future Levee Improvement Project can confirm no crossing was found through the levee. No permit has been identified authorizing pipe. (O.Yakimov - DWR UCIP) 05/03/2017 Unable to locate. (A. Freitag - DWR Sutter Yard)10/24/2016 Unable to locate. (A. Freitag - DWR Sutter Yard)04/25/2016 Unable to locate. (A. Freitag - DWR Sutter Yard)04/20/2015 Unable to locate. (A. Freitag - DWR Sutter Yard)06/23/2014 Unable to locate. (A. Freitag - DWR Sutter Yard)12/17/2013 Unable to locate. (A. Freitag - DWR Sutter Yard)07/18/2013 Same as last inspection. Unable to locate. (A. Freitag - DWR Sutter Yard) FIELD_STRUCT_DESC: 36-inch corrugated metal drainage pipe through the levee at an unknown depth below the crown. [Additional Reference(s): USACE Sacramento O&M Manual, Unit 137, August 1955, Revised 29 December 2016, (STA 303+70), listed as 36-inch pipe]. FS Date: 2/23/2021 3:28:33 PM

Top of Levee: View of levee crown looking upstream

Water-Side: View of levee slope looking from crown

Land-Side: View of levee slope looking from crown

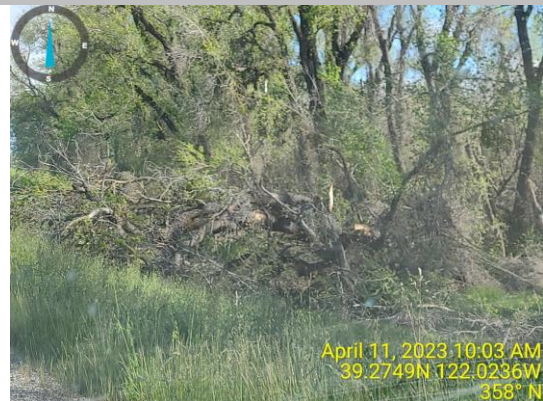
Photo 1 of 1 : SP\_2023\_MA0001\_297\_41\_20230414\_00105.jpg

LM Start	5.95	Rating **	U	Issue No.	41
LM End	5.95	Issue Type +	Ma	Location *	WS
Category	Earthen Levee			GPS Latitude/Longitude	
				Start	End
Item	Trim / Thin Trees			39.275336°	39.275336°
				-122.023609°	-122.023609°
DWR ID	DWR_MA0001_01_s_2023_41				
Comment Code					
T3 : Fallen tree with root ball.					
Inspector Comment

View of a fallen tree on the waterside slope and toe. Spring 2023.

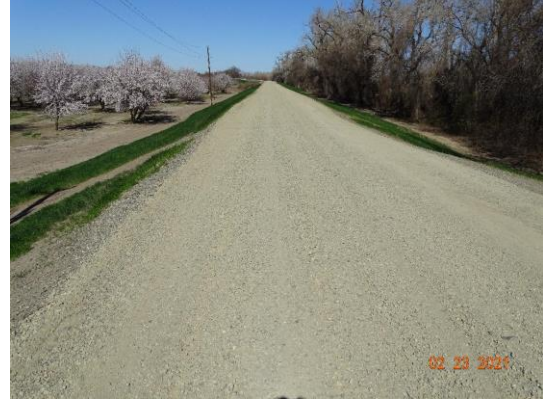
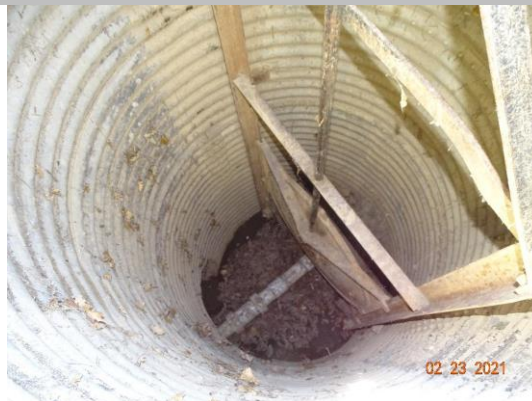
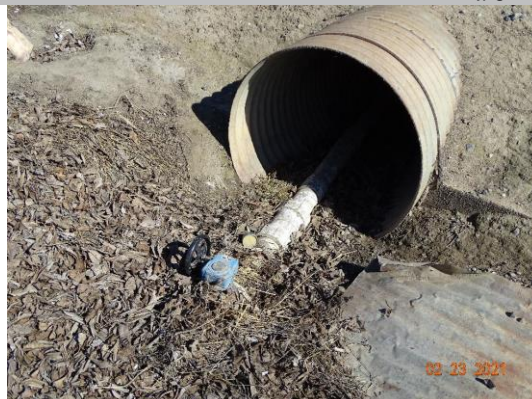
DS\_ID:16446  
FS\_ID:62913  
EP\_NO: N/A  
Repair Type: Urgent  
EVAL Issue: 3a, Flood Risk  
Crossing Status: Found  
UCIP Comments: 02/23/2021 Record remains Urgent. 4-inch PVC sleeved through 36-inch steel pipe through levee. Screw gate can't be closed due to the PVC pipe. No permit has been identified authorizing pipe. (O.Yakimov - DWR UCIP)  
10/01/2018 PVC pipe underneath the slide gate that is located inside CMP riser on WS shoulder was restored and blocks gate from closing. Sediment built up at the bottom of CMP riser. PVC pipe needs to be removed in order to properly close slide gate. (O.Yakimov - DWR UCIP)05/03/2017 Pipe leaked during the Jan/Feb 2017 high water event. Sand bags were placed at both the LS and WS outlets as well as down inside the standpipe to slow the water flow. The 5inch pvc was cut away but the slide gate could still not close fully. Suspect sediment build up was in the bottom of the stand pipe was blocking the gate. Inside of pipe should be cleaned out. (A. Freitag - DWR Sutter Yard)10/24/2016 Pvc was back running through the crossing and blocking the screwgate. photo attached. (A. Freitag - DWR Sutter Yard)09/28/2016 Crossing has been downgraded from Urgent to Non-Urgent 5-inch PVC pipe was cut to allow the slide gate to close. Need to contact owner to remove unauthorized pipe to comply with Title 23. (O. Magana - DWR UCIP)04/25/2016 5 inch pvc pipe running through crossing has been cut out to allow the slide gate to close. (A. Freitag - DWR Sutter Yard)04/20/2015 5inch pvc is still present blocking slide gate from closing. WS end of pipe has been exposed so there is no way to stop water from flowing through pipe during highwater times. (A. Freitag - DWR Sutter Yard)06/23/2014 Same as last inspection. There is no way to stop water from flowing through pipe during high water times. (A. Freitag - DWR Sutter Yard)12/17/2013 Same as last inspection. (A. Freitag - DWR Sutter Yard)07/18/2013 Same as last inspection. (A. Freitag - DWR Sutter Yard)10/19/2012 Unauthorized 5 inch PVC pipe running through 36 inch crossing. 5 inch PVC crossing prevents slide gate from closing during high water. Debris and sediment inside riser. This crossing was listed in the USACE Periodic Inspection as ID# USACE\_CESPK\_MA1C\_2010\_p\_0258 for 5 inch PVC pipe running through culvert. (O. Magana - DWR UCIP)

Top of Levee: View of levee crown looking upstream

Water-Side: Screw gate and PVC pipe inside CMP riser

Land-Side: 4-inch PVC with shut off valve sleeved through steel pipe

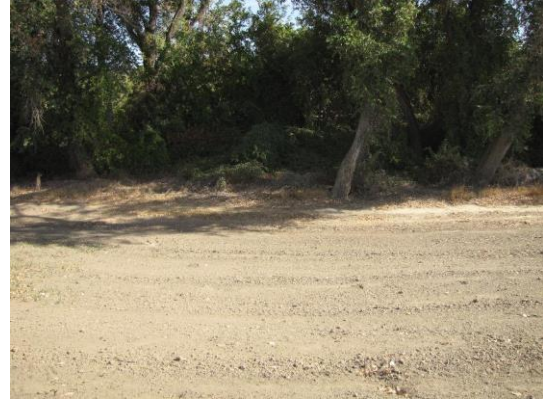
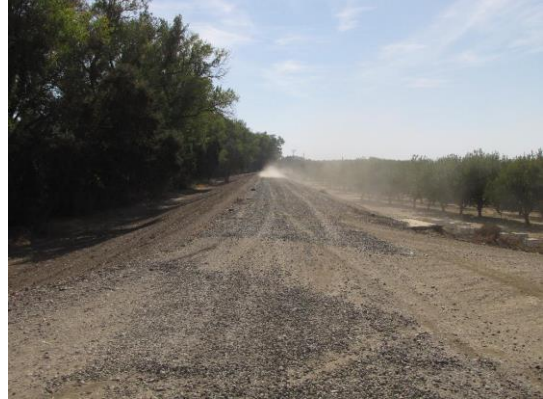
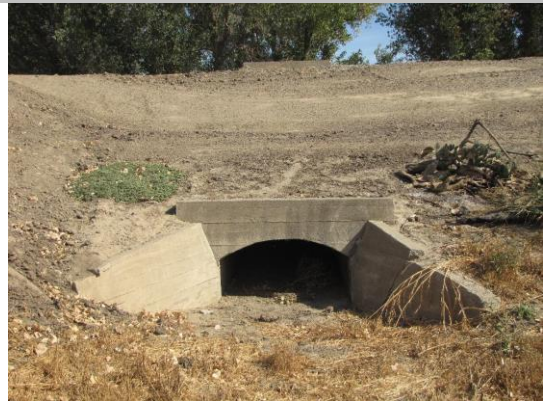
DS\_ID:16425  
FS\_ID:62914  
EP\_NO: N/A  
Repair Type: Non-Urgent  
EVAL Issue:  
Crossing Status: Found  
UCIP Comments: 02/23/2021 Record remains Non-Urgent. Crossing appears abandoned. Headwall and pipe on waterside not found. Slide gate removed from concrete riser on landside shoulder. Riser is covered with steel plate bolted to concrete. Soil inside pipe crossing blocking more than 50% of cross section. No permit has been identified authorizing pipe. (O.Yakimov - DWR UCIP)  
05/03/2017 Abandoned- needs to be done properly. (A. Freitag - DWR Sutter Yard)10/24/2016 Abandoned. (A. Freitag - DWR Sutter Yard)04/25/2016 Abandoned crossing. (A. Freitag - DWR Sutter Yard)04/20/2015 Same as last inspection. (A. Freitag - DWR Sutter Yard)06/23/2014 Same as last inspection. (A. Freitag - DWR Sutter Yard)12/17/2013 Same as last inspection. (A. Freitag - DWR Sutter Yard)07/18/2013 Same as last inspection. (A. Freitag - DWR Sutter Yard)10/19/2012 Need to be properly abandoned concrete structure; plate covers concrete box; Concrete headwall damaged. This crossing was listed in the USACE Periodic Inspection as ID# USACE\_CESPK\_MA1C\_2010\_p\_0262 for damage to concrete structure (vertical 2 inch wide cracks and spalling visible). (O. Magana - DWR UCIP)

FIELD\_STRUCT\_DESC: 72-inch corrugated metal (precast concrete) drainage pipe through the levee at an unknown depth below the crown. Structure is blocked on the waterside (WS) end with 3-foot concrete plug installed in 1980. Sliding metal gate (referenced in O&M manual) in concrete well on the landside (LS) shoulder. Concrete headwall at both toes. WS headwall not found. [Additional Reference(s): DWR Levee Log, 1992 (HLM 6.55), listed as abandoned 72-inch drain pipe. USACE Sacramento O&M Manual, Unit 137, August 1955, Revised 29 December 2016, (STA 339+74), listed as 72-inch pipe].  
FS Date: 2/23/2021 3:49:23 PM

View of WS no structure features visible.

Overview of levee crown looking downstream at crossing.

View of structure located in LS.

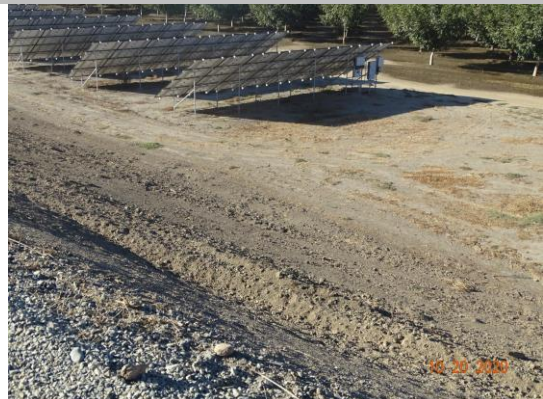
Photo 1 of 1 : SP\_2023\_MA0001\_297\_77\_20230410\_00018.jpg

LM Start	6.98	Rating **	M	Issue No.	77
LM End	6.98	Issue Type +	Ma	Location *	LS
Category	Earthen Levee			GPS Latitude/Longitude	
				Start	End
Item	Erosion / Vehicle Traffic			39.289935°	39.289935°
				-122.021462°	-122.021462°
DWR ID	DWR_MA0001_01_f_2020_77				
Comment Code					
E6 : Repair the levee slope damaged by vehicle traffic and prevent access where possible.					
Inspector Comment					
Repair erosion caused by vehicle on the slope.

View of the vehicle erosion along the landside slope. Fall 2020.

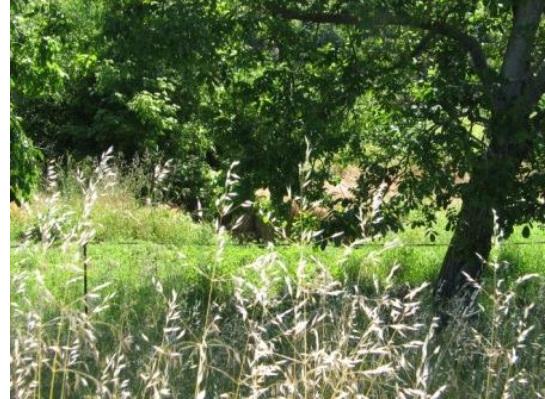
Photo 1 of 1 : SP\_2023\_MA0001\_297\_18\_20230410\_00009.jpg

View of the erosion along the waterside of the levee.

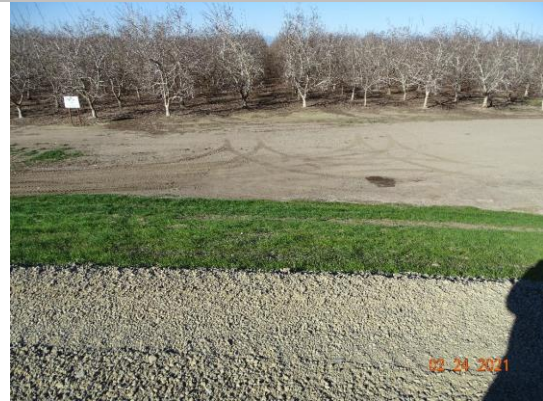
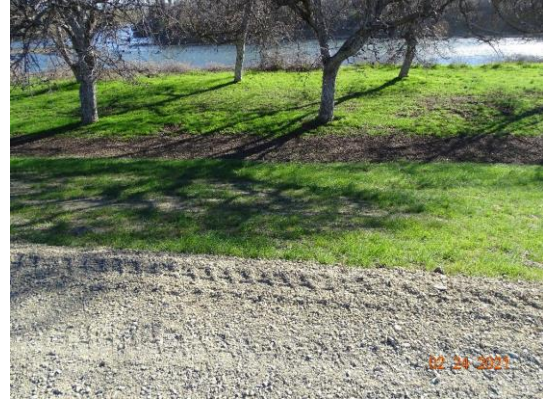
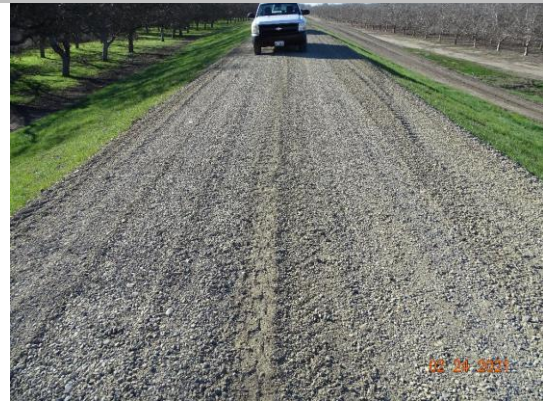
Comment Code						
Inspector Comment						
DS_ID:17655 FS_ID:62921 EP_NO: N/A Repair Type: Non-Urgent EVAL Issue: Crossing Status: Not Found UCIP Comments: 10/06/2021 After review of O&M Manual updated coordinated of potential crossing to match O&M (STA 538+42). Recommend conducting geophysical survey at updated location. (O.Yakimov - DWR UCIP) 02/24/2021 Record remains Non-Urgent. Crossing not found. Geophysical results did not confirm presence of pipe through levee at (39.328121 -122.09260). Record will remain in UCIP's inspection records until future Levee Improvement Project can confirm no crossing was found through the levee. No permit has been identified authorizing pipe. (O.Yakimov - DWR UCIP) 05/03/2017 Unable to locate. (A. Freitag - DWR Sutter Yard)10/24/2016 Unable to locate. (A. Freitag - DWR Sutter Yard)04/25/2016 Unable to locate. (A. Freitag - DWR Sutter Yard)04/20/2015 Unable to locate. (A. Freitag - DWR Sutter Yard)06/23/2014 Unable to locate. (A. Freitag - DWR Sutter Yard)12/17/2013 Unable to locate. (A. Freitag - DWR Sutter Yard)07/18/2013 Same as last inspection. Unable to locate. (A. Freitag - DWR Sutter Yard) FIELD_STRUCT_DESC: 36-inch corrugated metal drainage pipe through the levee at an unknown depth below the crown. Slide gate on the outlet end of the pipe. [Additional Reference(s): USACE Sacramento O&M Manual, Unit 137, August 1955, Revised 29 December 2016, (STA 538+42), listed as 36-inch pipe]. FS Date: 2/24/2021 10:43:23 AM

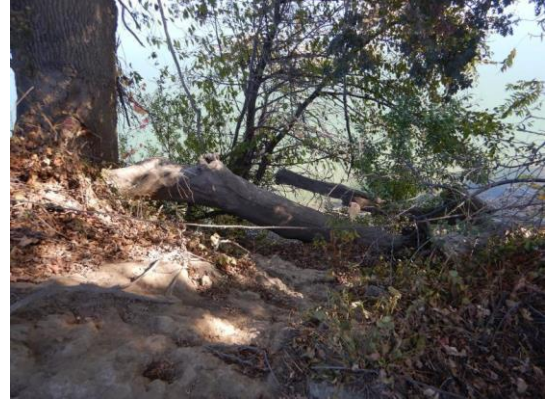
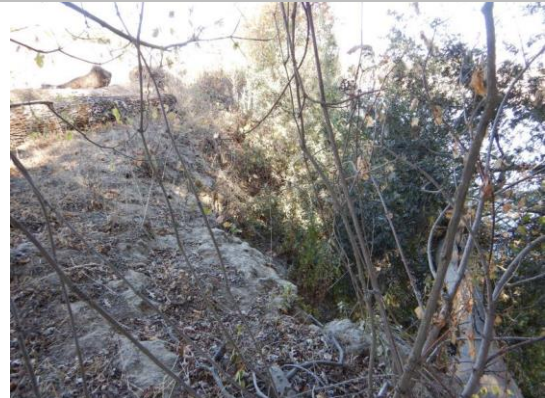
USACE 2018 Erosion Photo #1

USACE 2018 Erosion Photo #2

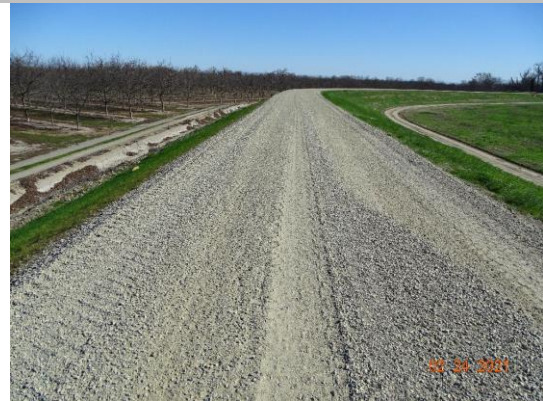
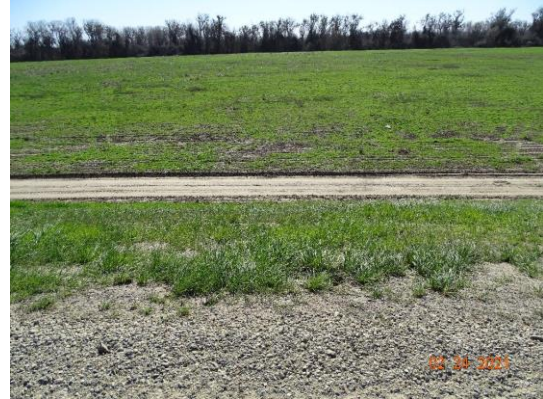
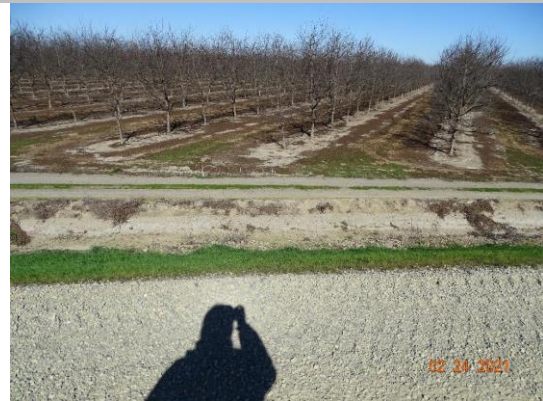
Comment Code					
Inspector Comment					
DS_ID:17654 FS_ID:62946 EP_NO: N/A Repair Type: Non-Urgent EVAL Issue: Crossing Status: Not Found UCIP Comments: 02/24/2021 Record is Non-Urgent. Crossing not found. Geophysical results did not confirm presence of pipe through levee. Record will remain in UCIP's inspection records until future Levee Improvement Project can confirm no crossing was found through the levee. No permit has been identified authorizing pipe. (O.Yakimov - DWR UCIP) 5/3/2017 Unable to locate. (DWR Sutter Yard- AFreitag)10/24/2016 Unable to locate.(DWR Sutter Yard- AFreitag)4/25/2016 Unable to locate.4/21/2015 Unable to locate.6/23/2014 Unable to locate.12/17/2013 Unable to locate.7/22/2013 Same as last inspection. Unable to locate. FIELD_STRUCT_DESC: 30-inch corrugated metal drainage pipe through the levee at an unknown depth below the crown. Slide gate on the outlet end of the pipe. [Additional Reference(s): USACE Sacramento O&M Manual, Unit 137, August 1955, Revised 29 December 2016, (STA 670+00), listed as 30-inch pipe]. FS Date: 2/24/2021 3:17:11 PM

Top of Levee: View of levee crown looking upstream

Water-Side: View of levee slope looking from crown

Land-Side: View of levee slope looking from crown

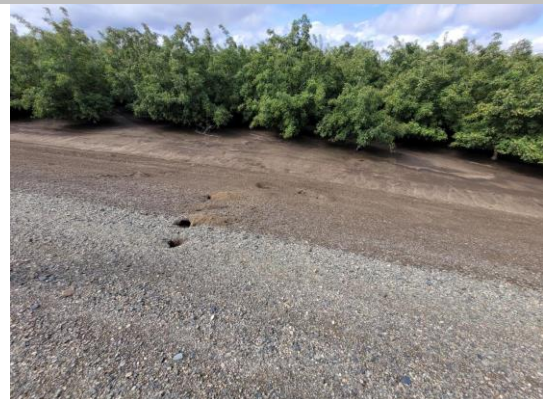
Photo 1 of 1 : SP\_2023\_MA0001\_297\_84\_20230410\_00019.jpg

View of the rodent activity along the landside slope. Fall 2022.

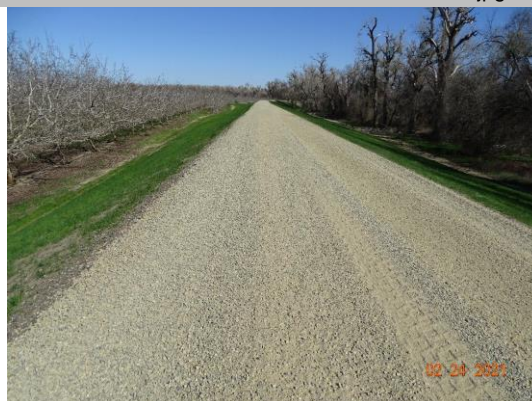
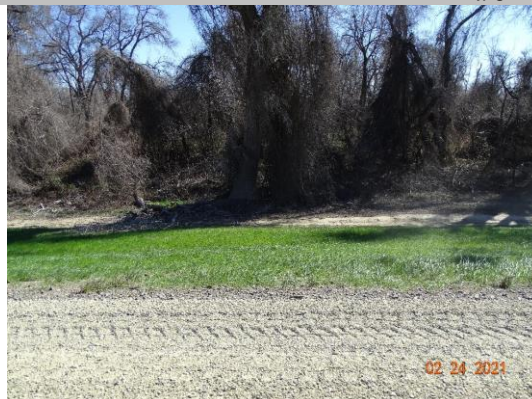
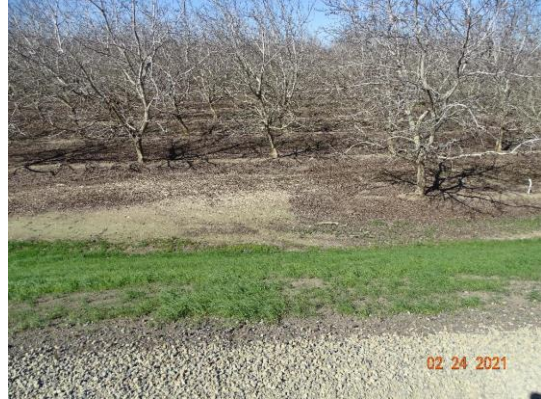
Comment Code					
Inspector Comment					
DS_ID:17653 FS_ID:62953 EP_NO: N/A Repair Type: Non-Urgent EVAL Issue: Crossing Status: Not Found UCIP Comments: 05/23/2017 Record is Non-Urgent. Crossing not found. Geophysical results did not confirm presence of pipe through levee. Record will remain in UCIP's inspection records until future Levee Improvement Project can confirm no crossing was found through the levee. No permit has been identified authorizing pipe. (A.Freitag - DWR UCIP) 05/03/2017 Unable to locate. (A. Freitag - DWR Sutter Yard)10/24/2016 Unable to locate. (A. Freitag - DWR Sutter Yard)04/25/2016 Unable to locate. (A. Freitag - DWR Sutter Yard)04/21/2015 Unable to locate. (A. Freitag - DWR Sutter Yard)06/23/2014 Unable to locate. (A. Freitag - DWR Sutter Yard)12/17/2013 Unable to locate. (A. Freitag - DWR Sutter Yard)07/22/2013 Same as last inspection. Unable to locate. (A. Freitag - DWR Sutter Yard) FIELD_STRUCT_DESC: 36-inch corrugated metal drainage pipe through the levee at an unknown depth below the crown. [Additional Reference(s): USACE Sacramento O&M Manual, Unit 137, August 1955, Revised 29 December 2016, (STA 727+65), listed as 36-inch pipe]. FS Date: 5/23/2017 12:01:00 PM

Top of Levee: View of levee crown looking upstream

Water-Side: View of levee slope looking from crown

Land-Side: View of levee slope looking from crown

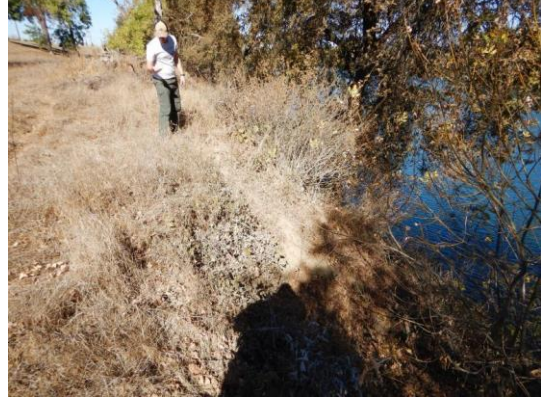
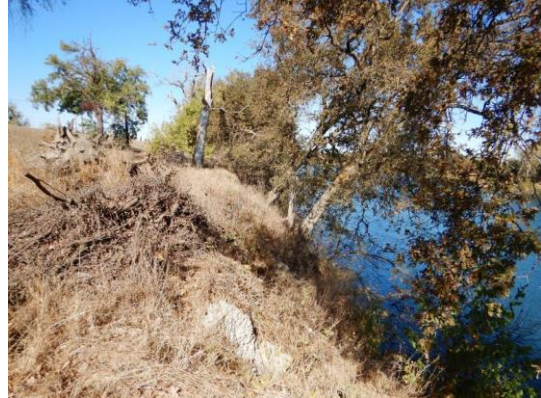
LM Start	16.35	Rating **	A/W	Issue No.	9
LM End	16.58	Issue Type +	Ma	Location *	WS
Category	Supplemental			GPS Latitude/Longitude	
				Start	End
Item	2018 USACE Erosion Survey			39.407837°	39.411111°
				-122.008763°	-122.009238°
DWR ID	DWR_MA0001_01_s_2022_9				
Comment Code					
Inspector Comment					
2018 Site ID: SAC 164.3 R					
Status: Eroding					
2018 Field Notes: Minor new erosion throughout site.					
Site History: Erosion site added in 1997 and removed in 2005. 2009 - Site added back in, hard toe with slow moving erosion. Potential geotechnical failure. 2011 - Site extended downstream. 2017 - New erosion along entire site.

USACE 2018 Erosion Photo #1

USACE 2018 Erosion Photo #2
