**Flood Control Project Maintenance
Levee Inspections**

Maintenance Issue Types Only, Levee Inspection Report By Mile - Spring 2024

Sutter Maintenance Yard Maintenance Area 0001

Waterway	Bank	Unit Miles	Inspection Start/End	Inspector
Unit No. 01 Sacramento River	Right	16.76	04/10/2024 04/10/2024	Makar Sokol

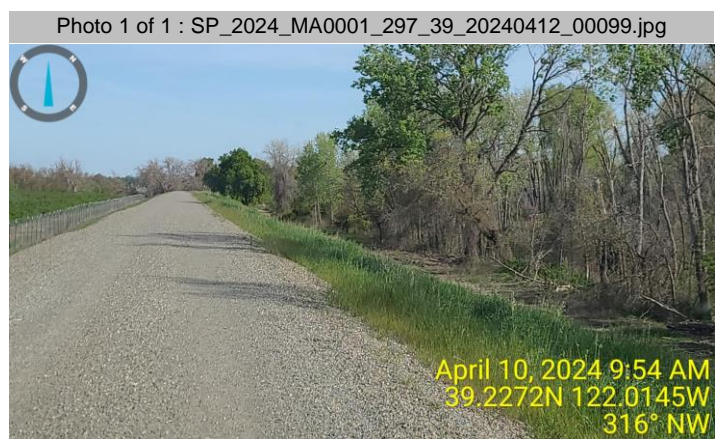
LM Start	1.29	Rating **	M	Issue No.	39
LM End	3.69	Issue Type +	Ma	Location *	WS
Category	Earthen Levee			GPS Latitude/Longitude	
				Start	End
Item	Vegetation			39.223352°	39.255962°
				-122.015893°	-122.009714°
DWR ID	DWR_MA0001_01_s_2024_39				
Comment Code					
V1 : Control annual grass and weeds on the levee slopes and easements.					
Inspector Comment

View of the vegetation along the waterside slope. Spring 2024.

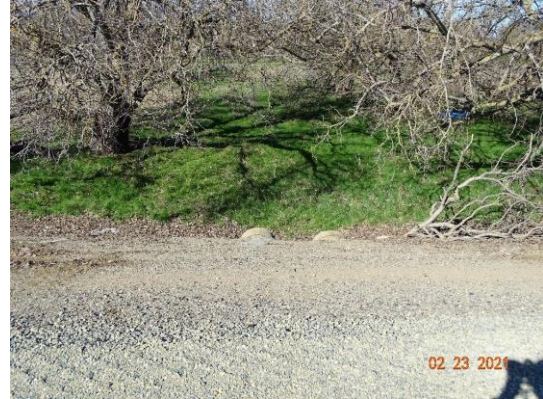
Photo 2 of 3 : UCIP_SP_2024_62869_91152.jpg

Land-Side: View of levee slope looking from crown

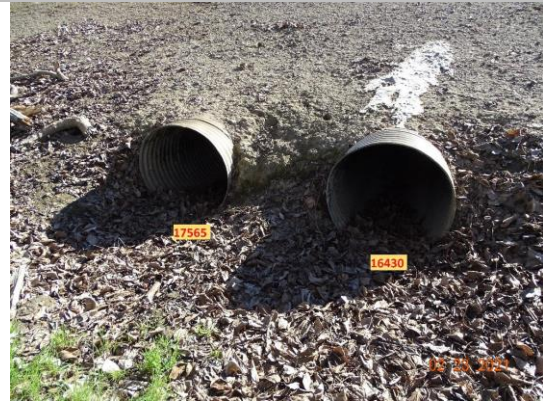
Photo 2 of 3 : UCIP_SP_2024_62871_91165.jpg

Land-Side: Pipe end at levee toe

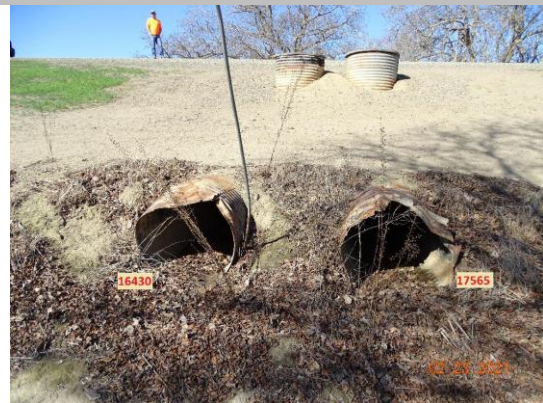
Photo 3 of 3 : UCIP_SP_2024_62871_91167.jpg

Water-Side: Pipe end at levee toe

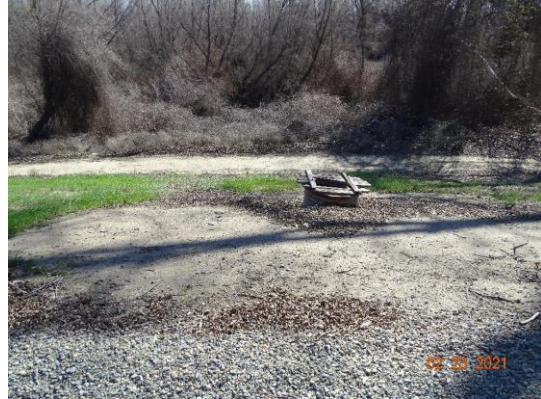
Photo 2 of 3 : UCIP_SP_2024_62873_91176.jpg

Water-Side: View of levee slope looking from crown. CMP riser on levee slope

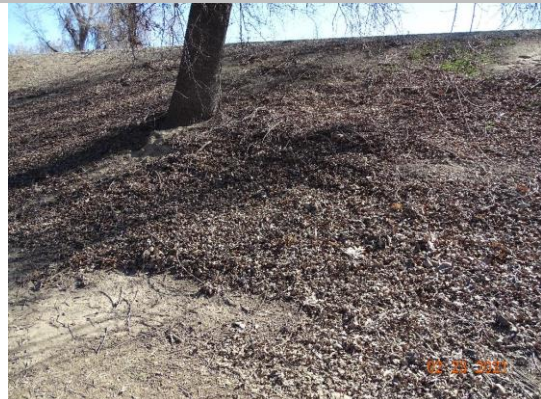
Photo 3 of 3 : UCIP_SP_2024_62873_91179.jpg

Land-Side: View of levee slope looking from toe. Pipe end not found

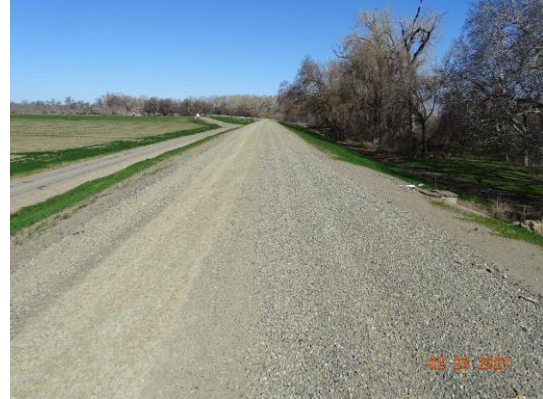
Photo 1 of 3 : UCIP_SP_2024_80997_91330.jpg

DS_ID:16426
FS_ID:80997
EP_NO: 9490
Repair Type: Urgent
EVAL Issue: 1, Pipe Integrity
Crossing Status: Found
UCIP Comments: 09/15/2023 Record updated from Non-Urgent to Urgent. DMP internal video inspection has found severe pipe defects. Crossing will be monitored until funding becomes available to address the issues. (O. Yakimov - DWR UCIP)
02/23/2021 Record remains Non-Urgent. No permit has been identified authorizing pipe. Need to have CVFPB review ABO and determine current owner. Bent stem has been repaired, pipe inlet and outfall cleared from sediment. (O.Yakimov - DWR UCIP)
05/03/2017 Sediment build up in WS pipe end. WS slide gate stem bent but it does not affect its operation. (A. Freitag - DWR Sutter Yard)10/24/2016 WS slide gate stem is still bent. (A. Freitag - DWR Sutter Yard)04/25/2016 WS slide gate is slightly bent. Rest of crossing appears to be in good condition. (A. Freitag - DWR Sutter Yard) 04/20/2015 LS inlet still has some minor sediment build up. Needs to be cleaned. (A. Freitag - DWR Sutter Yard)06/18/2014 Same as last inspection. (A. Freitag - DWR Sutter Yard)12/17/2013 Same as last inspection. (A. Freitag - DWR Sutter Yard)07/18/2013 WS slide gate looks to be in good condition but stem is slightly bent. Not sure if bend will hinder gates operation or not. LS inlet is still blocked by minor sediment build up.10/18/2012 LS pipe slightly deformed and sediment build up blocking about 30% of opening; need to check the condition of the slide gate-need photo. Metal marker down. This crossing was listed in the USACE Periodic Inspection as ID# USACE_CESPK_MA1C_2010_p_0187 for sediment build up at landward toe. (O. Magana - DWR UCIP)

Top of Levee: View of levee crown looking upstream

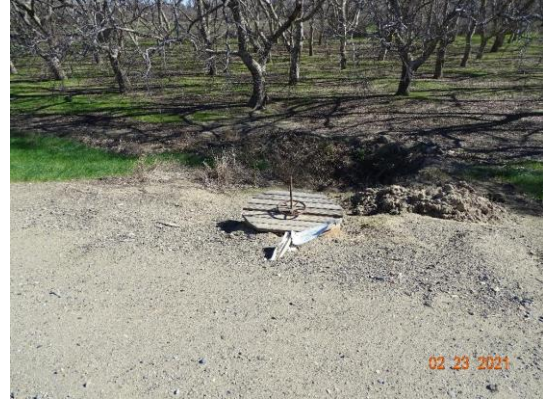
Photo 2 of 3 : UCIP_SP_2024_80997_91331.jpg

Water-Side: CMP riser on levee slope

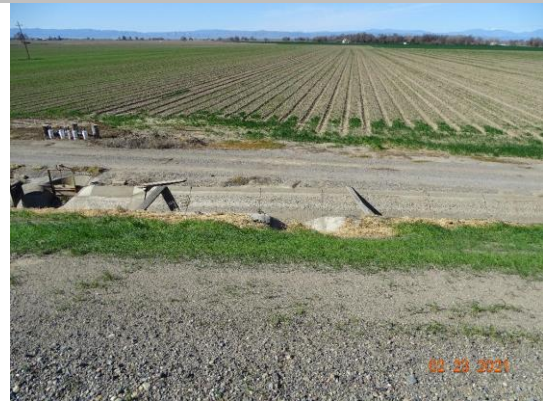
Photo 3 of 3 : UCIP_SP_2024_80997_91332.jpg

Land-Side: View of levee slope looking from crown

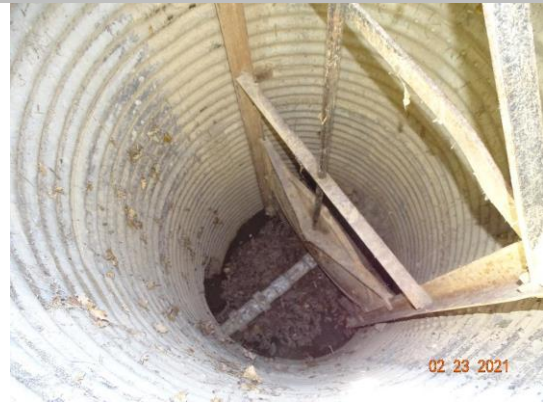
Photo 2 of 3 : UCIP_SP_2024_62913_91463.jpg

Water-Side: Screw gate and PVC pipe inside CMP riser

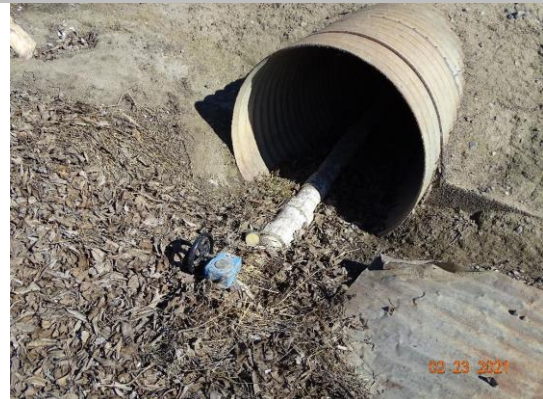
Photo 3 of 3 : UCIP_SP_2024_62913_91459.jpg

Land-Side: 4-inch PVC with shut off valve sleeved through steel pipe

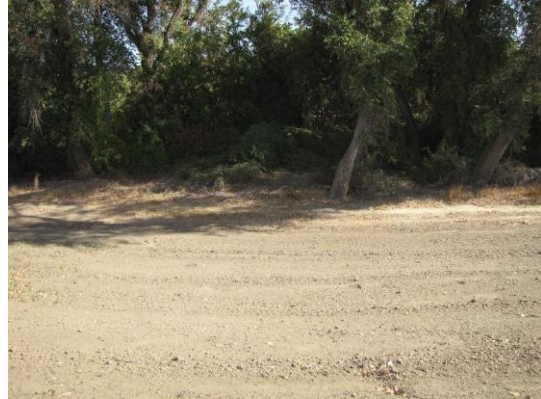
Photo 1 of 3 : UCIP_SP_2024_62914_70181.jpg

DS_ID:16425
FS_ID:62914
EP_NO: N/A
Repair Type: Non-Urgent
EVAL Issue:
Crossing Status: Found
UCIP Comments: 02/23/2021 Record remains Non-Urgent. Crossing appears abandoned. Headwall and pipe on waterside not found. Slide gate removed from concrete riser on landside shoulder. Riser is covered with steel plate bolted to concrete. Soil inside pipe crossing blocking more than 50% of cross section. No permit has been identified authorizing pipe. (O.Yakimov - DWR UCIP)
05/03/2017 Abandoned- needs to be done properly. (A. Freitag - DWR Sutter Yard)10/24/2016 Abandoned. (A. Freitag - DWR Sutter Yard)04/25/2016 Abandoned crossing. (A. Freitag - DWR Sutter Yard)04/20/2015 Same as last inspection. (A. Freitag - DWR Sutter Yard)06/23/2014 Same as last inspection. (A. Freitag - DWR Sutter Yard)12/17/2013 Same as last inspection. (A. Freitag - DWR Sutter Yard)07/18/2013 Same as last inspection. (A. Freitag - DWR Sutter Yard)10/19/2012 Need to be properly abandoned concrete structure; plate covers concrete box; Concrete headwall damaged. This crossing was listed in the USACE Periodic Inspection as ID# USACE_CESPK_MA1C_2010_p_0262 for damage to concrete structure (vertical 2 inch wide cracks and spalling visible). (O. Magana - DWR UCIP)

FIELD_STRUCT_DESC: 72-inch corrugated metal (precast concrete) drainage pipe through the levee at an unknown depth below the crown. Structure is blocked on the waterside (WS) end with 3-foot concrete plug installed in 1980. Sliding metal gate (referenced in O&M manual) in concrete well on the landside (LS) shoulder. Concrete headwall at both toes. WS headwall not found. [Additional Reference(s): DWR Levee Log, 1992 (HLM 6.55), listed as abandoned 72-inch drain pipe. USACE Sacramento O&M Manual, Unit 137, August 1955, Revised 29 December 2016, (STA 339+74), listed as 72-inch pipe].
FS Date: 2/23/2021 3:49:23 PM

View of WS no structure features visible.

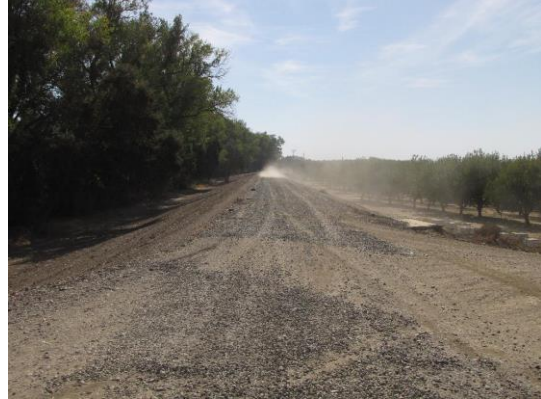
Photo 2 of 3 : UCIP_SP_2024_62914_70180.jpg

Overview of levee crown looking downstream at crossing.

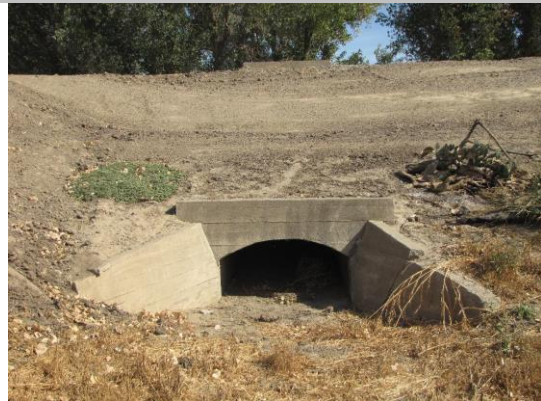
Photo 3 of 3 : UCIP_SP_2024_62914_70179.jpg

View of structure located in LS.

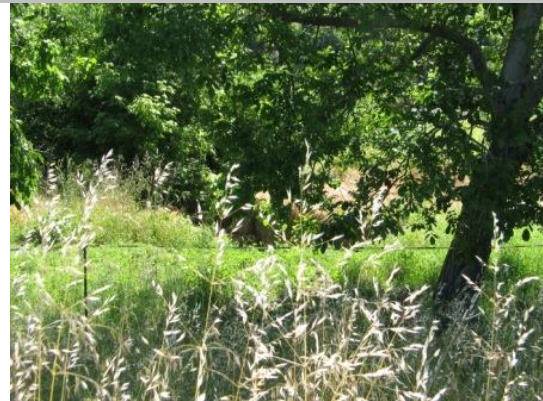
Photo 1 of 1 : SP_2024_MA0001_297_18_20240212_00009.jpg

View of the erosion along the waterside of the levee.

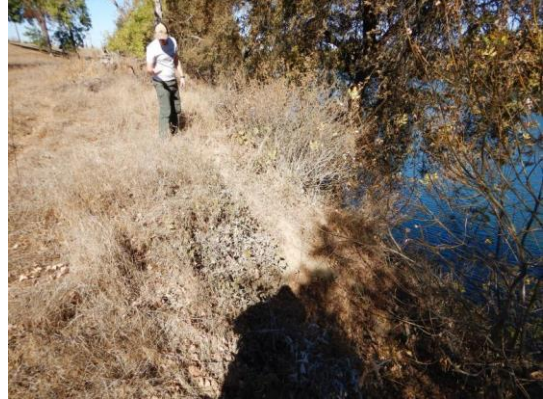
Photo 1 of 2 : SP_2024_MA0001_297_9_20240212_00006.jpg

LM Start	16.35	Rating **	A/W	Issue No.	9
LM End	16.58	Issue Type +	Ma	Location *	WS
Category	Supplemental			GPS Latitude/Longitude	
				Start	End
Item	2018 USACE Erosion Survey			39.407837°	39.411111°
				-122.008763°	-122.009238°
DWR ID	DWR_MA0001_01_s_2022_9				
Comment Code					
Inspector Comment					
2018 Site ID: SAC 164.3 R					
Status: Eroding					
2018 Field Notes: Minor new erosion throughout site.					
Site History: Erosion site added in 1997 and removed in 2005. 2009 - Site added back in, hard toe with slow moving erosion. Potential geotechnical failure. 2011 - Site extended downstream. 2017 - New erosion along entire site.

USACE 2018 Erosion Photo #1
