**Flood Control Project Maintenance  
Levee Inspections**

**Fall 2011 Levee Maintenance Deficiency Summary Report**

**Sutter Maintenance Yard Maintenance Area 0003**

**Levee Inspection Report By Mile - Fall 2011**

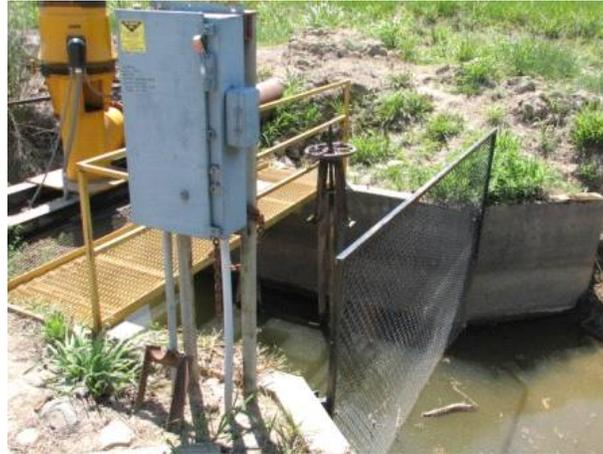
cathom\_f\_20110929\_813.jpg

Levee Mile Report Line	1
Start Levee Mile	0.80
End Levee Mile	0.80
Location	Land Side
Category	Interior Drainage & Piping Systems
Item	Sluice / Slide Gates

Levee mile 0.80, this photo is looking at the landside toe, one of these pipes leaked during the high water event of 2010/2011.

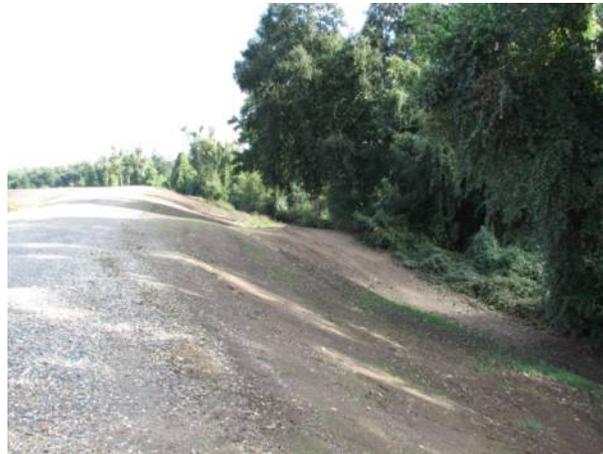
cathom\_f\_20111020\_960.jpg

Levee Mile Report Line	3
Start Levee Mile	2.29
End Levee Mile	2.42
Location	Water Side
Category	Earthen Levee
Item	Slope Stability

This photo is the waterside slope looking downstream at levee mile 2.29.

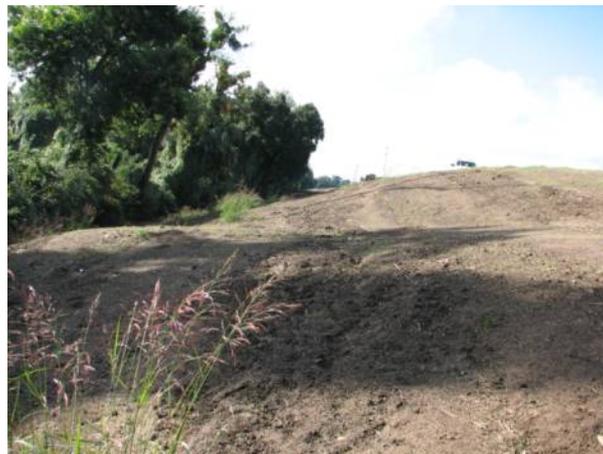
cathom\_f\_20111020\_961.jpg

Levee Mile Report Line	3
Start Levee Mile	2.29
End Levee Mile	2.42
Location	Water Side
Category	Earthen Levee
Item	Slope Stability

This photo is the waterside slope looking upstream.
