**Flood Control Project Maintenance
Levee Inspections**

Fall 2014 Levee Maintenance Deficiency Summary Report

Sutter Maintenance Yard Maintenance Area 0003

Waterway		Bank	Unit Miles	
Unit No. 01 Feather River		Right	5.11	
	Spring (March - May)	Summer (June - August)	(September - November) Fall	Winter (December - February)
Unit Maintenance Rating (Fall Only)			M	
Date of Inspection	05/01/2014 - 05/01/2014		10/14/2014 - 10/14/2014	
DWR Inspector	Matthew Hoffman		Matthew Hoffman	
Accompanied By

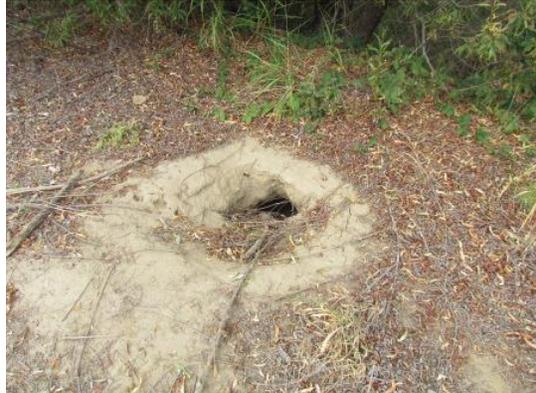
Photo 1 of 2 : FA_2014_MA0003_195_140_20141017_00249.jpg

LM Start	0.78	Rating **	U	Issue No.	140
LM End	0.78	Issue Type +	Ma	Location *	N/A
Category	Earthen Levee		GPS Latitude/Longitude		
			Start	End	
Item	Crown Surface / Depressions / Rutting		38.903339 °	38.903339 °	
			-121.606209 °	-121.606209 °	
DWR ID	DWR_MA0003_01_f_2014_140				
Action/Comments					
Repair depressions or ruts in the crown or slope. Inspector Comments: There is a sinkhole on the landward toe road approximately 12" in diameter leading to the adjacent drainage ditch.

This photo was taken from the landward levee slope near the toe road facing north looking at an approximately 12" sink hole going from the toe road to the adjacent drainage ditch that parallels the toe road. Fall 2014.

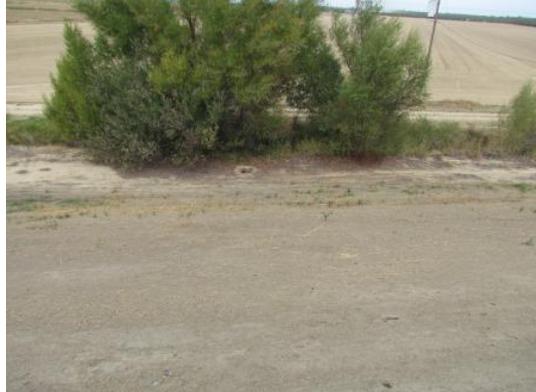
Photo 2 of 2 : FA_2014_MA0003_195_140_20141017_00250.jpg

This is another photo of the sink hole to show its relationship to to levee toe, toe road, and drainage ditch. Fall 2014.

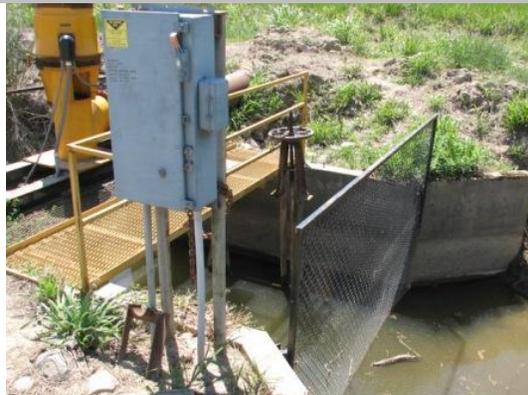
Photo 1 of 1 : FA_2014_MA0003_195_5_20141013_00001.jpg

LM Start	0.80	Rating **	M	Issue No.	5
LM End	0.80	Issue Type +	Ma	Location *	LS
Category	Interior Drainage & Piping Systems		GPS Latitude/Longitude		
			Start	End	
Item	Sluice / Slide Gates		38.903291 °	38.903291 °	
			-121.605747 °	-121.605747 °	
DWR ID	DWR_MA0003_01_s_2012_5				
Action/Comments					
Inspector Comments: This pipe leaked during the high water event of 2010/2011.

Levee mile 0.80, this photo is looking at the landside toe, one of these pipes leaked during the high water event of 2010/2011. A flap gate prevents flow from the waterward side to the landward side of the levee.

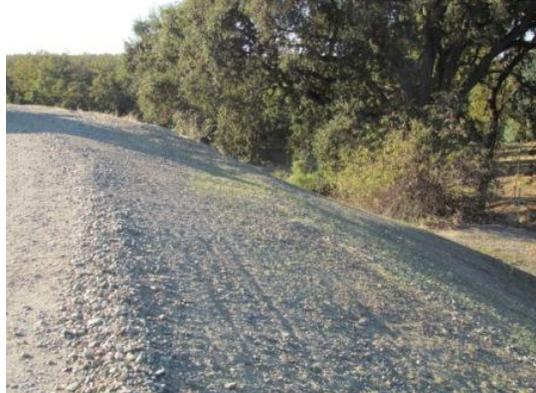
Photo 1 of 1 : FA_2014_MA0003_195_19_20141013_00007.jpg

LM Start	3.64	Rating **	M	Issue No.	19
LM End	3.64	Issue Type +	Ma	Location *	LS
Category	Earthen Levee		GPS Latitude/Longitude		
			Start	End	
Item	Vegetation		38.930063 °	38.930063 °	
			-121.590211 °	-121.590211 °	
DWR ID	DWR_MA0003_01_f_2013_19				
Action/Comments					
Elderberries are blocking visibility and flood fight capability. Inspector Comments: Elderberries on the landward levee toe.

This photo was taken from the levee crown facing south looking down the landward levee slope at a group of Elderberries. Fall 2013.

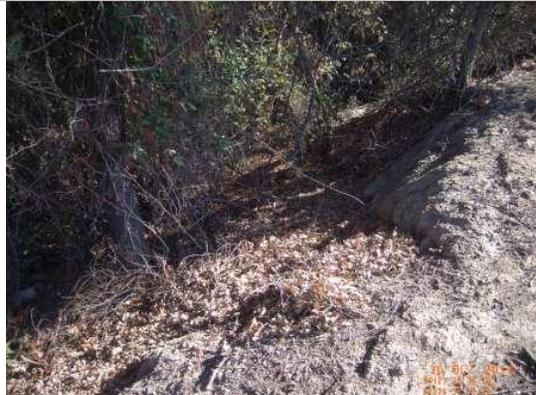
Photo 1 of 2 : FA_2014_MA0003_195_10_20141013_00002.jpg

LM Start	4.20	Rating **	M	Issue No.	10
LM End	4.20	Issue Type +	Ma	Location *	WS
Category	Supplemental		GPS Latitude/Longitude		
			Start	End	
Item	USACE Erosion Survey		38.937454 °	38.937937 °	
			-121.588544 °	-121.588471 °	
DWR ID	DWR_MA0003_01_f_2014_10				
Action/Comments					
Inspector Comments: 2013: Minor toe scour causing gradual erosion of bank slope. Site is within ecological reserve. [2013 Site ID: FHR_12-3_R]

USACE 2013 Photo #1

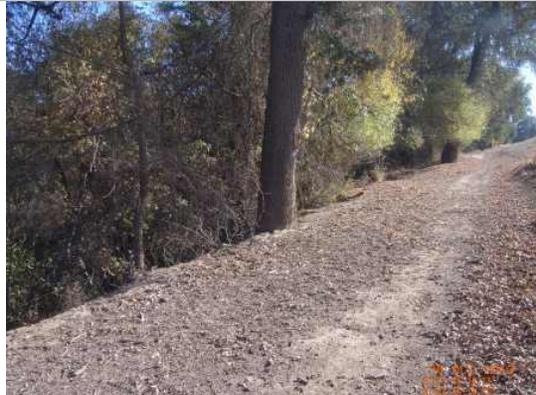
Photo 2 of 2 : FA_2014_MA0003_195_10_20141013_00003.jpg

USACE 2013 Photo #2

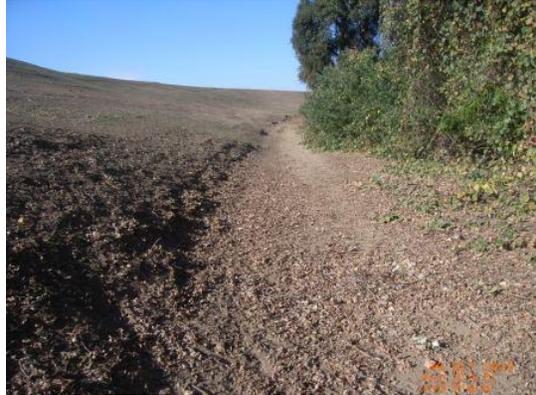
Photo 1 of 2 : FA_2014_MA0003_195_11_20141013_00004.jpg

LM Start	4.67	Rating **	M	Issue No.	11
LM End	4.67	Issue Type +	Ma	Location *	WS
Category	Supplemental		GPS Latitude/Longitude		
			Start	End	
Item	USACE Erosion Survey		38.945190 °	38.945967 °	
			-121.586073 °	-121.586328 °	
DWR ID	DWR_MA0003_01_f_2014_11				
Action/Comments					
Inspector Comments: 2013: Minor toe scour causing gradual erosion into the bank slope [2013 Site ID: FHR_12-8_R]

USACE 2013 Photo #1

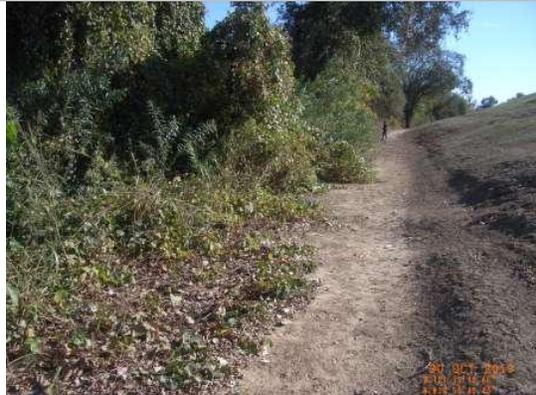
Photo 2 of 2 : FA_2014_MA0003_195_11_20141013_00005.jpg

USACE 2013 Photo #2
