**Flood Control Project Maintenance
Levee Inspections
LMA District Cover Sheet
Spring 2012 Levee Inspection Results**

Spring 2012 Levee Inspection Results

Sutter Maintenance Yard Maintenance Area 0003

Waterway		Bank	Unit Miles
Unit No. 01 Feather River		Right	5.19

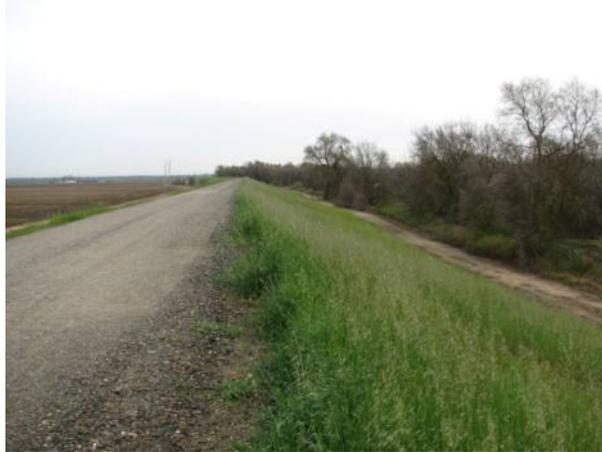
Levee Mile Report Line	4
Start Levee Mile	0.08
End Levee Mile	3.55
Location	Water Side
Category	Earthen Levee
Item	Vegetation

This photo was taken near levee 0.08 looking upstream at the waterside vegetation.

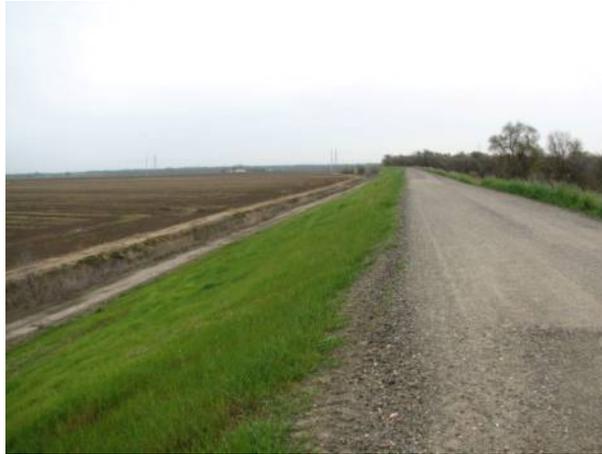
Levee Mile Report Line	5
Start Levee Mile	0.08
End Levee Mile	4.27
Location	Land Side
Category	Earthen Levee
Item	Vegetation

This photo was taken at levee mile 0.08 looking upstream at the landside vegetation.

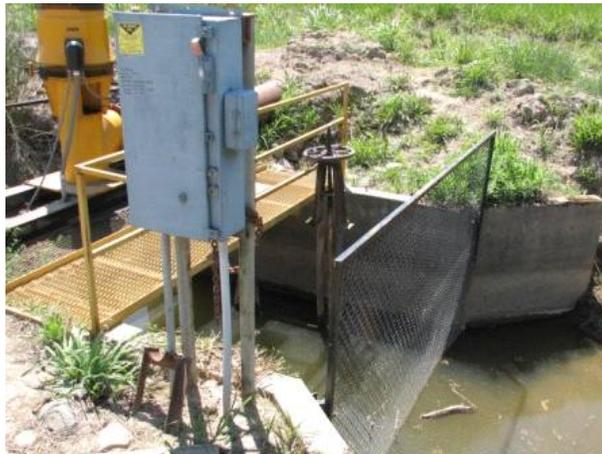
Levee Mile Report Line	6
Start Levee Mile	0.80
End Levee Mile	0.80
Location	Land Side
Category	Interior Drainage & Piping Systems
Item	Sluice / Slide Gates

Levee mile 0.80, this photo is looking at the landside toe, one of these pipes leaked during the high water event of 2010/2011. A flap gate prevents flow from the waterward side to the landward side of the levee.

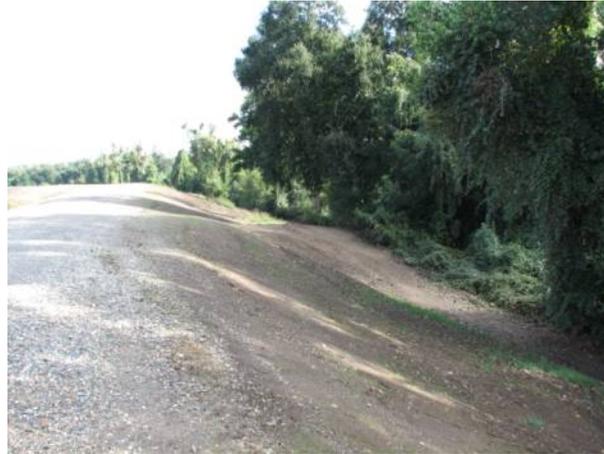
Levee Mile Report Line	8
Start Levee Mile	2.29
End Levee Mile	2.42
Location	Water Side
Category	Earthen Levee
Item	Slope Stability

This photo is the waterside slope looking downstream at levee mile 2.29.

DWR ID: DWR_MA0003_01_s_2012_5										
7	1.72	1.85	Earthen Levee	Crown Surface / Depressions / Rutting	CR	M Ma	C3 : Add appropriate gravel or road base. Grade and compact.	38.906503 ° -121.591216 °	38.907690 ° -121.589415 °	118
DWR ID: DWR_MA0003_01_s_2012_118										
8	2.29	2.42	Earthen Levee	Slope Stability	WS	M Ob	S1 : Repair slope instability. Inspector Comments: Material movement on the waterside slope. The LMA should investigate the matter further.	38.912960 ° -121.585220 °	38.914582 ° -121.584106 °	119 Y
DWR ID: DWR_MA0003_01_s_2012_119										
9	4.27	5.17	Earthen Levee	Vegetation	LS	M Ma	V1 : Control annual grass and weeds on the levee slopes and easements.	38.938489 ° -121.588693 °	38.950889 ° -121.585790 °	1
DWR ID: DWR_MA0003_01_s_2012_1

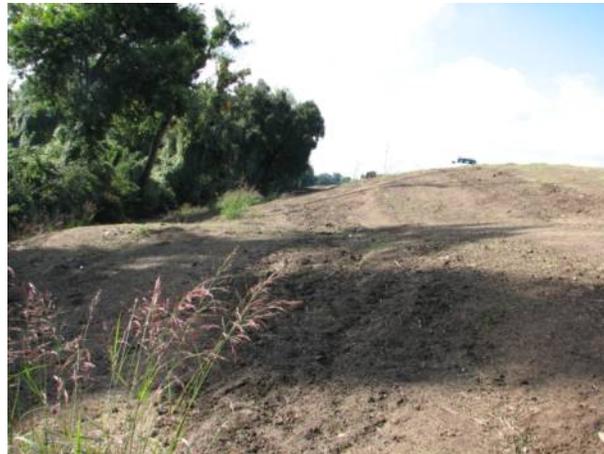
Levee Mile Report Line	8
Start Levee Mile	2.29
End Levee Mile	2.42
Location	Water Side
Category	Earthen Levee
Item	Slope Stability

This photo is the waterside slope looking upstream.
