**Flood Control Project Maintenance
Levee Inspections**
LMA District Cover Sheet
Spring 2014 Levee Inspection Results

Sutter Maintenance Yard Maintenance Area 0003

Levee Inspection Report By Mile - Spring 2014

Waterway	Bank	Unit Miles	Inspection Start/End	Inspector
Unit No. 01 Feather River	Right	5.19	05/01/2014 05/01/2014	Matthew Hoffman

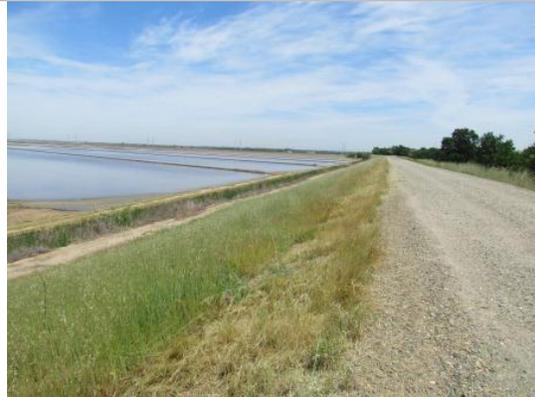
Photo 1 of 1 : mhoffman_s_20140502_499.jpg

LM Start	0.00	Rating **	M	Issue No.	8
LM End	1.22	Issue Type +	Ma	Location *	LS
Category	Earthen Levee		GPS Latitude/Longitude		
			Start	End	
Item	Vegetation		38.897983 °	38.902244 °	
			-121.617791 °	-121.598182 °	
DWR ID	DWR_MA0003_01_s_2014_8				
Action/Comments					
Control annual grass and weeds on the levee slopes and easements.

This photo was taken from the crown facing east looking down the landward levee slope at vegetation requiring maintenance. Spring 2014.

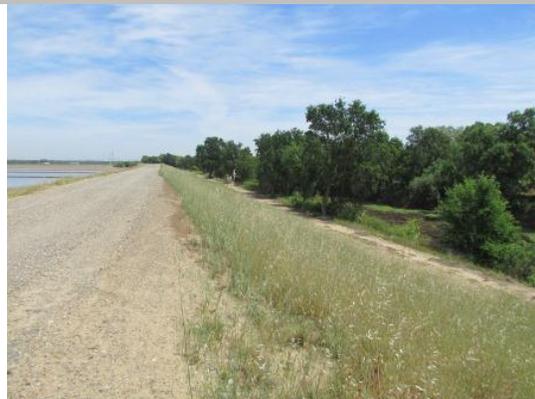
Photo 1 of 1 : mhoffman_s_20140502_500.jpg

LM Start	0.00	Rating **	M	Issue No.	9
LM End	5.19	Issue Type +	Ma	Location *	WS
Category	Earthen Levee		GPS Latitude/Longitude		
			Start	End	
Item	Vegetation		38.897983 °	38.949554 °	
			-121.617791 °	-121.586043 °	
DWR ID	DWR_MA0003_01_s_2014_9				
Action/Comments					
Control annual grass and weeds on the levee slopes and easements.

This photo was taken from the crown facing east looking down the waterward levee slope at vegetation requiring maintenance. Spring 214.

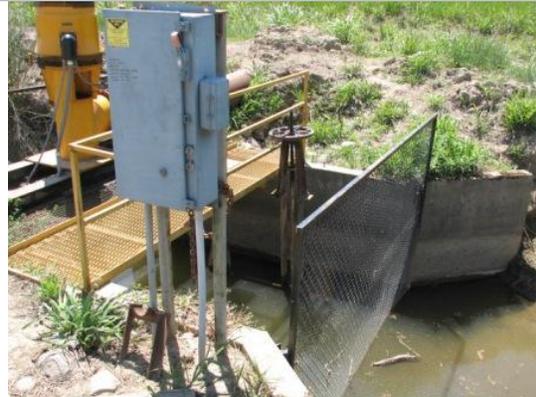
Photo 1 of 1 : mhoffman_s_20140401_398.jpg

LM Start	0.80	Rating **	M	Issue No.	5
LM End	0.80	Issue Type +	Ma	Location *	LS
Category	Interior Drainage & Piping Systems		GPS Latitude/Longitude		
			Start	End	
Item	Sluice / Slide Gates		38.903291 °	38.903291 °	
			-121.605747 °	-121.605747 °	
DWR ID	DWR_MA0003_01_s_2012_5				
Action/Comments					
Inspector Comments: This pipe leaked during the high water event of 2010/2011.

Levee mile 0.80, this photo is looking at the landside toe, one of these pipes leaked during the high water event of 2010/2011. A flap gate prevents flow from the waterward side to the landward side of the levee.

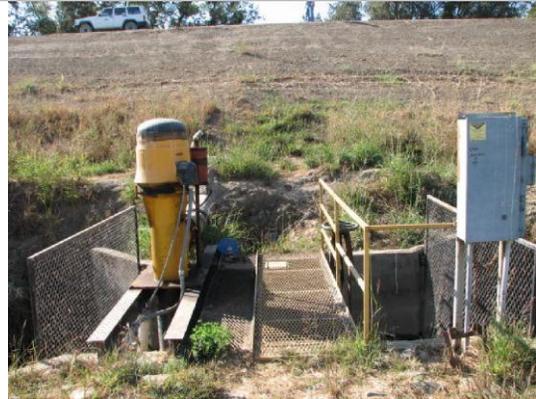
Photo 1 of 1 : UCIP_3559.jpg

LM Start	0.80	Rating **	M	Issue No.	2
LM End	0.80	Issue Type +	En	Location *	LS
Category	Supplemental		GPS Latitude/Longitude		
			Start	End	
Item	DWR UCIP Field Study		38.903264 °	38.903264 °	
			-121.605698 °	-121.605698 °	
DWR ID	DWR_MA0003_01_s_2014_2				
Action/Comments					
Inspector Comments: FS_ID:23619 EP_NO: N/A Repair Type: Crossing Status: UCIP Comments: Flap gates not visible on waterward headwall and it appears as though they have been replaced by sandbags. Slide gates on LS appear to be closed yet water leaks excessively from the WS at the sandbagged headwall. 5/21/2013 SBFCA project recommends replacing in accordance with title 23/21/2013 High water levels in WS ditch have pipe ends underwater but repairs have not yet been completed but are planned for when water levels drop. 10/30/2013 Same as last inspection. FIELD_STRUCT_DESC: 2 of 2. 18-inch pipe through the levee, 32.0 feet below the crown. Flap gate on the waterward end. Slide gate on the landward end at concrete headwall. Concrete "U" headwall at the waterward toe. Originally included in O+M manual (1955). FS Date: 11/4/2013 2:23:57 PM

Concrete headwall, slidegates, and metal walkway on LS toe.

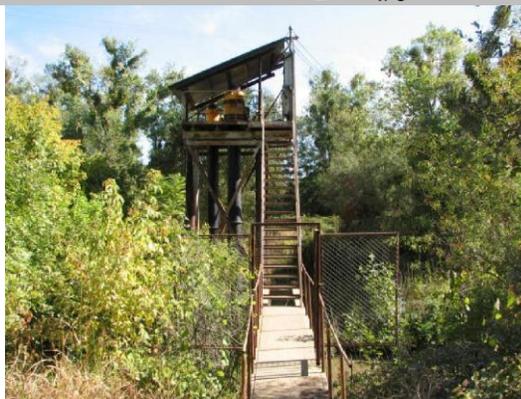
Photo 1 of 1 : UCIP_3560.jpg

LM Start	2.19	Rating **	M	Issue No.	3
LM End	2.19	Issue Type +	En	Location *	WS
Category	Supplemental		GPS Latitude/Longitude		
			Start	End	
Item	DWR UCIP Field Study		38.911734 °	38.911734 °	
			-121.586106 °	-121.586106 °	
DWR ID	DWR_MA0003_01_s_2014_3				
Action/Comments					
Inspector Comments: FS_ID:23623 EP_NO: 3284 Repair Type: Crossing Status: UCIP Comments: Pumping plant has been disconnected from levee. Need to determine if abandonment is appropriate or if this is now a gravity drain with flap gate 6/21/2013 Pumping plant was running and filling concrete vault on WS toe through the left flap gate and then flowing through levee pipe and filling irrigation ditch on LS. Left and middle flap gates appear to be connected to pumps and right gate appears abandoned. Recommend contacting owner to get more detail 8/30/2013 Same as last inspection. FIELD_STRUCT_DESC: 32-inch by 32-inch concrete box culvert through the levee approximately 28 feet below the crown. Transition between vault on RS and box culvert within levee section is made with a 41-inch CMP. Slide gate on LS at concrete headwall. Flap Gate in concrete vault on RS at terminal of pipes from pump structure in floodway. Pipes from pump station in creek be no longer connected. (Permit No. 3284) FS Date: 11/4/2013 2:26:19 PM

Pumping plant on WS toe at small slough. Pipes no longer connected to concrete box on WS toe.

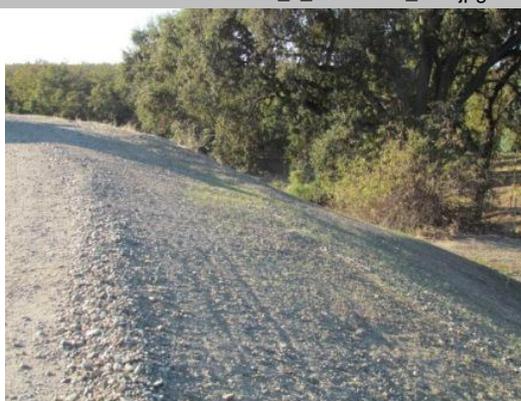
Photo 1 of 1 : mhoffman_s_20140401_400.jpg

LM Start	3.64	Rating **	M	Issue No.	19
LM End	3.64	Issue Type +	Ma	Location *	LS
Category	Earthen Levee		GPS Latitude/Longitude		
			Start	End	
Item	Vegetation		38.930063 °	38.930063 °	
			-121.590211 °	-121.590211 °	
DWR ID	DWR_MA0003_01_f_2013_19				
Action/Comments					
Elderberries are blocking visibility and flood fight capability. Inspector Comments: Elderberries on the landward levee toe.

This photo was taken from the levee crown facing south looking down the landward levee slope at a group of Elderberries. Fall 2013.

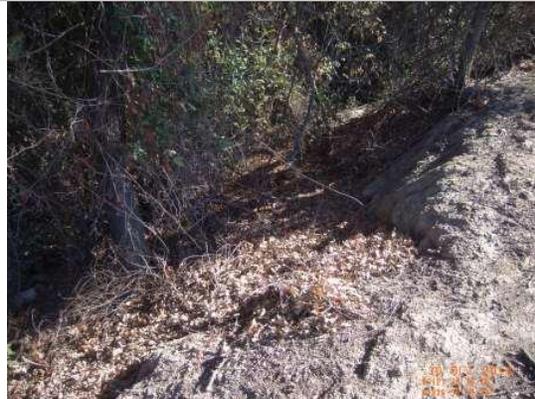
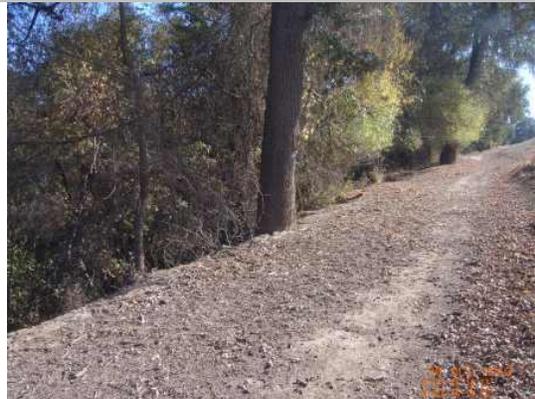
Photo 1 of 2 : USACE2013A_FHR_12-3_R_2.jpg

LM Start	4.20	Rating **	M	Issue No.	10
LM End	4.20	Issue Type +	Ma	Location *	WS
Category	Supplemental			GPS Latitude/Longitude	
				Start	End
Item	USACE Erosion Survey			38.937454 °	38.937937 °
				-121.588544 °	-121.588471 °
DWR ID					
Action/Comments					
Inspector Comments: 2013: Minor toe scour causing gradual erosion of bank slope. Site is within ecological reserve. [2013 Site ID: FHR_12-3_R]

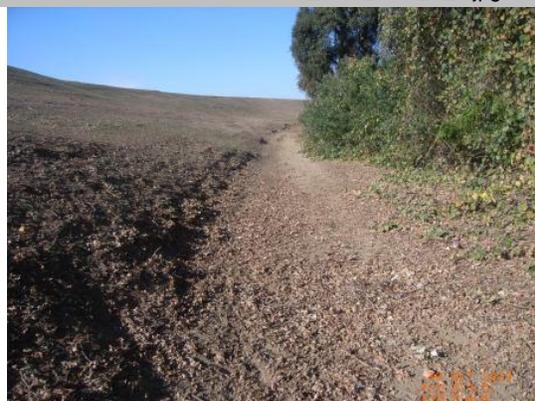
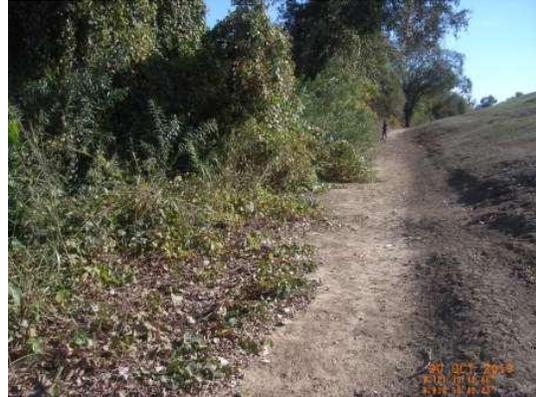
Photo 1 of 2 : USACE2013A_FHR_12-8_R_5.jpg

LM Start	4.67	Rating **	M	Issue No.	11
LM End	4.67	Issue Type +	Ma	Location *	WS
Category	Supplemental			GPS Latitude/Longitude	
				Start	End
Item	USACE Erosion Survey			38.945190 °	38.945967 °
				-121.586073 °	-121.586328 °
DWR ID					
Action/Comments					
Inspector Comments: 2013: Minor toe scour causing gradual erosion

LM Start	4.67	Rating **	M	Issue No.	11 (cont)
LM End	4.67	Issue Type +	Ma	Location *	WS
Category	Supplemental			GPS Latitude/Longitude	
				Start	End
Item	USACE Erosion Survey			38.945190 °	38.945967 °
				-121.586073 °	-121.586328 °
DWR ID					
Action/Comments					
Inspector Comments: 2013: Minor toe scour causing gradual erosion into the bank slope [2013 Site ID: FHR_12-8_R]
