**Flood Control Project Maintenance  
Levee Inspections**

**Maintenance Issue Types Only, Levee Inspection Report By Mile - Spring 2016**

**Sutter Maintenance Yard Maintenance Area 0003**

Waterway	Bank	Unit Miles	Inspection Start/End	Inspector
Unit No. 01 Feather River	Right	5.11	03/24/2016 03/30/2016	Sterling York

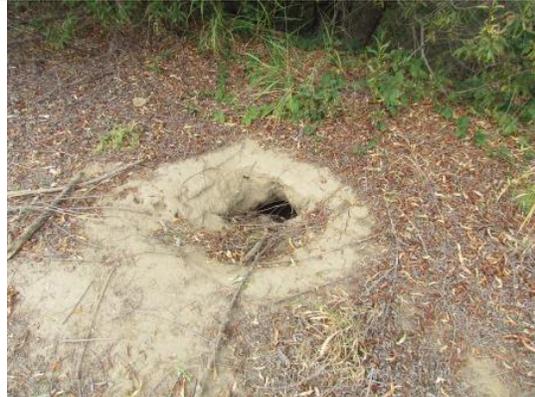
Photo 1 of 2 : SP\_2016\_MA0003\_195\_140\_20160307\_00011.jpg

LM Start	<b>0.78</b>	Rating **	M	Issue No.	<b>140</b>
LM End	<b>0.78</b>	Issue Type +	Ma	Location *	LS
Category	Earthen Levee			GPS Latitude/Longitude	
				Start	End
Item	Animal Control			38.903339 °	38.903339 °
				-121.606209 °	-121.606209 °
DWR ID	DWR_MA0003_01_f_2014_140				
Comment Code					
A3 : No rodents visible, but rodent burrows visible; need to backfill and compact or grout burrows.					
Inspector Comment					
There is a rodent hole on the landward toe road approximately 6" in diameter.

This photo was taken from the landward levee slope near the toe road facing north looking at an approximately 6" rodent hole. Fall 2014.

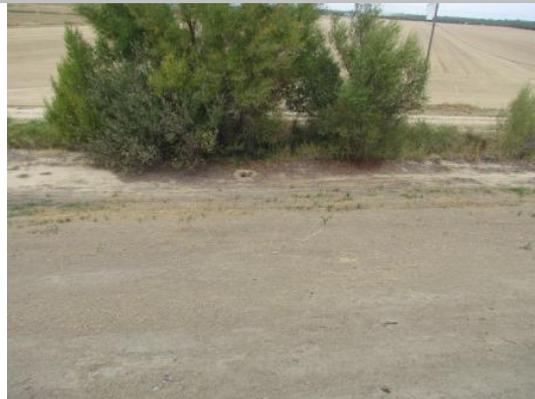
Photo 2 of 2 : SP\_2016\_MA0003\_195\_140\_20160307\_00012.jpg

This is another photo of the rodent hole to show its relationship to levee toe, toe road, and drainage ditch. Fall 2014.

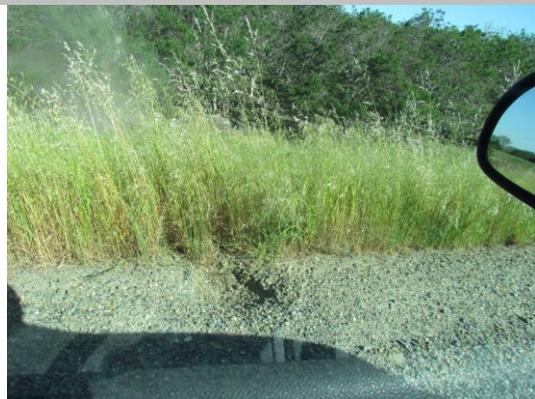
Photo 1 of 1 : SP\_2016\_MA0003\_195\_13\_20160307\_00006.jpg

LM Start	<b>1.51</b>	Rating **	M	Issue No.	<b>13</b>
LM End	<b>1.51</b>	Issue Type +	Ma	Location *	CR
Category	Earthen Levee			GPS Latitude/Longitude	
				Start	End
Item	Crown Surface / Depressions / Rutting			38.904680 °	38.904680 °
				-121.594229 °	-121.594229 °
DWR ID	DWR_MA0003_01_s_2015_13				
Comment Code					
C2 : Repair depressions or ruts in the crown or slope.					
Inspector Comment

Photo of a depression in the crown, taken looking at the landside.

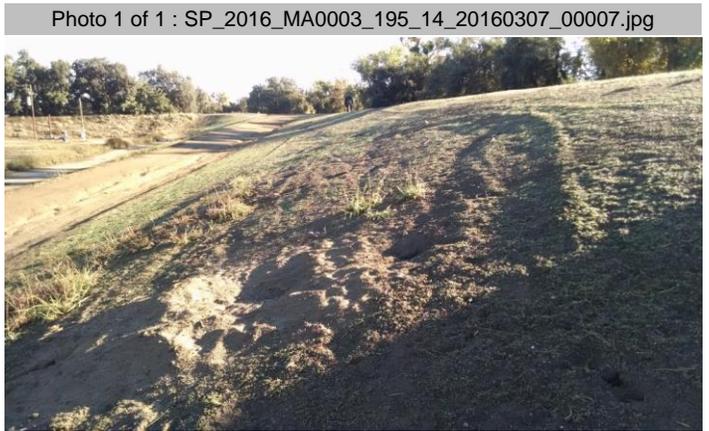
LM Start	<b>1.77</b>	Rating **	M	Issue No.	<b>14</b>
LM End	<b>1.77</b>	Issue Type +	Ma	Location *	LS
Category	Earthen Levee			GPS Latitude/Longitude	
				Start	End
Item	Animal Control			38.907025 °	38.907025 °
				-121.590375 °	-121.590375 °
DWR ID	DWR_MA0003_01_s_2015_14				
Comment Code					
A3 : No rodents visible, but rodent burrows visible; need to backfill and compact or grout burrows.					
Inspector Comment

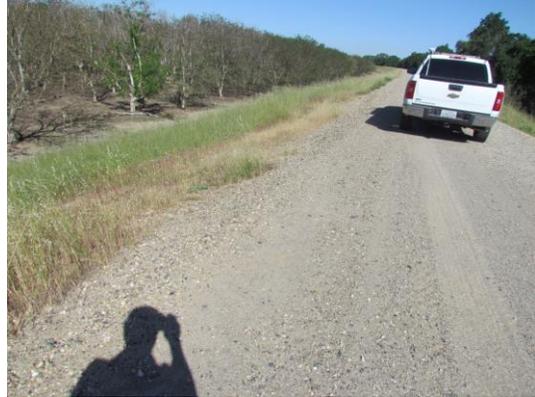
Photo 1 of 1 : SP\_2016\_MA0003\_195\_20\_20160307\_00010.jpg

LM Start	<b>3.20</b>	Rating **	M	Issue No.	<b>20</b>
LM End	<b>3.20</b>	Issue Type +	Ma	Location *	LS
Category	Earthen Levee		GPS Latitude/Longitude		
			Start	End	
Item	Slope Stability		38.925909 °	38.925909 °	
			-121.585401 °	-121.585401 °	
DWR ID	DWR_MA0003_01_s_2015_20				
Comment Code					
S1 : Repair slope instability.					
Inspector Comment

Photo of slope on the landside facing upstream, areas with little vegetation appear to have eroded leaving the crown smaller.

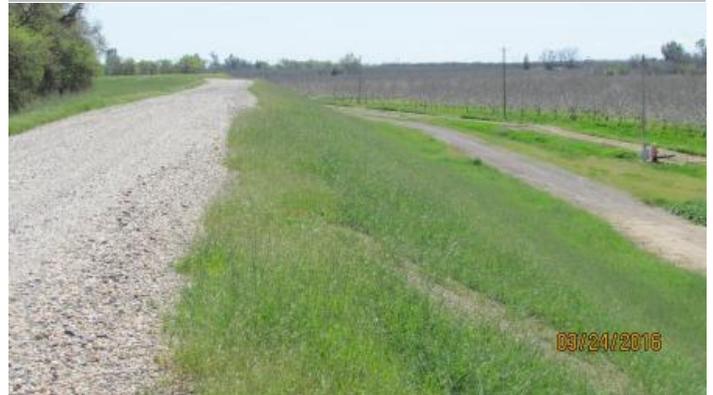
Photo 1 of 1 : SP\_2016\_MA0003\_195\_12\_20160404\_00028.jpg

LM Start	<b>3.75</b>	Rating **	M	Issue No.	<b>12</b>
LM End	<b>4.47</b>	Issue Type +	Ma	Location *	LS
Category	Earthen Levee		GPS Latitude/Longitude		
			Start	End	
Item	Vegetation		38.932157 °	38.942033 °	
			-121.591031 °	-121.587681 °	
DWR ID	DWR_MA0003_01_s_2016_12				
Comment Code					
V1 : Control annual grass and weeds on the levee slopes and easements.					
Inspector Comment

Vegetation on the landside looking downstream.

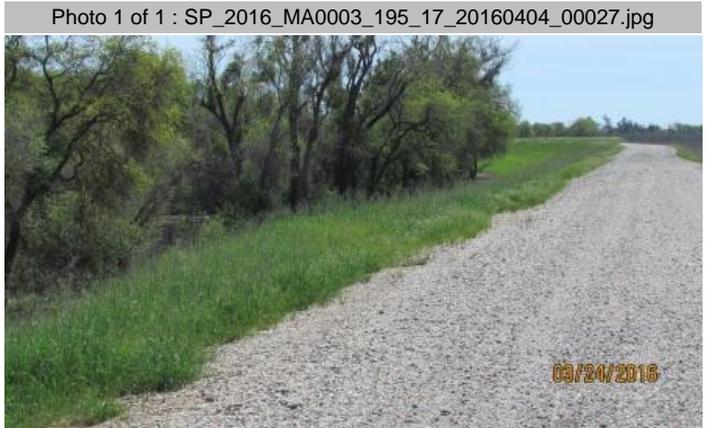
LM Start	<b>3.75</b>	Rating **	M	Issue No.	<b>17</b>
LM End	<b>4.47</b>	Issue Type +	Ma	Location *	WS
Category	Earthen Levee		GPS Latitude/Longitude		
			Start	End	
Item	Vegetation		38.932157 °	38.942039 °	
			-121.591031 °	-121.587680 °	
DWR ID	DWR_MA0003_01_s_2016_17				
Comment Code					
V1 : Control annual grass and weeds on the levee slopes and easements.					
Inspector Comment

Vegetation on waterside looking downstream.

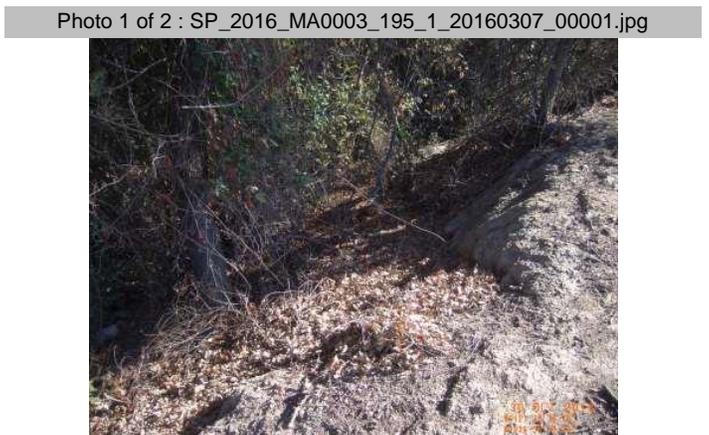
USACE 2013 Photo #1

LM Start	<b>4.15</b>	Rating **	M	Issue No.	<b>1</b>
LM End	<b>4.18</b>	Issue Type +	Ma	Location *	WS
Category	Supplemental		GPS Latitude/Longitude		
			Start	End	
Item	2015 USACE Erosion Survey, DRAFT		38.937451 °	38.937937 °	
			-121.588512 °	-121.588471 °	
DWR ID	DWR_MA0003_01_s_2016_1				
Comment Code					
Inspector Comment					
2013 - Minor toe scour causing gradual erosion of bank slope. Site is within ecological reserve. 2015: Last observed in 2013. [2015 Site ID: FHR_12-3_R]

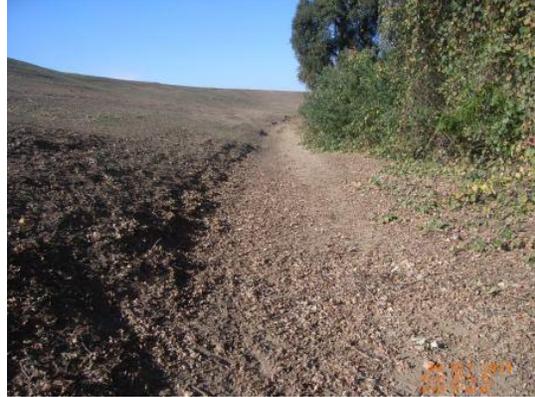
Photo 1 of 2 : SP\_2016\_MA0003\_195\_2\_20160307\_00003.jpg

LM Start	<b>4.71</b>	Rating **	M	Issue No.	<b>2</b>
LM End	<b>4.76</b>	Issue Type +	Ma	Location *	WS
Category	Supplemental			GPS Latitude/Longitude	
				Start	End
Item	2015 USACE Erosion Survey, DRAFT			38.945188 °	38.945958 °
				-121.586096 °	-121.586394 °
DWR ID	DWR_MA0003_01_s_2016_2				
Comment Code					
Inspector Comment					
2013 - Minor toe scour causing gradual erosion into the bank slope. 2015: Last observed in 2013. [2015 Site ID: FHR_12-8_R]
