**Flood Control Project Maintenance
Levee Inspections
LMA District Cover Sheet
Spring 2010 Levee Inspection Results**

Sutter Maintenance Yard Maintenance Area 0003

Levee Inspection Report By Mile - Spring 2010

Waterway	Bank	Unit Miles	Inspection Start/End	Inspector
Unit No. 01 Feather River	Right	5.19	06/08/2010 06/08/2010	Clay Thomas

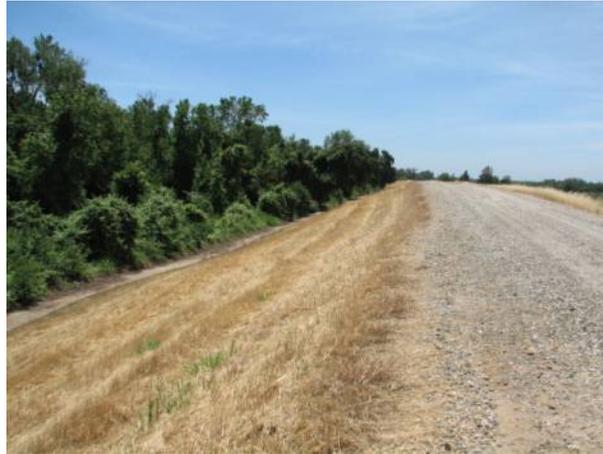
Levee Mile Report Line	1
Start Levee Mile	0.02
End Levee Mile	3.30
Location	Water Side
Category	Earthen Levee
Item	Vegetation
Water side vegetation levee mile 5.19.	
cathom_s_20100610_118.jpg

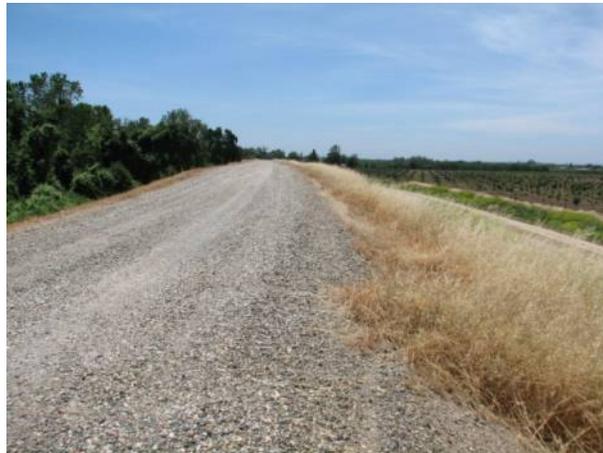
Levee Mile Report Line	2
Start Levee Mile	0.02
End Levee Mile	5.17
Location	Land Side
Category	Earthen Levee
Item	Vegetation
Land side vegetation levee mile 5.19.	
cathom_s_20100610_119.jpg
