**Flood Control Project Maintenance
Levee Inspections**
LMA District Cover Sheet
Spring 2013 Levee Inspection Results

Sutter Maintenance Yard Maintenance Area 0003

Waterway		Bank	Unit Miles
Unit No. 01 Feather River		Right	5.19

Levee Inspection Report By Mile - Spring 2013

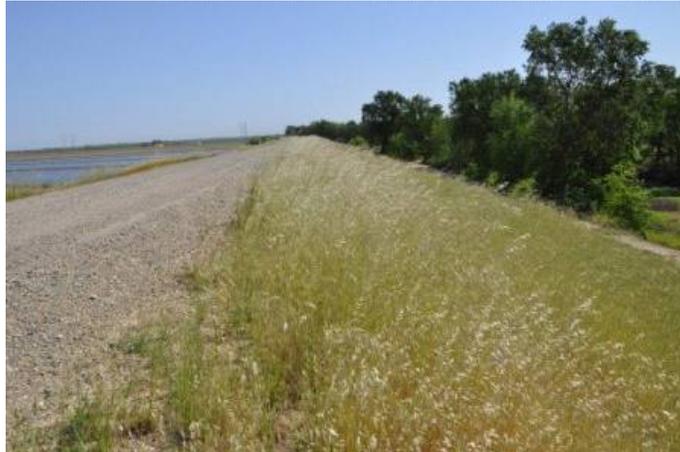
Levee Mile Report Line	4
Start Levee Mile	0.08
End Levee Mile	5.18
Location	Water Side
Category	
Item	Vegetation
Typical W/S seasonal vegetation.	
rburnett_s_20130422_247.JPG

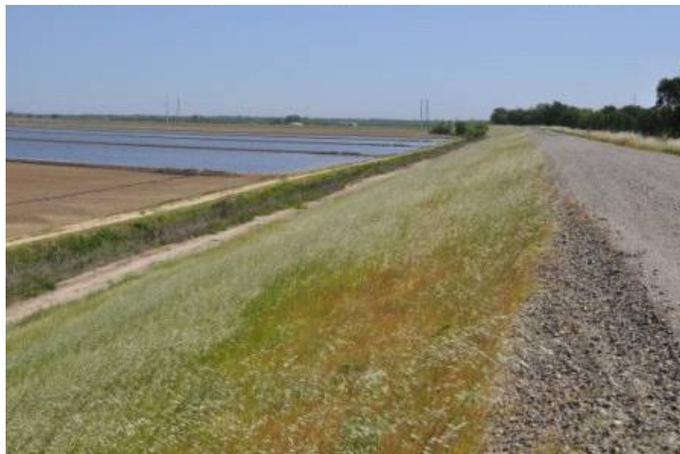
Levee Mile Report Line	5
Start Levee Mile	0.08
End Levee Mile	5.18
Location	Land Side
Category	
Item	Vegetation
Typical L/S seasonal vegetation.	
rburnett_s_20130422_248.JPG

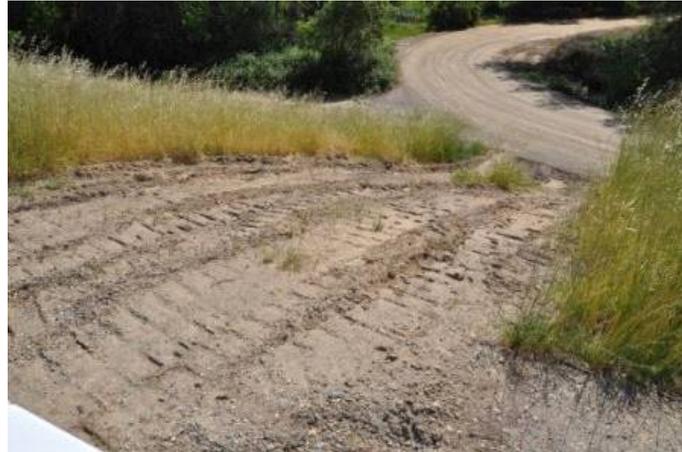
Levee Mile Report Line	7
Start Levee Mile	2.15
End Levee Mile	2.15
Location	Water Side
Category	
Item	Slope Stability
W/S slope damage. Repair prior to flood season.	
rburnett_s_20130422_249.JPG

DWR ID: DWR_MA0003_01_s_2012_5										
7	2.15	2.15		Slope Stability	LS	M Ma	S3 : Repair the levee slope damaged by vehicle traffic and prevent access where possible.	38.911220 ° -121.586530 °	38.911220 ° -121.586530 °	3 Y
DWR ID: DWR_MA0003_01_s_2013_3										
8	2.29	2.42		Slope Stability	WS	M Ob	S1 : Repair slope instability. Inspector Comments: Material movement on the waterside slope. The LMA should investigate the matter further.	38.912960 ° -121.585220 °	38.914582 ° -121.584106 °	119 Y
DWR ID: DWR_MA0003_01_s_2012_119

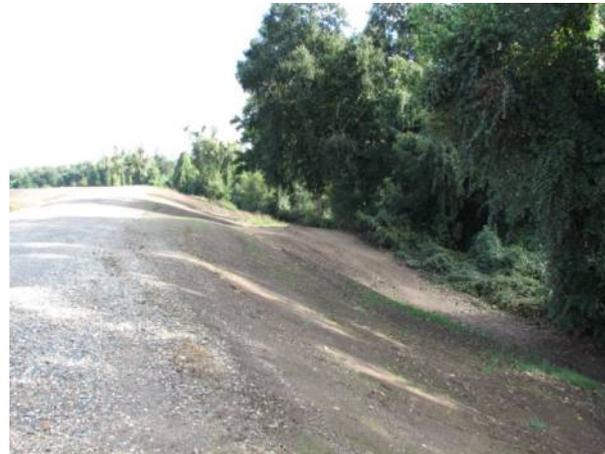
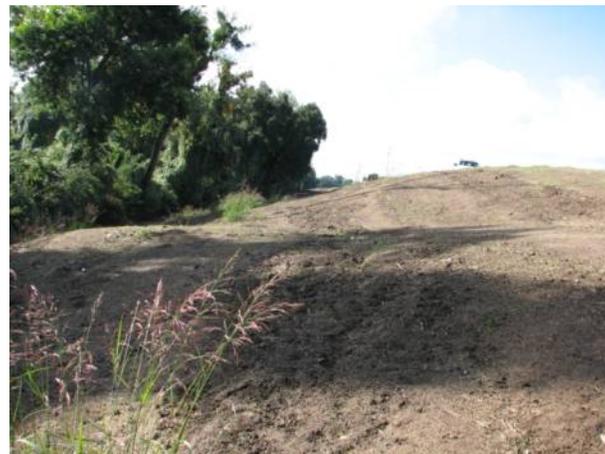
Levee Mile Report Line	8
Start Levee Mile	2.29
End Levee Mile	2.42
Location	Water Side
Category	
Item	Slope Stability
This photo is the waterside slope looking downstream at levee mile 2.29.	
jhirabay_s_20130314_005.jpg

Levee Mile Report Line	8
Start Levee Mile	2.29
End Levee Mile	2.42
Location	Water Side
Category	
Item	Slope Stability
This photo is the waterside slope looking upstream.	
jhirabay_s_20130314_006.jpg
