**Flood Control Project Maintenance
Levee Inspections**

Fall 2012 Levee Maintenance Deficiency Summary Report

Sacramento Maintenance Yard Maintenance Area 0004

Waterway		Bank	Unit Miles
Unit No. 01 Sacramento River		Right	3.40

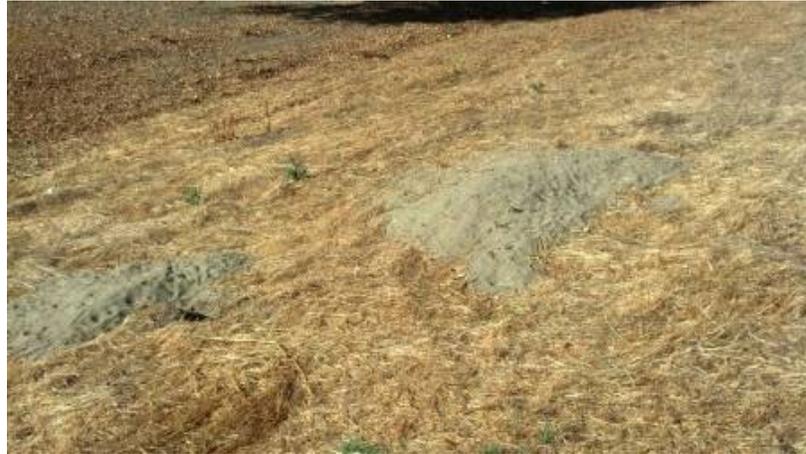
Levee Mile Report Line	5
Start Levee Mile	0.05
End Levee Mile	0.05
Location	Land Side
Category	Earthen Levee
Item	Animal Control

Rodent holes on the landside of the levee slope. Photo fall 2012.

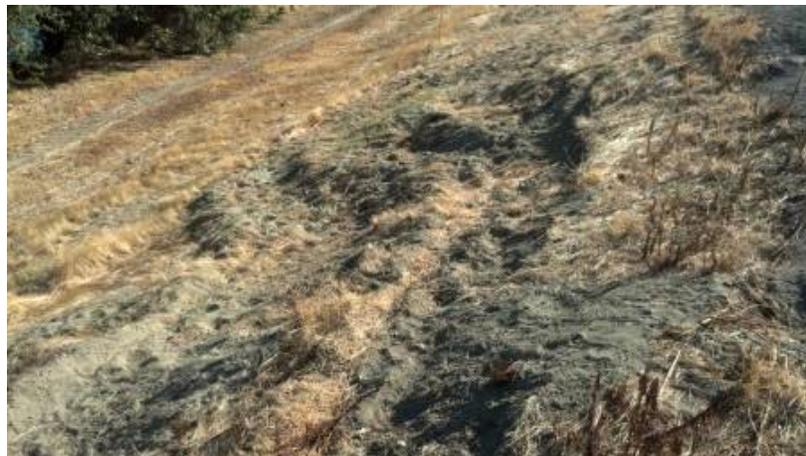
Levee Mile Report Line	6
Start Levee Mile	0.06
End Levee Mile	0.06
Location	Water Side
Category	Earthen Levee
Item	Slope Stability

Slope damage due to equipment on the waterside slope. Photo fall 2012.

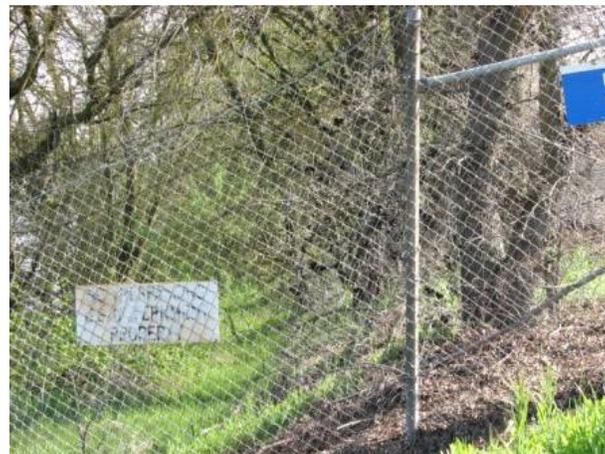
Levee Mile Report Line	7
Start Levee Mile	0.28
End Levee Mile	0.44
Location	Water Side
Category	Earthen Levee
Item	Trim / Thin Trees

The trees need to be trimmed up and thinned to meet standards.

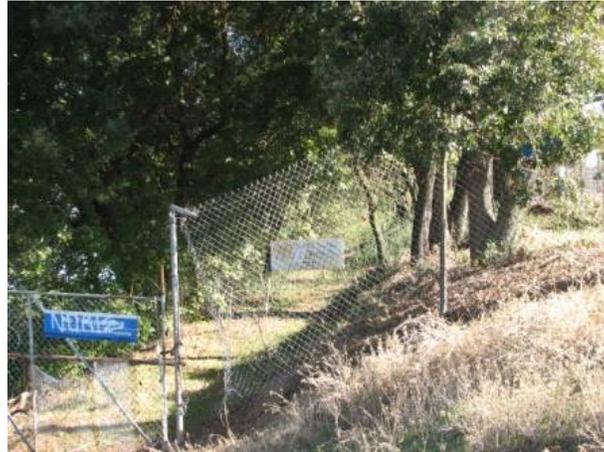
Levee Mile Report Line	7
Start Levee Mile	0.28
End Levee Mile	0.44
Location	Water Side
Category	Earthen Levee
Item	Trim / Thin Trees
<p>The trees have been raised but vegetation needs to be trimmed. Fall 2011</p>	
<p>johngw_f_20120911_015.jpg</p>

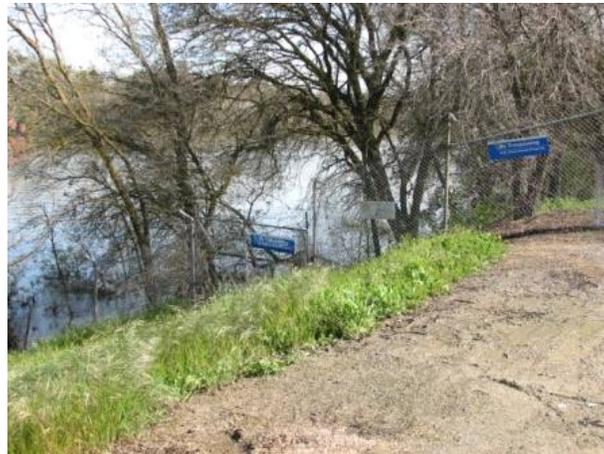
Levee Mile Report Line	8
Start Levee Mile	0.28
End Levee Mile	0.28
Location	Crown
Category	Earthen Levee
Item	Encroachments
<p>The fence goes down the waterside with no removal sections.</p>	
<p>johngw_f_20120911_001.jpg</p>

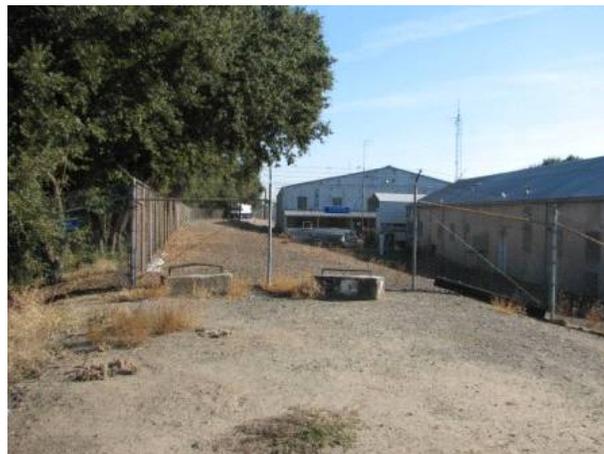
Levee Mile Report Line	8
Start Levee Mile	0.28
End Levee Mile	0.28
Location	Crown
Category	Earthen Levee
Item	Encroachments
<p>The fence crosses the levee crown with no gate for access. The buildings are the USACE yard. Fall 2011</p>	
<p>johngw_f_20120911_002.jpg</p>

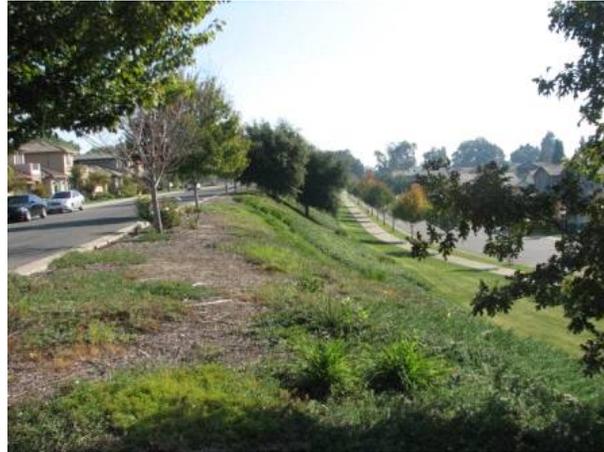
Levee Mile Report Line	9
Start Levee Mile	1.32
End Levee Mile	1.95
Location	Land Side
Category	Earthen Levee
Item	Vegetation
Landscaping on the landside slope outside of the Rivers development. Fall 2011	
johngw_f_20120911_005.jpg

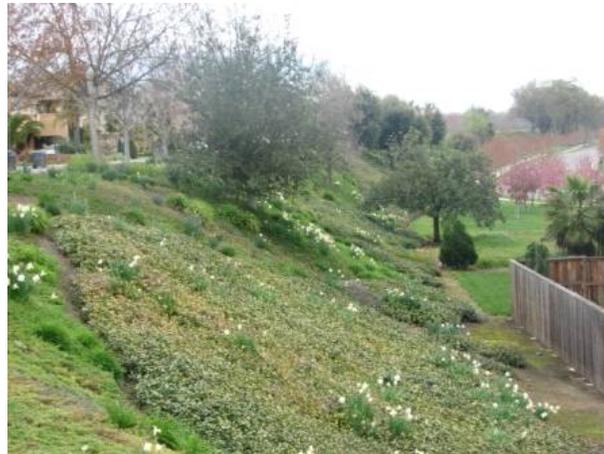
Levee Mile Report Line	9
Start Levee Mile	1.32
End Levee Mile	1.95
Location	Land Side
Category	Earthen Levee
Item	Vegetation
Photo taken spring 2012, permitted landscape in the Rivers project.	
johngw_f_20120911_006.jpg

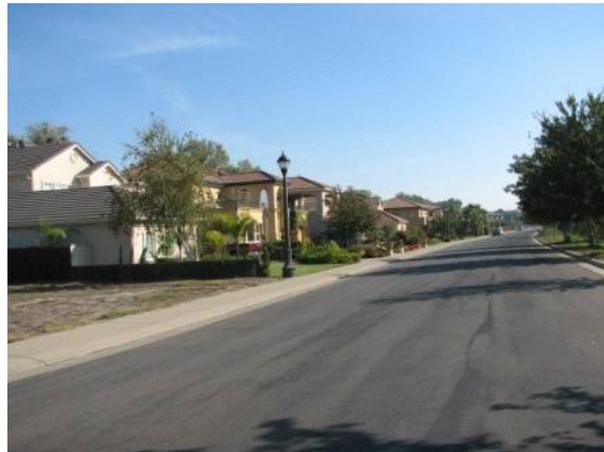
Levee Mile Report Line	10
Start Levee Mile	1.33
End Levee Mile	1.49
Location	Crown
Category	Earthen Levee
Item	Encroachments
Houses on the crown of the levee Fall 2011	
johngw_f_20120911_007.jpg

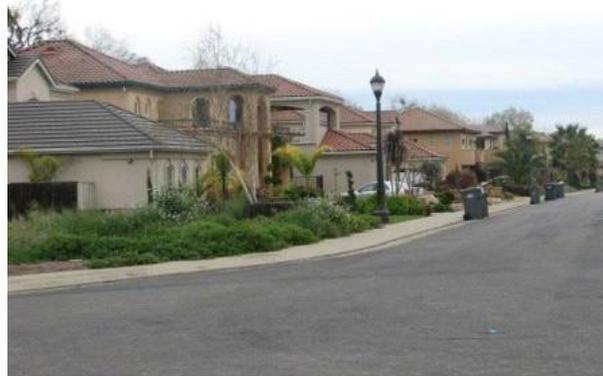
Levee Mile Report Line	10
Start Levee Mile	1.33
End Levee Mile	1.49
Location	Crown
Category	Earthen Levee
Item	Encroachments
Photo taken spring 2012, permitted houses built on the waterside of the crown.	
johngw_f_20120911_008.jpg

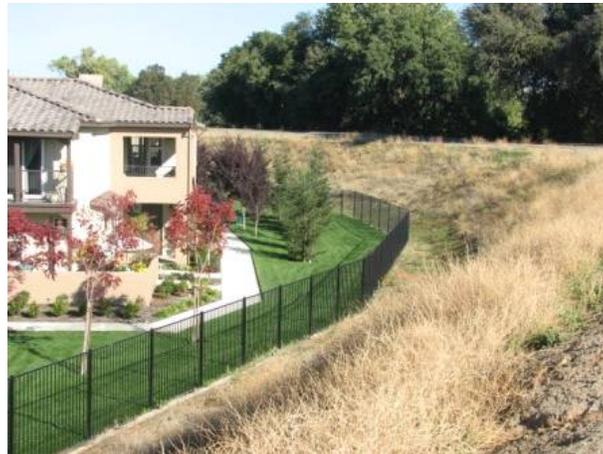
Levee Mile Report Line	11
Start Levee Mile	2.00
End Levee Mile	2.17
Location	Land Side
Category	Earthen Levee
Item	Encroachments
Fence and landscaping along the levee toe by the condos in the Rivers.	
johngw_f_20120911_012.jpg

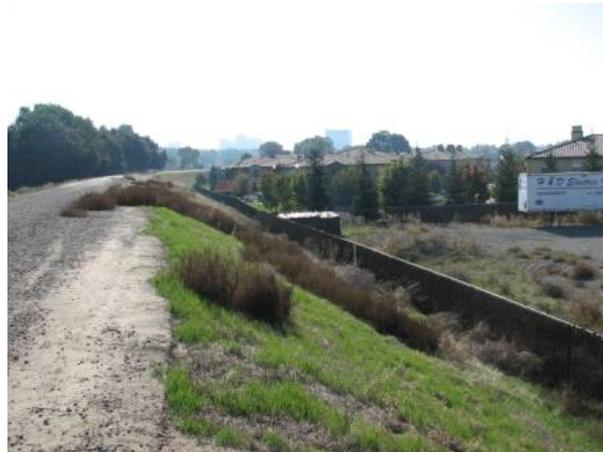
Levee Mile Report Line	11
Start Levee Mile	2.00
End Levee Mile	2.17
Location	Land Side
Category	Earthen Levee
Item	Encroachments
The fence runs along the toe of the levee. Fall 2011	
johngw_f_20120911_013.jpg

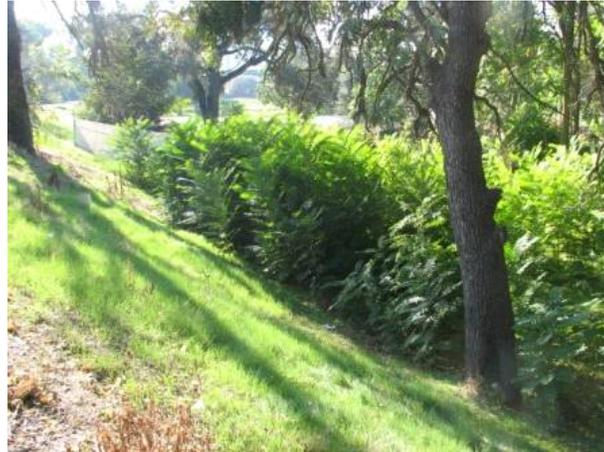
Levee Mile Report Line	12
Start Levee Mile	2.87
End Levee Mile	2.87
Location	Land Side
Category	Earthen Levee
Item	Vegetation
<p>The vegetation on the landside toe blocks visibility. Fall 2011</p>	
<p>johngw_f_20120911_018.jpg</p>

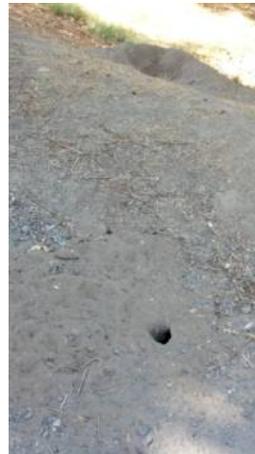
Levee Mile Report Line	13
Start Levee Mile	3.00
End Levee Mile	3.00
Location	Land Side
Category	Earthen Levee
Item	Animal Control
<p>Rodent holes one in the crown and the other on the slope. Photo fall 2012.</p>	
<p>johngw_f_20121022_810.jpg</p>

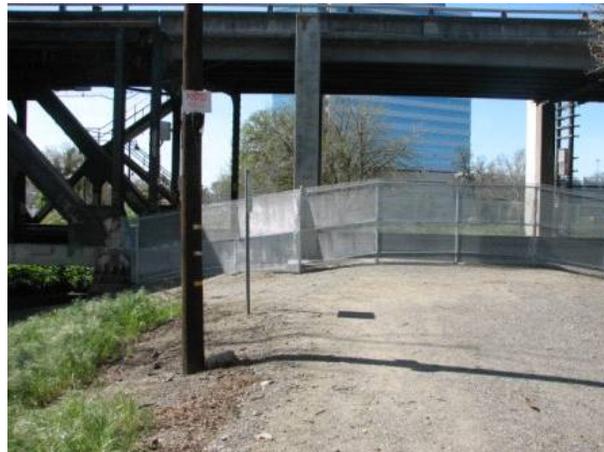
Levee Mile Report Line	14
Start Levee Mile	3.02
End Levee Mile	3.02
Location	Crown
Category	Earthen Levee
Item	Encroachments
<p>The fence is across the levee crown on both side of the railroad tracks.</p>	
<p>johngw_f_20120911_003.jpg</p>

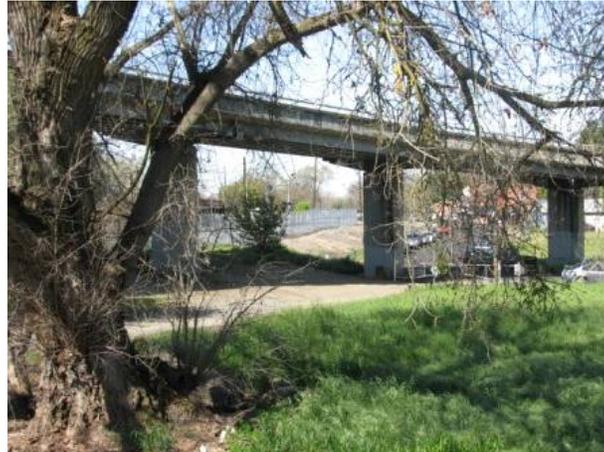
Levee Mile Report Line	14
Start Levee Mile	3.02
End Levee Mile	3.02
Location	Crown
Category	Earthen Levee
Item	Encroachments

The fence on both side of the tracks goes to Third Street.

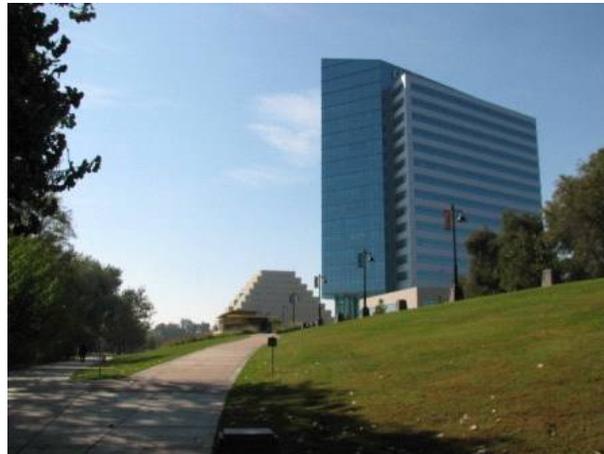
Levee Mile Report Line	15
Start Levee Mile	3.07
End Levee Mile	3.30
Location	Land Side
Category	Earthen Levee
Item	Encroachments

CalSTRS and Ziegot building. Fall 2011

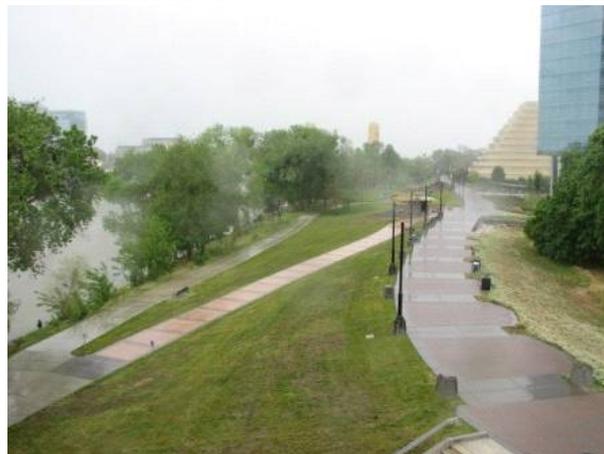
Levee Mile Report Line	16
Start Levee Mile	3.07
End Levee Mile	3.40
Location	Water Side
Category	Earthen Levee
Item	Vegetation

Landscaping on the waterside of the levee

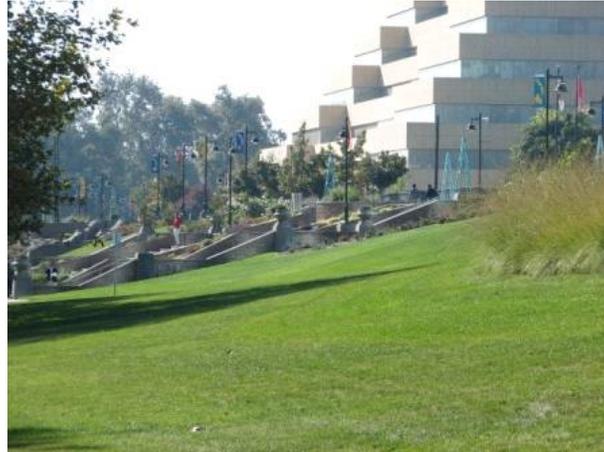
Levee Mile Report Line	16
Start Levee Mile	3.07
End Levee Mile	3.40
Location	Water Side
Category	Earthen Levee
Item	Vegetation

Steps and landscaping on the crown and waterside of the levee. Fall 2011
