**Flood Control Project Maintenance
Levee Inspections**

Fall 2010 Levee Maintenance Deficiency Summary Report

Sacramento River Basin

Sacramento Maintenance Yard Maintenance Area 0004

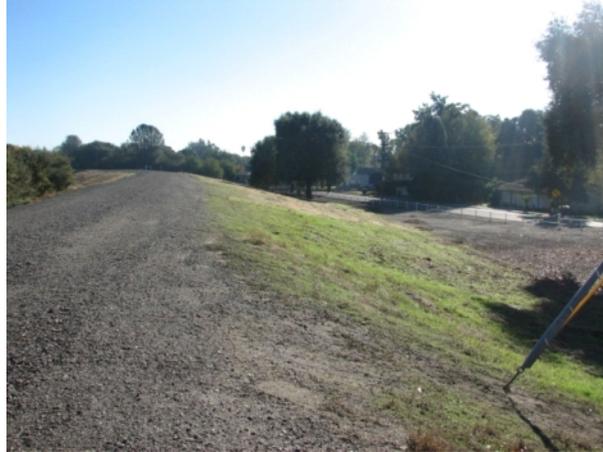
Levee Mile Report Line	1
Start Levee Mile	0.03
End Levee Mile	0.03
Location	Land Side
Category	Earthen Levee
Item	Vegetation
Landside view of the levee slope at 0.0 LM	
johngw_f_20101108_294.jpg

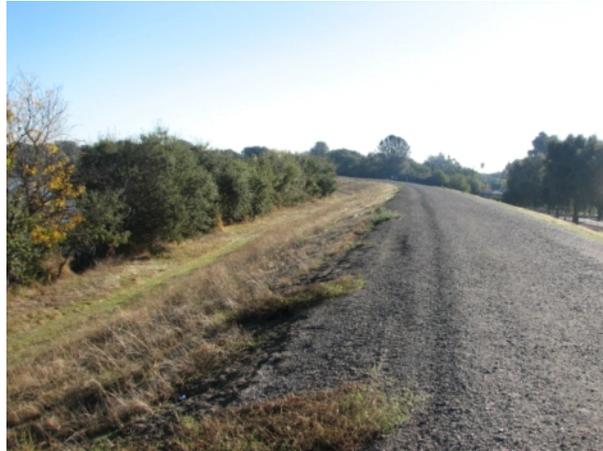
Levee Mile Report Line	1
Start Levee Mile	0.03
End Levee Mile	0.03
Location	Land Side
Category	Earthen Levee
Item	Vegetation
Waterside slope view at 0.0 LM	
johngw_f_20101108_295.jpg

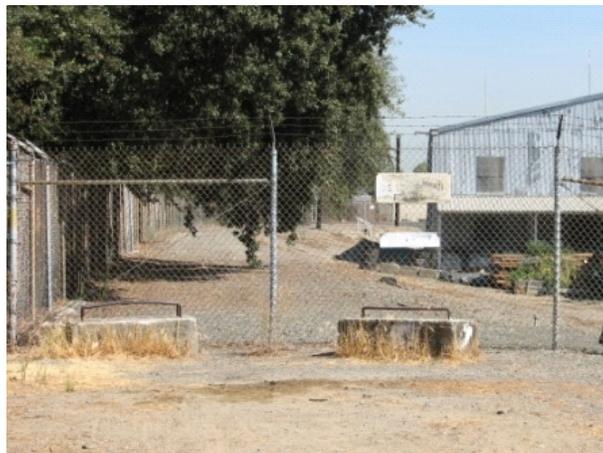
Levee Mile Report Line	2
Start Levee Mile	0.26
End Levee Mile	0.71
Location	Crown
Category	Earthen Levee
Item	Encroachments
COE fence blocks the levee crown.	
johngw_f_20101119_300.jpg

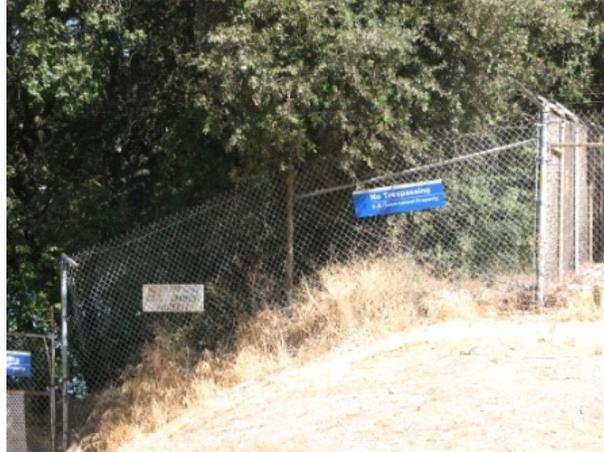
Levee Mile Report Line	2
Start Levee Mile	0.26
End Levee Mile	0.71
Location	Crown
Category	Earthen Levee
Item	Encroachments
COE fence goes down th waterside slope.	
johngw_f_20101119_301.jpg

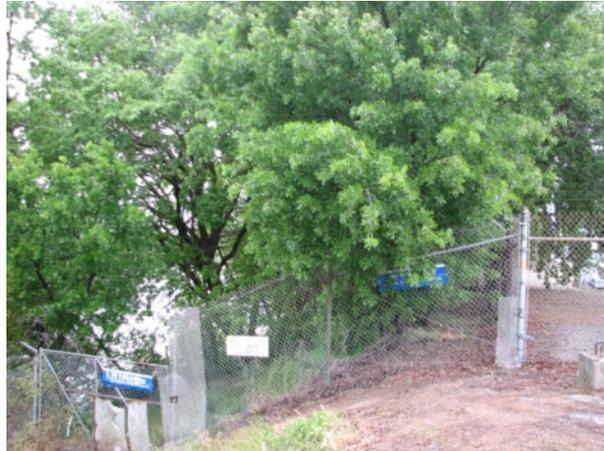
Levee Mile Report Line	3
Start Levee Mile	0.28
End Levee Mile	0.44
Location	Water Side
Category	Earthen Levee
Item	Trim / Thin Trees
Trees need to be raised	
johngw_f_20101012_008.jpg

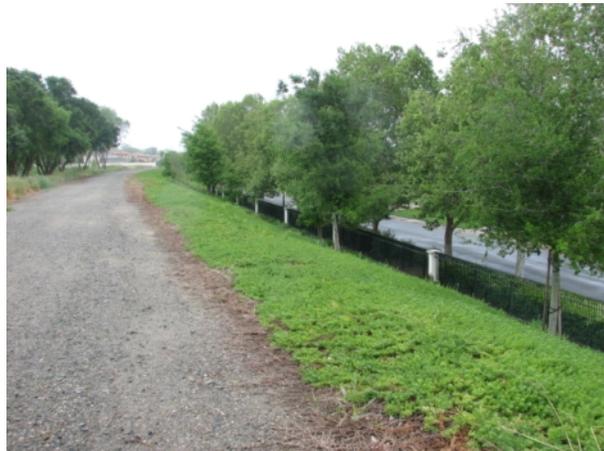
Levee Mile Report Line	5
Start Levee Mile	1.12
End Levee Mile	1.95
Location	Land Side
Category	Earthen Levee
Item	Encroachments
Landscape on landside of levee	
johngw_f_20101012_003.jpg

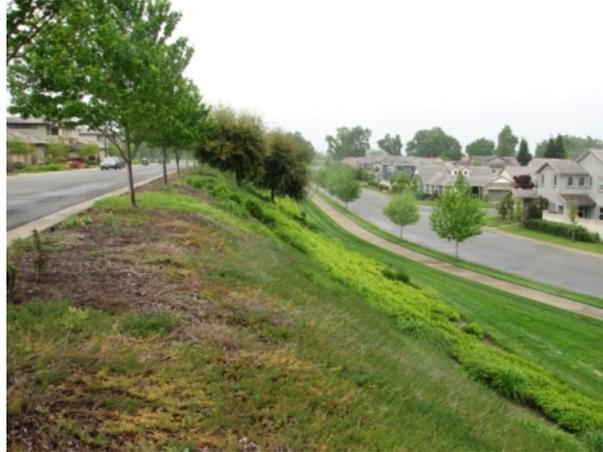
Levee Mile Report Line	5
Start Levee Mile	1.12
End Levee Mile	1.95
Location	Land Side
Category	Earthen Levee
Item	Encroachments
Landscape	
johngw_f_20101012_004.jpg

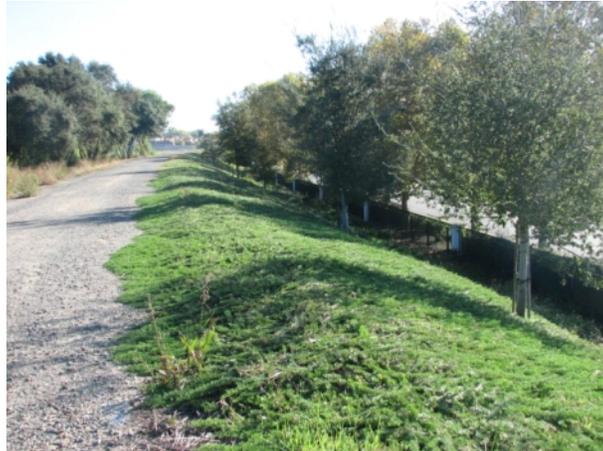
Levee Mile Report Line	5
Start Levee Mile	1.12
End Levee Mile	1.95
Location	Land Side
Category	Earthen Levee
Item	Encroachments
Landscaping on the landside slope outside of the Rivers development.	
johngw_f_20101108_296.jpg

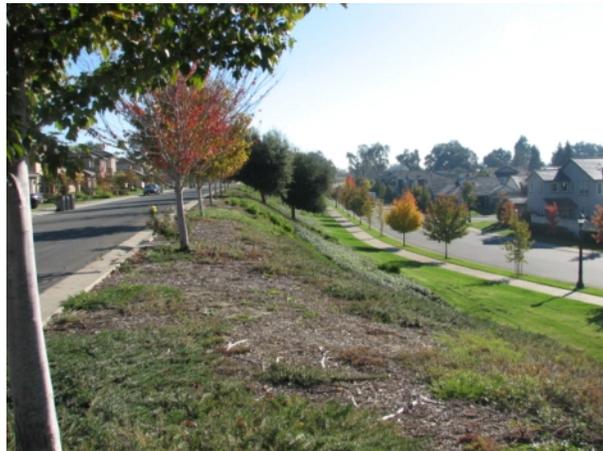
Levee Mile Report Line	5
Start Levee Mile	1.12
End Levee Mile	1.95
Location	Land Side
Category	Earthen Levee
Item	Encroachments
Landscaping inside of the Rivers landside levee slopr in front of the homes.	
johngw_f_20101108_297.jpg

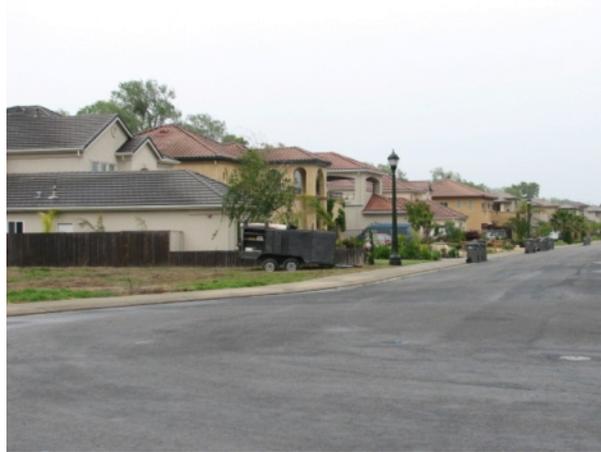
Levee Mile Report Line	6
Start Levee Mile	1.33
End Levee Mile	1.49
Location	Crown
Category	Earthen Levee
Item	Encroachments
Houses on the crown of the levee	
johngw_f_20101012_005.jpg

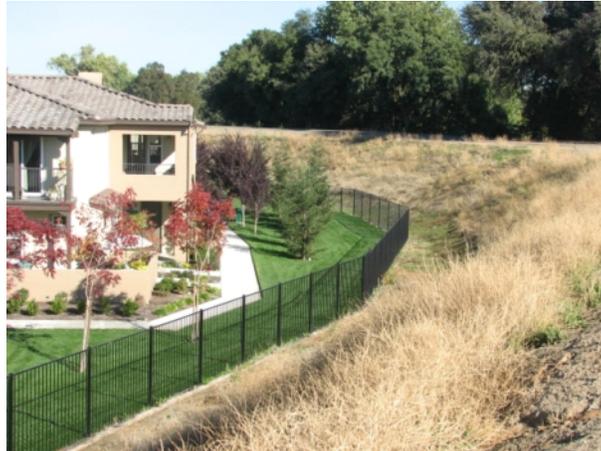
Levee Mile Report Line	7
Start Levee Mile	2.00
End Levee Mile	2.17
Location	Land Side
Category	Earthen Levee
Item	Encroachments
Fence and landscaping along the levee toe by the condos in the Rivers.	
johngw_f_20101108_298.jpg

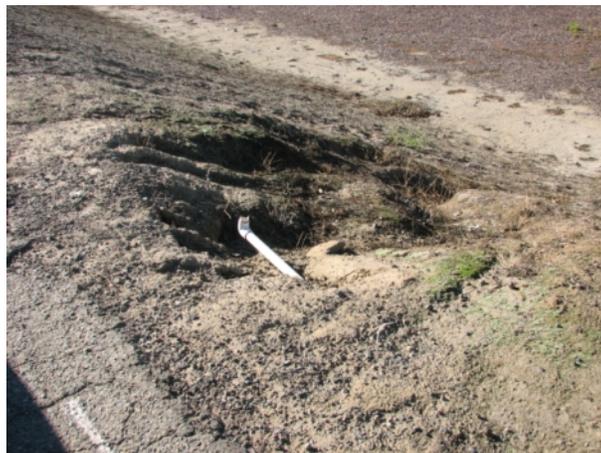
Levee Mile Report Line	8
Start Levee Mile	2.36
End Levee Mile	2.36
Location	Land Side
Category	Earthen Levee
Item	Erosion / Bank Caving
Broken irrigation pipe along the shoulder of the levee. The break in the irrigation has started to erode the slope.	
johngw_f_20101108_299.jpg

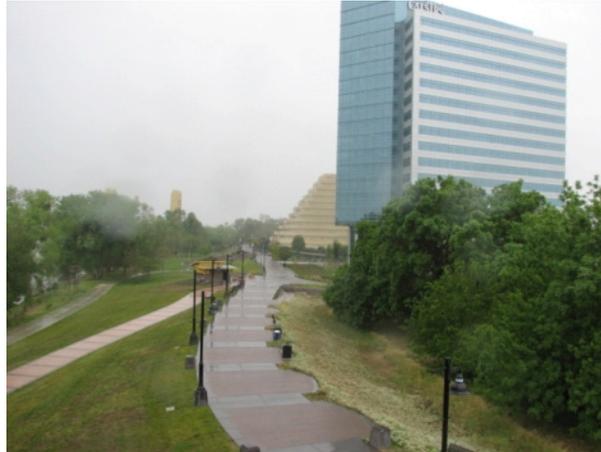
Levee Mile Report Line	10
Start Levee Mile	3.07
End Levee Mile	3.30
Location	Land Side
Category	Earthen Levee
Item	Encroachments
Calster and Ziegot building	
johngw_f_20101012_007.jpg

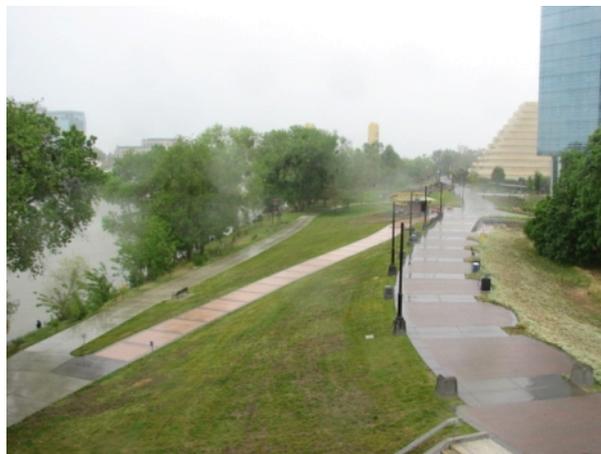
Levee Mile Report Line	11
Start Levee Mile	3.07
End Levee Mile	3.40
Location	Water Side
Category	Earthen Levee
Item	Encroachments
Landscaping on the waterside of the levee	
johngw_f_20101012_006.jpg
