**Flood Control Project Maintenance  
Levee Inspections**

**Fall 2014 Levee Maintenance Deficiency Summary Report**

**Sacramento Maintenance Yard Maintenance Area 0004**

**Levee Inspection Report By Mile - Fall 2014**

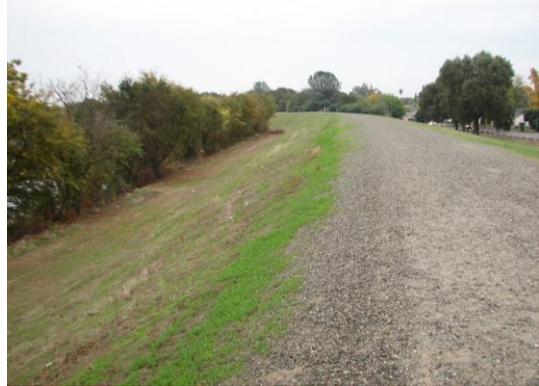
Photo 1 of 2 : FA\_2014\_MA0004\_298\_1\_20141120\_00014.jpg

Levee mile 0.00, vegetation controlled on the water side levee slope. Fall 2014.

LM Start	<b>0.00</b>	Rating **	A/W	Issue No.	<b>1</b>
LM End	<b>3.40</b>	Issue Type +	Ma	Location *	LS
Category	Earthen Levee		GPS Latitude/Longitude		
			Start	End	
Item	Vegetation		°	°	
			°	°	
DWR ID	DWR_MA0004_01_f_2014_1				
Action/Comments					
Control annual grass and weeds on the levee slopes and easements.

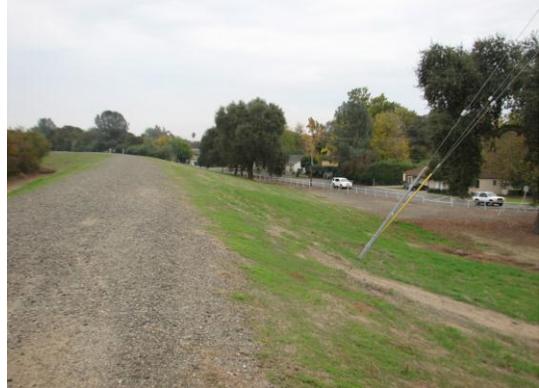
Photo 2 of 2 : FA\_2014\_MA0004\_298\_1\_20141120\_00015.jpg

Levee mile 0.00, vegetation controlled on the land side levee slope. Fall 2014.

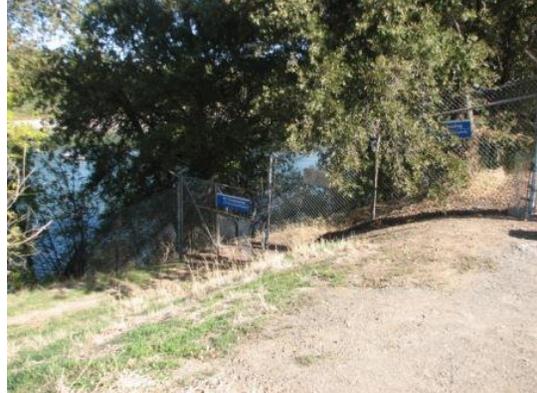
Photo 1 of 2 : FA\_2014\_MA0004\_298\_2\_20141014\_00001.jpg

LM Start	<b>0.28</b>	Rating **	U	Issue No.	<b>2</b>
LM End	<b>0.28</b>	Issue Type +	En	Location *	CR
Category	Earthen Levee			GPS Latitude/Longitude	
				Start	End
Item	Encroachments			38.597193 °	38.597193 °
				-121.543421 °	-121.543421 °
DWR ID	DWR_MA0004_01_s_2012_2				
Action/Comments					
Fence Inspector Comments: This is the USACE yard and the chain link fence crosses the levee. The fence runs the length of the yard on the crown.

The fence blocks access to the waterside levee slope. Fall 2013

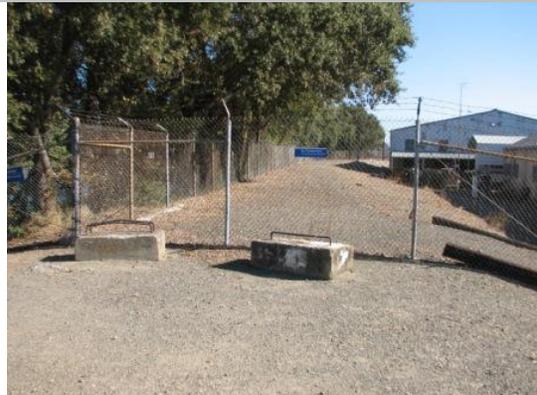
Photo 2 of 2 : FA\_2014\_MA0004\_298\_2\_20141014\_00002.jpg

The fence blocks the crown of the levee. Fall 2013

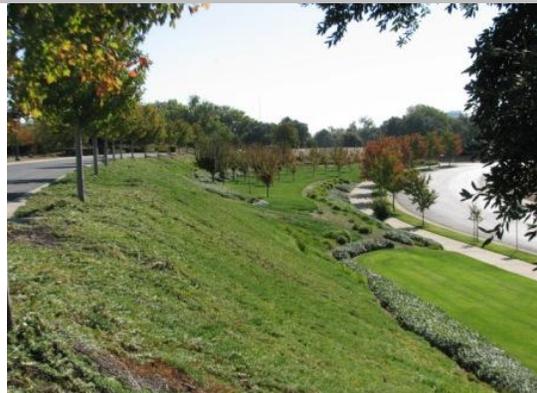
Photo 1 of 2 : FA\_2014\_MA0004\_298\_7\_20141014\_00004.jpg

LM Start	<b>1.32</b>	Rating **	A/W	Issue No.	<b>7</b>
LM End	<b>1.95</b>	Issue Type +	Ma	Location *	LS
Category	Earthen Levee			GPS Latitude/Longitude	
				Start	End
Item	Vegetation			38.602756 °	38.600449 °
				-121.525618 °	-121.514459 °
DWR ID	DWR_MA0004_01_s_2012_7				
Action/Comments					
Landscaping Inspector Comments: The Rivers housing development

The landside levee slope is landscaped. Fall 2013

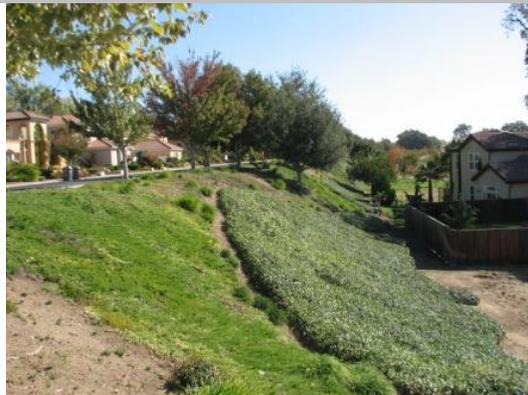
Photo 2 of 2 : FA\_2014\_MA0004\_298\_7\_20141014\_00005.jpg

LM Start	<b>1.32</b>	Rating **	A/W	Issue No.	<b>7 (cont)</b>
LM End	<b>1.95</b>	Issue Type +	Ma	Location *	LS
Category	Earthen Levee		GPS Latitude/Longitude		
			Start	End	
Item	Vegetation		38.602756 °	38.600449 °	
			-121.525618 °	-121.514459 °	
DWR ID	DWR_MA0004_01_s_2012_7				
Action/Comments					
Landscaping Inspector Comments: The Rivers housing development

The landside of the levee slope is landscaped. Fall 2013

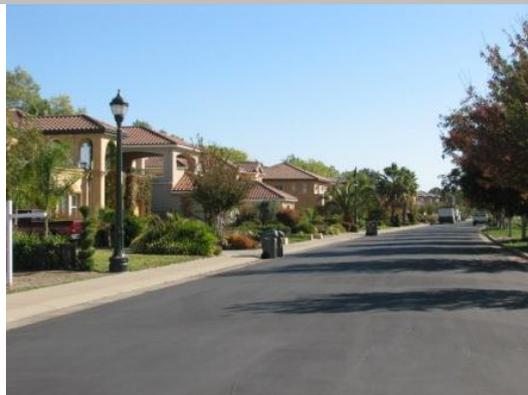
Photo 1 of 1 : FA\_2014\_MA0004\_298\_8\_20141014\_00006.jpg

LM Start	<b>1.33</b>	Rating **	A/W	Issue No.	<b>8</b>
LM End	<b>1.49</b>	Issue Type +	Ma	Location *	CR
Category	Earthen Levee		GPS Latitude/Longitude		
			Start	End	
Item	Encroachments		38.602764 °	38.602596 °	
			-121.525319 °	-121.522439 °	
DWR ID	DWR_MA0004_01_s_2012_8				
Action/Comments					
Building Inspector Comments: The Rivers housing development houses on crown of levee waterside

Houses have been built on the crown of the levee. Fall 2013

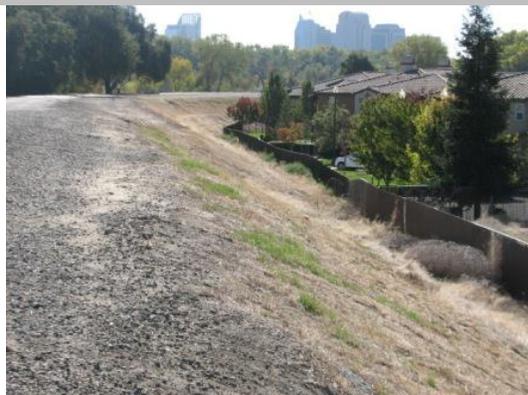
Photo 1 of 1 : FA\_2014\_MA0004\_298\_14\_20141014\_00009.jpg

LM Start	<b>2.00</b>	Rating **	M	Issue No.	<b>14</b>
LM End	<b>2.17</b>	Issue Type +	En	Location *	LS
Category	Earthen Levee		GPS Latitude/Longitude		
			Start	End	
Item	Encroachments		38.599834 °	38.597531 °	
			-121.513994 °	-121.513147 °	
DWR ID	DWR_MA0004_01_s_2012_14				
Action/Comments					
Fence Inspector Comments: A fence runs along the toe of the landside levee

The fence runs along the toe and is within the easement. Fall 2013

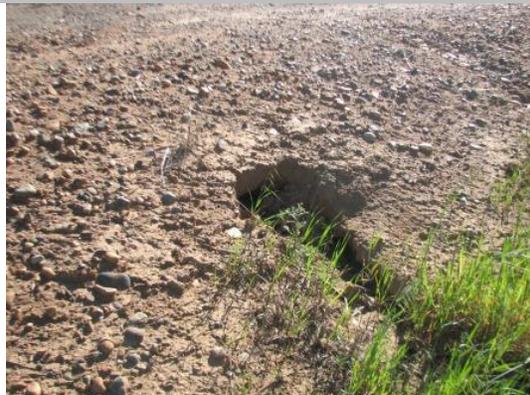
Photo 1 of 2 : FA\_2014\_MA0004\_298\_19\_20141014\_00012.jpg

LM Start	<b>2.06</b>	Rating **	U	Issue No.	<b>19</b>
LM End	<b>2.06</b>	Issue Type +	Ma	Location *	LS
Category	Earthen Levee		GPS Latitude/Longitude		
			Start	End	
Item	Erosion / Bank Caving		38.599133 °	38.599133 °	
			-121.513384 °	-121.513384 °	
DWR ID	DWR_MA0004_01_s_2014_19				
Action/Comments					
Schedule repair of erosion site prior to the next inspection. Inspector Comments: Looks like it may be a old squirrel hole. Burrow goes thru the shoulder and breaks out on levee slope.

The exit side of the erosion from shoulder. Spring 2014

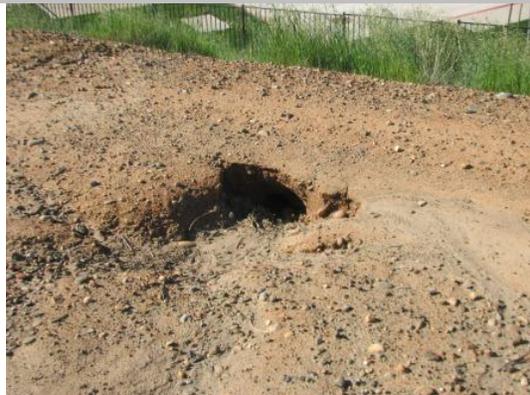
Photo 2 of 2 : FA\_2014\_MA0004\_298\_19\_20141014\_00013.jpg

Erosion on levee shoulder entrance side on crown. Spring 2014

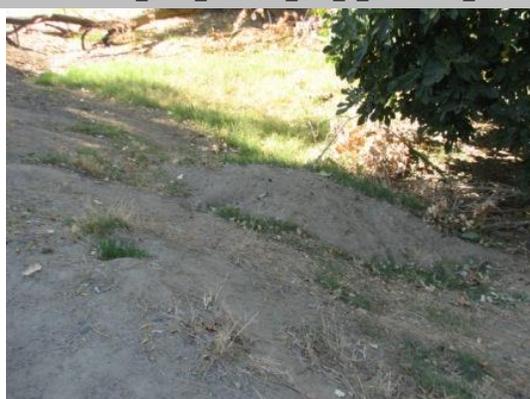
Photo 1 of 1 : FA\_2014\_MA0004\_298\_3\_20141014\_00003.jpg

A large rodent hole on the landside levee slope. Fall 2013

LM Start	<b>3.00</b>	Rating **	M	Issue No.	<b>3</b>
LM End	<b>3.00</b>	Issue Type +	Ma	Location *	LS
Category	Earthen Levee		GPS Latitude/Longitude		
			Start	End	
Item	Animal Control		38.587135 °	38.587135 °	
			-121.508093 °	-121.508093 °	
DWR ID	DWR_MA0004_01_f_2012_3				
Action/Comments					
Exterminate rodents and backfill and compact or grout burrows.

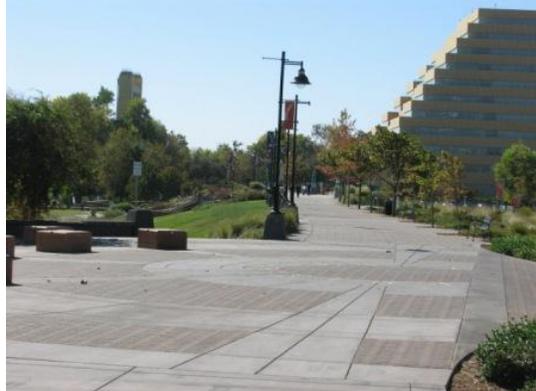
Photo 1 of 2 : FA\_2014\_MA0004\_298\_12\_20141014\_00007.jpg

LM Start	<b>3.07</b>	Rating **	A/W	Issue No.	<b>12</b>
LM End	<b>3.40</b>	Issue Type +	En	Location *	WS
Category	Earthen Levee		GPS Latitude/Longitude		
			Start	End	
Item	Vegetation		38.585642 °	38.534710 °	
			-121.508385 °	-121.517390 °	
DWR ID	DWR_MA0004_01_s_2012_12				
Action/Comments					
Landscaping Inspector Comments: West Sacramento's River walk runs from Tower Bridge to the I Street bridge.

The Riverwalk is part of the landscape on the levee. Fall 2013

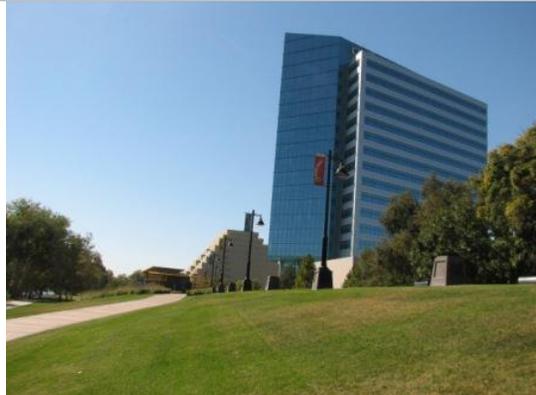
Photo 2 of 2 : FA\_2014\_MA0004\_298\_12\_20141014\_00008.jpg

Landscaping and buildings are on the crown and waterside levee. Fall 2013
