**Flood Control Project Maintenance
Levee Inspections**
LMA District Cover Sheet
Spring 2009 Levee Inspection Results

**Flood Control Project Maintenance
Levee Inspections
Unit Cover Sheet
Spring 2009 Levee Inspection Results
Maintenance Area 0004**

Levee Inspection Report By Mile - Spring 2009

Waterway	Bank	Unit Miles	Inspection Start/End	Inspector
Unit No. 01 Sacramento River	Right	3.40	05/05/2009 05/05/2009	John Williamson

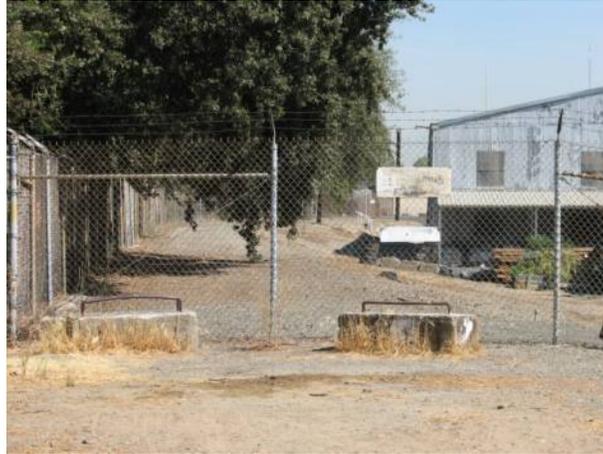
Levee Mile Report Line	2
Start Levee Mile	0.26
End Levee Mile	0.71
Location	Crown
Category	Earthen Levee
Item	Encroachments
Corp. of Engineers fence across levee blocking levee crown

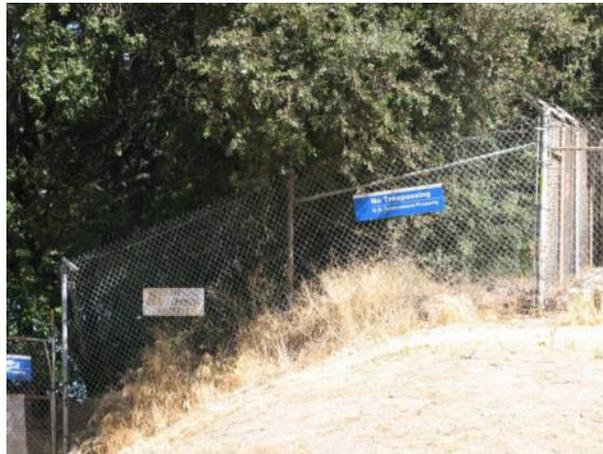
Levee Mile Report Line	2
Start Levee Mile	0.26
End Levee Mile	0.71
Location	Crown
Category	Earthen Levee
Item	Encroachments
Corp of Engineers fence down waterside slope small walk thru gate at toe un able to inspect
