**Flood Control Project Maintenance
Levee Inspections
LMA District Cover Sheet
Spring 2010 Levee Inspection Results**

Sacramento Maintenance Yard Maintenance Area 0004

Waterway			Bank	Unit Miles
Unit No. 01 Sacramento River			Right	3.40
	Spring (March - May)	Summer (June - August)	(September - November) Fall	Winter (December - February)
Unit Maintenance Rating (Fall Only)				
Date of Inspection	4/27/2010 - 4/27/2010			
DWR Inspector	John Williamson			
Accompanied By

Levee Inspection Report By Mile - Spring 2010

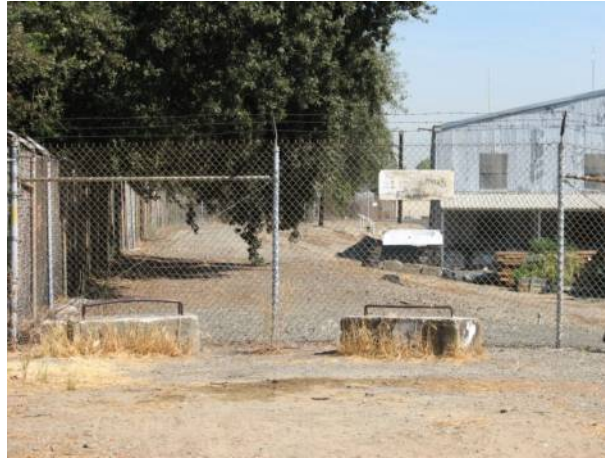
Levee Mile Report Line	3
Start Levee Mile	0.26
End Levee Mile	0.71
Location	Crown
Category	Earthen Levee
Item	Encroachments

Corp. of Engineers fence across levee blocking levee crown

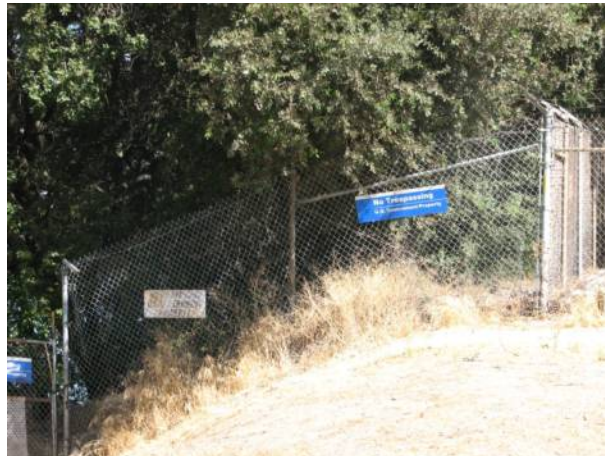
Levee Mile Report Line	3
Start Levee Mile	0.26
End Levee Mile	0.71
Location	Crown
Category	Earthen Levee
Item	Encroachments

Corp of Engineers fence down waterside slope small walk thru gate at toe un able to inspect

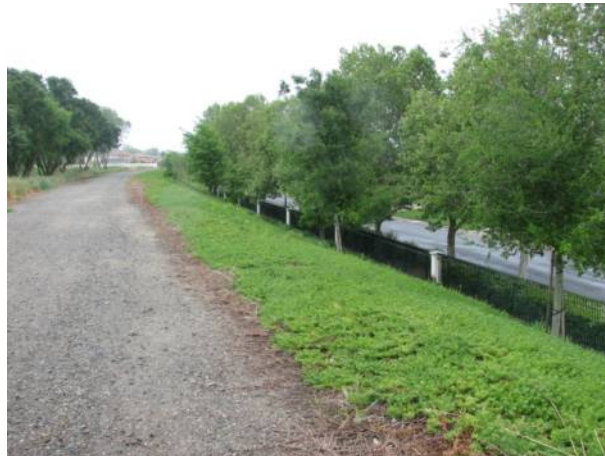
Levee Mile Report Line	8
Start Levee Mile	1.12
End Levee Mile	1.95
Location	Land Side
Category	Earthen Levee
Item	Encroachments

Landscape on landside of levee

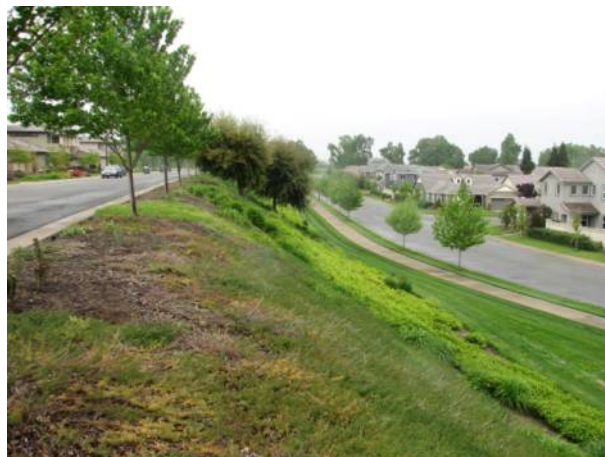
Levee Mile Report Line	8
Start Levee Mile	1.12
End Levee Mile	1.95
Location	Land Side
Category	Earthen Levee
Item	Encroachments

Landscape

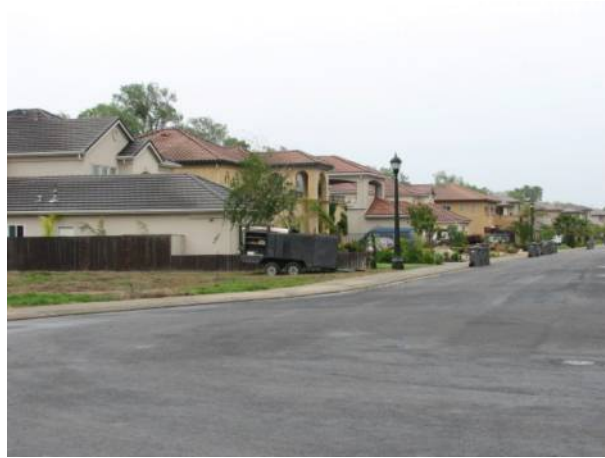
Levee Mile Report Line	9
Start Levee Mile	1.33
End Levee Mile	1.48
Location	Crown
Category	Earthen Levee
Item	Encroachments

Houses on the crown of the levee

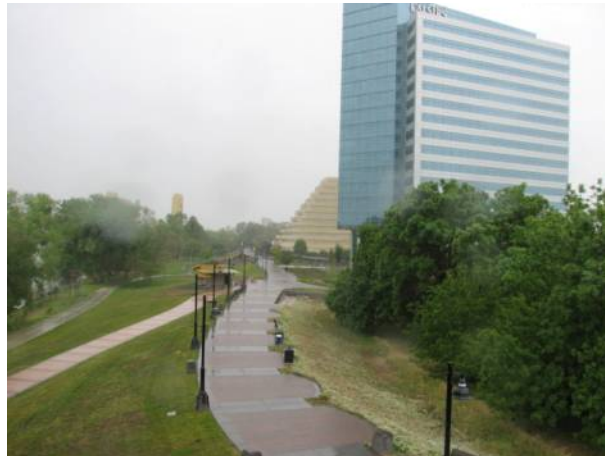
Levee Mile Report Line	16
Start Levee Mile	3.07
End Levee Mile	3.30
Location	Land Side
Category	Earthen Levee
Item	Encroachments

Calster and Ziegot building

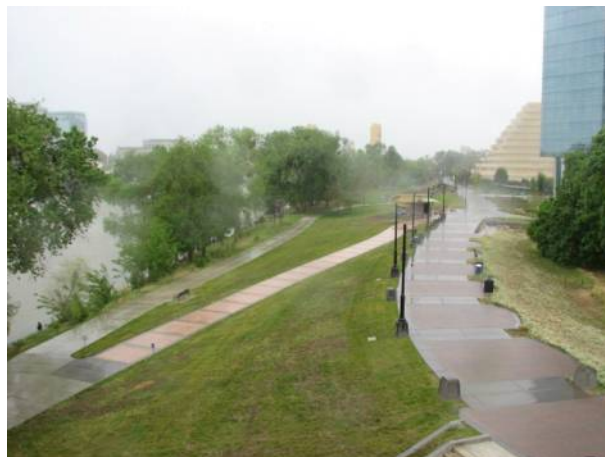
Levee Mile Report Line	17
Start Levee Mile	3.07
End Levee Mile	3.40
Location	Water Side
Category	Earthen Levee
Item	Encroachments

Landscaping on the waterside of the levee
