**Flood Control Project Maintenance
Levee Inspections****LMA District Cover Sheet****Spring 2011 Levee Inspection Results****Sacramento Maintenance Yard Maintenance Area 0004**

Levee Inspection Report By Mile - Spring 2011

Waterway						Bank	Unit Miles	Inspection Start/End	Inspector	
Unit No. 01 Sacramento River						Right	3.40	03/29/2011 03/29/2011	John Williamson	
LMR No.	Levee Mile		Category	Item	Location	Rating	Action/Comment	GPS Latitude/Longitude		Issue No. Photo
	Start	End						Start	End	
1	0.28	0.44	Earthen Levee	Trim / Thin Trees	WS	M	Trim and thin trees to allow visibility of the ground and room to flood fight. Inspector Comments: chain link fence runs along the waterside shoulder of levee and no access to trim and thin trees or vegetation. This is the fence for the COE Brythe Yard and runs the entire yard.	38.597188 ° -121.543401 °	38.598649 ° -121.540960 °	15 Y
2	0.28	0.28	Earthen Levee	Encroachments	CR	CO	Fences Inspector Comments: This is the USACE yard and the chain link fence crosses the levee. The fence runs the length of the yard on the crown.	38.597193 ° -121.543421 °	38.597193 ° -121.543421 °	2 Y

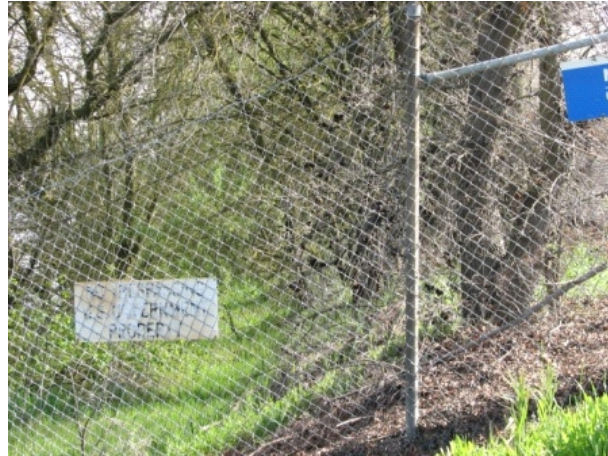
johngw_s_20110329_403.jpg

Levee Mile Report Line	1
Start Levee Mile	0.28
End Levee Mile	0.44
Location	Water Side
Category	Earthen Levee
Item	Trim / Thin Trees

The trees need to be trimmed up and thinned to be standards.

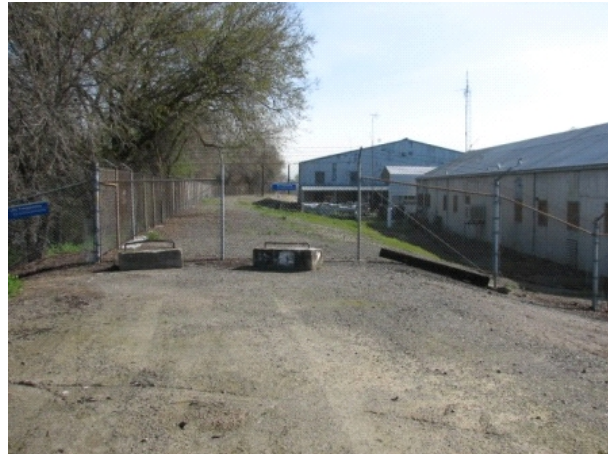
johngw_s_20110329_404.jpg

Levee Mile Report Line	2
Start Levee Mile	0.28
End Levee Mile	0.28
Location	Crown
Category	Earthen Levee
Item	Encroachments

The fence crosses the levee crown with no gate for access. The buildings are the USACE yard.

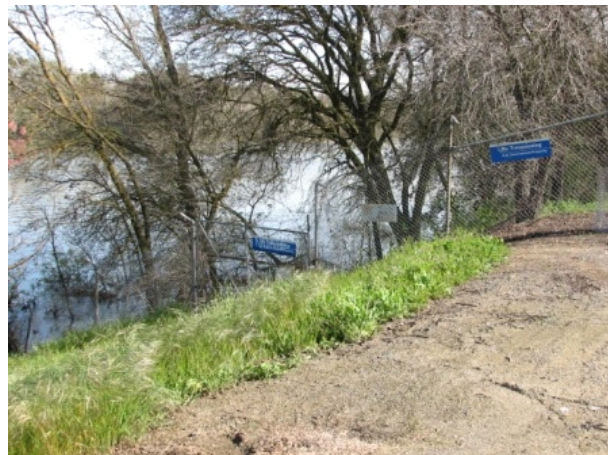
johngw_s_20110329_405.jpg

Levee Mile Report Line	2
Start Levee Mile	0.28
End Levee Mile	0.28
Location	Crown
Category	Earthen Levee
Item	Encroachments

The fence goes down the waterside with no removal sections.

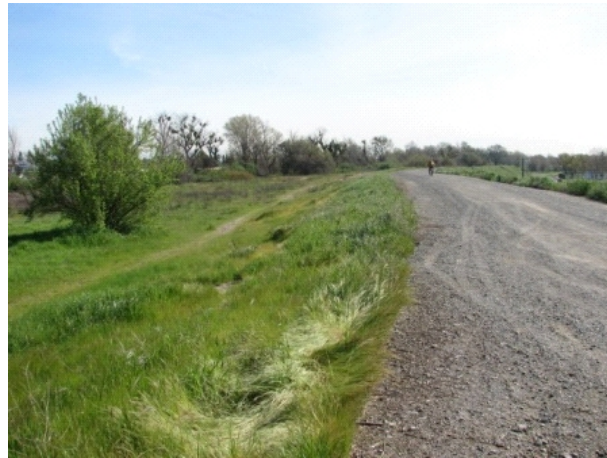
johngw_s_20110329_406.jpg

Levee Mile Report Line	3
Start Levee Mile	0.74
End Levee Mile	1.12
Location	Land Side
Category	Earthen Levee
Item	Vegetation

The grasses comply with standards.

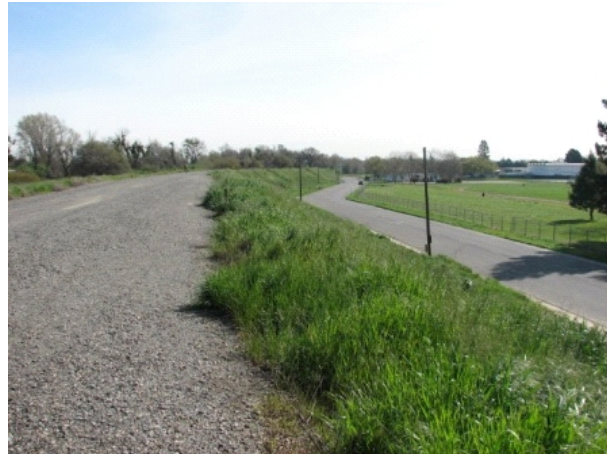
johngw_s_20110329_407.jpg

Levee Mile Report Line	4
Start Levee Mile	0.75
End Levee Mile	1.24
Location	Water Side
Category	Earthen Levee
Item	Vegetation

The vegetation complies with standards. Need to mow by fall.

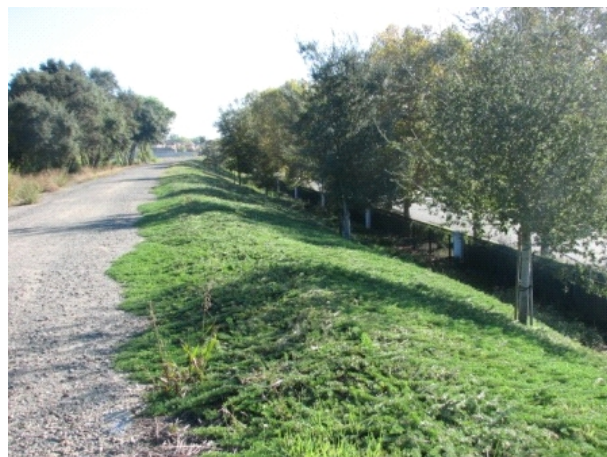
johngw_s_20110228_005.jpg

Levee Mile Report Line	5
Start Levee Mile	1.12
End Levee Mile	1.95
Location	Land Side
Category	Earthen Levee
Item	Encroachments

Landscape

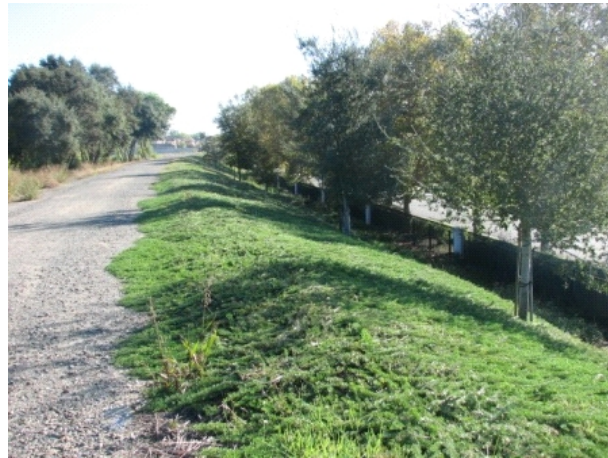
johngw_s_20110228_005.jpg

Levee Mile Report Line	5
Start Levee Mile	1.12
End Levee Mile	1.95
Location	Land Side
Category	Earthen Levee
Item	Encroachments

Landscaping on the landside slope outside of the Rivers development.

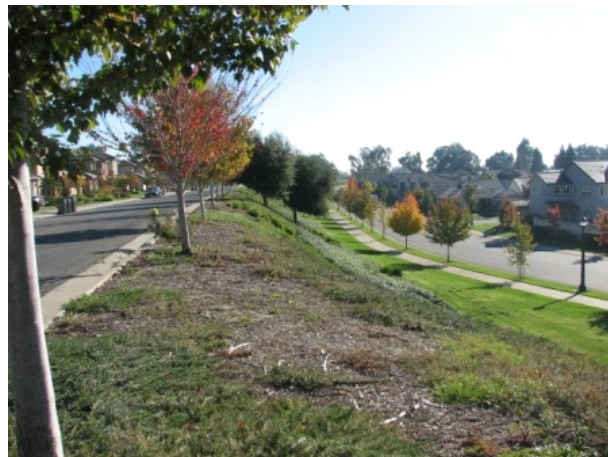
johngw_s_20110228_006.jpg

Levee Mile Report Line	5
Start Levee Mile	1.12
End Levee Mile	1.95
Location	Land Side
Category	Earthen Levee
Item	Encroachments

Landscaping inside of the Rivers landside levee slope in front of the homes.

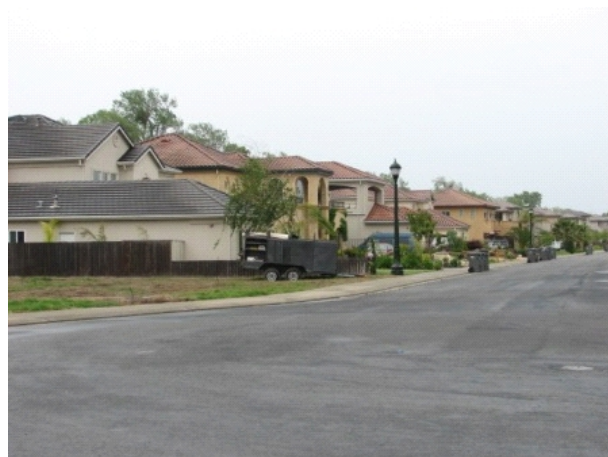
johngw_s_20110228_007.jpg

Levee Mile Report Line	6
Start Levee Mile	1.33
End Levee Mile	1.49
Location	Crown
Category	Earthen Levee
Item	Encroachments

Houses on the crown of the levee

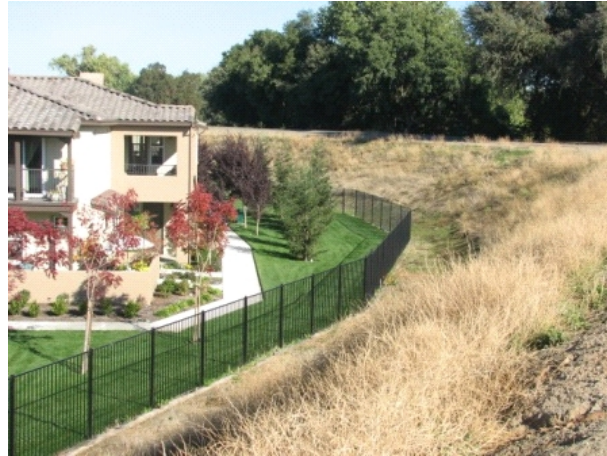
johngw_s_20110228_010.jpg

Levee Mile Report Line	7
Start Levee Mile	2.00
End Levee Mile	2.17
Location	Land Side
Category	Earthen Levee
Item	Encroachments

Fence and landscaping along the levee toe by the condos in the Rivers.

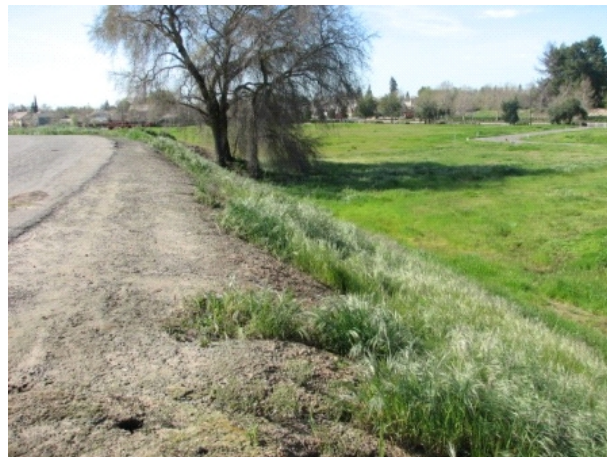
johngw_s_20110329_408.jpg

Levee Mile Report Line	8
Start Levee Mile	2.19
End Levee Mile	2.30
Location	Land Side
Category	Earthen Levee
Item	Vegetation

The vegetation complies with standards. Need to mow by fall.

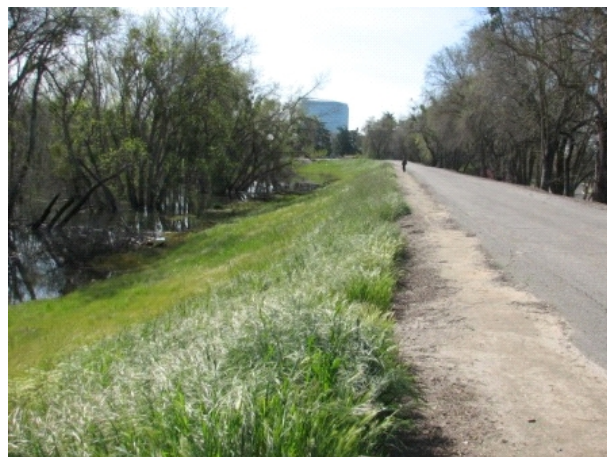
johngw_s_20110329_409.jpg

Levee Mile Report Line	10
Start Levee Mile	2.46
End Levee Mile	3.01
Location	Water Side
Category	Earthen Levee
Item	Vegetation

The vegetation complies with the standards. Need to mow by fall.

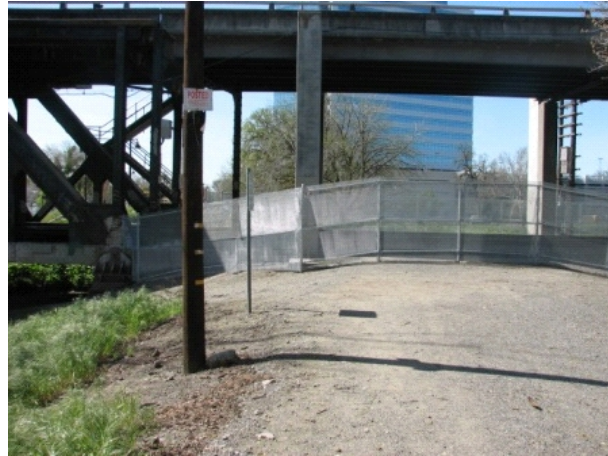
johngw_s_20110329_410.jpg

Levee Mile Report Line	12
Start Levee Mile	3.02
End Levee Mile	3.02
Location	Crown
Category	Earthen Levee
Item	Encroachments

The fence is across the levee crown on both side of the railroad tracks.

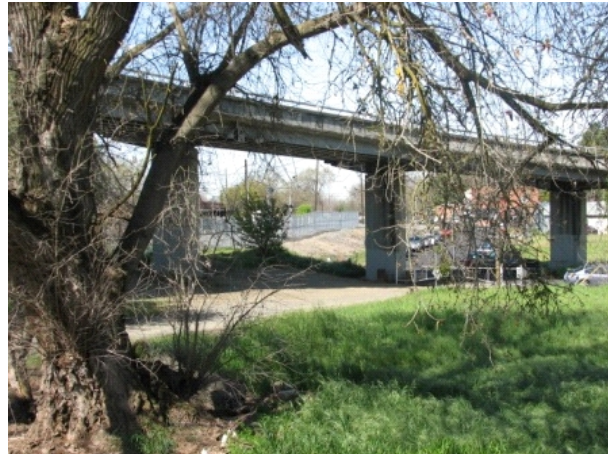
johngw_s_20110329_411.jpg

Levee Mile Report Line	12
Start Levee Mile	3.02
End Levee Mile	3.02
Location	Crown
Category	Earthen Levee
Item	Encroachments

The fence on both side of the tracks goes to Third street.

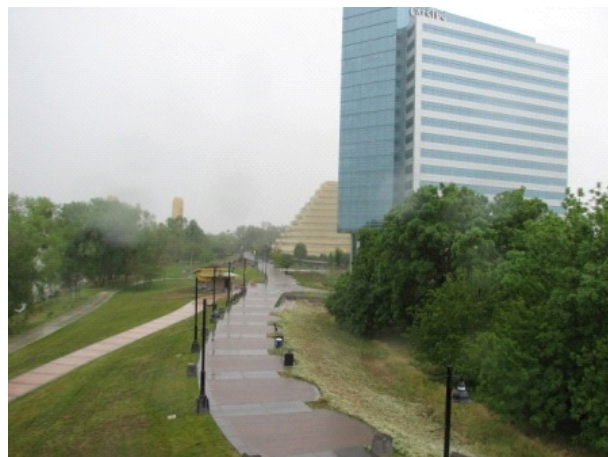
johngw_s_20110228_009.jpg

13	3.07	3.30	Earthen Levee	Encroachments	LS	PO	Buildings Inspector Comments: CalSTRS building and Ziegot building	38.585640 ° -121.508383 °	38.582230 ° -121.509110 °	13 Y
14	3.07	3.40	Earthen Levee	Encroachments	WS	PO	Landscaping Inspector Comments: West Sacramento's River walk runs from Tower Bridge to I st Bridge	38.585642 ° -121.508385 °	38.534710 ° -121.517390 °	12 Y

Levee Mile Report Line	13
Start Levee Mile	3.07
End Levee Mile	3.30
Location	Land Side
Category	Earthen Levee
Item	Encroachments

CalSTRS and Ziegler building

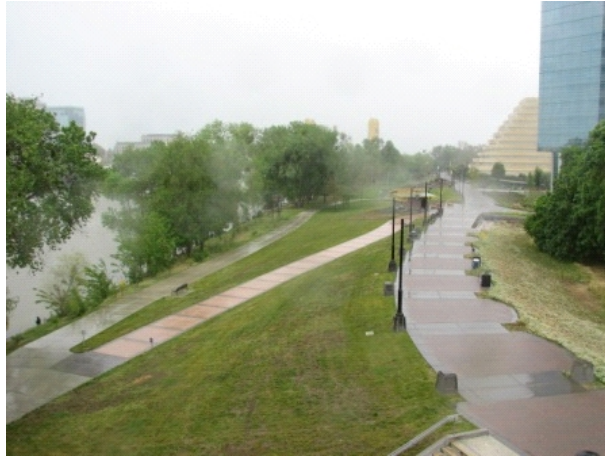
johngw_s_20110228_008.jpg

Levee Mile Report Line	14
Start Levee Mile	3.07
End Levee Mile	3.40
Location	Water Side
Category	Earthen Levee
Item	Encroachments

Landscaping on the waterside of the levee
