**Flood Control Project Maintenance
Levee Inspections**
LMA District Cover Sheet
Spring 2012 Levee Inspection Results

Sacramento Maintenance Yard Maintenance Area 0004

Spring 2012 Levee Inspection Results

Waterway	Bank	Unit Miles
Unit No. 01 Sacramento River	Right	3.40

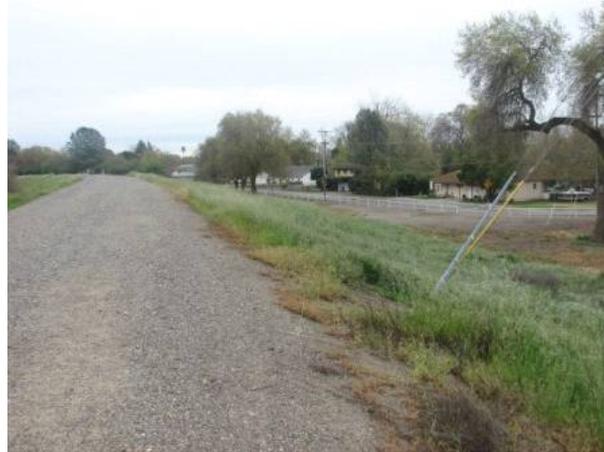
Levee Mile Report Line	4
Start Levee Mile	0.02
End Levee Mile	0.28
Location	Land Side
Category	Earthen Levee
Item	Vegetation
Photo taken spring 2012, grasses are taller than 12".	
johngw_s_20120328_619.jpg

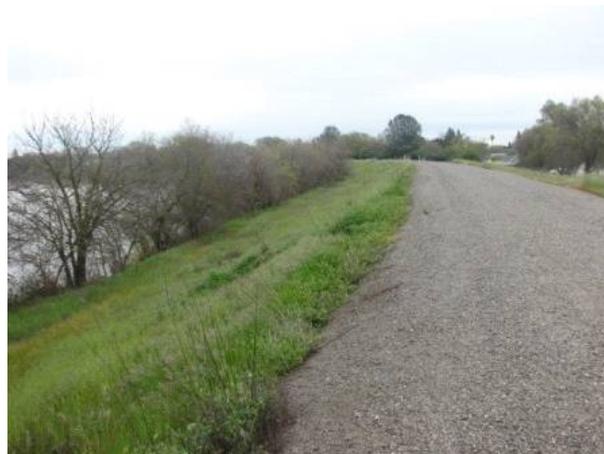
Levee Mile Report Line	5
Start Levee Mile	0.02
End Levee Mile	0.19
Location	Water Side
Category	Earthen Levee
Item	Vegetation
Photo taken spring 2012, grasses are taller than 12".	
johngw_s_20120328_620.jpg

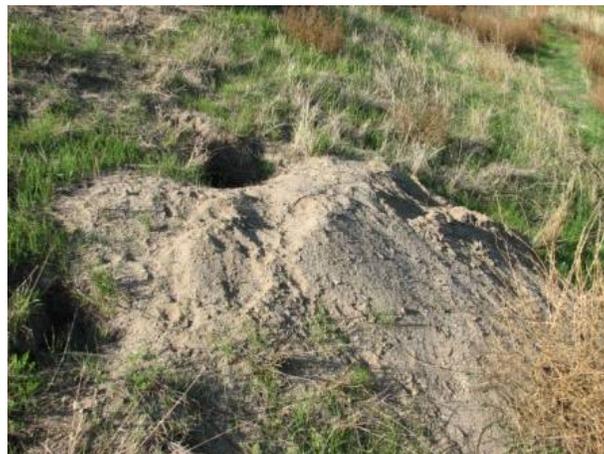
Levee Mile Report Line	6
Start Levee Mile	0.04
End Levee Mile	0.04
Location	Water Side
Category	Earthen Levee
Item	Animal Control
A large rodent hole Fall 2011	
johngw_s_20120313_014.jpg

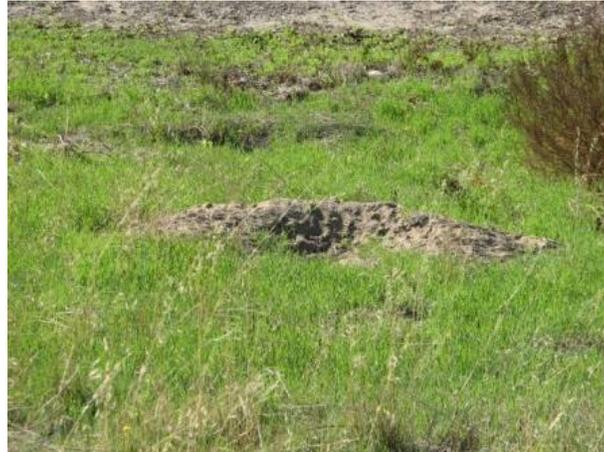
Levee Mile Report Line	7
Start Levee Mile	0.05
End Levee Mile	0.05
Location	Land Side
Category	Earthen Levee
Item	Animal Control
A large rodent hole. Fall 2011	
johngw_s_20120313_015.jpg

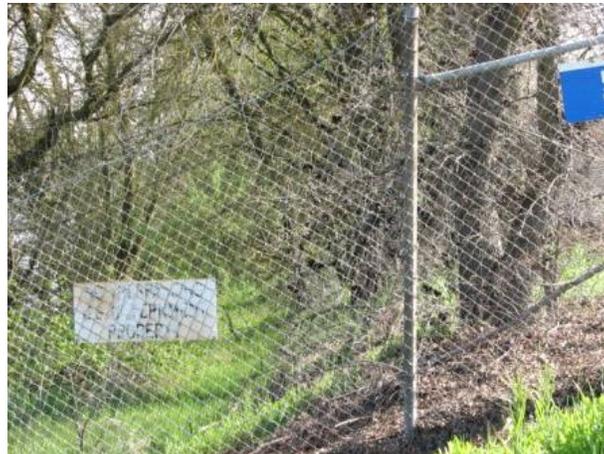
Levee Mile Report Line	9
Start Levee Mile	0.28
End Levee Mile	0.44
Location	Water Side
Category	Earthen Levee
Item	Trim / Thin Trees
The trees need to be trimmed up and thinned to meet standards.	
johngw_s_20120313_012.jpg

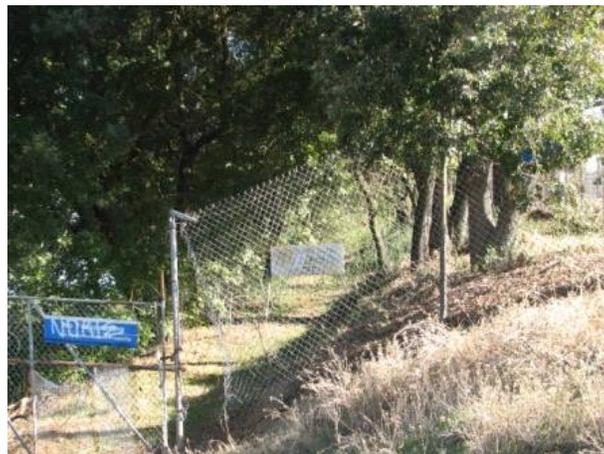
Levee Mile Report Line	9
Start Levee Mile	0.28
End Levee Mile	0.44
Location	Water Side
Category	Earthen Levee
Item	Trim / Thin Trees
The trees have been raised but vegetation needs to be trimmed. Fall 2011	
johngw_s_20120313_013.jpg

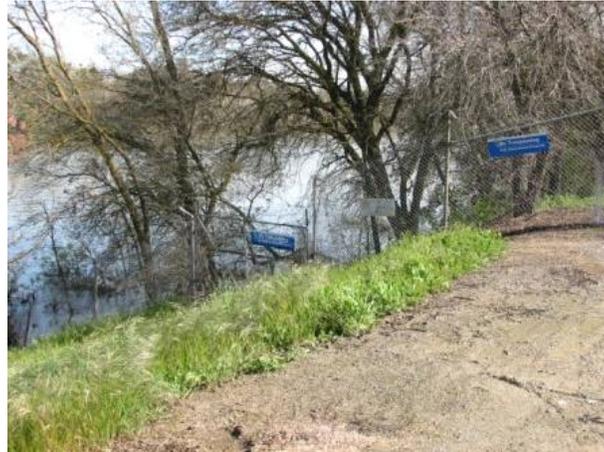
10	0.28	0.28	Earthen Levee	Encroachments	CR	U En	FE : Fences Inspector Comments: This is the USACE yard and the chain link fence crosses the levee. The fence runs the length of the yard on the crown.	38.597193 ° -121.543421 °	38.597193 ° -121.543421 °	2 Y
DWR ID: DWR_MA0004_01_s_2012_2										
11	0.68	1.31	Earthen Levee	Crown Surface / Depressions / Rutting	CR	C Ma	C2 : Regrade the crown roadway for proper drainage. Inspector Comments: I am unable to inspect this area due to construction. A SB wall and reconstruction of the levee is in progress.	38.600857 ° -121.537060 °	38.602755 ° -121.525830 °	177 Y
DWR ID: DWR_MA0004_01_s_2012_177										
12	1.32	1.95	Earthen Levee	Vegetation	LS	A/W En	V6 : Landscaping Inspector Comments: The Rivers housing development	38.602756 ° -121.525618 °	38.600449 ° -121.514459 °	7 Y
DWR ID: DWR_MA0004_01_s_2012_7

Levee Mile Report Line	10
Start Levee Mile	0.28
End Levee Mile	0.28
Location	Crown
Category	Earthen Levee
Item	Encroachments
The fence goes down the waterside with no removal sections.	
johngw_s_20120313_001.jpg

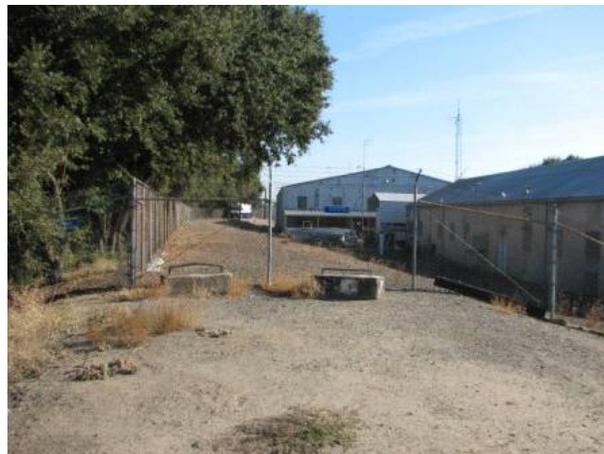
Levee Mile Report Line	10
Start Levee Mile	0.28
End Levee Mile	0.28
Location	Crown
Category	Earthen Levee
Item	Encroachments
The fence crosses the levee crown with no gate for access. The buildings are the USACE yard. Fall 2011	
johngw_s_20120313_002.jpg

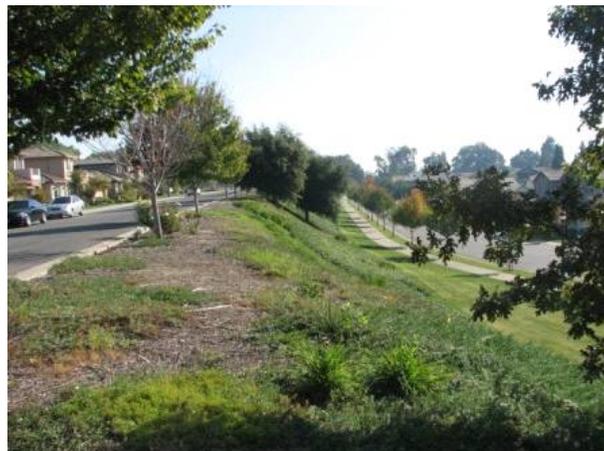
Levee Mile Report Line	12
Start Levee Mile	1.32
End Levee Mile	1.95
Location	Land Side
Category	Earthen Levee
Item	Vegetation
Landscaping on the landside slope outside of the Rivers development. Fall 2011	
johngw_s_20120313_005.jpg

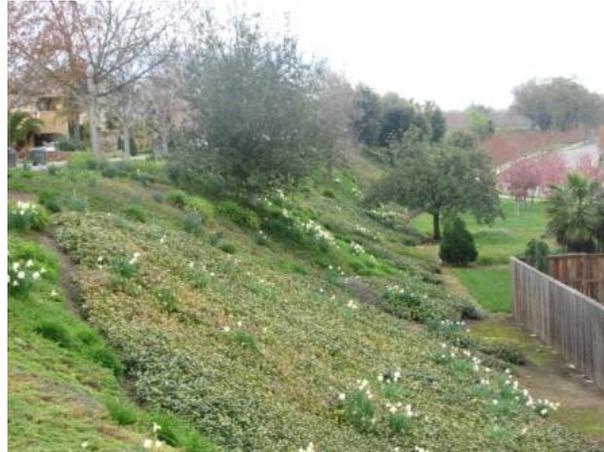
Levee Mile Report Line	12
Start Levee Mile	1.32
End Levee Mile	1.95
Location	Land Side
Category	Earthen Levee
Item	Vegetation
Photo taken spring 2012, permitted landscape in the Rivers project.	
johngw_s_20120328_621.jpg

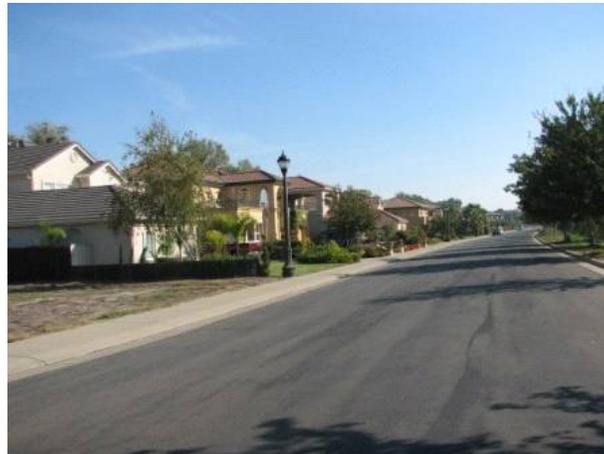
Levee Mile Report Line	13
Start Levee Mile	1.33
End Levee Mile	1.49
Location	Crown
Category	Earthen Levee
Item	Encroachments
Houses on the crown of the levee Fall 2011	
johngw_s_20120313_006.jpg

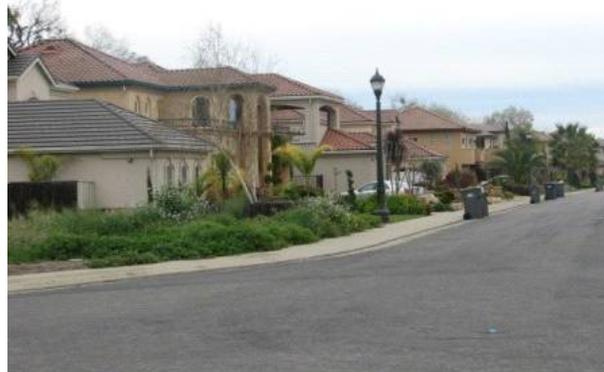
Levee Mile Report Line	13
Start Levee Mile	1.33
End Levee Mile	1.49
Location	Crown
Category	Earthen Levee
Item	Encroachments
Photo taken spring 2012, permitted houses built on the waterside of the crown.	
johngw_s_20120328_622.jpg

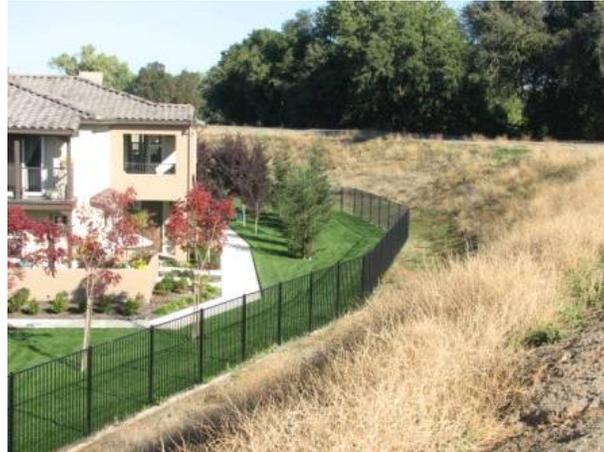
Levee Mile Report Line	15
Start Levee Mile	2.00
End Levee Mile	2.17
Location	Land Side
Category	Earthen Levee
Item	Encroachments
Fence and landscaping along the levee toe by the condos in the Rivers.	
johngw_s_20120313_010.jpg

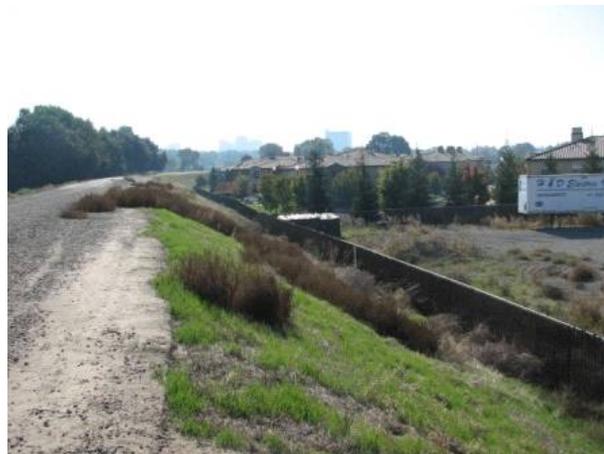
Levee Mile Report Line	15
Start Levee Mile	2.00
End Levee Mile	2.17
Location	Land Side
Category	Earthen Levee
Item	Encroachments
The fence runs along the toe of the levee. Fall 2011	
johngw_s_20120313_011.jpg

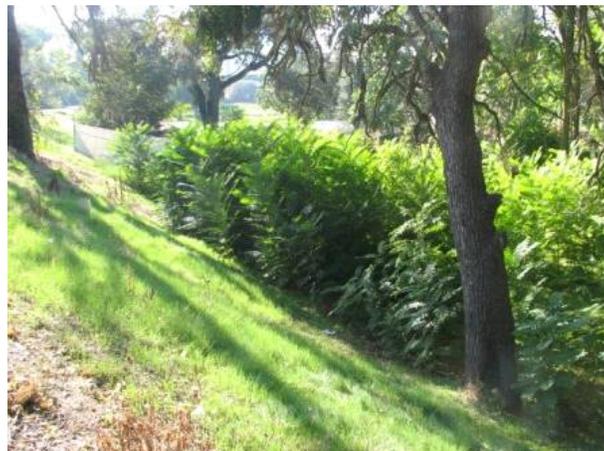
Levee Mile Report Line	18
Start Levee Mile	2.87
End Levee Mile	2.87
Location	Land Side
Category	Earthen Levee
Item	Vegetation
The vegetation on the landside toe blocks visibility. Fall 2011	
johngw_s_20120313_018.jpg

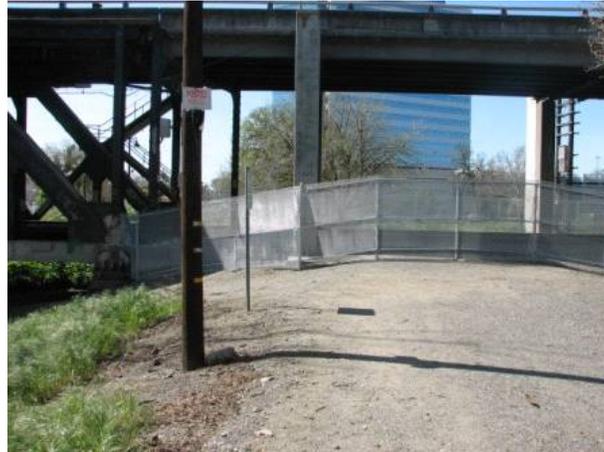
johngw_s_20120313_003.jpg

20	3.02	3.02	Earthen Levee	Encroachments	CR A/W En	FE : Fences Inspector Comments: Fence was installed from the 'I' St. bridge to 3rd St. on both sides of the railroad tracks. The fence crosses the crown. The crown was not accessible because of the railroad tracks before.	38.586887 ° -121.508150 °	38.586887 ° -121.508150 °	6 Y	
DWR ID: DWR_MA0004_01_s_2012_6										
21	3.07	3.30	Earthen Levee	Encroachments	LS A/W En	BU : Buildings Inspector Comments: CalSTRS building and Ziegot building	38.585640 ° -121.508383 °	38.582230 ° -121.509110 °	13 Y	
DWR ID: DWR_MA0004_01_s_2012_13										
22	3.07	3.40	Earthen Levee	Vegetation	WSA/W En	V6 : Landscaping Inspector Comments: West Sacramento's River walk runs from Tower Bridge to I st Bridge	38.585642 ° -121.508385 °	38.534710 ° -121.517390 °	12 Y	
DWR ID: DWR_MA0004_01_s_2012_12

Levee Mile Report Line	20
Start Levee Mile	3.02
End Levee Mile	3.02
Location	Crown
Category	Earthen Levee
Item	Encroachments

The fence is across the levee crown on both side of the railroad tracks.

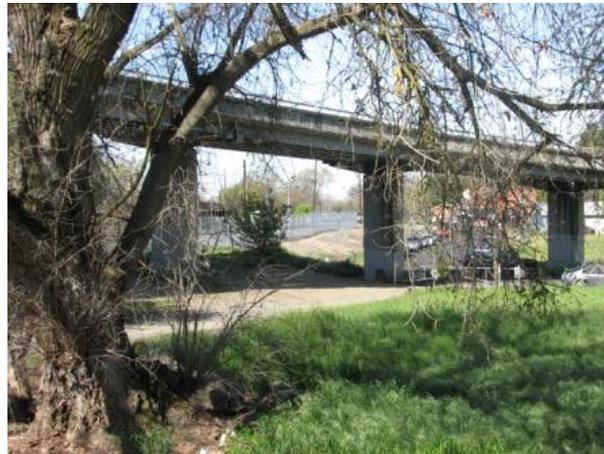
johngw_s_20120313_004.jpg

Levee Mile Report Line	20
Start Levee Mile	3.02
End Levee Mile	3.02
Location	Crown
Category	Earthen Levee
Item	Encroachments

The fence on both side of the tracks goes to Third street.

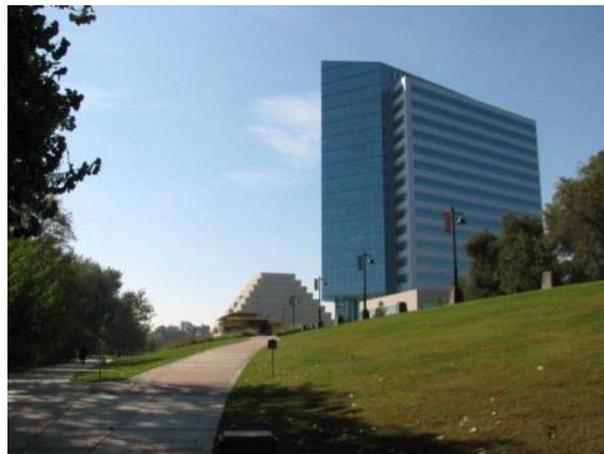
johngw_s_20120313_009.jpg

Levee Mile Report Line	21
Start Levee Mile	3.07
End Levee Mile	3.30
Location	Land Side
Category	Earthen Levee
Item	Encroachments

CalSTRS and Ziegot building. Fall 2011

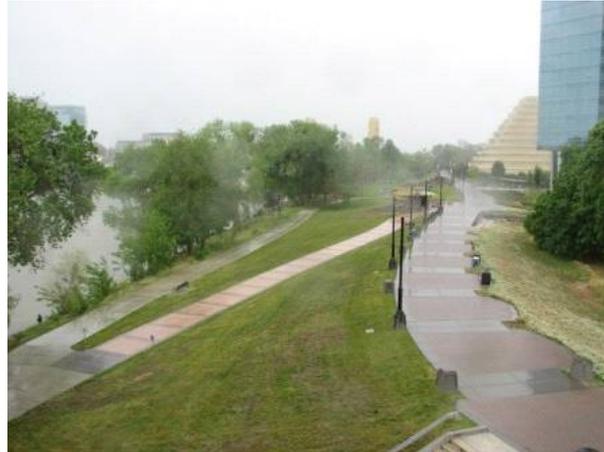
Levee Mile Report Line	22
Start Levee Mile	3.07
End Levee Mile	3.40
Location	Water Side
Category	Earthen Levee
Item	Vegetation
Landscaping on the waterside of the levee	
johngw_s_20120313_007.jpg

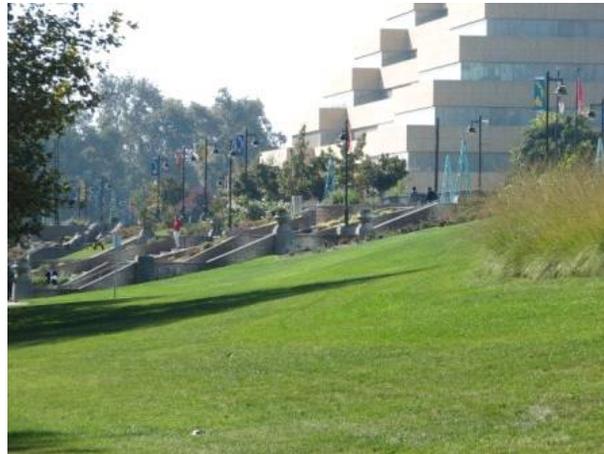
Levee Mile Report Line	22
Start Levee Mile	3.07
End Levee Mile	3.40
Location	Water Side
Category	Earthen Levee
Item	Vegetation
Steps and landscaping on the crown and waterside of the levee. Fall 2011	
johngw_s_20120313_008.jpg
