**Flood Control Project Maintenance
Levee Inspections****LMA District Cover Sheet****Spring 2013 Levee Inspection Results****Sacramento Maintenance Yard Maintenance Area 0004**

Levee Inspection Report By Mile - Spring 2013

Sacramento Maintenance Yard Maintenance Area 0004

Waterway							Bank	Unit Miles	Inspection Start/End	Inspector
Unit No. 01 Sacramento River							Right	3.40		John Williamson
LMR No.	Levee Mile		Category	Item	Location *	Rating ** +	Action/Comment	GPS Latitude/Longitude		Issue No. Photo
	Start	End						Start	End	
1				Operations & Maintenance Manuals	LS	A Ma		° °	° °	9
								DWR ID: DWR_MA0004_01_s_2013_9		
2				Emergency Supplies & Equipment	LS	A Ma		° °	° °	10
								DWR ID: DWR_MA0004_01_s_2013_10		
3				Flood Preparedness & Training	LS	A Ma		° °	° °	11
								DWR ID: DWR_MA0004_01_s_2013_11		
4	0.02	0.28		Vegetation	LS	A Ma	V1 : Control annual grass and weeds on the levee slopes and easements.	38.596814 ° -121.547522 °	38.597193 ° -121.543420 °	1 Y
								DWR ID: DWR_MA0004_01_s_2013_1		
5	0.02	0.28		Vegetation	WS	A Ma	V1 : Control annual grass and weeds on the levee slopes and easements.	38.596814 ° -121.547521 °	38.597193 ° -121.543420 °	4 Y

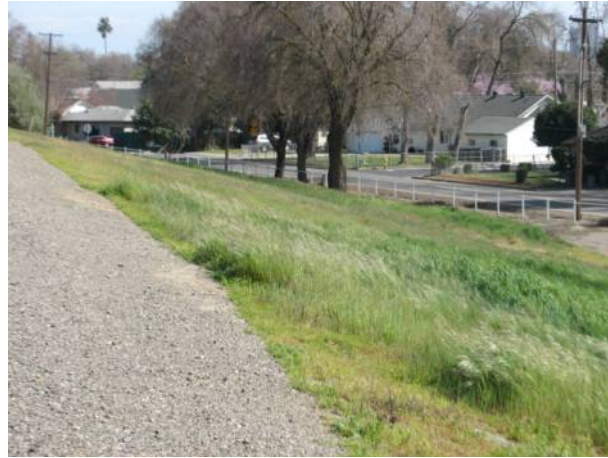
Levee Mile Report Line	4
Start Levee Mile	0.02
End Levee Mile	0.28
Location	Land Side
Category	
Item	Vegetation
The levee has no unwanted vegetation. Spring 2013	
johnngw_s_20130325_816.JPG

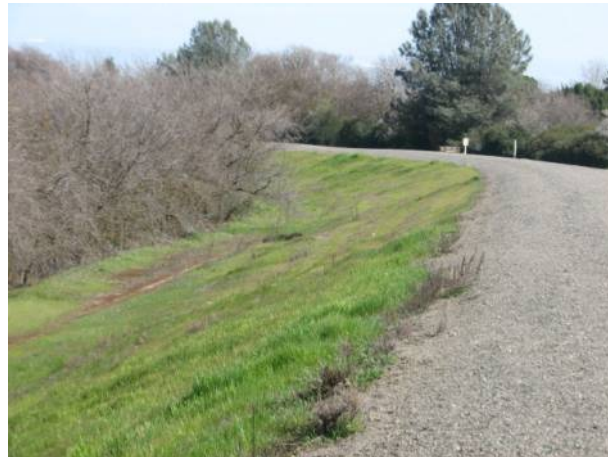
Levee Mile Report Line	5
Start Levee Mile	0.02
End Levee Mile	0.28
Location	Water Side
Category	
Item	Vegetation
The levee has no unwanted vegetation. Spring 2013	
johnngw_s_20130325_817.JPG

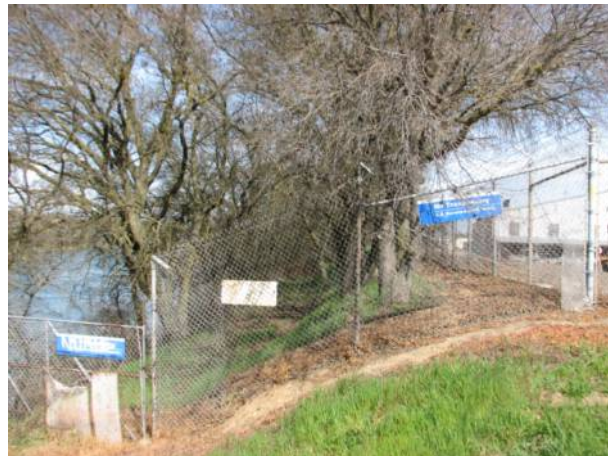
Levee Mile Report Line	7
Start Levee Mile	0.28
End Levee Mile	0.44
Location	Water Side
Category	
Item	Trim / Thin Trees
The trees have been raised but vegetation needs to be trimmed. Spring 2013	
johnngw_s_20130325_818.JPG

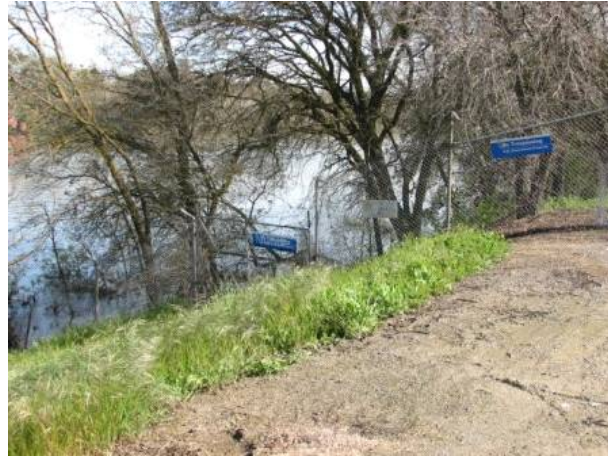
Levee Mile Report Line	8
Start Levee Mile	0.28
End Levee Mile	0.28
Location	Crown
Category	
Item	Encroachments
The fence goes down the waterside with no removable sections.	
johngw_s_20130221_001.jpg

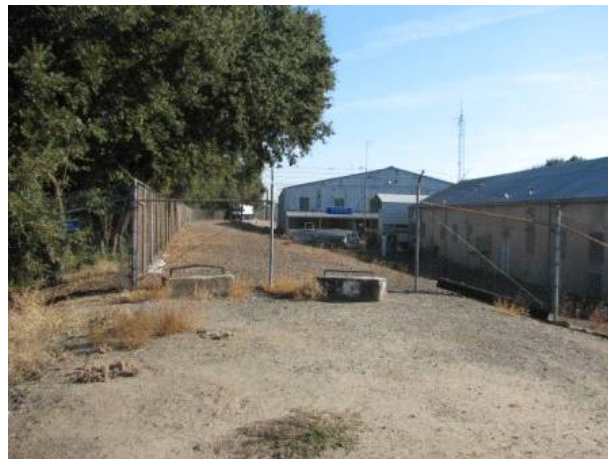
Levee Mile Report Line	8
Start Levee Mile	0.28
End Levee Mile	0.28
Location	Crown
Category	
Item	Encroachments
The fence crosses the levee crown with no gate for access. The buildings are the USACE yard. Fall 2011	
johngw_s_20130221_002.jpg

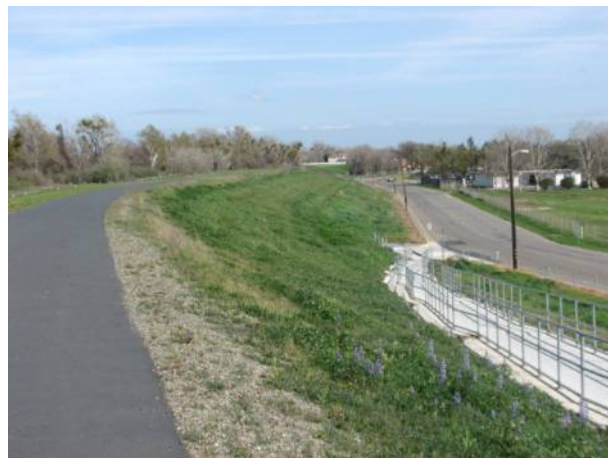
Levee Mile Report Line	9
Start Levee Mile	0.73
End Levee Mile	1.27
Location	Land Side
Category	
Item	Vegetation
Restored area has no unwanted vegetation on levee slope. Spring 2013	
johngw_s_20130325_819.JPG

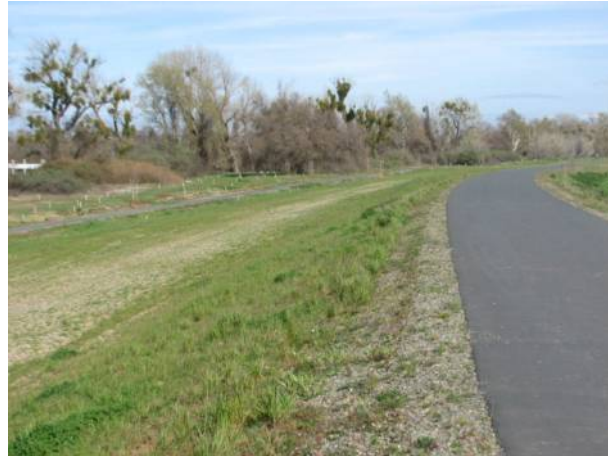
Levee Mile Report Line	10
Start Levee Mile	0.73
End Levee Mile	1.27
Location	Water Side
Category	
Item	Vegetation
Restored area, The vegetation is sparse but no unwanted vegetation on the levee. Spring 2013	
johngw_s_20130325_820.JPG

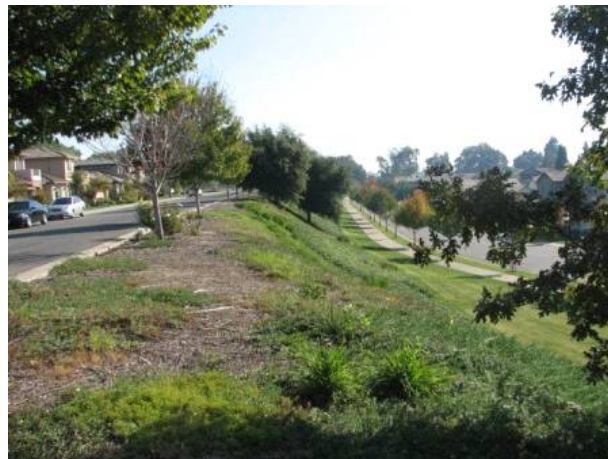
Levee Mile Report Line	11
Start Levee Mile	1.32
End Levee Mile	1.95
Location	Land Side
Category	
Item	Vegetation
Landscaping on the landside slope outside of the Rivers development. Fall 2011	
johngw_s_20130221_004.jpg

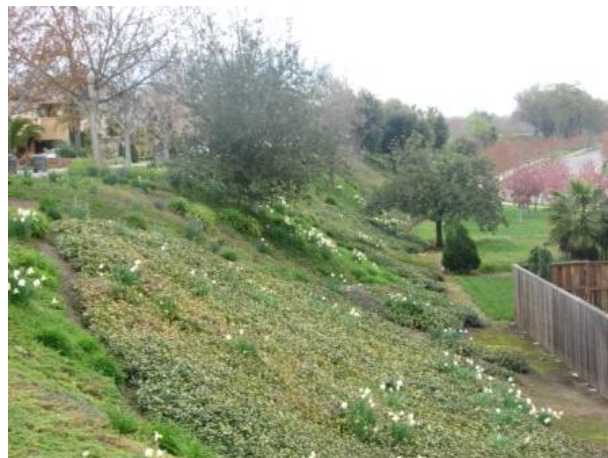
Levee Mile Report Line	11
Start Levee Mile	1.32
End Levee Mile	1.95
Location	Land Side
Category	
Item	Vegetation
Photo taken spring 2012, permitted landscape in the Rivers project.	
johngw_s_20130221_005.jpg

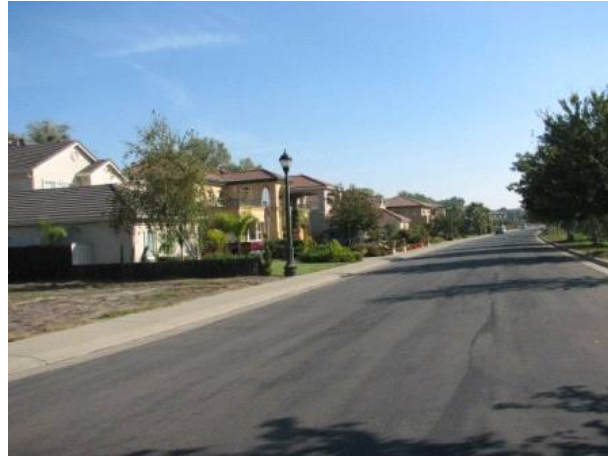
Levee Mile Report Line	12
Start Levee Mile	1.33
End Levee Mile	1.49
Location	Crown
Category	
Item	Encroachments
Houses on the crown of the levee Fall 2011	
johngw_s_20130221_006.jpg

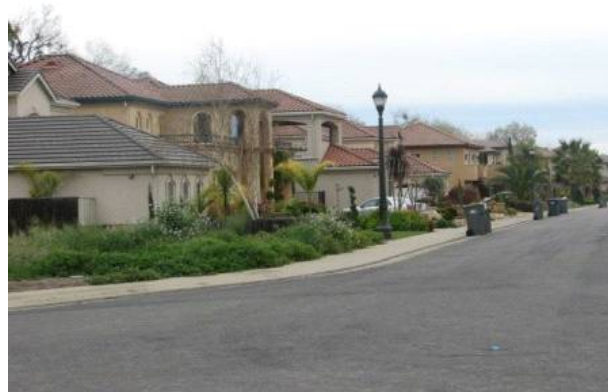
Levee Mile Report Line	12
Start Levee Mile	1.33
End Levee Mile	1.49
Location	Crown
Category	
Item	Encroachments
Photo taken spring 2012, permitted houses built on the waterside of the crown.	
johngw_s_20130221_007.jpg

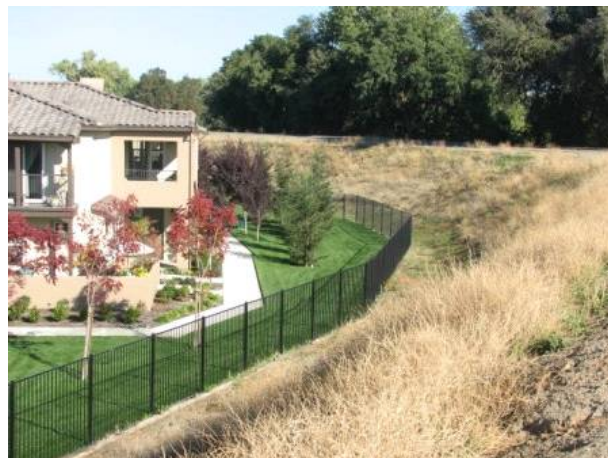
Levee Mile Report Line	13
Start Levee Mile	2.00
End Levee Mile	2.17
Location	Land Side
Category	
Item	Encroachments
Fence and landscaping along the levee toe by the condos in the Rivers.	
johngw_s_20130221_010.jpg

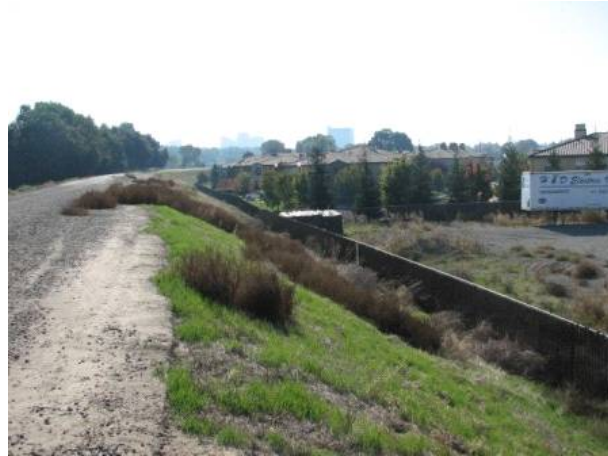
Levee Mile Report Line	13
Start Levee Mile	2.00
End Levee Mile	2.17
Location	Land Side
Category	
Item	Encroachments
The fence runs along the toe of the levee. Fall 2011	
johngw_s_20130221_011.jpg

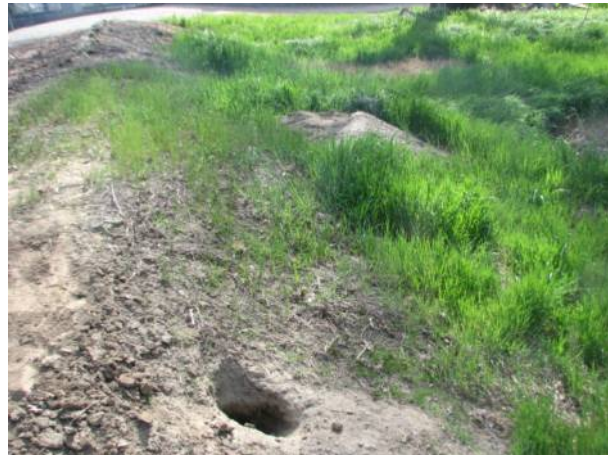
Levee Mile Report Line	15
Start Levee Mile	3.00
End Levee Mile	3.00
Location	Land Side
Category	
Item	Animal Control
No rodents visible but hole need to be backfilled. Spring 2013	
johngw_s_20130325_821.JPG

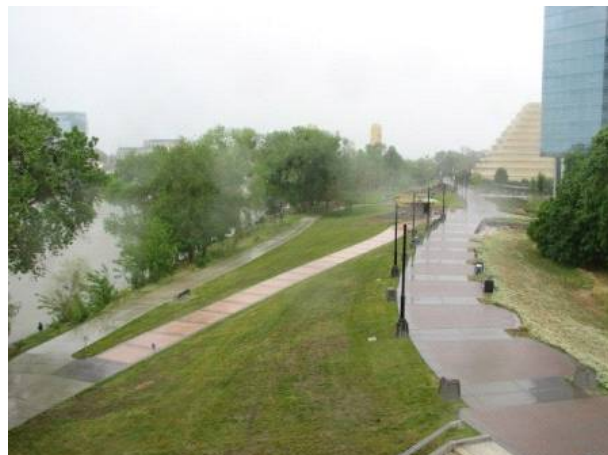
Levee Mile Report Line	16
Start Levee Mile	3.07
End Levee Mile	3.40
Location	Water Side
Category	
Item	Vegetation
Landscaping on the waterside of the levee	
johngw_s_20130221_008.jpg

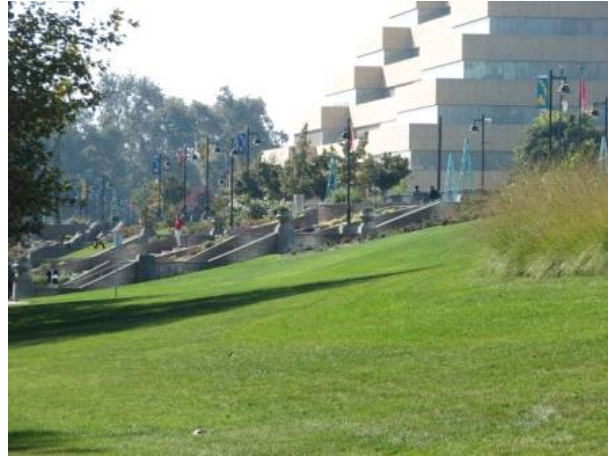
Levee Mile Report Line	16
Start Levee Mile	3.07
End Levee Mile	3.40
Location	Water Side
Category	
Item	Vegetation
Steps and landscaping on the crown and waterside of the levee. Fall 2011	
johngw_s_20130221_009.jpg
