**Flood Control Project Maintenance  
Levee Inspections****LMA District Cover Sheet****Spring 2014 Levee Inspection Results****Sacramento Maintenance Yard Maintenance Area 0004**

**Levee Inspection Report By Mile - Spring 2014**

Waterway	Bank	Unit Miles	Inspection Start/End	Inspector
Unit No. 01 Sacramento River	Right	3.40	03/13/2014 03/13/2014	John Williamson

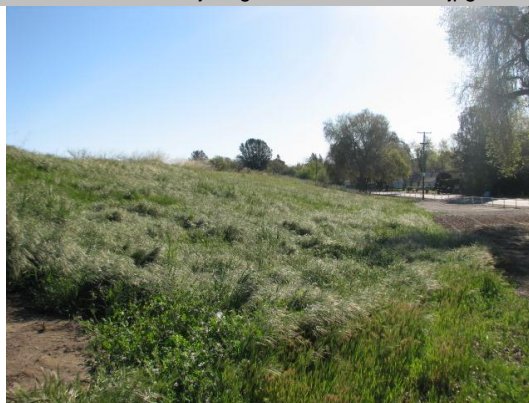
Photo 1 of 1 : johngw\_s\_20140317\_643.jpg

LM Start	0.02	Rating **	A	Issue No.	1
LM End	0.28	Issue Type +	Ma	Location *	LS
Category	Earthen Levee			GPS Latitude/Longitude	
				Start	End
Item	Vegetation			38.596830 °	38.597193 °
				-121.547527 °	-121.543420 °
DWR ID	DWR_MA0004_01_s _ 2014_1				
Action/Comments					
Control annual grass and weeds on the levee slopes and easements.

The vegetation complies with standards. Spring 2014

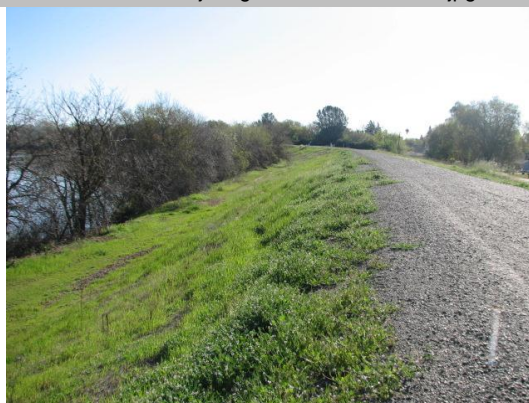
Photo 1 of 1 : johngw\_s\_20140317\_644.jpg

LM Start	0.02	Rating **	A	Issue No.	4
LM End	0.28	Issue Type +	Ma	Location *	WS
Category	Earthen Levee			GPS Latitude/Longitude	
				Start	End
Item	Vegetation			38.596831 °	38.597193 °
				-121.547527 °	-121.543420 °
DWR ID	DWR_MA0004_01_s _ 2014_4				
Action/Comments					
Control annual grass and weeds on the levee slopes and easements.

The vegetation complies with standards. Spring 2014

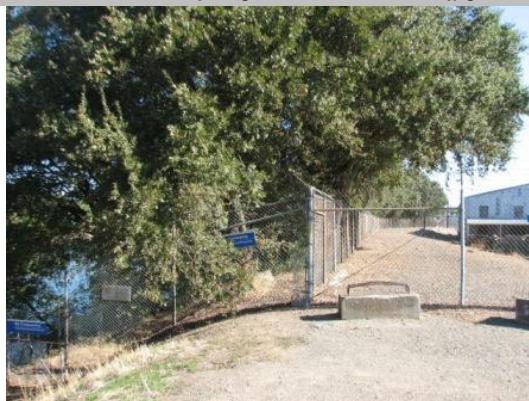
Photo 1 of 2 : johngw\_s\_20140306\_291.jpg

LM Start	0.28	Rating **	M	Issue No.	15
LM End	0.44	Issue Type +	Ma	Location *	WS
Category	Earthen Levee			GPS Latitude/Longitude	
				Start	End
Item	Trim / Thin Trees			38.597188 °	38.598649 °
				-121.543401 °	-121.540960 °
DWR ID	DWR_MA0004_01_s _ 2012_15				
Action/Comments					
Trim and thin trees to allow visibility of the ground and room to flood fight.					
Inspector Comments: Chain link fence runs along the waterside shoulder of levee and no access to trim and thin trees or vegetation. This is the fence for the USACE Brythe Yard and runs the entire yard.

The trees are partially obstructing visibility. Fall 2013

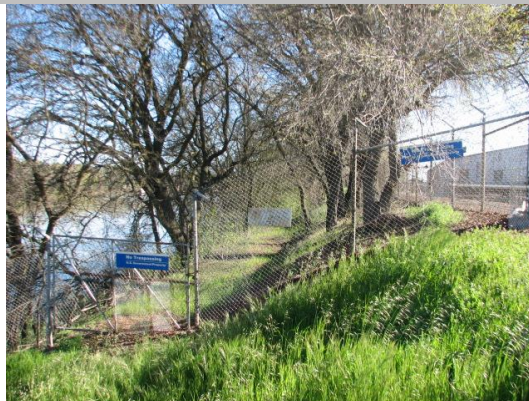
Photo 2 of 2 : johngw\_s\_20140317\_645.jpg

LM Start	0.28	Rating **	M	Issue No.	15 (cont)
LM End	0.44	Issue Type +	Ma	Location *	WS
Category	Earthen Levee			GPS Latitude/Longitude	
				Start	End
Item	Trim / Thin Trees			38.597188 °	38.598649 °
				-121.543401 °	-121.540960 °
DWR ID	DWR_MA0004_01_s _ 2012_15				
Action/Comments					
Trim and thin trees to allow visibility of the ground and room to flood fight.					
Inspector Comments: Chain link fence runs along the waterside shoulder of levee and no access to trim and thin trees or vegetation. This is the fence for the USACE Brythe Yard and runs the entire yard.

Trees on the waterside levee slope may obstruct visibility. Spring 2014

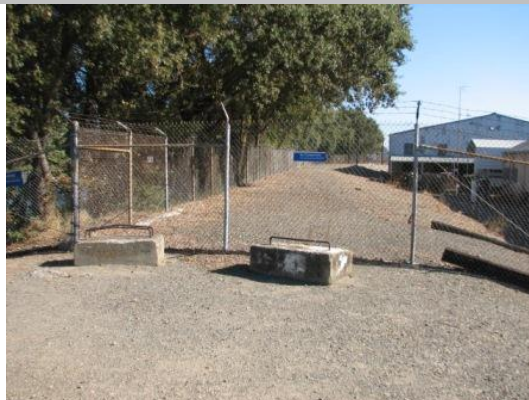
Photo 1 of 2 : johngw\_s\_20140306\_282.jpg

LM Start	0.28	Rating **	U	Issue No.	2
LM End	0.28	Issue Type +	En	Location *	CR
Category	Earthen Levee			GPS Latitude/Longitude	
				Start	End
Item	Encroachments			38.597193 °	38.597193 °
				-121.543421 °	-121.543421 °
DWR ID	DWR_MA0004_01_s _ 2012_2				
Action/Comments					
Fence					
Inspector Comments: This is the USACE yard and the chain link fence crosses the levee. The fence runs the length of the yard on the crown.

The fence blocks the crown of the levee. Fall 2013

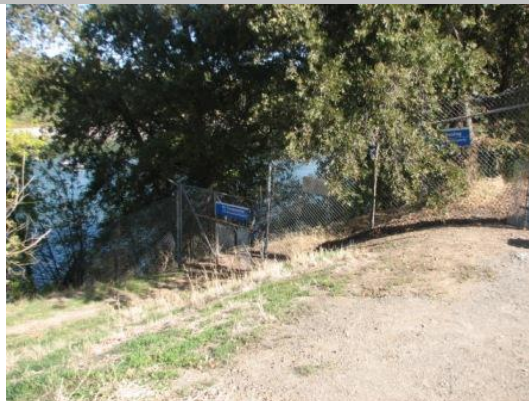
Photo 2 of 2 : johngw\_s\_20140306\_283.jpg

LM Start	0.28	Rating **	U	Issue No.	2 (cont)
LM End	0.28	Issue Type +	En	Location *	CR
Category	Earthen Levee			GPS Latitude/Longitude	
				Start	End
Item	Encroachments			38.597193 °	38.597193 °
				-121.543421 °	-121.543421 °
DWR ID	DWR_MA0004_01_s _ 2012_2				
Action/Comments					
Fence					
Inspector Comments: This is the USACE yard and the chain link fence crosses the levee. The fence runs the length of the yard on the crown.

The fence blocks access to the waterside levee slope. Fall 2013

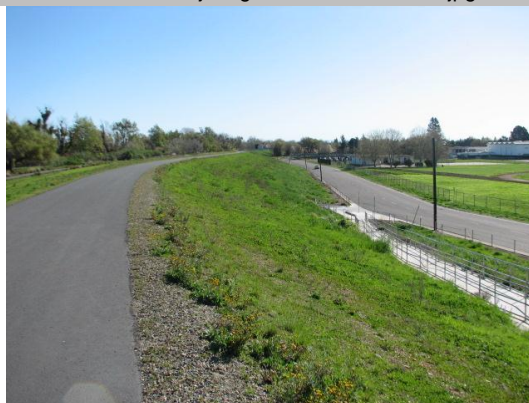
Photo 1 of 1 : johngw\_s\_20140317\_646.jpg

LM Start	0.72	Rating **	A	Issue No.	5
LM End	1.29	Issue Type +	Ma	Location *	LS
Category	Earthen Levee			GPS Latitude/Longitude	
				Start	End
Item	Vegetation			38.601112 °	38.602837 °
				-121.536464 °	-121.526368 °
DWR ID	DWR_MA0004_01_s _ 2014_5				
Action/Comments					
Control annual grass and weeds on the levee slopes and easements.

The vegetation is 50% grasses and complies with standards. Spring 2014

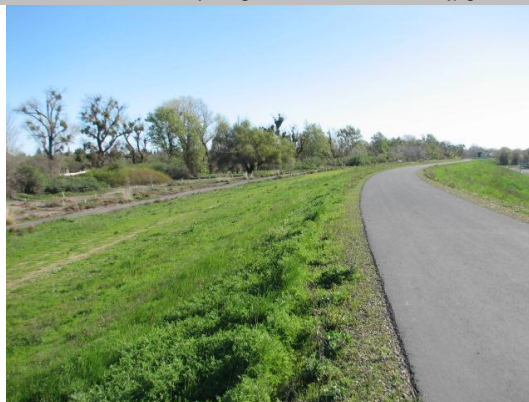
Photo 1 of 1 : johngw\_s\_20140317\_647.jpg

LM Start	0.73	Rating **	A	Issue No.	6
LM End	1.29	Issue Type +	Ma	Location *	WS
Category	Earthen Levee			GPS Latitude/Longitude	
				Start	End
Item	Vegetation			38.601363 °	38.602837 °
				-121.536134 °	-121.526368 °
DWR ID	DWR_MA0004_01_s _ 2014_6				
Action/Comments					
Control annual grass and weeds on the levee slopes and easements.

The vegetation is 50% grasses and complies with standards. Spring 2014

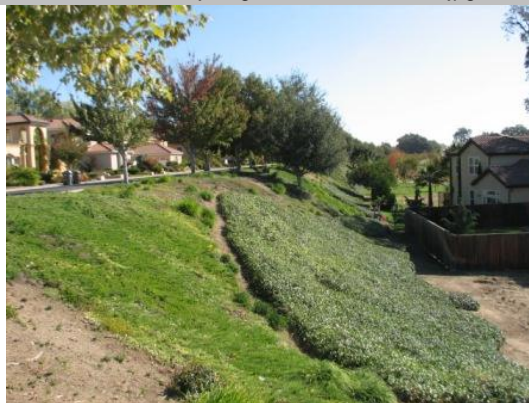
Photo 1 of 2 : johngw\_s\_20140306\_285.jpg

LM Start	1.32	Rating **	A/W	Issue No.	7
LM End	1.95	Issue Type +	Ma	Location *	LS
Category	Earthen Levee			GPS Latitude/Longitude	
				Start	End
Item	Vegetation			38.602756 °	38.600449 °
				-121.525618 °	-121.514459 °
DWR ID	DWR_MA0004_01_s _ 2012_7				
Action/Comments					
Landscaping					
Inspector Comments: The Rivers housing development

The landside of the levee slope is landscaped. Fall 2013

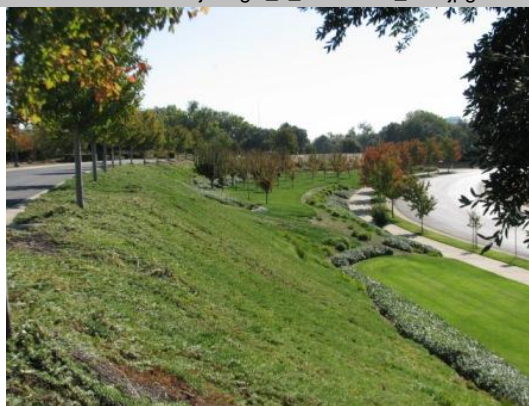
Photo 2 of 2 : johngw\_s\_20140306\_286.jpg

The landside levee slope is landscaped. Fall 2013

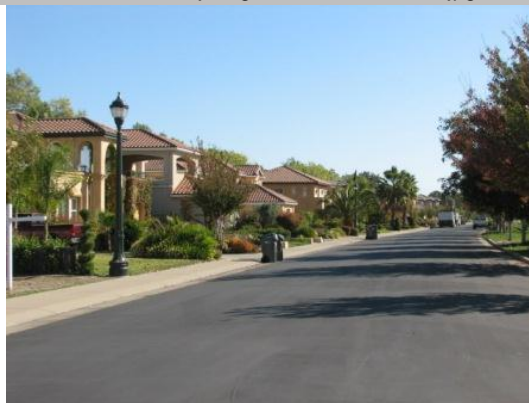
Photo 1 of 1 : johngw\_s\_20140306\_287.jpg

LM Start	1.33	Rating **	A/W	Issue No.	8
LM End	1.49	Issue Type +	Ma	Location *	CR
Category	Earthen Levee			GPS Latitude/Longitude	
				Start	End
Item	Encroachments			38.602764 °	38.602596 °
				-121.525319 °	-121.522439 °
DWR ID	DWR_MA0004_01_s _ 2012_8				
Action/Comments					
Building

Houses have been built on the crown of the levee. Fall 2013

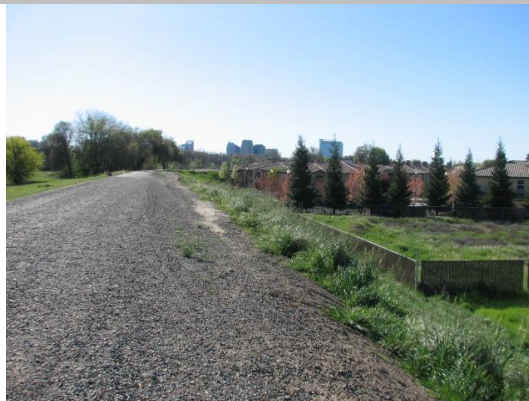
Photo 1 of 1 : johngw\_s\_20140317\_648.jpg

LM Start	1.97	Rating **	M	Issue No.	13
LM End	2.31	Issue Type +	Ma	Location *	LS
Category	Earthen Levee			GPS Latitude/Longitude	
				Start	End
Item	Vegetation			38.600092 °	38.595785 °
				-121.514142 °	-121.512753 °
DWR ID	DWR_MA0004_01_s _ 2014_13				
Action/Comments					
Control annual grass and weeds on the levee slopes and easements.

Tall grasses partially block visibility on the levee slope. Spring 2014

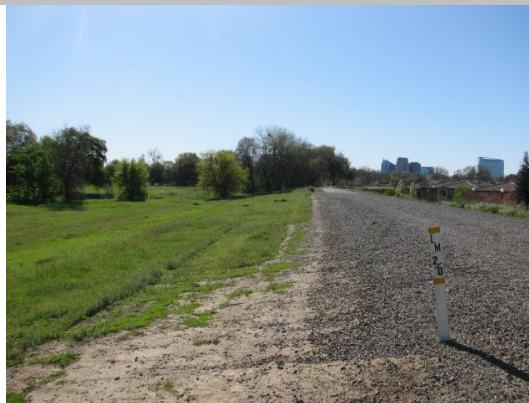
Photo 1 of 1 : johngw\_s\_20140317\_649.jpg

LM Start	1.97	Rating **	M	Issue No.	16
LM End	2.45	Issue Type +	Ma	Location *	WS
Category	Earthen Levee			GPS Latitude/Longitude	
				Start	End
Item	Vegetation			38.600092 °	38.593777 °
				-121.514142 °	-121.512087 °
DWR ID	DWR_MA0004_01_s _ 2014_16				
Action/Comments					
Control annual grass and weeds on the levee slopes and easements.

Tall grasses partially blocks visibility. Spring 2014

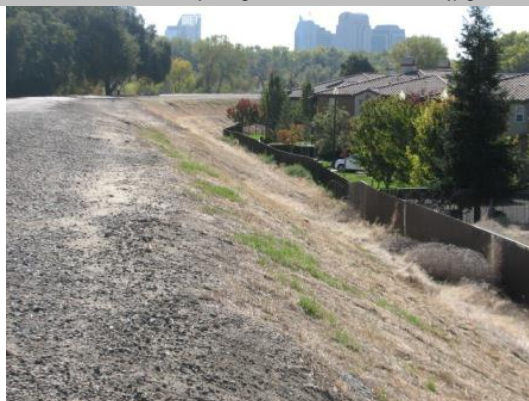
Photo 1 of 1 : johngw\_s\_20140306\_290.jpg

LM Start	2.00	Rating **	M	Issue No.	14
LM End	2.17	Issue Type +	En	Location *	LS
Category	Earthen Levee			GPS Latitude/Longitude	
				Start	End
Item	Encroachments			38.599834 °	38.597531 °
				-121.513994 °	-121.513147 °
DWR ID	DWR_MA0004_01_s _ 2012_14				
Action/Comments					
Fence					
Inspector Comments: A fence runs along the toe of the landside levee

The fence runs along the toe and is within the easement. Fall 2013

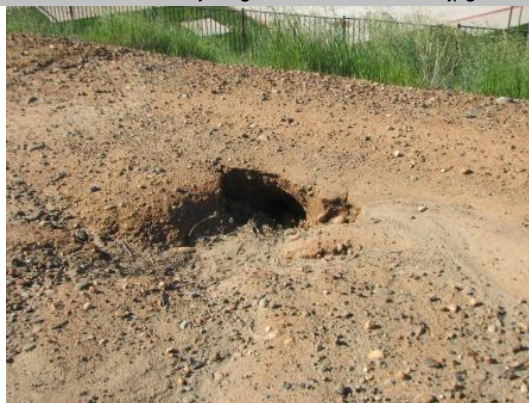
Photo 1 of 2 : johngw\_s\_20140317\_650.jpg

LM Start	2.06	Rating **	U	Issue No.	19
LM End	2.06	Issue Type +	Ma	Location *	LS
Category	Earthen Levee			GPS Latitude/Longitude	
				Start	End
Item	Erosion / Bank Caving			38.599133 °	38.599133 °
				-121.513384 °	-121.513384 °
DWR ID	DWR_MA0004_01_s _ 2014_19				
Action/Comments					
Schedule repair of erosion site prior to the next inspection. Inspector Comments: Looks like it may be a old squirrel hole. Burrow goes thru the shoulder and breaks out on levee slope.

Erosion on levee shoulder entrance side on crown. Spring 2014

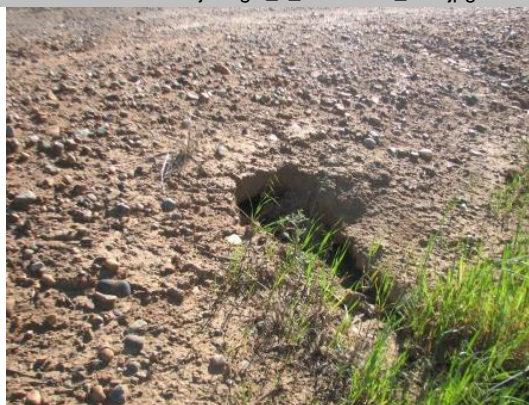
Photo 2 of 2 : johngw\_s\_20140317\_651.jpg

The exit side of the erosion from shoulder. Spring 2014

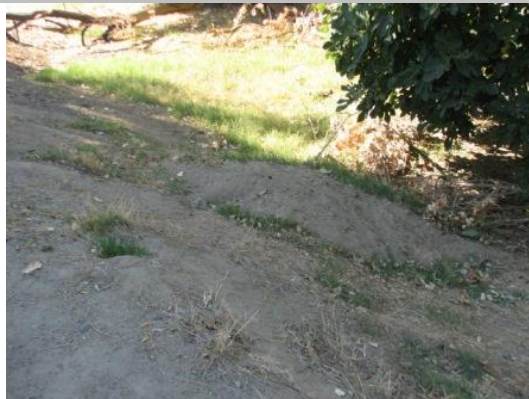
Photo 1 of 1 : johngw\_s\_20140306\_284.jpg

LM Start	3.00	Rating **	M	Issue No.	3
LM End	3.00	Issue Type +	Ma	Location *	LS
Category	Earthen Levee			GPS Latitude/Longitude	
				Start	End
Item	Animal Control			38.587135 °	38.587135 °
				-121.508093 °	-121.508093 °
DWR ID	DWR_MA0004_01_f_2012_3				
Action/Comments					
Exterminate rodents and backfill and compact or grout burrows.

A large rodent hole on the landside levee slope. Fall 2013

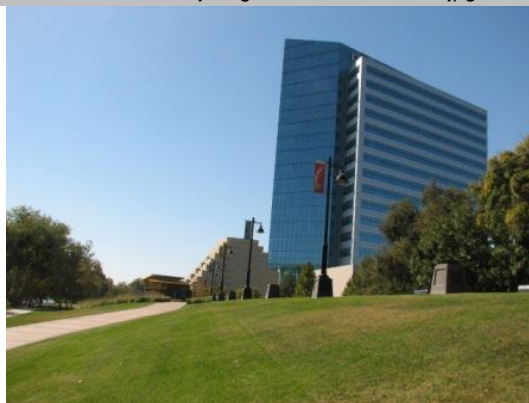
Photo 1 of 2 : johngw\_s\_20140306\_288.jpg

LM Start	3.07	Rating **	A/W	Issue No.	12
LM End	3.40	Issue Type +	En	Location *	WS
Category	Earthen Levee			GPS Latitude/Longitude	
				Start	End
Item	Vegetation			38.585642 °	38.534710 °
				-121.508385 °	-121.517390 °
DWR ID	DWR_MA0004_01_s_2012_12				
Action/Comments					
Landscaping Inspector Comments: West Sacramento's River walk runs from Tower Bridge to the I Street bridge.

Landscaping and buildings are on the crown and waterside levee. Fall 2013

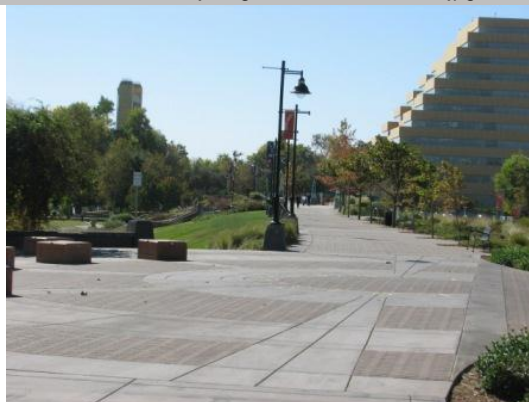
Photo 2 of 2 : johngw\_s\_20140306\_289.jpg

The Riverwalk is part of the landscape on the levee. Fall 2013
