**Flood Control Project Maintenance
Levee Inspections****LMA District Cover Sheet****Spring 2015 Levee Inspection Results****Sacramento Maintenance Yard Maintenance Area 0004**

Levee Inspection Report By Mile - Spring 2015

Waterway	Bank	Unit Miles	Inspection Start/End	Inspector
Unit No. 01 Sacramento River	Right	3.47	04/15/2015 04/15/2015	Jai Lor

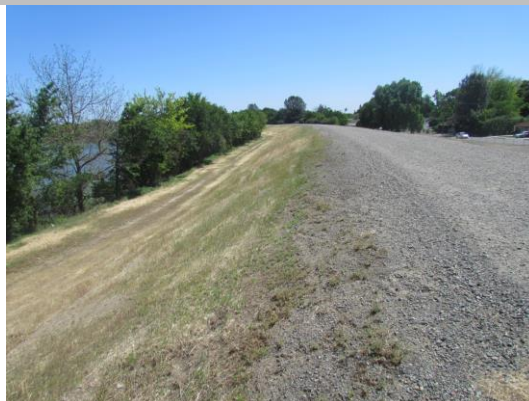
Photo 1 of 1 : SP_2015_MA0004_298_1_20150417_00014.jpg

LM Start	0.00	Rating **	A/W	Issue No.	1
LM End	3.40	Issue Type +	Ma	Location *	LS
Category	Earthen Levee			GPS Latitude/Longitude	
				Start	End
Item	Vegetation				°
					°
DWR ID	DWR_MA0004_01_f_2014_1				
Action/Comments					
Control annual grass and weeds on the levee slopes and easements.

View of the vegetation on the landward side of the levee looking downstream. Spring 2015.

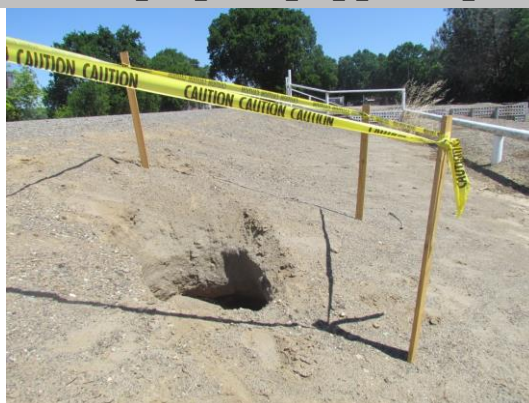
Photo 1 of 2 : SP_2015_MA0004_298_4_20150417_00015.jpg

LM Start	0.19	Rating **	U	Issue No.	4
LM End	0.19	Issue Type +	Ma	Location *	LS
Category	Earthen Levee			GPS Latitude/Longitude	
				Start	End
Item	Slope Stability			38.596797 °	38.596797 °
				-121.544192 °	-121.544192 °
DWR ID	DWR_MA0004_01_s_2015_4				
Action/Comments					
Repair slope instability.

View of the sinkhole on the landward side of the levee looking downstream. Spring 2015.

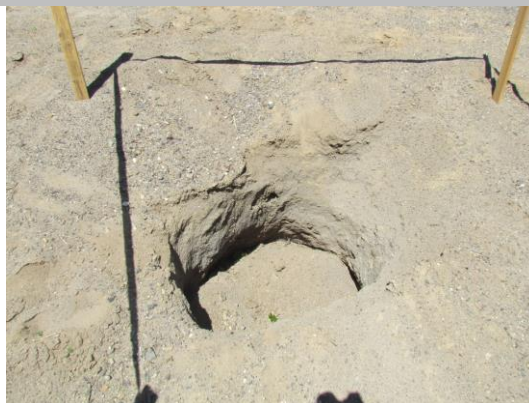
Photo 2 of 2 : SP_2015_MA0004_298_4_20150417_00016.jpg

LM Start	0.19	Rating **	U	Issue No.	4 (cont)
LM End	0.19	Issue Type +	Ma	Location *	LS

A close-up shot of the sinkhole on the landward side of the levee. Spring 2015.

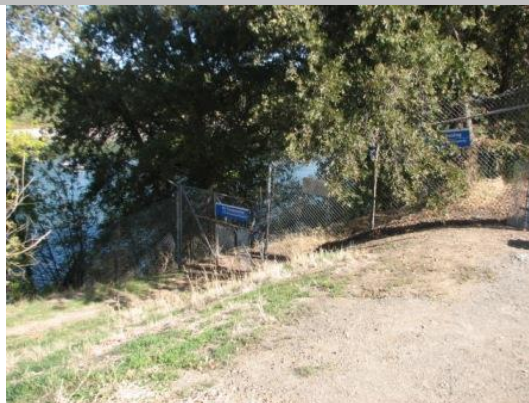
Photo 1 of 2 : SP_2015_MA0004_298_2_20150326_00003.jpg

LM Start	0.24	Rating **	U	Issue No.	2
LM End	0.24	Issue Type +	En	Location *	CR
Category	Earthen Levee			GPS Latitude/Longitude	
				Start	End
Item	Encroachments			38.597193 °	38.597193 °
				-121.543421 °	-121.543421 °
DWR ID	DWR_MA0004_01_s _ 2012_2				
Action/Comments					
Fence					
Inspector Comments: This is the USACE yard and the chain link fence crosses the levee. The fence runs the length of the yard on the crown.

The fence blocks access to the waterside levee slope. Fall 2013

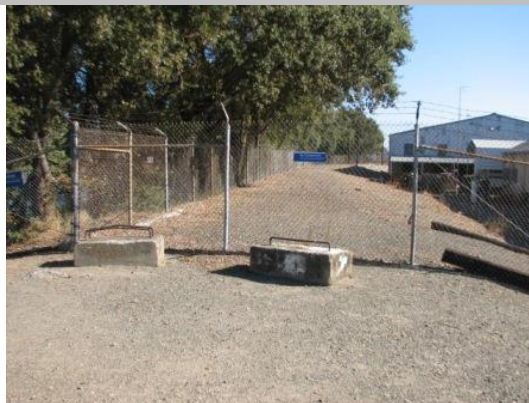
Photo 2 of 2 : SP_2015_MA0004_298_2_20150326_00004.jpg

The fence blocks the crown of the levee. Fall 2013

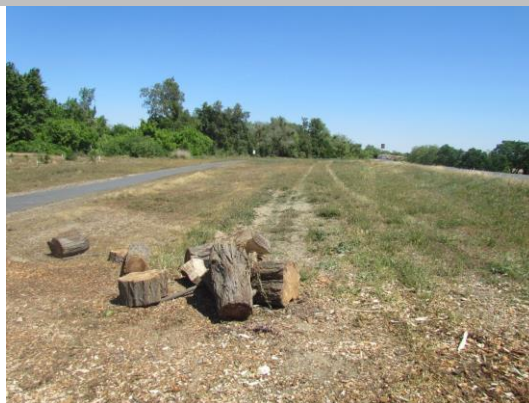
Photo 1 of 1 : SP_2015_MA0004_298_5_20150417_00017.jpg

LM Start	1.03	Rating **	M	Issue No.	5
LM End	1.03	Issue Type +	En	Location *	LS
Category	Earthen Levee			GPS Latitude/Longitude	
				Start	End
Item	Encroachments			38.602373 °	38.602373 °
				-121.531265 °	-121.531265 °
DWR ID	DWR_MA0004_01_s _ 2015_5				
Action/Comments					
Firewood

View of the firewood on the landward side of the levee looking downstream. Spring 2015.

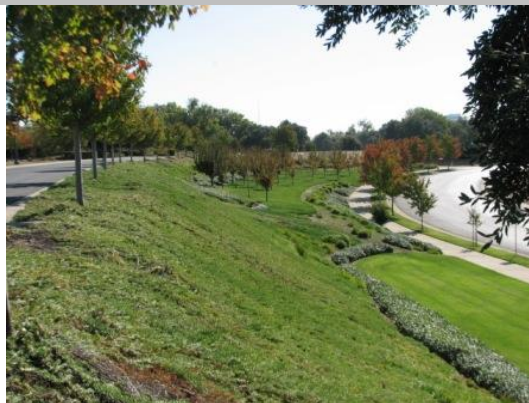
Photo 1 of 2 : SP_2015_MA0004_298_7_20150326_00006.jpg

LM Start	1.34	Rating **	A/W	Issue No.	7
LM End	1.97	Issue Type +	Ma	Location *	LS
Category	Earthen Levee			GPS Latitude/Longitude	
				Start	End
Item	Vegetation			38.602756 °	38.600449 °
				-121.525618 °	-121.514459 °
DWR ID	DWR_MA0004_01_s _ 2012_7				
Action/Comments					
Landscaping					
Inspector Comments: The Rivers housing development

The landside levee slope is landscaped. Fall 2013

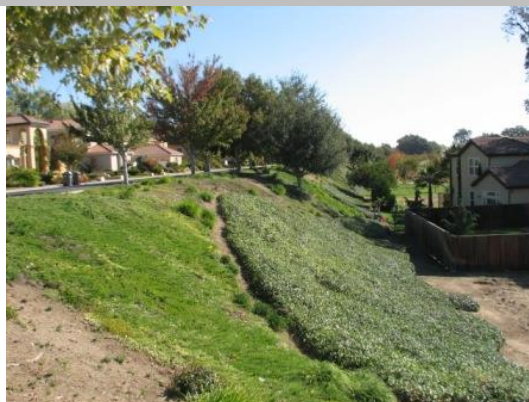
Photo 2 of 2 : SP_2015_MA0004_298_7_20150326_00007.jpg

LM Start	1.34	Rating **	A/W	Issue No.	7 (cont)
LM End	1.97	Issue Type +	Ma	Location *	LS

The landside of the levee slope is landscaped. Fall 2013

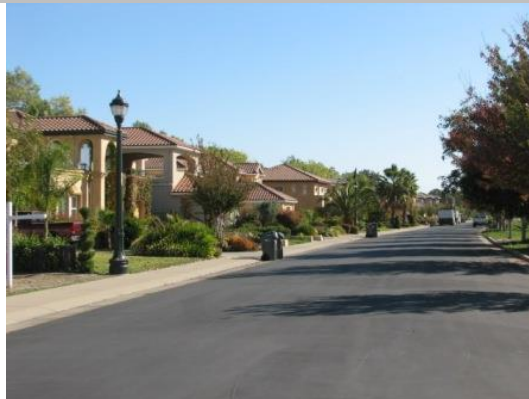
Photo 1 of 1 : SP_2015_MA0004_298_8_20150326_00008.jpg

LM Start	1.35	Rating **	A/W	Issue No.	8
LM End	1.51	Issue Type +	Ma	Location *	CR
Category	Earthen Levee			GPS Latitude/Longitude	
				Start	End
Item	Encroachments			38.602764 °	38.602596 °
				-121.525319 °	-121.522439 °
DWR ID	DWR_MA0004_01_s _ 2012_8				
Action/Comments					
Building					
Inspector Comments: The Rivers housing development houses on crown of levee waterside

Houses have been built on the crown of the levee. Fall 2013

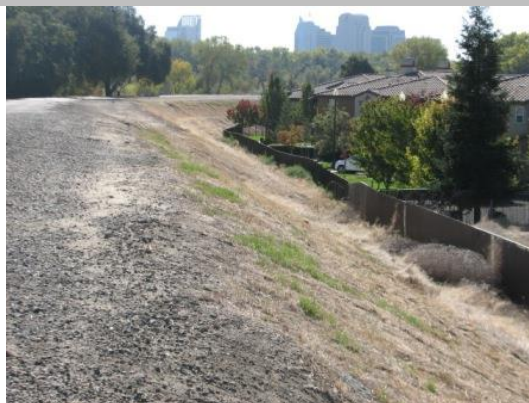
Photo 1 of 1 : SP_2015_MA0004_298_14_20150326_00011.jpg

LM Start	2.02	Rating **	M	Issue No.	14
LM End	2.21	Issue Type +	En	Location *	LS
Category	Earthen Levee			GPS Latitude/Longitude	
				Start	End
Item	Encroachments			38.599834 °	38.597531 °
				-121.513994 °	-121.513147 °
DWR ID	DWR_MA0004_01_s _ 2012_14				
Action/Comments					
Fence					
Inspector Comments: A fence runs along the toe of the landside levee

The fence runs along the toe and is within the easement. Fall 2013

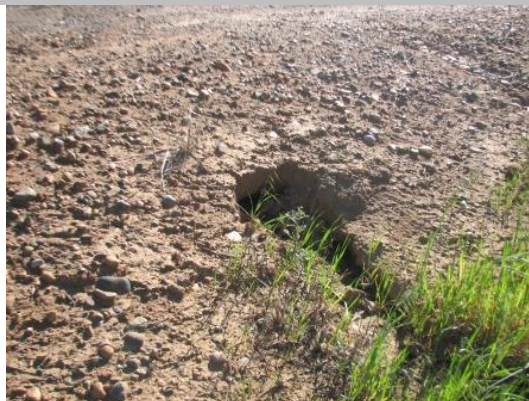
Photo 1 of 2 : SP_2015_MA0004_298_19_20150326_00012.jpg

LM Start	2.08	Rating **	U	Issue No.	19
LM End	2.08	Issue Type +	Ma	Location *	LS
Category	Earthen Levee			GPS Latitude/Longitude	
				Start	End
Item	Erosion / Bank Caving			38.599133 °	38.599133 °
				-121.513384 °	-121.513384 °
DWR ID	DWR_MA0004_01_s _ 2014_19				
Action/Comments					
Schedule repair of erosion site prior to the next inspection. Inspector Comments: Looks like it may be a old squirrel hole. Burrow goes thru the shoulder and breaks out on levee slope.

The exit side of the erosion from shoulder. Spring 2014

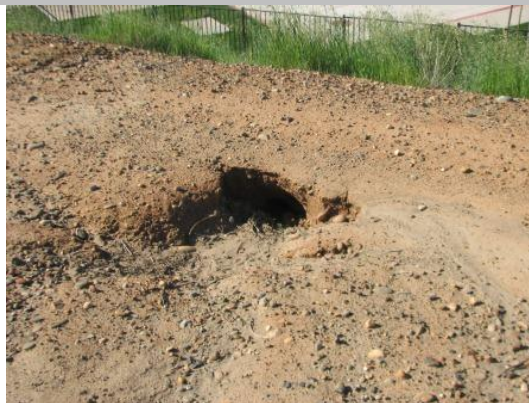
Photo 2 of 2 : SP_2015_MA0004_298_19_20150326_00013.jpg

LM Start	2.08	Rating **	U	Issue No.	19 (cont)	
LM End	2.08	Issue Type +	Ma	Location *	LS	
Category	Earthen Levee			GPS Latitude/Longitude		
				Start		End
Item	Erosion / Bank Caving			38.599133 °	38.599133 °	
				-121.513384 °	-121.513384 °	
DWR ID	DWR_MA0004_01_s_2014_19					
Action/Comments						
Schedule repair of erosion site prior to the next inspection. Inspector Comments: Looks like it may be a old squirrel hole. Burrow goes thru the shoulder and breaks out on levee slope.

Erosion on levee shoulder entrance side on crown. Spring 2014

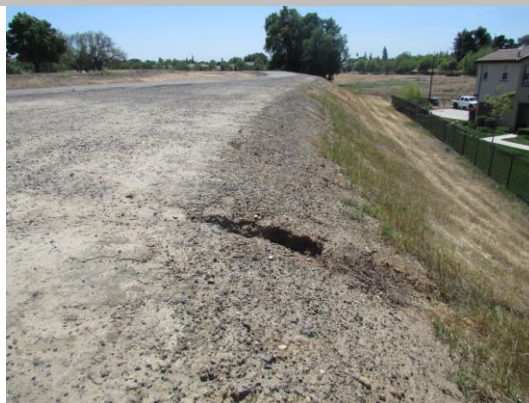
Photo 1 of 1 : SP_2015_MA0004_298_13_20150417_00018.jpg

LM Start	2.18	Rating **	M	Issue No.	13
LM End	2.18	Issue Type +	Ma	Location *	LS
Category	Earthen Levee			GPS Latitude/Longitude	
				Start	End
Item	Erosion / Bank Caving			38.597967 °	38.597967 °
				-121.512892 °	-121.512892 °
DWR ID	DWR_MA0004_01_s_2015_13				
Action/Comments					
Note and monitor erosion site.

View of the erosion on the landward side of the levee looking downstream. Spring 2015.

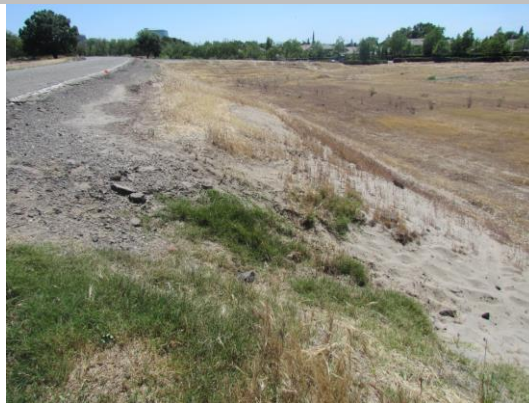
Photo 1 of 1 : SP_2015_MA0004_298_15_20150417_00019.jpg

LM Start	2.28	Rating **	M	Issue No.	15
LM End	2.28	Issue Type +	Ma	Location *	LS
Category	Earthen Levee			GPS Latitude/Longitude	
				Start	End
Item	Slope Stability			38.596557 °	38.596557 °
				-121.513159 °	-121.513159 °
DWR ID	DWR_MA0004_01_s_2015_15				
Action/Comments					
Repair the levee slope damaged by foot traffic and prevent access where possible.

View of the slope stability on the landward side of the levee looking downstream. Spring 2015.

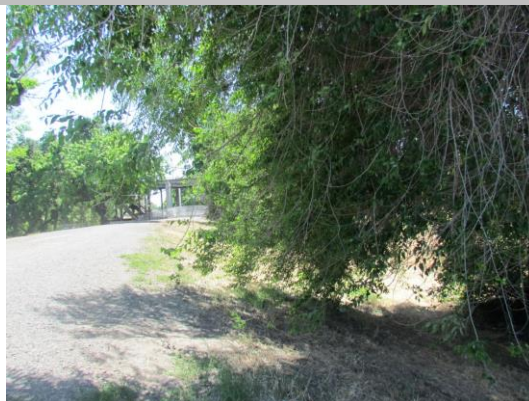
Photo 1 of 1 : SP_2015_MA0004_298_16_20150417_00020.jpg

LM Start	3.01	Rating **	M	Issue No.	16
LM End	3.01	Issue Type +	Ma	Location *	LS
Category	Earthen Levee			GPS Latitude/Longitude	
				Start	End
Item	Trim / Thin Trees			38.587532 °	38.587532 °
				-121.507980 °	-121.507980 °
DWR ID	DWR_MA0004_01_s_2015_16				
Action/Comments					
Trim trees to at least five feet above ground level.

View of the tree branches on the landward side of the levee looking downstream. Spring 2015.

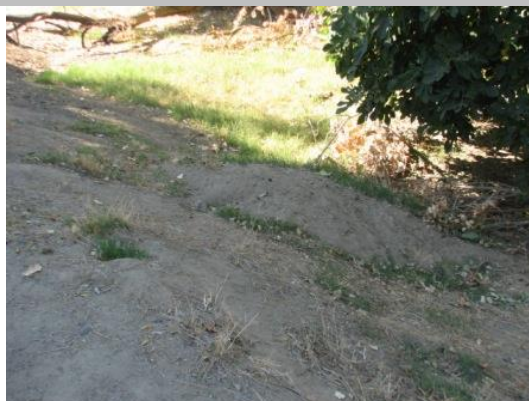
Photo 1 of 1 : SP_2015_MA0004_298_3_20150326_00005.jpg

LM Start	3.03	Rating **	M	Issue No.	3
LM End	3.03	Issue Type +	Ma	Location *	LS
Category	Earthen Levee			GPS Latitude/Longitude	
				Start	End
Item	Animal Control			38.587135 °	38.587135 °
				-121.508093 °	-121.508093 °
DWR ID	DWR_MA0004_01_f_2012_3				
Action/Comments					
Exterminate rodents and backfill and compact or grout burrows.

A large rodent hole on the landside levee slope. Fall 2013

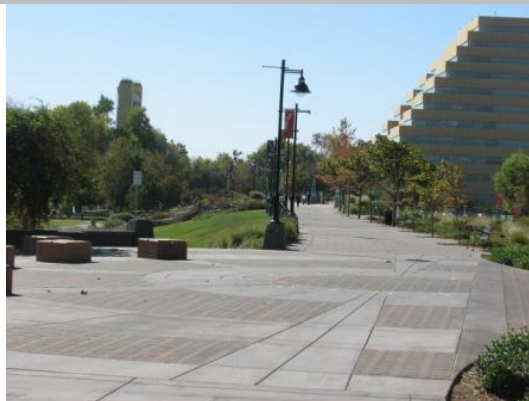
Photo 1 of 2 : SP_2015_MA0004_298_12_20150326_00009.jpg

LM Start	3.14	Rating **	A/W	Issue No.	12
LM End	3.40	Issue Type +	En	Location *	WS
Category	Earthen Levee			GPS Latitude/Longitude	
				Start	End
Item	Vegetation			38.585642 °	38.534710 °
				-121.508385 °	-121.517390 °
DWR ID	DWR_MA0004_01_s_2012_12				
Action/Comments					
Landscaping					
Inspector Comments: West Sacramento's River walk runs from Tower Bridge to the I Street bridge.

The Riverwalk is part of the landscape on the levee. Fall 2013

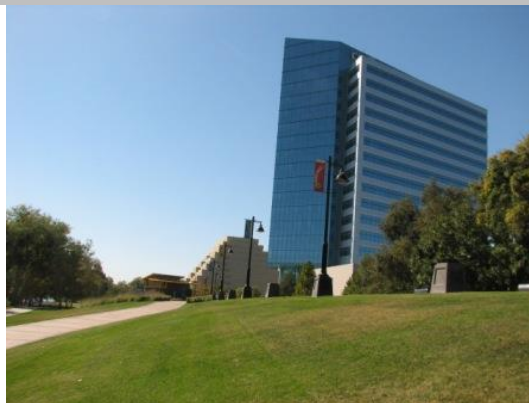
Photo 2 of 2 : SP_2015_MA0004_298_12_20150326_00010.jpg

LM Start	3.14	Rating **	A/W	Issue No.	12 (cont)
LM End	3.40	Issue Type +	En	Location *	WS
Category	Earthen Levee			GPS Latitude/Longitude	
				Start	End
Item	Vegetation			38.585642 °	38.534710 °
				-121.508385 °	-121.517390 °
DWR ID	DWR_MA0004_01_s _ 2012_12				
Action/Comments					
Landscaping					
Inspector Comments: West Sacramento's River walk runs from Tower Bridge to the I Street bridge.

Landscaping and buildings are on the crown and waterside levee. Fall 2013
