**Flood Control Project Maintenance
Levee Inspections****LMA District Cover Sheet****Spring 2016 Levee Inspection Results****Sacramento Maintenance Yard Maintenance Area 0004**

Spring 2016 Levee Inspection Results

Sacramento Maintenance Yard Maintenance Area 0004

Waterway			Bank	Unit Miles
Unit No. 01 Sacramento River			Right	3.47
	Spring (March - May)	Summer (June - August)	(September - November) Fall	Winter (December - February)
Unit Maintenance Rating (Fall Only)				
Date of Inspection	4/1/2016 - 4/1/2016			
DWR Inspector	Jai Lor			
Accompanied By

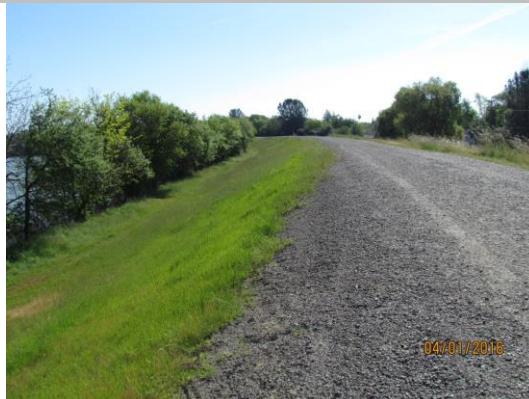
Photo 1 of 1 : SP_2016_MA0004_298_15_20160411_00030.jpg

LM Start	0.00	Rating **	A	Issue No.	15
LM End	1.55	Issue Type +	Ma	Location *	WS
Category	Earthen Levee			GPS Latitude/Longitude	
				Start	End
Item	Vegetation			38.596835 °	38.602505 °
				-121.547676 °	-121.521710 °
DWR ID	DWR_MA0004_01_s_2016_15				
Comment Code					
V1 : Control annual grass and weeds on the levee slopes and easements.					
Inspector Comment

View of the vegetation on the waterward side of the levee looking downstream. Spring 2016.

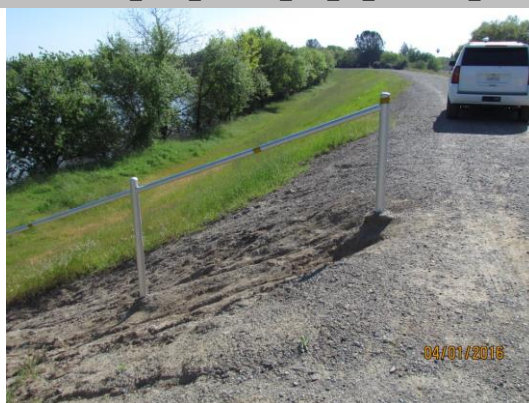
Photo 1 of 1 : SP_2016_MA0004_298_16_20160411_00031.jpg

LM Start	0.00	Rating **	M	Issue No.	16
LM End	0.00	Issue Type +	Ma	Location *	WS
Category	Earthen Levee			GPS Latitude/Longitude	
				Start	End
Item	Slope Stability			38.596823 °	38.596823 °
				-121.547608 °	-121.547608 °
DWR ID	DWR_MA0004_01_s_2016_16				
Comment Code					
S2 : Repair the levee slope damaged by foot traffic and prevent access where possible.					
Inspector Comment

View of the slope stability on the waterward side of the levee looking downstream. Spring 2016.

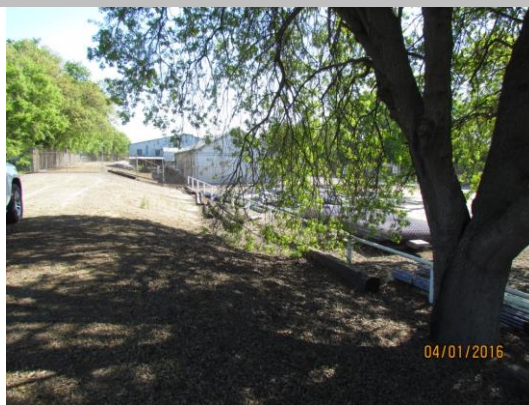
Photo 1 of 1 : SP_2016_MA0004_298_28_20160411_00032.jpg

LM Start	0.22	Rating **	M	Issue No.	28
LM End	0.22	Issue Type +	Ma	Location *	LS
Category	Earthen Levee			GPS Latitude/Longitude	
				Start	End
Item	Trim / Thin Trees			38.597035 °	38.597035 °
				-121.543620 °	-121.543620 °
DWR ID	DWR_MA0004_01_s_2016_28				
Comment Code					
T1 : Trim trees to at least five feet above ground level.					
Inspector Comment

View of the tree branches on the landward side of the levee looking downstream. Spring 2016.

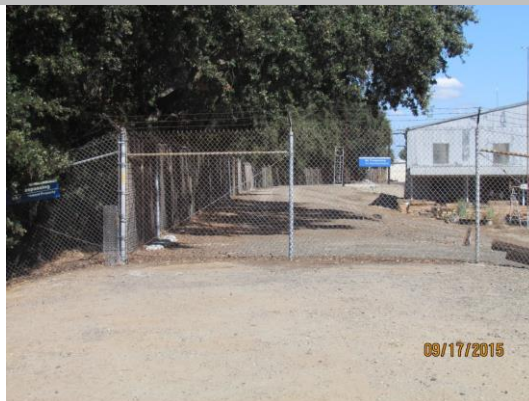
Photo 1 of 1 : SP_2016_MA0004_298_2_20160304_00003.jpg

LM Start	0.24	Rating **	U	Issue No.	2
LM End	0.24	Issue Type +	En	Location *	CR
Category	Earthen Levee			GPS Latitude/Longitude	
				Start	End
Item	Encroachments			38.597193 °	38.597193 °
				-121.543421 °	-121.543421 °
DWR ID	DWR_MA0004_01_s _ 2012_2				
Comment Code					
FE : Fence					
Inspector Comment					
This is the USACE yard and the chain link fence crosses the levee. The fence runs the length of the yard on the crown.

View of the fence blocking access on the crown of the levee looking downstream. Fall 2015.

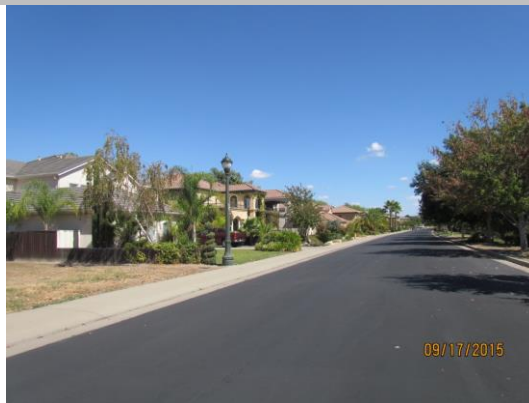
Photo 1 of 1 : SP_2016_MA0004_298_8_20160304_00006.jpg

LM Start	1.36	Rating **	A/W	Issue No.	8
LM End	1.51	Issue Type +	Ma	Location *	CR
Category	Earthen Levee			GPS Latitude/Longitude	
				Start	End
Item	Encroachments			38.602770 °	38.602591 °
				-121.525275 °	-121.522382 °
DWR ID	DWR_MA0004_01_s_2012_8				
Comment Code					
BU : Building					
Inspector Comment					
The Rivers housing development houses on crown of levee waterside

View of the houses on the crown of the levee looking downstream. Fall 2015.

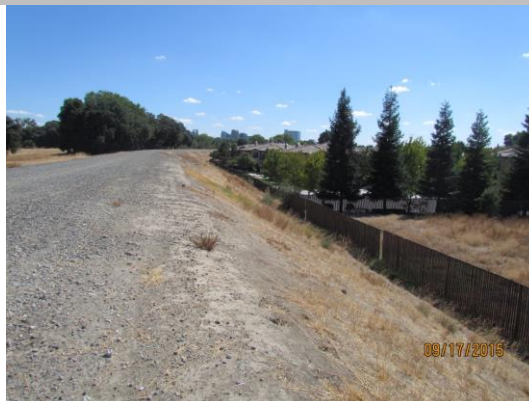
Photo 1 of 1 : SP_2016_MA0004_298_14_20160304_00010.jpg

LM Start	2.02	Rating **	M	Issue No.	14
LM End	2.21	Issue Type +	En	Location *	LS
Category	Earthen Levee			GPS Latitude/Longitude	
				Start	End
Item	Encroachments			38.599813 °	38.597533 °
				-121.513978 °	-121.513134 °
DWR ID	DWR_MA0004_01_s _ 2012_14				
Comment Code					
FE : Fence					
Inspector Comment					
A fence runs along the toe of the landside levee

View of the fence running along the toe of the landward side of the levee looking downstream. Fall 2015.

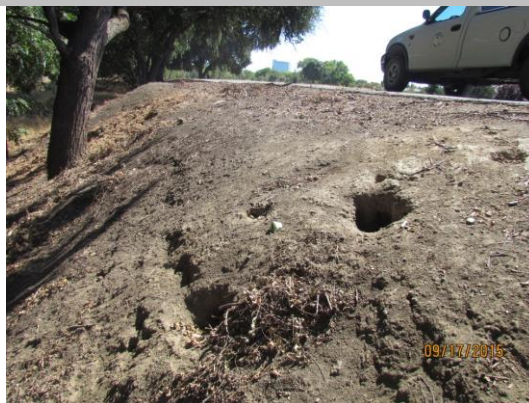
Photo 1 of 1 : SP_2016_MA0004_298_18_20160304_00011.jpg

LM Start	2.12	Rating **	M	Issue No.	18
LM End	2.12	Issue Type +	Ma	Location *	WS
Category	Earthen Levee			GPS Latitude/Longitude	
				Start	End
Item	Animal Control			38.598613 °	38.598613 °
				-121.513012 °	-121.513012 °
DWR ID	DWR_MA0004_01_f_2015_18				
Comment Code					
A3 : No rodents visible, but rodent burrows visible; need to backfill and compact or grout burrows.					
Inspector Comment

View of the animal holes on the waterward side of the levee looking downstream. Fall 2015.

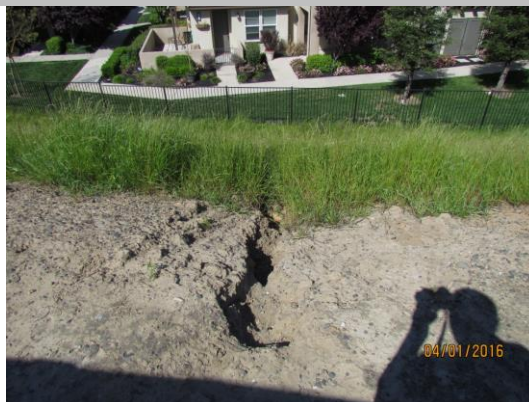
Photo 1 of 2 : SP_2016_MA0004_298_13_20160411_00035.jpg

LM Start	2.18	Rating **	M	Issue No.	13
LM End	2.18	Issue Type +	Ma	Location *	LS
Category	Earthen Levee			GPS Latitude/Longitude	
				Start	End
Item	Erosion / Bank Caving			38.597932 °	38.597932 °
				-121.512887 °	-121.512887 °
DWR ID	DWR_MA0004_01_s_2015_13				
Comment Code					
E2 : Schedule repair of erosion site prior to the next inspection.					
Inspector Comment

Runoff erosion is on the shoulder of the landward side. Spring 2016.

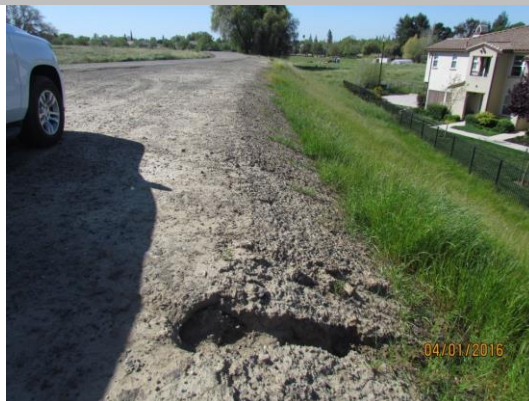
Photo 2 of 2 : SP_2016_MA0004_298_13_20160411_00034.jpg

LM Start	2.18	Rating **	M	Issue No.	13 (cont)	
LM End	2.18	Issue Type +	Ma	Location *	LS	
Category	Earthen Levee			GPS Latitude/Longitude		
				Start		End
Item	Erosion / Bank Caving			38.597932 °		38.597932 °
				-121.512887 °		-121.512887 °
DWR ID	DWR_MA0004_01_s_2015_13					
Comment Code						
E2 : Schedule repair of erosion site prior to the next inspection.						
Inspector Comment

Perspective view of the runoff erosion on the landward side of the levee looking upstream. Spring 2016.

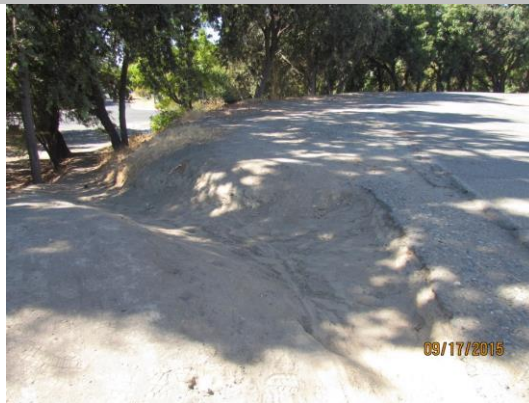
Photo 1 of 1 : SP_2016_MA0004_298_22_20160304_00013.jpg

LM Start	2.65	Rating **	M	Issue No.	22
LM End	2.65	Issue Type +	Ma	Location *	LS
Category	Earthen Levee			GPS Latitude/Longitude	
				Start	End
Item	Slope Stability			38.591380 °	38.591380 °
				-121.511345 °	-121.511345 °
DWR ID	DWR_MA0004_01_f_2015_22				
Comment Code					
S2 : Repair the levee slope damaged by foot traffic and prevent access where possible.					
Inspector Comment

View of the depression on the landward side of the levee due to foot traffic looking upstream. Fall 2015.

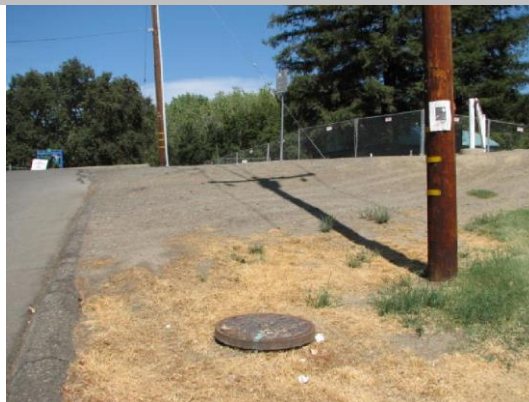
Photo 1 of 2 : UCIP_SP_2016_41443_9371.jpg

LM Start	2.69	Rating **	M	Issue No.	39
LM End	2.69	Issue Type +	En	Location *	LS
Category	Supplemental			GPS Latitude/Longitude	
				Start	End
Item	DWR UCIP Field Study			38.590910 °	38.590910 °
				-121.510830 °	-121.510830 °
DWR ID					
Comment Code					
Inspector Comment					
FS_ID:41443 DS_ID:19405 EP_NO: N/A Repair Type: Non-Urgent Crossing Status: Found UCIP Comments: Found during the field survey, not listed in the desk study. FIELD_STRUCT_DESC: A 6-inch sewer line from the public facility of boat launching area. No other details available. FS Date: 9/12/2012

Landside view- manhole on the side of the levee and a road.

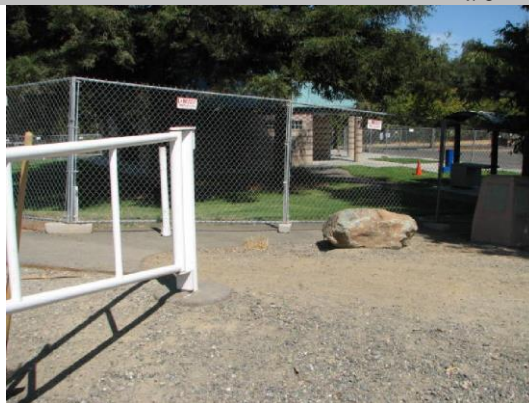
Photo 2 of 2 : UCIP_SP_2016_41443_9370.jpg

LM Start	2.69	Rating **	M	Issue No.	39 (cont)
LM End	2.69	Issue Type +	En	Location *	LS
Category	Supplemental			GPS Latitude/Longitude	
				Start	End
Item	DWR UCIP Field Study			38.590910 °	38.590910 °
				-121.510830 °	-121.510830 °
DWR ID					
Comment Code					
Inspector Comment					
FS_ID:41443 DS_ID:19405 EP_NO: N/A Repair Type: Non-Urgent Crossing Status: Found UCIP Comments: Found during the field survey, not listed in the desk study. FIELD_STRUCT_DESC: A 6-inch sewer line from the public facility of boat launching area. No other details available. FS Date: 9/12/2012

Waterside view- public facility in the background.

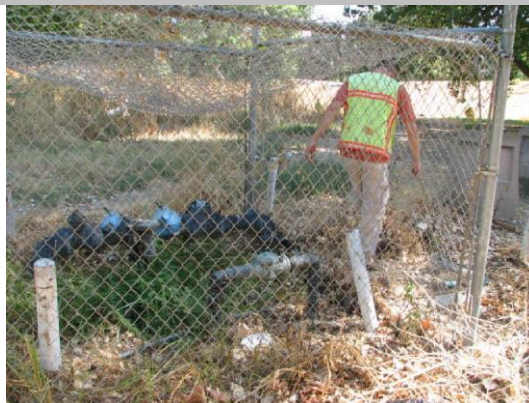
Photo 2 of 2 : UCIP_SP_2016_41485_9366.jpg

FS_ID:41485
DS_ID:19406
EP_NO: N/A
Repair Type: Non-Urgent
Crossing Status: Found
UCIP Comments: Found during field survey. Not listed in the desk study.
FIELD_STRUCT_DESC: 1 of 2. A 3-inch wrapped GI water pipe(of 3-inch and 5-inch water pipe) daylight in a metal cage box. A valve box for the pipe is also found.
FS Date: 9/12/2012

Waterside view- pipe daylight in a metal cage.

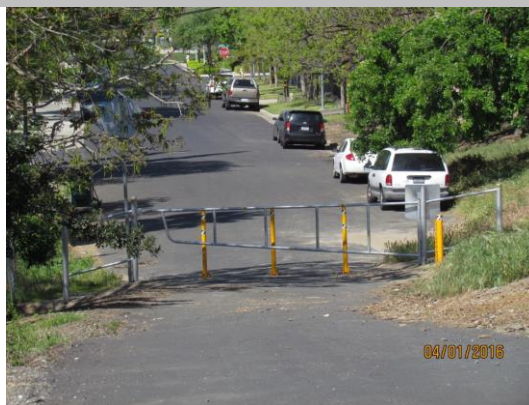
Photo 1 of 2 : SP_2016_MA0004_298_35_20160411_00040.jpg

Bollards are blocking the access gate on the levee ramp. Spring 2016.

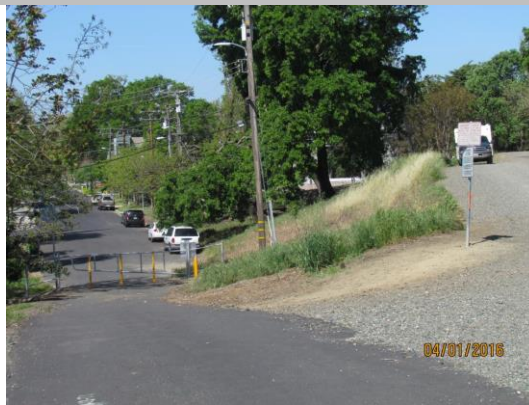
Photo 2 of 2 : SP_2016_MA0004_298_35_20160411_00039.jpg

Perspective view of the bollards at the levee toe looking upstream. Spring 2016.

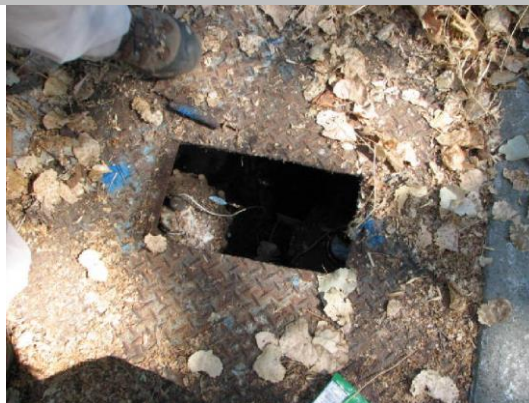
Photo 2 of 2 : UCIP_SP_2016_41486_9368.jpg

LM Start	2.82	Rating **	M	Issue No.	37
LM End	2.82	Issue Type +	En	Location *	LS
Category	Supplemental			GPS Latitude/Longitude	
				Start	End
Item	DWR UCIP Field Study			38.590130 °	38.590130 °
				-121.508740 °	-121.508740 °
DWR ID					
Comment Code					
Inspector Comment					
FS_ID:41486 DS_ID:19407 EP_NO: N/A Repair Type: Non-Urgent Crossing Status: Found UCIP Comments: Found during field survey, not listed in the desk study. FIELD_STRUCT_DESC: 2 of 2. A 5-inch wrapped GI water pipe(of 3-inch and 5-inch water pipe) daylight in a metal cage box. A valve box for the pipe is also found. FS Date: 9/12/2012

Waterside view- manhole/control valve.

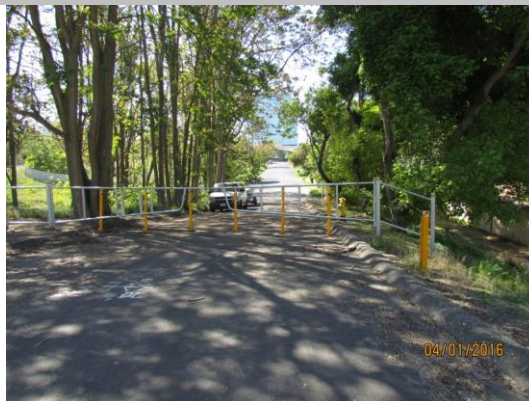
Photo 1 of 3 : SP_2016_MA0004_298_34_20160411_00037.jpg

The City of West Sacramento has put bollards and blocked access to the gates. Spring 2016.

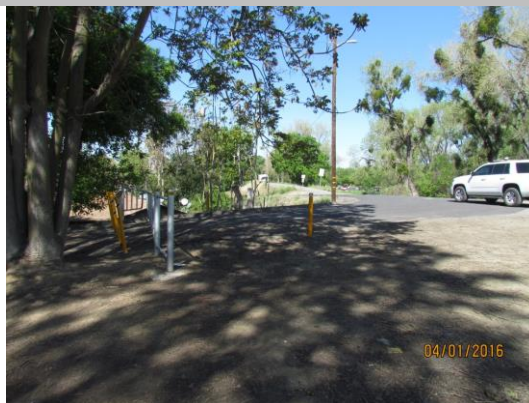
Photo 2 of 3 : SP_2016_MA0004_298_34_20160411_00036.jpg

Perspective view of the bollards on the landward side looking upstream. Spring 2016.

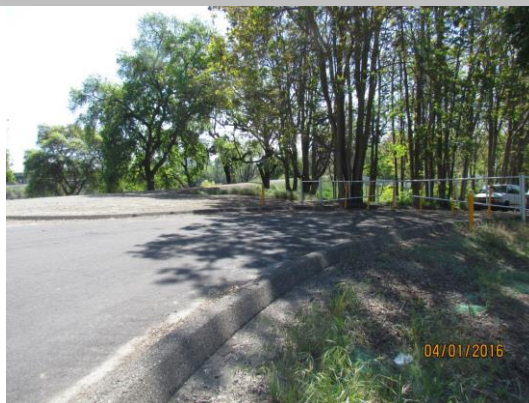
Photo 3 of 3 : SP_2016_MA0004_298_34_20160411_00038.jpg

Perspective view of the bollards looking downstream. Spring 2016.

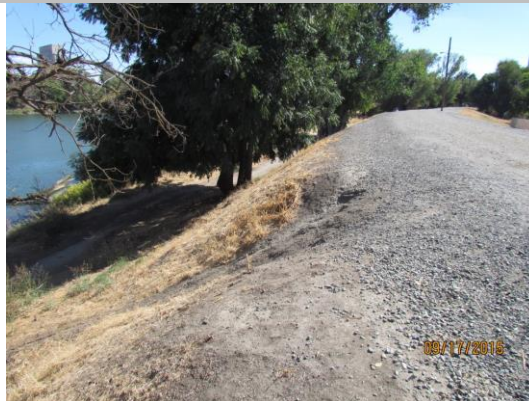
Photo 1 of 1 : SP_2016_MA0004_298_24_20160304_00015.jpg

LM Start	2.91	Rating **	M	Issue No.	24
LM End	2.91	Issue Type +	Ma	Location *	WS
Category	Earthen Levee			GPS Latitude/Longitude	
				Start	End
Item	Slope Stability			38.588937 °	38.588937 °
				-121.507920 °	-121.507920 °
DWR ID	DWR_MA0004_01_f_2015_24				
Comment Code					
S2 : Repair the levee slope damaged by foot traffic and prevent access where possible.					
Inspector Comment

View of the slope stability due to foot traffic on the waterward side of the levee looking downstream. Fall 2015.

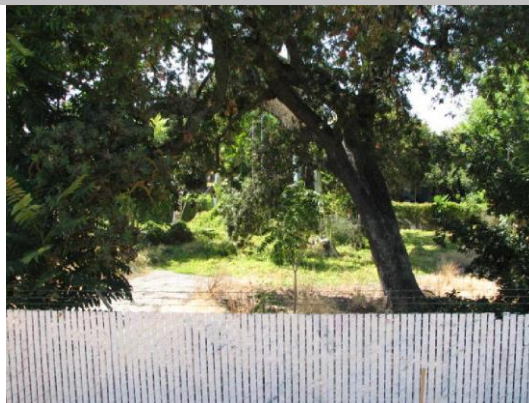
Photo 1 of 2 : UCIP_SP_2016_41557_9767.jpg

LM Start	2.93	Rating **	M	Issue No.	38
LM End	2.93	Issue Type +	En	Location *	WS
Category	Supplemental			GPS Latitude/Longitude	
				Start	End
Item	DWR UCIP Field Study			38.588688 °	38.588688 °
				-121.507910 °	-121.507910 °
DWR ID					
Comment Code					
Inspector Comment					
FS_ID:41557 DS_ID:18883 EP_NO: N/A Repair Type: Non-Urgent Crossing Status: Found UCIP Comments: Abandoned 7-inch pipe found. Needs to be abandoned properly. FIELD_STRUCT_DESC: 2 of 4. An abandoned 7-inch pipe of one 3-inch, two 7-inch and one 10-inch pipes through the levee 18.6 feet below the crown. Unable to locate. Pipes exposed and extend 10 feet from bank. O&M Manual Sac 116, August 1955, Revision Year 2011. FS Date: 9/12/2012

Land side view- Water tower area.

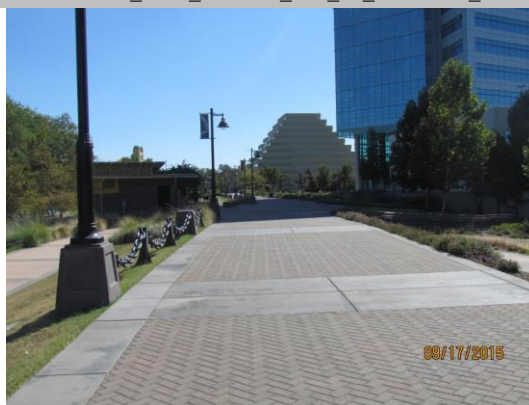
Photo 1 of 2 : SP_2016_MA0004_298_12_20160304_00007.jpg

The Riverwalk is part of the landscape on the levee. Fall 2015.

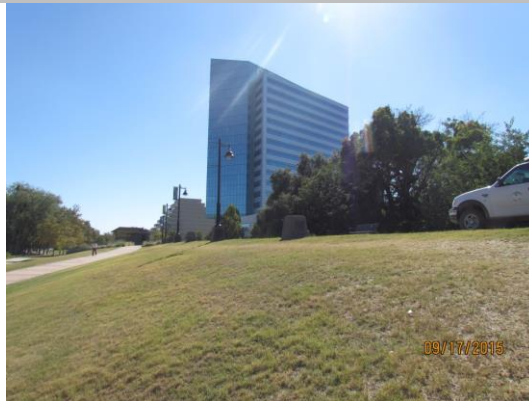
Photo 2 of 2 : SP_2016_MA0004_298_12_20160304_00008.jpg

Landscaping and buildings are on the crown and waterward side of the levee. Fall 2015.

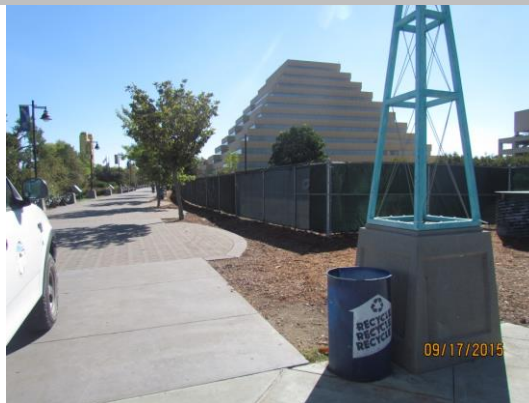
Photo 1 of 2 : SP_2016_MA0004_298_27_20160304_00018.jpg

LM Start	3.24	Rating **	M	Issue No.	27
LM End	3.29	Issue Type +	En	Location *	LS
Category	Earthen Levee			GPS Latitude/Longitude	
				Start	End
Item	Encroachments			38.584168 °	38.583435 °
				-121.508632 °	-121.508785 °
DWR ID	DWR_MA0004_01_f_2015_27				
Comment Code					
FE : Fence					
Inspector Comment					
There is a fence at the shoulder of the levee crown. There seems to be no work being done inside of the fence as of 9/17/2015.

View of the fence on the crown of the levee looking downstream. Fall 2015.

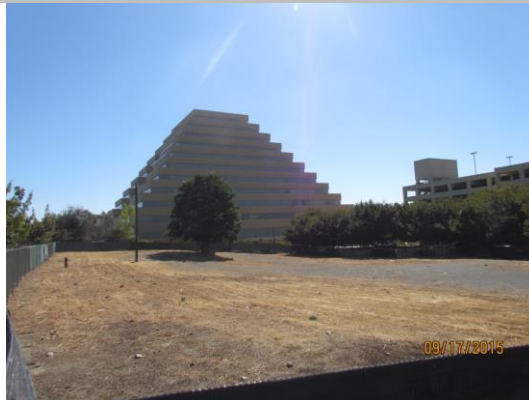
Photo 2 of 2 : SP_2016_MA0004_298_27_20160304_00019.jpg

View of the inside of the fence looking downstream. Fall 2015.
