**Flood Control Project Maintenance
Levee Inspections**
LMA District Cover Sheet
Spring 2017 Levee Inspection Results

Sacramento Maintenance Yard Maintenance Area 0004

Levee Inspection Report By Mile - Spring 2017

Waterway	Bank	Unit Miles	Inspection Start/End	Inspector
Unit No. 01 Sacramento River	Right	3.47	04/14/2017 04/14/2017	Zach Jojola

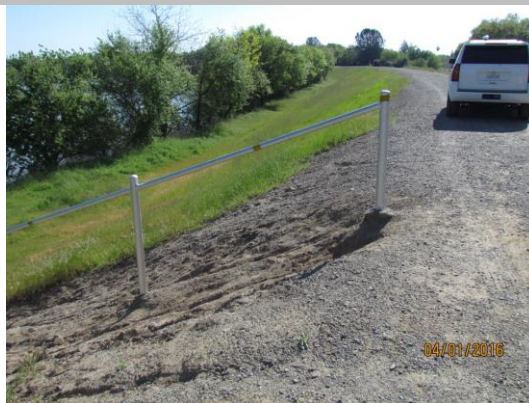
Photo 1 of 1 : SP_2017_MA0004_298_16_20170320_00011.jpg

LM Start	0.00	Rating **	M	Issue No.	16
LM End	0.00	Issue Type +	Ma	Location *	WS
Category	Earthen Levee			GPS Latitude/Longitude	
				Start	End
Item	Slope Stability			38.596823 °	38.596823 °
				-121.547608 °	-121.547608 °
DWR ID	DWR_MA0004_01_s_2016_16				
Comment Code					
S2 : Repair the levee slope damaged by foot traffic and prevent access where possible.					
Inspector Comment

View of the slope stability on the waterward side of the levee looking downstream. Spring 2016.

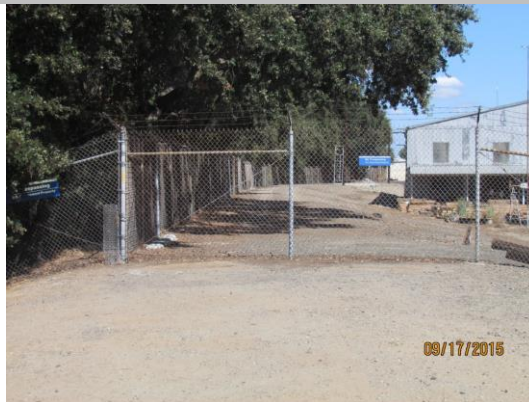
Photo 1 of 1 : SP_2017_MA0004_298_2_20170320_00001.jpg

LM Start	0.24	Rating **	U	Issue No.	2
LM End	0.24	Issue Type +	En	Location *	CR
Category	Earthen Levee			GPS Latitude/Longitude	
				Start	End
Item	Encroachments			38.597193 °	38.597193 °
				-121.543421 °	-121.543421 °
DWR ID	DWR_MA0004_01_s_2012_2				
Comment Code					
FE : Fence					
Inspector Comment					
This is the USACE yard and the chain link fence crosses the levee. The fence runs the length of the yard on the crown.

View of the fence blocking access on the crown of the levee looking downstream. Fall 2015.

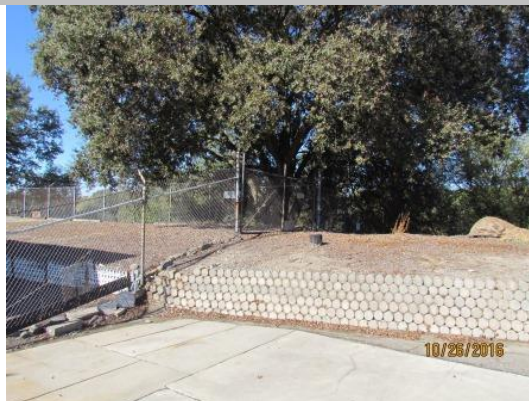
Photo 1 of 1 : SP_2017_MA0004_298_15_20170320_00010.jpg

LM Start	0.41	Rating **	U	Issue No.	15
LM End	0.41	Issue Type +	En	Location *	CR
Category	Earthen Levee			GPS Latitude/Longitude	
				Start	End
Item	Encroachments			38.598661 °	38.598661 °
				-121.540895 °	-121.540895 °
DWR ID	DWR_MA0004_01_f_2016_15				
Comment Code					
FE : Fence					
Inspector Comment					
Chain link fence crosses the levee. USACE facility.

View of fence crossing the crown on NE side of USACE facility. Fall 2016.

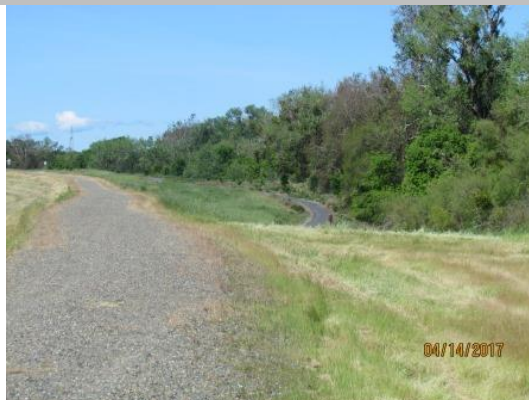
Photo 1 of 1 : SP_2017_MA0004_298_25_20170414_00038.jpg

LM Start	0.76	Rating **	U	Issue No.	25
LM End	1.26	Issue Type +	Ma	Location *	WS
Category	Earthen Levee			GPS Latitude/Longitude	
				Start	End
Item	Vegetation			38.601343 °	38.602814 °
				-121.536152 °	-121.526948 °
DWR ID	DWR_MA0004_01_s_2017_25				
Comment Code					
V1 : Control annual grass and weeds on the levee slopes and easements.					
Inspector Comment

Tall grass on waterside levee slope, blocking visibility. Spring 2017.

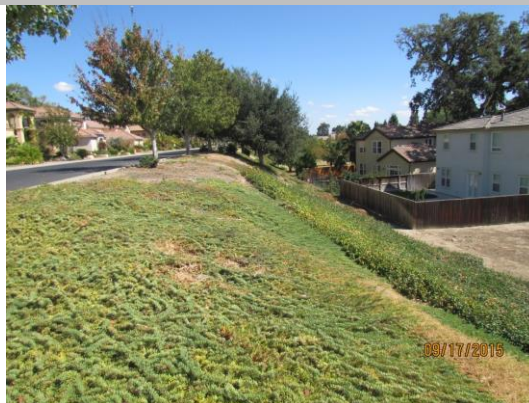
Photo 1 of 1 : SP_2017_MA0004_298_7_20170320_00003.jpg

LM Start	1.34	Rating **	A/W	Issue No.	7
LM End	1.97	Issue Type +	En	Location *	LS
Category	Earthen Levee			GPS Latitude/Longitude	
				Start	End
Item	Vegetation			38.602761 °	38.600449 °
				-121.525566 °	-121.514459 °
DWR ID	DWR_MA0004_01_s_2012_7				
Comment Code					
V6 : Landscaping					
Inspector Comment					
The Rivers housing development

View of the landscaping on the landward side of the levee looking downstream. Fall 2015.

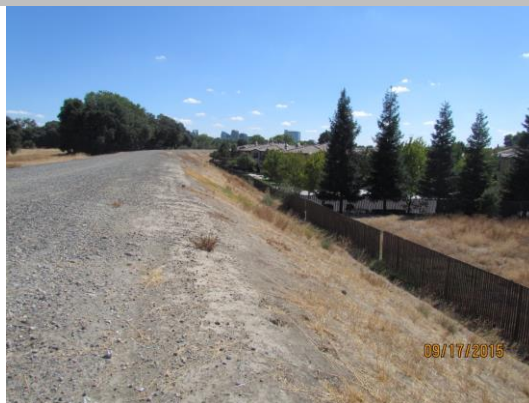
Photo 1 of 1 : SP_2017_MA0004_298_14_20170320_00009.jpg

LM Start	2.02	Rating **	M	Issue No.	14
LM End	2.21	Issue Type +	En	Location *	LS
Category	Earthen Levee			GPS Latitude/Longitude	
				Start	End
Item	Encroachments			38.599813 °	38.597533 °
				-121.513978 °	-121.513134 °
DWR ID	DWR_MA0004_01_s_2017_14				
Comment Code					
FE : Fence					
Inspector Comment					
A fence runs along the toe of the landside levee

View of the fence running along the toe of the landward side of the levee looking downstream. Fall 2015.

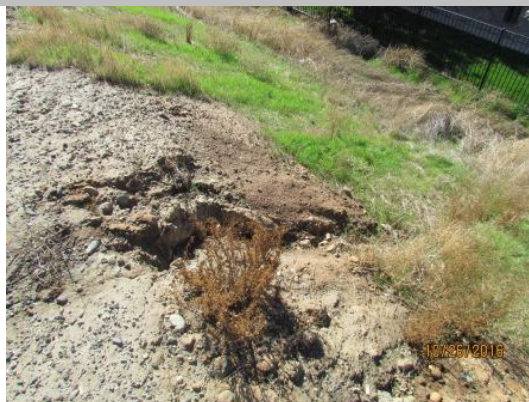
Photo 1 of 1 : SP_2017_MA0004_298_17_20170320_00012.jpg

LM Start	2.12	Rating **	M	Issue No.	17
LM End	2.12	Issue Type +	Ma	Location *	LS
Category	Earthen Levee			GPS Latitude/Longitude	
				Start	End
Item	Slope Stability			38.598625 °	38.598625 °
				-121.513121 °	-121.513121 °
DWR ID	DWR_MA0004_01_f_2016_17				
Comment Code					
S1 : Repair slope instability.					
Inspector Comment

Runoff erosion that causes slope instability. Fall 2016.

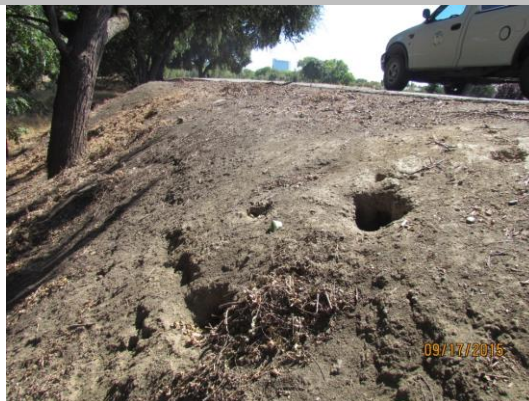
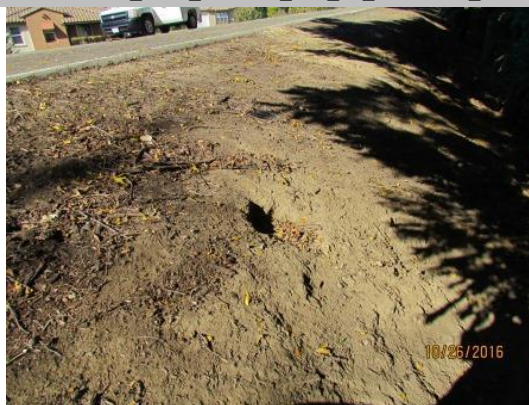
LM Start	2.12	Rating **	M	Issue No.	18
LM End	2.12	Issue Type +	Ma	Location *	WS
Category	Earthen Levee			GPS Latitude/Longitude	
				Start	End
Item	Animal Control			38.598613 °	38.598613 °
				-121.513012 °	-121.513012 °
DWR ID	DWR_MA0004_01_f_2015_18				
Comment Code					
A3 : No rodents visible, but rodent burrows visible; need to backfill and compact or grout burrows.					
Inspector Comment

View of the animal holes on the waterward side of the levee looking downstream. Fall 2015.

Updated view of animal holes on WS slope. Fall 2016.

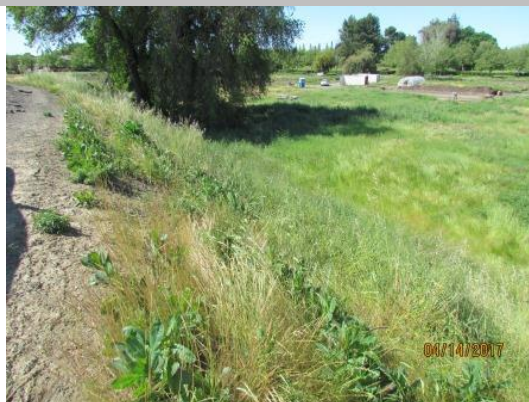
Photo 1 of 1 : SP_2017_MA0004_298_26_20170414_00039.jpg

LM Start	2.13	Rating **	U	Issue No.	26
LM End	2.54	Issue Type +	Ma	Location *	LS
Category	Earthen Levee			GPS Latitude/Longitude	
				Start	End
Item	Vegetation			38.598507 °	38.592872 °
				-121.513004 °	-121.511968 °
DWR ID	DWR_MA0004_01_s_2017_26				
Comment Code					
V1 : Control annual grass and weeds on the levee slopes and easements.					
Inspector Comment

Tall grass on landside levee slope, blocking visibility. Spring 2017.

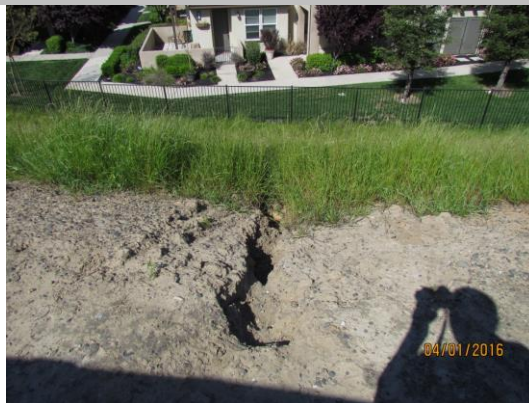
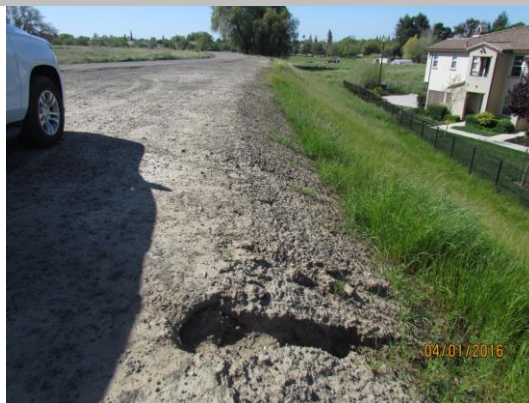
LM Start	2.18	Rating **	M	Issue No.	13
LM End	2.18	Issue Type +	Ma	Location *	LS
Category	Earthen Levee			GPS Latitude/Longitude	
				Start	End
Item	Erosion / Bank Caving			38.597932 °	38.597932 °
				-121.512887 °	-121.512887 °
DWR ID	DWR_MA0004_01_s_2015_13				
Comment Code					
E2 : Schedule repair of erosion site prior to the next inspection.					
Inspector Comment

Runoff erosion is on the shoulder of the landward side. Spring 2016.

Perspective view of the runoff erosion on the landward side of the levee looking upstream. Spring 2016.

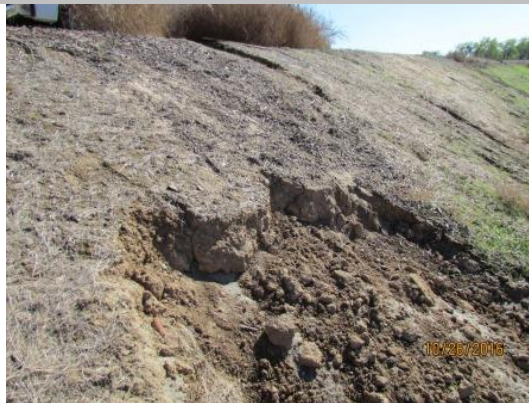
Photo 1 of 1 : SP_2017_MA0004_298_19_20170320_00015.jpg

LM Start	2.38	Rating **	M	Issue No.	19
LM End	2.38	Issue Type +	Ma	Location *	LS
Category	Earthen Levee			GPS Latitude/Longitude	
				Start	End
Item	Erosion / Bank Caving			38.595163 °	38.595163 °
				-121.512460 °	-121.512460 °
DWR ID	DWR_MA0004_01_f_2016_19				
Comment Code					
E2 : Schedule repair of erosion site prior to the next inspection.					
Inspector Comment					
LS slope erosion.

Landside slope erosion near the crown and toward levee toe. Fall 2016.

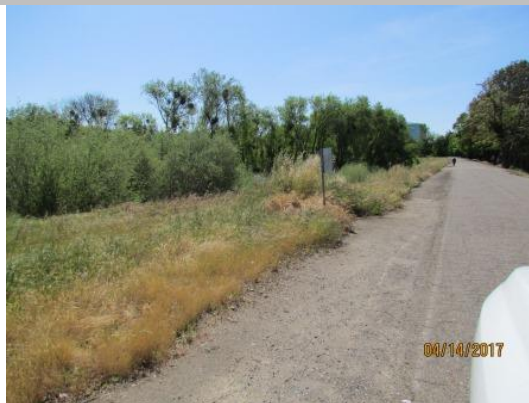
Photo 1 of 1 : SP_2017_MA0004_298_28_20170414_00040.jpg

Tall grass on waterside levee slope, blocking visibility. Spring 2017.

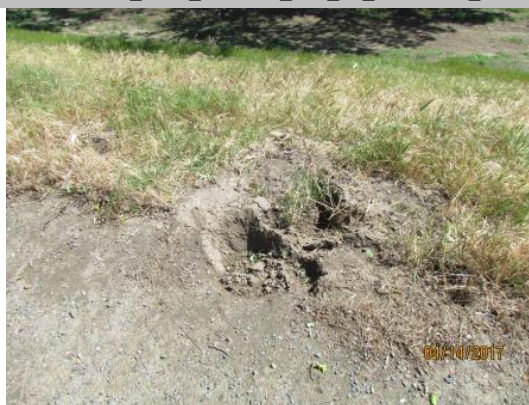
Photo 1 of 1 : SP_2017_MA0004_298_29_20170414_00041.jpg

LM Start	2.61	Rating **	M	Issue No.	29
LM End	2.61	Issue Type +	Ma	Location *	WS
Category	Earthen Levee			GPS Latitude/Longitude	
				Start	End
Item	Animal Control			38.591827 °	38.591827 °
				-121.511695 °	-121.511695 °
DWR ID	DWR_MA0004_01_s_2017_29				
Comment Code					
A3 : No rodents visible, but rodent burrows visible; need to backfill and compact or grout burrows.					
Inspector Comment					
Large rodent holes on waterside levee shoulder.

View of one rodent hole on waterside levee slope. Spring 2017.

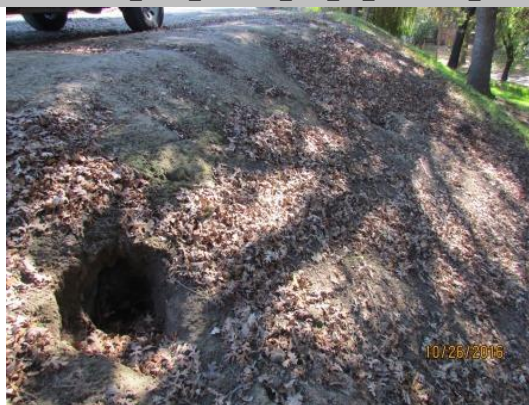
Photo 1 of 1 : SP_2017_MA0004_298_20_20170320_00016.jpg

LM Start	2.63	Rating **	U	Issue No.	20
LM End	2.63	Issue Type +	Ma	Location *	LS
Category	Earthen Levee			GPS Latitude/Longitude	
				Start	End
Item	Animal Control			38.591532 °	38.591532 °
				-121.511646 °	-121.511646 °
DWR ID	DWR_MA0004_01_f_2016_20				
Comment Code					
A3 : No rodents visible, but rodent burrows visible; need to backfill and compact or grout burrows.					
Inspector Comment

Large diameter animal burrows on LS slope. Fall 2016.

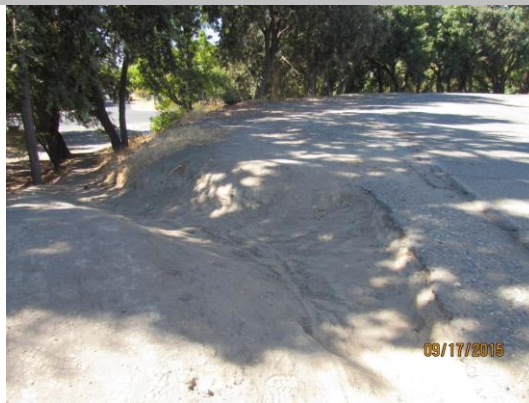
Photo 1 of 1 : SP_2017_MA0004_298_22_20170320_00018.jpg

LM Start	2.65	Rating **	M	Issue No.	22
LM End	2.65	Issue Type +	Ma	Location *	LS
Category	Earthen Levee			GPS Latitude/Longitude	
				Start	End
Item	Slope Stability			38.591380 °	38.591380 °
				-121.511345 °	-121.511345 °
DWR ID	DWR_MA0004_01_f_2015_22				
Comment Code					
S2 : Repair the levee slope damaged by foot traffic and prevent access where possible.					
Inspector Comment

View of the depression on the landward side of the levee due to foot traffic looking upstream. Fall 2015.

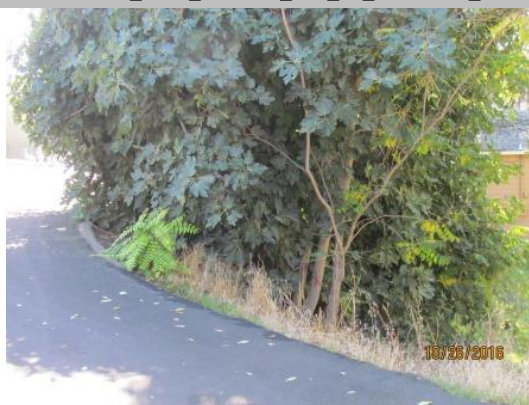
Photo 1 of 1 : SP_2017_MA0004_298_21_20170320_00017.jpg

LM Start	2.67	Rating **	M	Issue No.	21
LM End	2.68	Issue Type +	En	Location *	LS
Category	Earthen Levee			GPS Latitude/Longitude	
				Start	End
Item	Vegetation			38.591228 °	38.591080 °
				-121.511130 °	-121.510994 °
DWR ID	DWR_MA0004_01_f_2016_21				
Comment Code					
V6 : Landscaping					
Inspector Comment

View of small trees that block visibility of LS slope. Fall 2016.

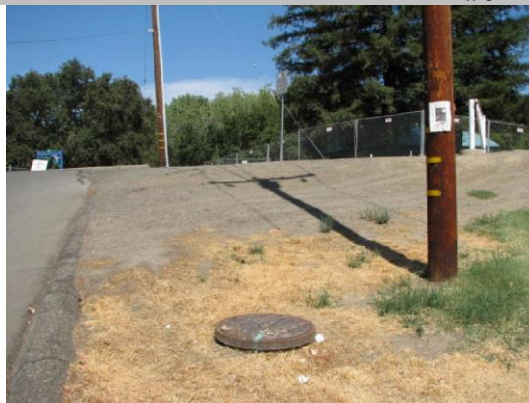
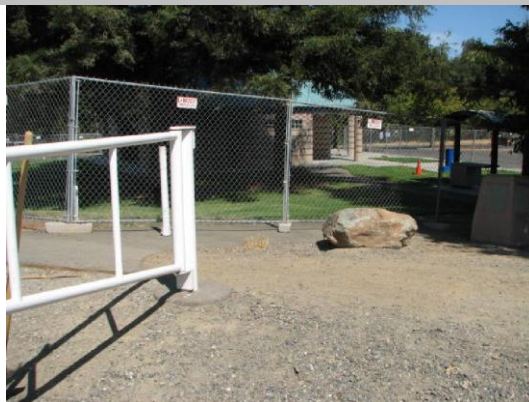
LM Start	2.69	Rating **	M	Issue No.	40
LM End	2.69	Issue Type +	En	Location *	LS
Category	Supplemental			GPS Latitude/Longitude	
				Start	End
Item	DWR UCIP Field Study			38.590910 °	38.590910 °
				-121.510830 °	-121.510830 °
DWR ID					
Comment Code					
Inspector Comment					
FS_ID:41443 DS_ID:19405 EP_NO: N/A Repair Type: Non-Urgent Crossing Status: Found UCIP Comments: Found during the field survey, not listed in the desk study. FIELD_STRUCT_DESC: A 6-inch sewer line from the public facility of boat launching area. No other details available. FS Date: 9/12/2012

Landside view- manhole on the side of the levee and a road.

Waterside view- public facility in the background.

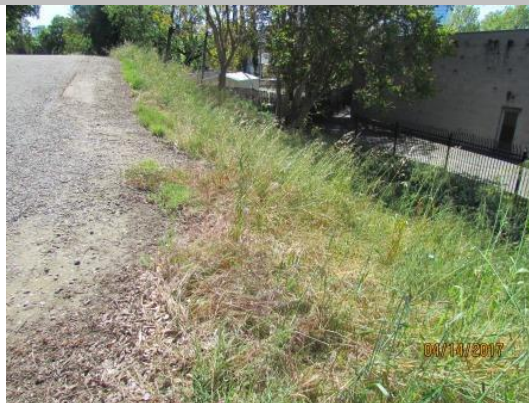
Photo 1 of 1 : SP_2017_MA0004_298_30_20170414_00042.jpg

Tall grass on landside levee slope, blocking visibility. Spring 2017.

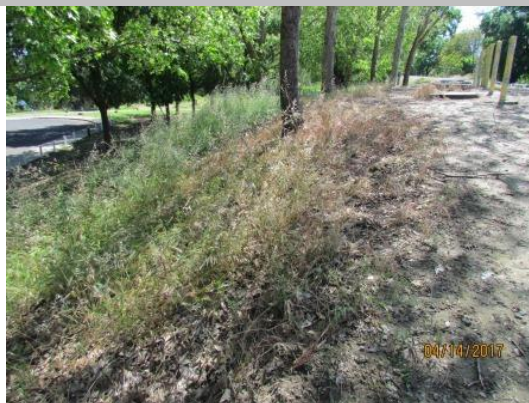
Photo 1 of 1 : SP_2017_MA0004_298_31_20170414_00043.jpg

LM Start	2.74	Rating **	U	Issue No.	31
LM End	3.05	Issue Type +	Ma	Location *	WS
Category	Earthen Levee			GPS Latitude/Longitude	
				Start	End
Item	Vegetation			38.590399 °	38.586980 °
				-121.510215 °	-121.508173 °
DWR ID	DWR_MA0004_01_s_2017_31				
Comment Code					
V1 : Control annual grass and weeds on the levee slopes and easements.					
Inspector Comment

Tall grass on waterside levee slope, blocking visibility. Spring 2017.

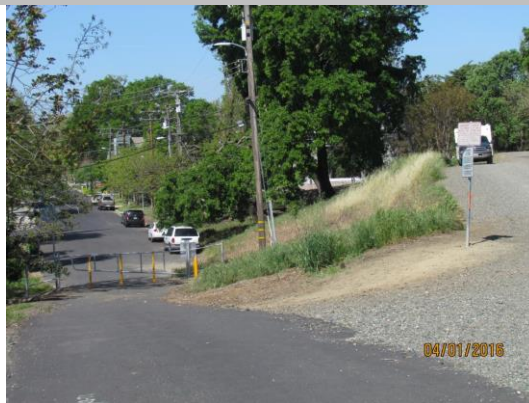
Photo 2 of 2 : SP_2017_MA0004_298_35_20170320_00027.jpg

Perspective view of the bollards at the levee toe looking upstream. Spring 2016.

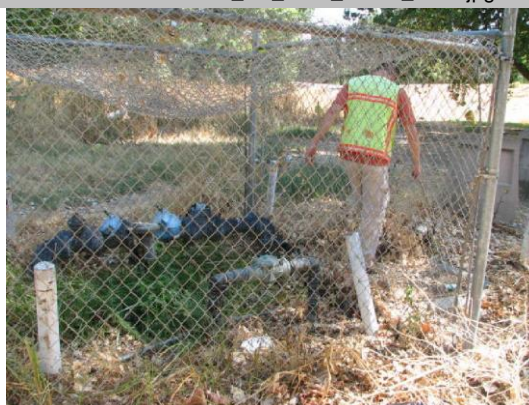
Photo 1 of 2 : UCIP_SP_2017_41486_9369.jpg

LM Start	2.82	Rating **	M	Issue No.	42
LM End	2.82	Issue Type +	En	Location *	LS
Category	Supplemental			GPS Latitude/Longitude	
				Start	End
Item	DWR UCIP Field Study			38.590130 °	38.590130 °
				-121.508740 °	-121.508740 °
DWR ID					
Comment Code					
Inspector Comment					
FS_ID:41486 DS_ID:19407 EP_NO: N/A Repair Type: Non-Urgent Crossing Status: Found UCIP Comments: Found during field survey, not listed in the desk study. FIELD_STRUCT_DESC: 2 of 2. A 5-inch wrapped GI water pipe(of 3-inch and 5-inch water pipe) daylight in a metal cage box. A valve box for the pipe is also found. FS Date: 9/12/2012

Waterside view- pipe daylight in a cage.

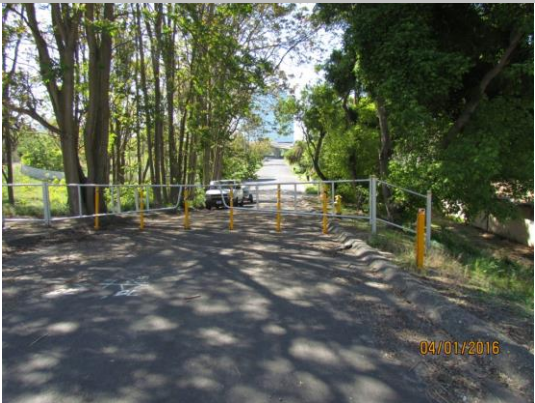
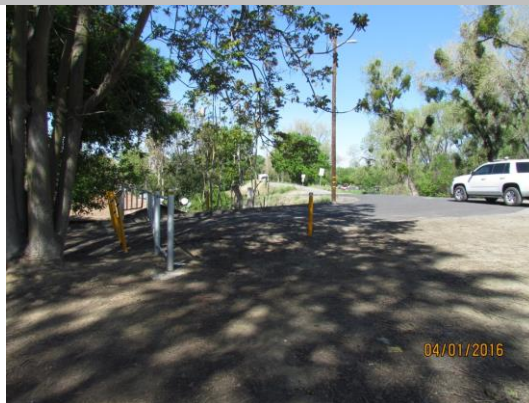
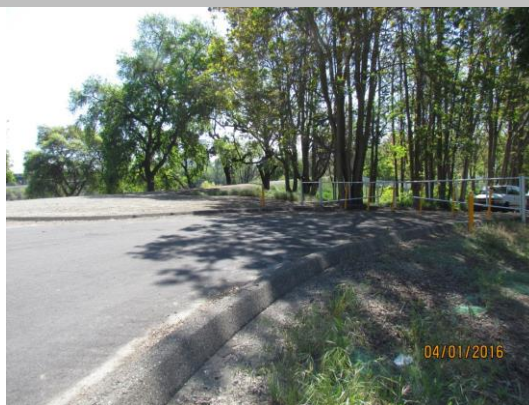
The City of West Sacramento has put bollards and blocked access to the gates. Spring 2016.

Perspective view of the bollards on the landward side looking upstream.
Spring 2016.

Perspective view of the bollards looking downstream. Spring 2016.

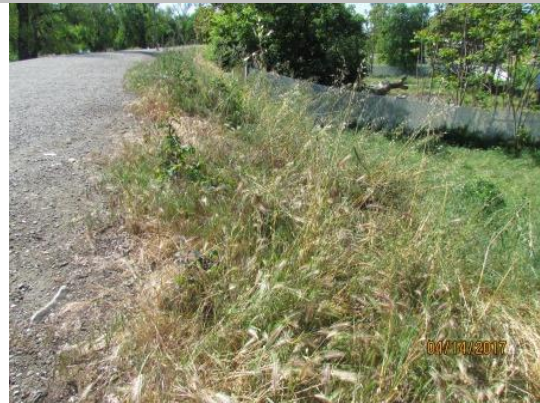
Photo 1 of 1 : SP_2017_MA0004_298_36_20170414_00044.jpg

Tall grass on landside levee slope, blocking visibility. Spring 2017.

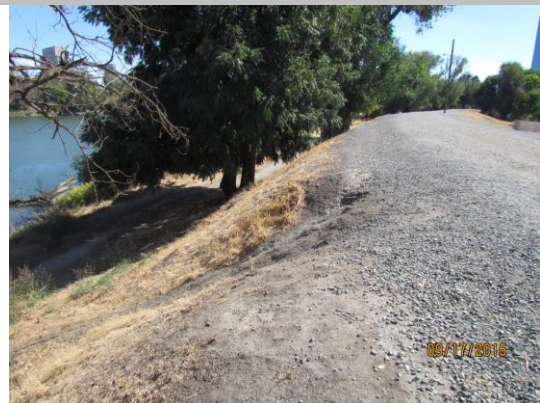
Photo 1 of 1 : SP_2017_MA0004_298_24_20170320_00020.jpg

LM Start	2.91	Rating **	M	Issue No.	24
LM End	2.91	Issue Type +	Ma	Location *	WS
Category	Earthen Levee			GPS Latitude/Longitude	
				Start	End
Item	Slope Stability			38.588937 °	38.588937 °
				-121.507920 °	-121.507920 °
DWR ID	DWR_MA0004_01_f_2015_24				
Comment Code					
S2 : Repair the levee slope damaged by foot traffic and prevent access where possible.					
Inspector Comment

View of the slope stability due to foot traffic on the waterward side of the levee looking downstream. Fall 2015.

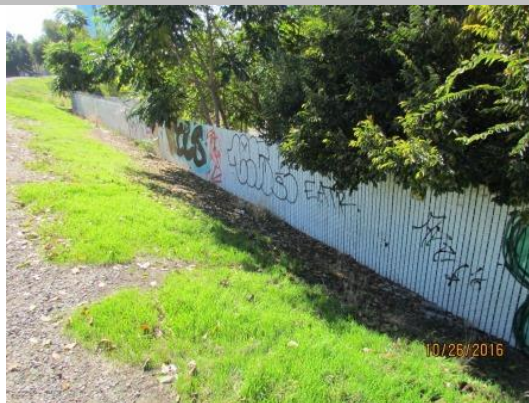
Photo 1 of 1 : SP_2017_MA0004_298_23_20170320_00019.jpg

View of fence on LS slope. Fall 2016.

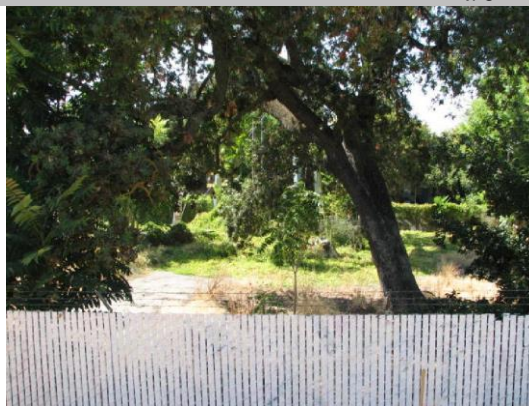
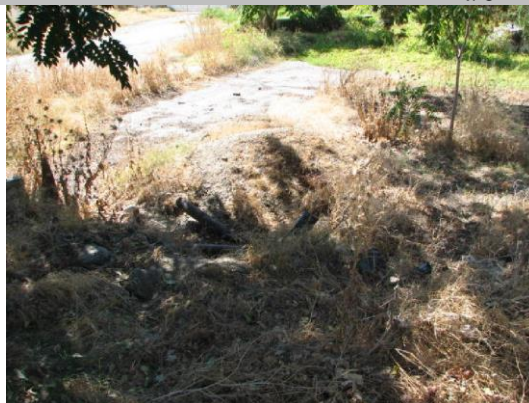
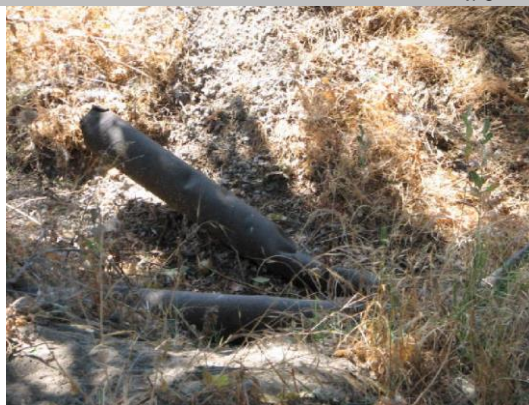
LM Start	2.93	Rating **	M	Issue No.	43
LM End	2.93	Issue Type +	En	Location *	LS
Category	Supplemental			GPS Latitude/Longitude	
				Start	End
Item	DWR UCIP Field Study			38.588688 °	38.588688 °
				-121.507910 °	-121.507910 °
DWR ID					
Comment Code					
Inspector Comment					
FS_ID:41557 DS_ID:18883 EP_NO: N/A Repair Type: Non-Urgent Crossing Status: Found UCIP Comments: Abandoned 7-inch pipe found. Needs to be abandoned properly. FIELD_STRUCT_DESC: *ABANDONED* 2 of 4. An abandoned 7-inch pipe of one 3-inch, two 7-inch and one 10-inch pipes through the levee 18.6 feet below the crown. Unable to locate. Pipes exposed and extend 10 feet from bank. O&M Manual Sac 116, August 1955, Revision Year 2011. FS Date: 9/12/2012

LM Start	2.93	Rating **	M	Issue No.	43 (cont)	
LM End	2.93	Issue Type +	En	Location *	LS	
Category	Supplemental			GPS Latitude/Longitude		
				Start		End
Item	DWR UCIP Field Study			38.588688 °		38.588688 °
				-121.507910 °		-121.507910 °
DWR ID						
Comment Code						
Inspector Comment						
FS_ID:41557						
DS_ID:18883						
EP_NO: N/A						
Repair Type: Non-Urgent						
Crossing Status: Found						
UCIP Comments: Abandoned 7-inch pipe found. Needs to be abandoned properly.						
FIELD_STRUCT_DESC: *ABANDONED* 2 of 4. An abandoned 7-inch pipe of one 3-inch, two 7-inch and one 10-inch pipes through the levee 18.6 feet below the crown. Unable to locate. Pipes exposed and extend 10 feet from bank. O&M Manual Sac 116, August 1955, Revision Year 2011.						
FS Date: 9/12/2012

Land side view- abandoned pipes inside the tower area

Land side view- abandoned pipes inside the tower area.

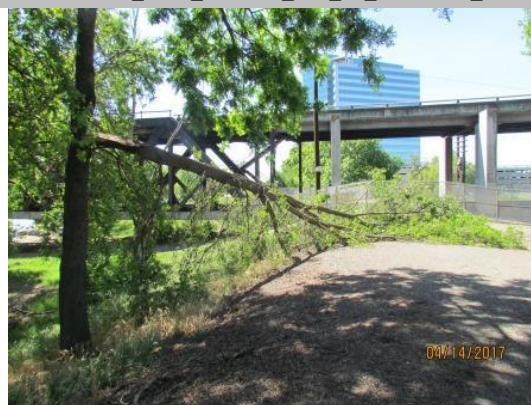
Photo 1 of 1 : SP_2017_MA0004_298_39_20170414_00045.jpg

View of fallen tree on levee crown. Spring 2017.

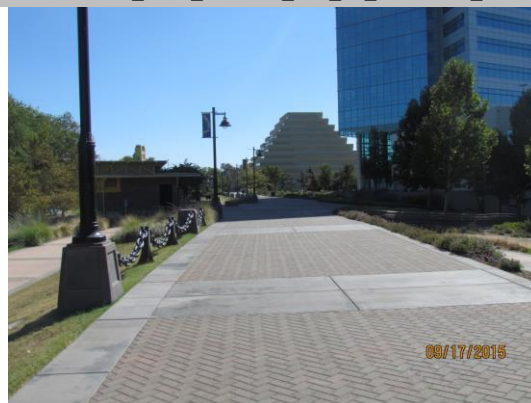
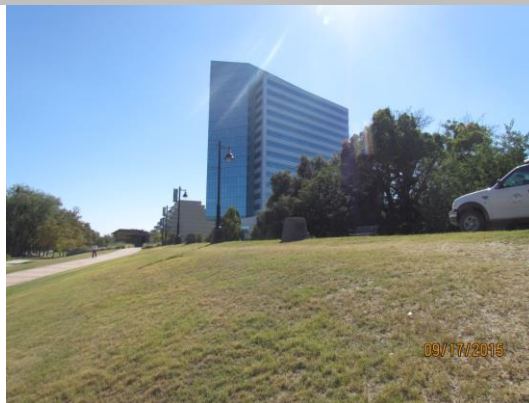
The Riverwalk is part of the landscape on the levee. Fall 2015.

Landscaping and buildings are on the crown and waterward side of the levee. Fall 2015.

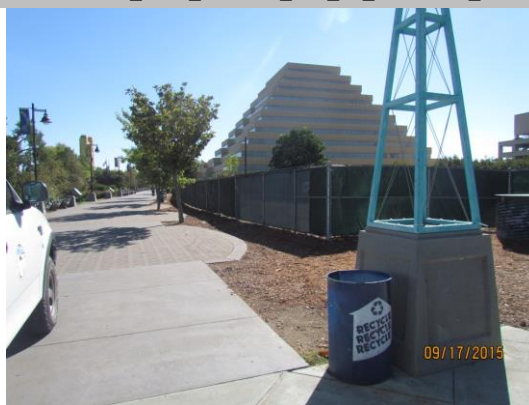
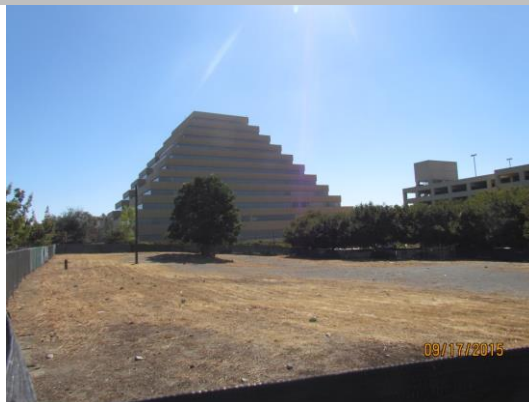
View of the fence on the crown of the levee looking downstream. Fall 2015.

View of the inside of the fence looking downstream. Fall 2015.
