**Flood Control Project Maintenance
Levee Inspections**
LMA District Cover Sheet
Spring 2018 Levee Inspection Results

Sacramento Maintenance Yard Maintenance Area 0004

Spring 2018 Levee Inspection Results

Waterway			Bank	Unit Miles
Unit No. 01 Sacramento River			Right	3.47
	Spring (March - May)	Summer (June - August)	(September - November) Fall	Winter (December - February)
Unit Maintenance Rating (Fall Only)				
Date of Inspection	4/27/2018 - 4/27/2018			
DWR Inspector	Zach Jojola			
Accompanied By	Life Kelley DWR

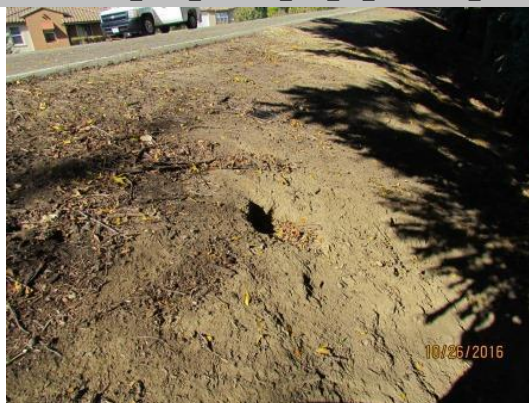
Photo 1 of 1 : SP_2018_MA0004_298_18_20180306_00012.jpg

LM Start	2.12	Rating **	A/W	Issue No.	18
LM End	2.12	Issue Type +	Ma	Location *	WS
Category	Earthen Levee			GPS Latitude/Longitude	
				Start	End
Item	Animal Control			38.598613 °	38.598613 °
				-121.513012 °	-121.513012 °
DWR ID	DWR_MA0004_01_f_2015_18				
Comment Code					
A3 : No rodents visible, but rodent burrows visible; need to backfill and compact or grout burrows.					
Inspector Comment					
Rodent holes have been fixed. Monitor area due to past activity.

Updated view of animal holes on WS slope. Fall 2016.

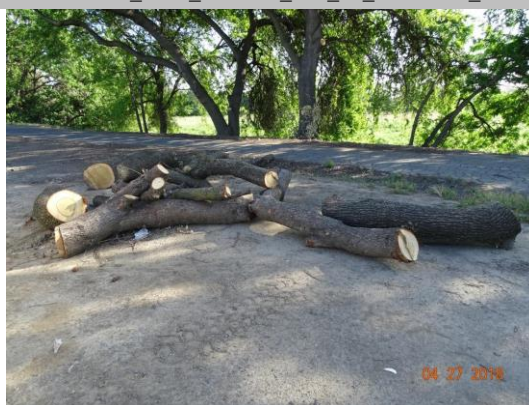
Photo 1 of 1 : SP_2018_MA0004_298_19_20180427_00031.jpg

LM Start	2.15	Rating **	M	Issue No.	19
LM End	2.15	Issue Type +	Ma	Location *	CR
Category	Earthen Levee			GPS Latitude/Longitude	
				Start	End
Item	Encroachments			38.598181 °	38.598181 °
				-121.512862 °	-121.512862 °
DWR ID	DWR_MA0004_01_s_2018_19				
Comment Code					
TR : Tree or limb					
Inspector Comment					
Tree limbs left on the crown.

View of tree limbs on the crown. Spring 2018.

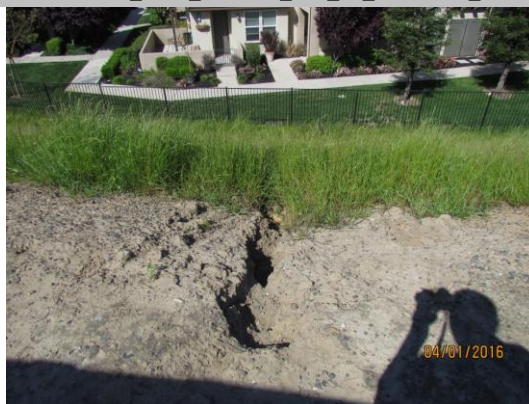
Photo 1 of 2 : SP_2018_MA0004_298_13_20180306_00005.jpg

LM Start	2.18	Rating **	A/W	Issue No.	13
LM End	2.18	Issue Type +	Ma	Location *	LS
Category	Earthen Levee			GPS Latitude/Longitude	
				Start	End
Item	Erosion / Bank Caving			38.597932 °	38.597932 °
				-121.512887 °	-121.512887 °
DWR ID	DWR_MA0004_01_s_2015_13				
Comment Code					
E2 : Schedule repair of erosion site prior to the next inspection.					
Inspector Comment

Runoff erosion is on the shoulder of the landward side. Spring 2016.

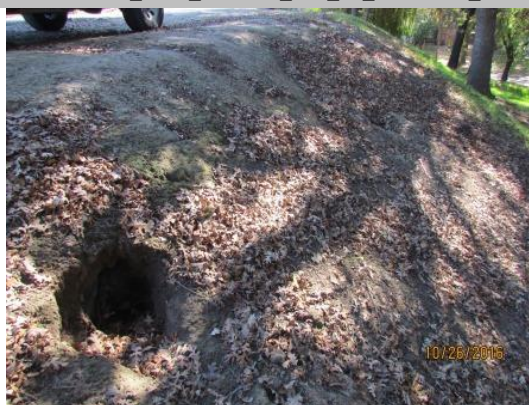
Photo 1 of 1 : SP_2018_MA0004_298_20_20180306_00013.jpg

LM Start	2.63	Rating **	M	Issue No.	20
LM End	2.63	Issue Type +	Ma	Location *	LS
Category	Earthen Levee			GPS Latitude/Longitude	
				Start	End
Item	Animal Control			38.591532 °	38.591532 °
				-121.511646 °	-121.511646 °
DWR ID	DWR_MA0004_01_f_2016_20				
Comment Code					
A3 : No rodents visible, but rodent burrows visible; need to backfill and compact or grout burrows.					
Inspector Comment					
The rodents have been exterminated, but the hole needs to be backfilled.

Large diameter animal burrows on LS slope. Fall 2016.

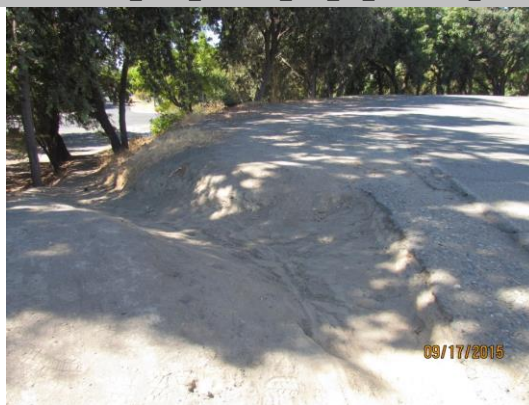
Photo 1 of 1 : SP_2018_MA0004_298_22_20180306_00015.jpg

LM Start	2.65	Rating **	A/W	Issue No.	22
LM End	2.65	Issue Type +	Ma	Location *	LS
Category	Earthen Levee			GPS Latitude/Longitude	
				Start	End
Item	Slope Stability			38.591380 °	38.591380 °
				-121.511345 °	-121.511345 °
DWR ID	DWR_MA0004_01_f_2015_22				
Comment Code					
S2 : Repair the levee slope damaged by foot traffic and prevent access where possible.					
Inspector Comment					
Material has been added to build the slope back up, however the path is still active. Recommend monitoring.

View of the depression on the landward side of the levee due to foot traffic looking upstream. Fall 2015.

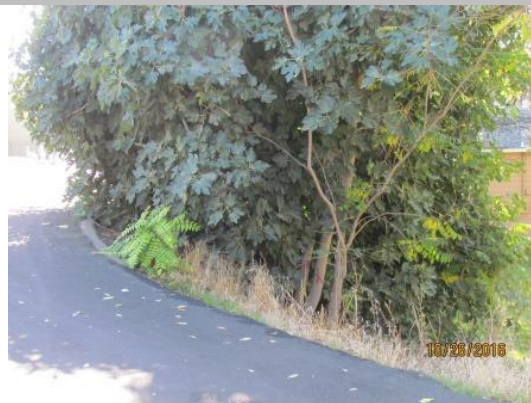
Photo 1 of 1 : SP_2018_MA0004_298_21_20180306_00014.jpg

LM Start	2.67	Rating **	M	Issue No.	21
LM End	2.68	Issue Type +	En	Location *	LS
Category	Earthen Levee			GPS Latitude/Longitude	
				Start	End
Item	Vegetation			38.591228 °	38.591080 °
				-121.511130 °	-121.510994 °
DWR ID	DWR_MA0004_01_f_2016_21				
Comment Code					
V6 : Landscaping					
Inspector Comment

View of small trees that block visibility of LS slope. Fall 2016.

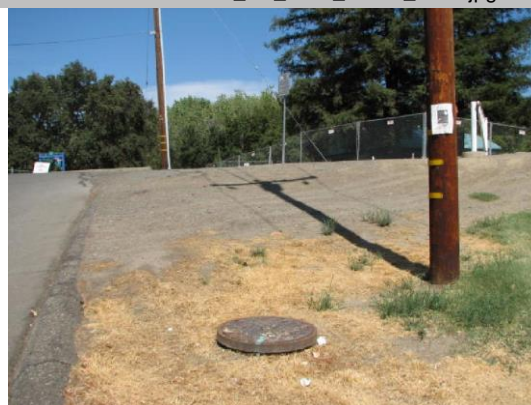
Photo 1 of 2 : UCIP_SP_2018_41443_9371.jpg

LM Start	2.69	Rating **	M	Issue No.	30
LM End	2.69	Issue Type +	En	Location *	
Category	Supplemental			GPS Latitude/Longitude	
				Start	End
Item	DWR UCIP Field Study			38.590910 °	38.590910 °
				-121.510830 °	-121.510830 °
DWR ID					
Comment Code					
Inspector Comment					
FS_ID:41443 DS_ID:19405 EP_NO: N/A Repair Type: Non-Urgent Crossing Status: Found UCIP Comments: Found during the field survey, not listed in the desk study. FIELD_STRUCT_DESC: 6-inch steel sewer line from the public facility of the boat launching area. No other details available. FS Date: 9/12/2012

Landside view- manhole on the side of the levee and a road.

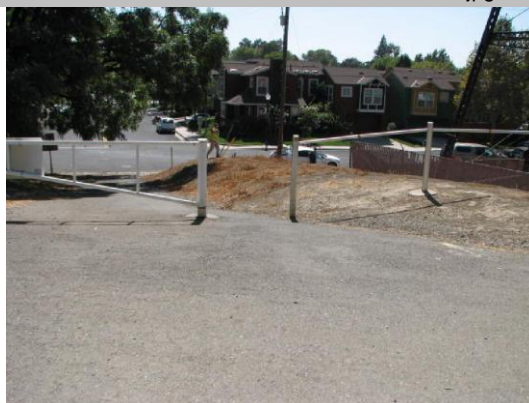
Photo 1 of 3 : UCIP_SP_2018_41485_9367.jpg

LM Start	2.77	Rating **	M	Issue No.	31
LM End	2.77	Issue Type +	En	Location *	
Category	Supplemental			GPS Latitude/Longitude	
				Start	End
Item	DWR UCIP Field Study			38.590140 °	38.590140 °
				-121.509750 °	-121.509750 °
DWR ID					
Comment Code					
Inspector Comment					
FS_ID:41485					
DS_ID:19406					
EP_NO: N/A					
Repair Type: Non-Urgent					
Crossing Status: Found					
UCIP Comments: Found during field survey. Not listed in the desk study.					
FIELD_STRUCT_DESC: 1 of 2: 3-inch wrapped galvanized iron (GI)					
water pipe through the levee, at an unknown depth. Pipe daylights in a					
metal cage box. Valve box for the pipe is also found.					
FS Date: 9/12/2012

Landside overview

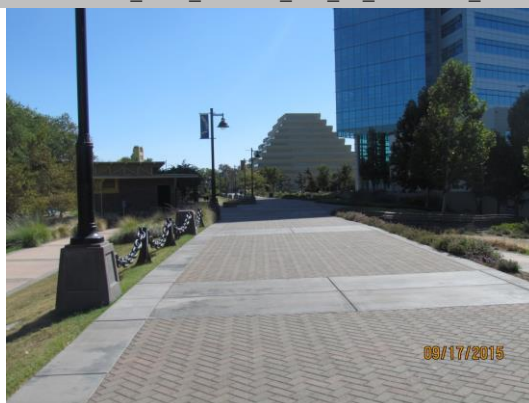
Photo 1 of 2 : SP_2018_MA0004_298_12_20180306_00003.jpg

The Riverwalk is part of the landscape on the levee. Fall 2015.

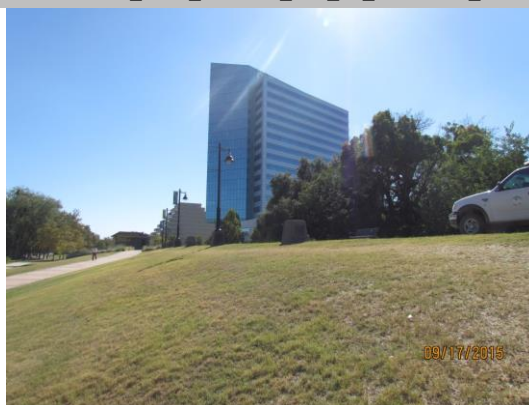
Photo 2 of 2 : SP_2018_MA0004_298_12_20180306_00004.jpg

Landscaping and buildings are on the crown and waterward side of the levee. Fall 2015.

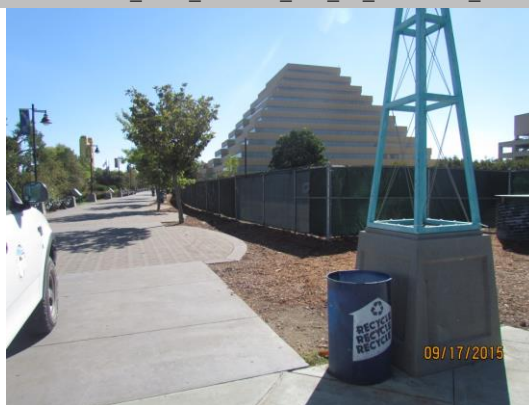
Photo 1 of 2 : SP_2018_MA0004_298_27_20180306_00019.jpg

LM Start	3.24	Rating **	M	Issue No.	27
LM End	3.29	Issue Type +	En	Location *	LS
Category	Earthen Levee			GPS Latitude/Longitude	
				Start	End
Item	Encroachments			38.584168 °	38.583435 °
				-121.508632 °	-121.508785 °
DWR ID	DWR_MA0004_01_f_2015_27				
Comment Code					
FE : Fence					
Inspector Comment					
There is a fence at the shoulder of the levee crown. There seems to be no work being done inside of the fence as of 9/17/2015.

View of the fence on the crown of the levee looking downstream. Fall 2015.
