**Flood Control Project Maintenance
Levee Inspections**
LMA District Cover Sheet
Spring 2019 Levee Inspection Results

Sacramento Maintenance Yard Maintenance Area 0004

Levee Inspection Report By Mile - Spring 2019

Waterway	Bank	Unit Miles	Inspection Start/End	Inspector
Unit No. 01 Sacramento River	Right	3.47	04/02/2019 04/02/2019	Luz Dial

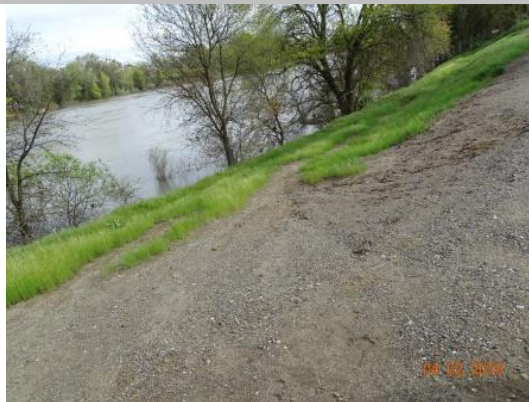
Photo 1 of 1 : SP_2019_MA0004_298_7_20190402_00031.jpg

LM Start	0.21	Rating **	M	Issue No.	7
LM End	0.22	Issue Type +	Ma	Location *	WS
Category	Earthen Levee			GPS Latitude/Longitude	
				Start	End
Item	Slope Stability			38.596840 °	38.596947 °
				-121.543848 °	-121.543727 °
DWR ID	DWR_MA0004_01_s_2019_7				
Comment Code					
S2 : Repair the levee slope damaged by foot traffic and prevent access where possible.					
Inspector Comment					
Repair footpath and erosion.

View looking north at footpath and erosion rills. Spring 2019

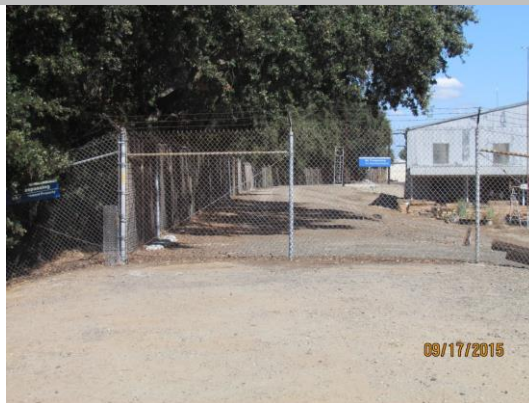
Photo 1 of 1 : SP_2019_MA0004_298_2_20190307_00001.jpg

LM Start	0.24	Rating **	U	Issue No.	2
LM End	0.24	Issue Type +	En	Location *	CR
Category	Earthen Levee			GPS Latitude/Longitude	
				Start	End
Item	Encroachments			38.597193 °	38.597193 °
				-121.543421 °	-121.543421 °
DWR ID	DWR_MA0004_01_s_2012_2				
Comment Code					
FE : Fence					
Inspector Comment					
This is the USACE yard, and the chain link fence crosses the levee. The fence runs the length of the yard on the crown.

View of the fence blocking access on the crown of the levee looking downstream. Fall 2015.

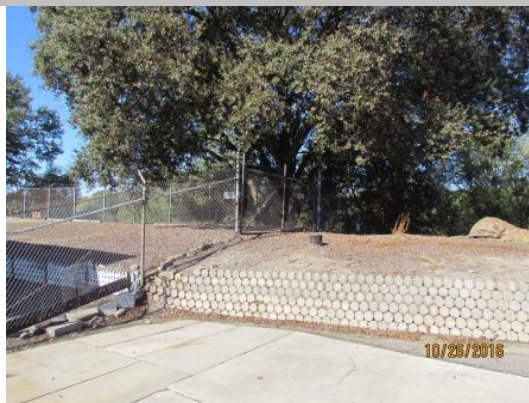
Photo 1 of 1 : SP_2019_MA0004_298_15_20190307_00007.jpg

LM Start	0.41	Rating **	U	Issue No.	15
LM End	0.41	Issue Type +	En	Location *	CR
Category	Earthen Levee			GPS Latitude/Longitude	
				Start	End
Item	Encroachments			38.598661 °	38.598661 °
				-121.540895 °	-121.540895 °
DWR ID	DWR_MA0004_01_f_2016_15				
Comment Code					
BU : Building					
Inspector Comment					
Chain link fence crosses the levee. USACE facility.

View of fence crossing the crown on NE side of USACE facility. Fall 2016.

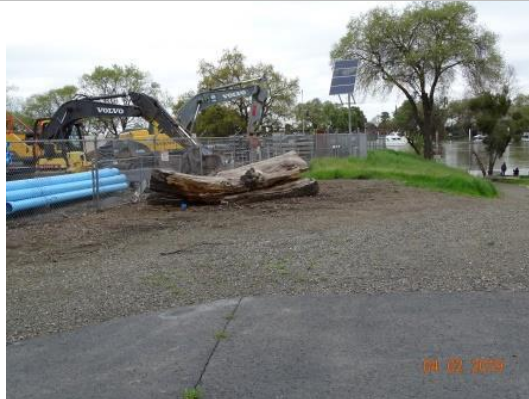
Photo 1 of 1 : SP_2019_MA0004_298_30_20190402_00032.jpg

LM Start	0.75	Rating **	M	Issue No.	30
LM End	0.75	Issue Type +	Ma	Location *	WS
Category	Earthen Levee			GPS Latitude/Longitude	
				Start	End
Item	Encroachments			38.601257 °	38.601257 °
				-121.536243 °	-121.536243 °
DWR ID	DWR_MA0004_01_s _ 2019_30				
Comment Code					
TR : Tree or limb					
Inspector Comment					
Remove tree log from the levee easement.

View looking north at tree log on waterside easement. Spring 2019

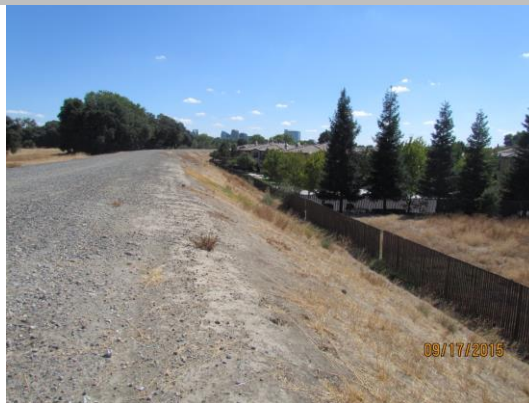
Photo 1 of 1 : SP_2019_MA0004_298_14_20190307_00006.jpg

LM Start	2.02	Rating **	M	Issue No.	14
LM End	2.21	Issue Type +	En	Location *	LS
Category	Earthen Levee			GPS Latitude/Longitude	
				Start	End
Item	Encroachments			38.599813 °	38.597533 °
				-121.513978 °	-121.513134 °
DWR ID	DWR_MA0004_01_s_2017_14				
Comment Code					
FE : Fence					
Inspector Comment					
A fence runs along the toe of the landside levee.

View of the fence running along the toe of the landward side of the levee looking downstream. Fall 2015.

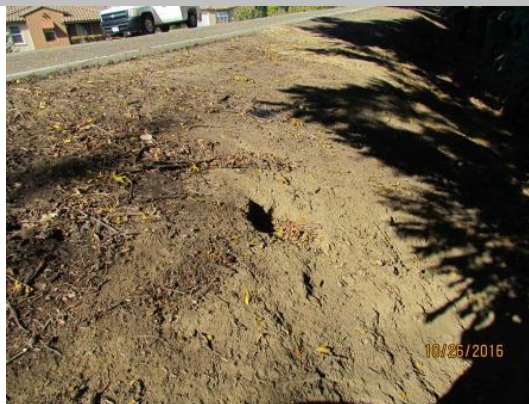
Photo 1 of 1 : SP_2019_MA0004_298_18_20190307_00010.jpg

Updated view of animal holes on WS slope. Fall 2016.

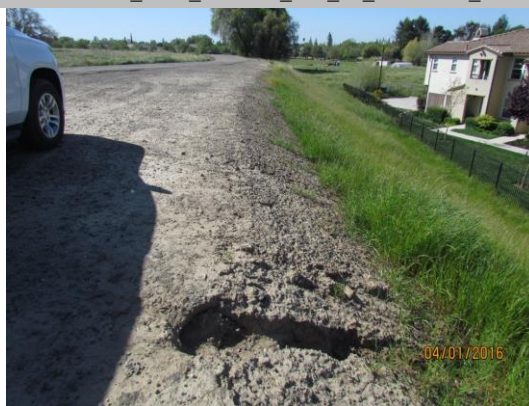
Photo 2 of 2 : SP_2019_MA0004_298_13_20190307_00005.jpg

LM Start	2.18	Rating **	M	Issue No.	13 (cont)	
LM End	2.18	Issue Type +	Ma	Location *	LS	
Category	Earthen Levee			GPS Latitude/Longitude		
				Start		End
Item	Erosion / Bank Caving			38.597932 °		38.597932 °
				-121.512887 °		-121.512887 °
DWR ID	DWR_MA0004_01_s _ 2015_13					
Comment Code						
E2 : Schedule repair of erosion site prior to the next inspection.						
Inspector Comment

Perspective view of the runoff erosion on the landward side of the levee looking upstream. Spring 2016.

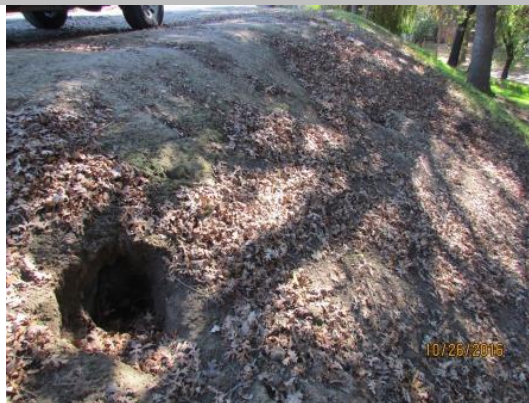
Photo 1 of 1 : SP_2019_MA0004_298_20_20190307_00012.jpg

Large diameter animal burrows on LS slope. Fall 2016.

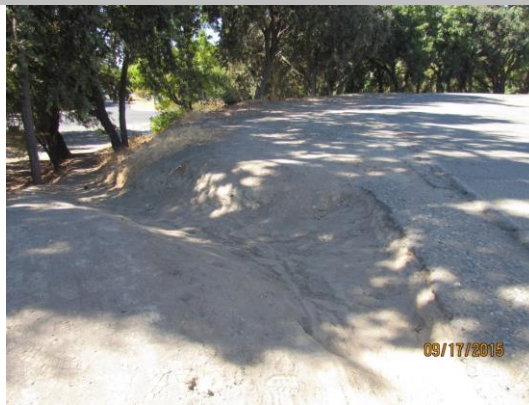
Photo 1 of 1 : SP_2019_MA0004_298_22_20190307_00014.jpg

LM Start	2.65	Rating **	A/W	Issue No.	22
LM End	2.65	Issue Type +	Ma	Location *	LS
Category	Earthen Levee			GPS Latitude/Longitude	
				Start	End
Item	Slope Stability			38.591380 °	38.591380 °
				-121.511345 °	-121.511345 °
DWR ID	DWR_MA0004_01_f_2015_22				
Comment Code					
S2 : Repair the levee slope damaged by foot traffic and prevent access where possible.					
Inspector Comment

View looking upstream of the depression on the landward side of the levee due to foot traffic. Fall 2015.

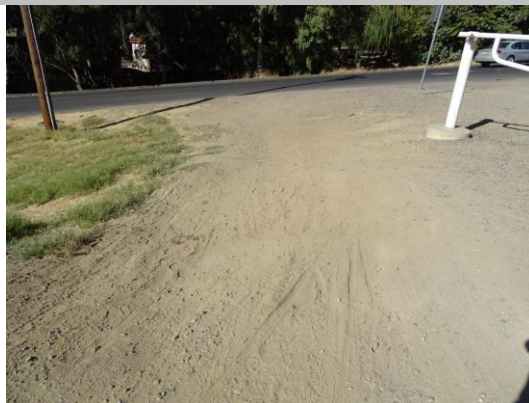
Photo 1 of 1 : SP_2019_MA0004_298_17_20190307_00009.jpg

LM Start	2.70	Rating **	M	Issue No.	17
LM End	2.70	Issue Type +	Ma	Location *	LS
Category	Earthen Levee			GPS Latitude/Longitude	
				Start	End
Item	Slope Stability			38.590802 °	38.590802 °
				-121.510736 °	-121.510736 °
DWR ID	DWR_MA0004_01_f_2018_17				
Comment Code					
S3 : Repair the levee slope damaged by vehicle traffic and prevent access where possible.					
Inspector Comment					
Repair slope damage from vehicular traffic bypassing gate. Recommend placement of a barrier.

View of slope damage from vehicular traffic bypassing gate. Fall 2018

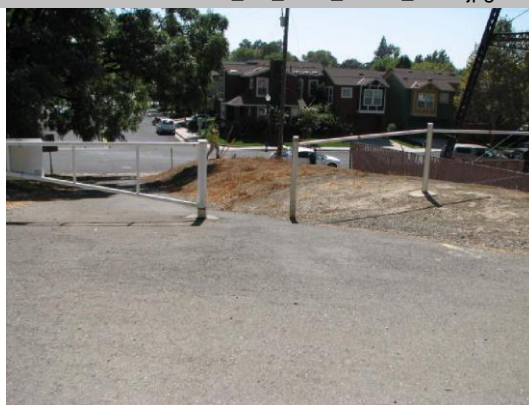
Photo 1 of 3 : UCIP_SP_2019_41485_9367.jpg

LM Start	2.77	Rating **	M	Issue No.	50
LM End	2.77	Issue Type +	En	Location *	
Category	Supplemental			GPS Latitude/Longitude	
				Start	End
Item	DWR UCIP Field Study			38.590140 °	38.590140 °
				-121.509750 °	-121.509750 °
DWR ID	19406				
Comment Code					
Inspector Comment					
FS_ID:41485 DS_ID:19406 EP_NO: N/A Repair Type: Non-Urgent Crossing Status: Found UCIP Comments: Found during field survey. Not listed in the desk study. FIELD_STRUCT_DESC: 1 of 2: 3-inch wrapped galvanized iron (GI) water pipe through the levee, at an unknown depth. Pipe daylights in a metal cage box. Valve box for the pipe is also found. FS Date: 9/12/2012

Landside overview

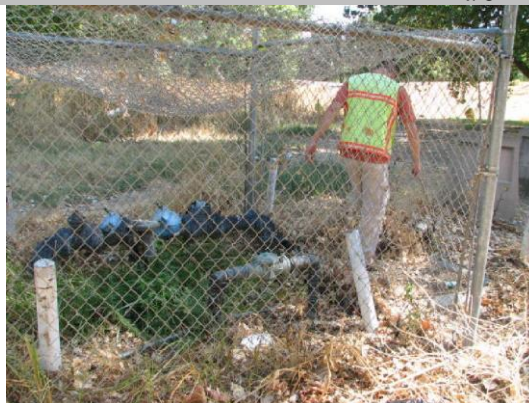
Photo 2 of 3 : UCIP_SP_2019_41485_9366.jpg

LM Start	2.77	Rating **	M	Issue No.	50 (cont)	
LM End	2.77	Issue Type +	En	Location *		
Category	Supplemental			GPS Latitude/Longitude		
				Start	End	
Item	DWR UCIP Field Study			38.590140 °	38.590140 °	
				-121.509750 °	-121.509750 °	
DWR ID	19406					
Comment Code						
Inspector Comment						
FS_ID:41485						
DS_ID:19406						
EP_NO: N/A						
Repair Type: Non-Urgent						
Crossing Status: Found						
UCIP Comments: Found during field survey. Not listed in the desk study.						
FIELD_STRUCT_DESC: 1 of 2: 3-inch wrapped galvanized iron (GI)						
water pipe through the levee, at an unknown depth. Pipe daylights in a						
metal cage box. Valve box for the pipe is also found.						
FS Date: 9/12/2012

Waterside view- pipe daylight in a metal cage.

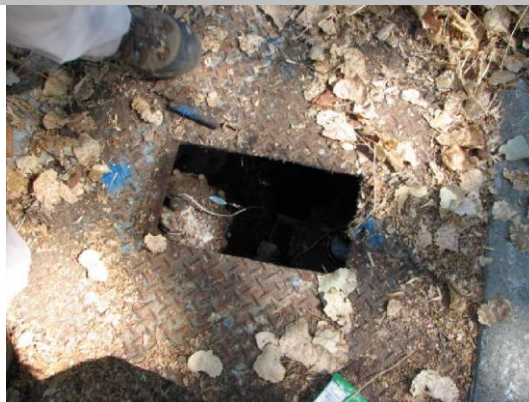
Photo 3 of 3 : UCIP_SP_2019_41485_9365.jpg

Waterside view- a manhole/control valve box.

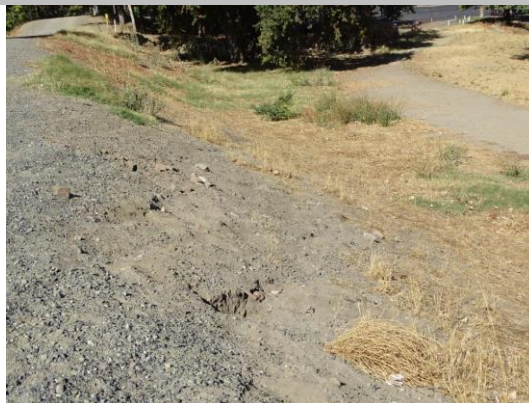
Photo 1 of 1 : SP_2019_MA0004_298_25_20190307_00017.jpg

LM Start	2.81	Rating **	M	Issue No.	25
LM End	2.81	Issue Type +	Ma	Location *	WS
Category	Earthen Levee			GPS Latitude/Longitude	
				Start	End
Item	Slope Stability			38.589834 °	38.589834 °
				-121.509110 °	-121.509110 °
DWR ID	DWR_MA0004_01_f_2018_25				
Comment Code					
S3 : Repair the levee slope damaged by vehicle traffic and prevent access where possible.					
Inspector Comment					
Repair slope damage from vehicular traffic.

View of slope damage from vehicular traffic. Fall 2018

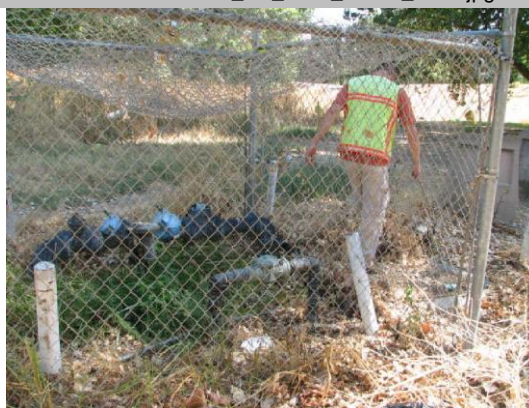
Photo 1 of 2 : UCIP_SP_2019_41486_9369.jpg

LM Start	2.82	Rating **	M	Issue No.	51
LM End	2.82	Issue Type +	En	Location *	
Category	Supplemental			GPS Latitude/Longitude	
				Start	End
Item	DWR UCIP Field Study			38.590130 °	38.590130 °
				-121.508740 °	-121.508740 °
DWR ID	19407				
Comment Code					
Inspector Comment					
FS_ID:41486 DS_ID:19407 EP_NO: N/A Repair Type: Non-Urgent Crossing Status: Found UCIP Comments: Found during field survey, not listed in the desk study. FIELD_STRUCT_DESC: 2 of 2: 5-inch wrapped galvanized iron (GI) water pipe through the levee, at an unknown depth. Pipe daylights in a metal cage box. Valve box for the pipe is also found. FS Date: 9/12/2012

Waterside view- pipe daylight in a cage.

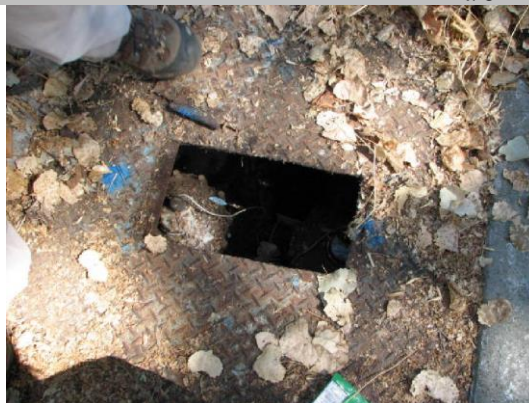
Photo 2 of 2 : UCIP_SP_2019_41486_9368.jpg

LM Start	2.82	Rating **	M	Issue No.	51 (cont)	
LM End	2.82	Issue Type +	En	Location *		
Category	Supplemental			GPS Latitude/Longitude		
				Start	End	
Item	DWR UCIP Field Study			38.590130 °	38.590130 °	
				-121.508740 °	-121.508740 °	
DWR ID	19407					
Comment Code						
Inspector Comment						
FS_ID:41486 DS_ID:19407 EP_NO: N/A Repair Type: Non-Urgent Crossing Status: Found UCIP Comments: Found during field survey, not listed in the desk study. FIELD_STRUCT_DESC: 2 of 2: 5-inch wrapped galvanized iron (GI) water pipe through the levee, at an unknown depth. Pipe daylights in a metal cage box. Valve box for the pipe is also found. FS Date: 9/12/2012

Waterside view- manhole/control valve.

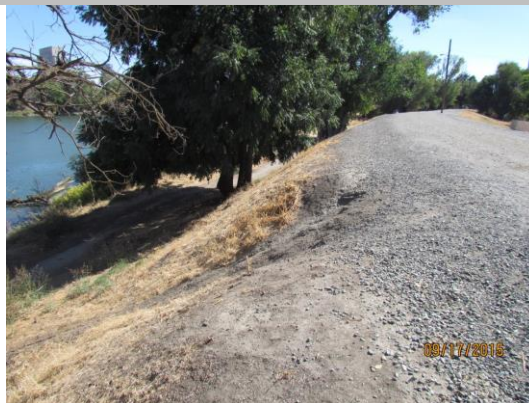
Photo 1 of 1 : SP_2019_MA0004_298_24_20190307_00016.jpg

LM Start	2.91	Rating **	A/W	Issue No.	24
LM End	2.91	Issue Type +	Ma	Location *	WS
Category	Earthen Levee			GPS Latitude/Longitude	
				Start	End
Item	Slope Stability			38.588937 °	38.588937 °
				-121.507920 °	-121.507920 °
DWR ID	DWR_MA0004_01_s_2018_24				
Comment Code					
S2 : Repair the levee slope damaged by foot traffic and prevent access where possible.					
Inspector Comment					
Footpath on landside slope. LMA added river rock to stabilize slope.

View looking downstream of the slope stability issue due to foot traffic on the waterward side of the levee . Fall 2015.

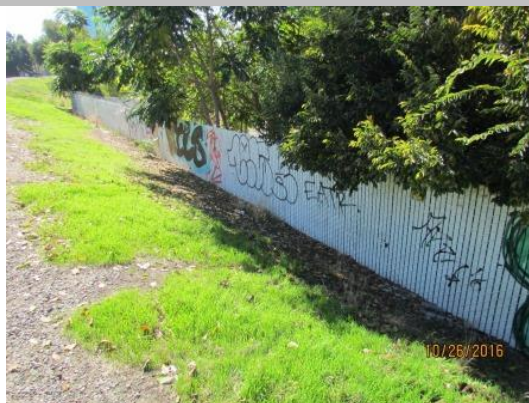
Photo 1 of 1 : SP_2019_MA0004_298_23_20190307_00015.jpg

LM Start	2.92	Rating **	U	Issue No.	23
LM End	2.95	Issue Type +	En	Location *	LS
Category	Earthen Levee			GPS Latitude/Longitude	
				Start	End
Item	Encroachments			38.588762 °	38.588384 °
				-121.507951 °	-121.507894 °
DWR ID	DWR_MA0004_01_f_2016_23				
Comment Code					
FE : Fence					
Inspector Comment

View of fence on LS slope. Fall 2016.

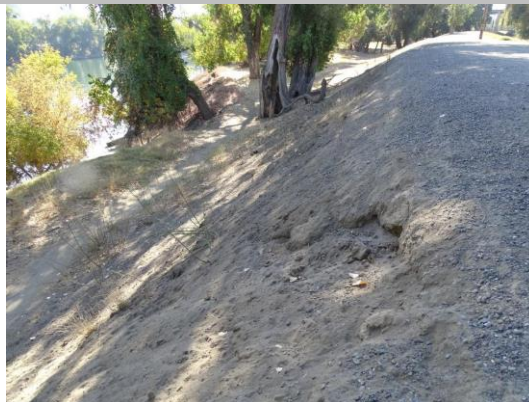
Photo 1 of 1 : SP_2019_MA0004_298_28_20190307_00020.jpg

LM Start	2.92	Rating **	M	Issue No.	28
LM End	2.92	Issue Type +	Ma	Location *	WS
Category	Earthen Levee			GPS Latitude/Longitude	
				Start	End
Item	Slope Stability			38.588740 °	38.588740 °
				-121.507894 °	-121.507894 °
DWR ID	DWR_MA0004_01_f_2018_28				
Comment Code					
S2 : Repair the levee slope damaged by foot traffic and prevent access where possible.					
Inspector Comment					
Repair slope damage/caving due to foot traffic.

View of slope damage from foot traffic. Fall 2018

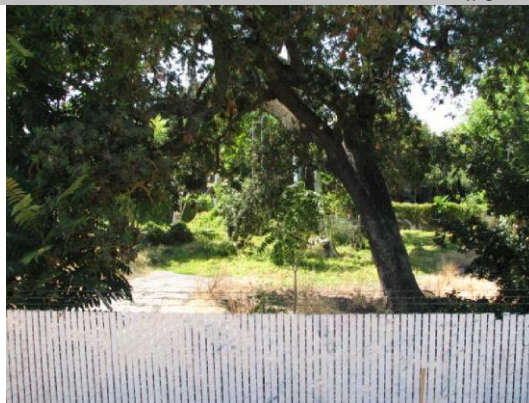
Photo 1 of 3 : UCIP_SP_2019_41557_9767.jpg

LM Start	2.93	Rating **	M	Issue No.	52
LM End	2.93	Issue Type +	En	Location *	
Category	Supplemental			GPS Latitude/Longitude	
				Start	End
Item	DWR UCIP Field Study			38.588688 °	38.588688 °
				-121.507910 °	-121.507910 °
DWR ID	18883				
Comment Code					
Inspector Comment					
FS_ID:41557 DS_ID:18883 EP_NO: N/A Repair Type: Non-Urgent Crossing Status: Found UCIP Comments: Abandoned 7-inch pipe found. Needs to be abandoned properly. FIELD_STRUCT_DESC: *ABANDONED* 2 of 4: 7-inch pipe of an unknown material or purpose through the levee, 18.6 feet below the crown. Unable to locate. Pipe exposed and extends 10 feet from the bank and 5 feet above current water surface. Needs to be removed or grouted. [Additional Reference(s): DWR Levee Log, 2005. USACE Sacramento O&M Manual 116, August 1955, (RM 59.65)]. FS Date: 9/12/2012

Land side view- Water tower area.

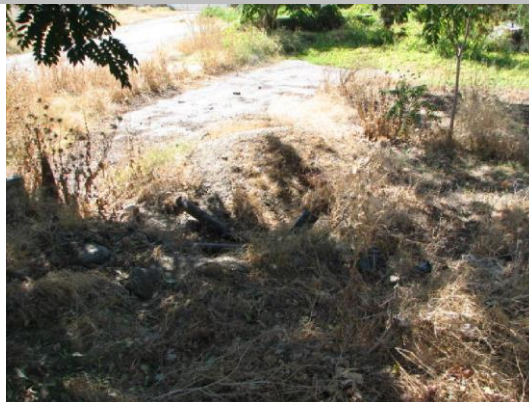
Photo 2 of 3 : UCIP_SP_2019_41557_9770.jpg

Land side view- abandoned pipes inside the tower area

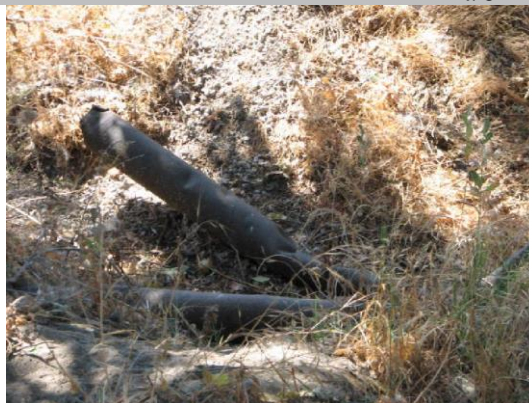
Photo 3 of 3 : UCIP_SP_2019_41557_9769.jpg

LM Start	2.93	Rating **	M	Issue No.	52 (cont)	
LM End	2.93	Issue Type +	En	Location *		
Category	Supplemental			GPS Latitude/Longitude		
				Start		End
Item	DWR UCIP Field Study			38.588688 °	38.588688 °	
				-121.507910 °	-121.507910 °	
DWR ID	18883					
Comment Code						
Inspector Comment						
FS_ID:41557						
DS_ID:18883						
EP_NO: N/A						
Repair Type: Non-Urgent						
Crossing Status: Found						
UCIP Comments: Abandoned 7-inch pipe found. Needs to be abandoned properly.						
FIELD_STRUCT_DESC: *ABANDONED* 2 of 4: 7-inch pipe of an unknown material or purpose through the levee, 18.6 feet below the crown. Unable to locate. Pipe exposed and extends 10 feet from the bank and 5 feet above current water surface. Needs to be removed or grouted. [Additional Reference(s): DWR Levee Log, 2005. USACE Sacramento O&M Manual 116, August 1955, (RM 59.65)].						
FS Date: 9/12/2012

Land side view- abandoned pipes inside the tower area.

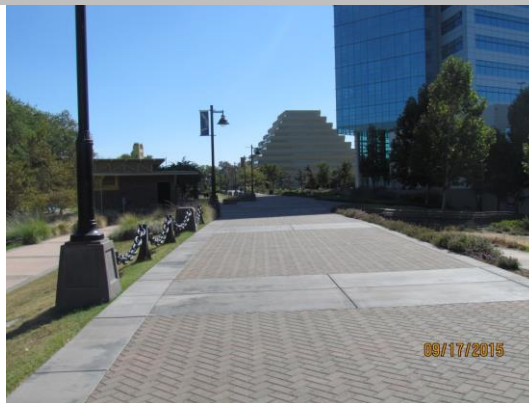
Photo 1 of 2 : SP_2019_MA0004_298_12_20190307_00002.jpg

The Riverwalk is part of the landscape on the levee. Fall 2015.

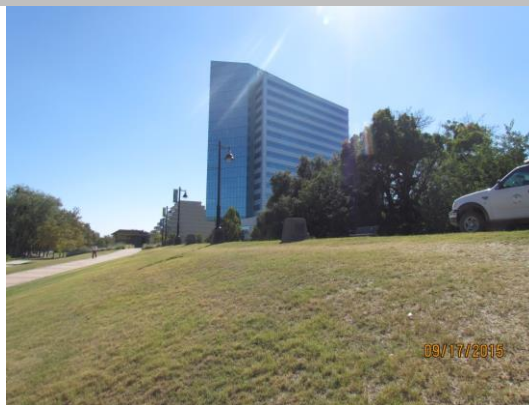
Photo 2 of 2 : SP_2019_MA0004_298_12_20190307_00003.jpg

Landscaping and buildings are on the crown and waterward side of the levee. Fall 2015.

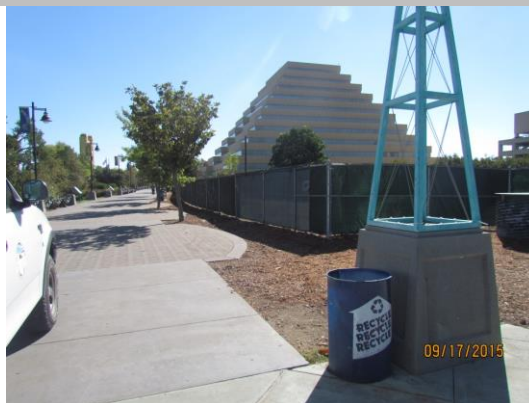
Photo 1 of 2 : SP_2019_MA0004_298_27_20190307_00018.jpg

LM Start	3.24	Rating **	M	Issue No.	27
LM End	3.29	Issue Type +	En	Location *	LS
Category	Earthen Levee			GPS Latitude/Longitude	
				Start	End
Item	Encroachments			38.584168 °	38.583435 °
				-121.508632 °	-121.508785 °
DWR ID	DWR_MA0004_01_f_2015_27				
Comment Code					
FE : Fence					
Inspector Comment					
Fence on the levee shoulder.

View looking downstream of the fence on the crown of the levee . Fall 2015.

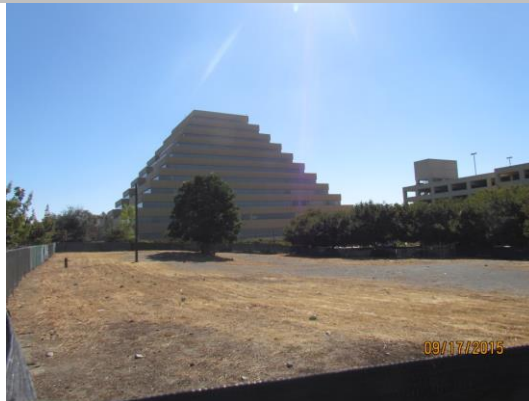
Photo 2 of 2 : SP_2019_MA0004_298_27_20190307_00019.jpg

View looking downstream of the inside of the fence . Fall 2015.
