**Flood Control Project Maintenance
Levee Inspections**
LMA District Cover Sheet
Spring 2020 Levee Inspection Results

Sacramento Maintenance Yard Maintenance Area 0004

Spring 2020 Levee Inspection Results

Waterway			Bank	Unit Miles
Unit No. 01 Sacramento River			Right	3.47
	Spring (March - May)	Summer (June - August)	(September - November) Fall	Winter (December - February)
Unit Maintenance Rating (Fall Only)				
Date of Inspection	4/9/2020 - 4/9/2020			
DWR Inspector	Luz Dial			
Accompanied By

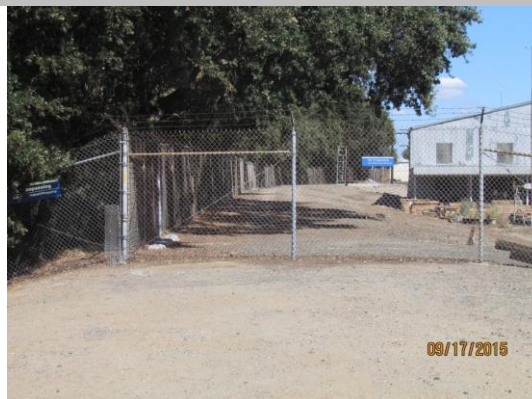
Photo 1 of 1 : SP_2020_MA0004_298_2_20200302_00001.jpg

View of the fence blocking access on the crown of the levee looking downstream. Fall 2015.

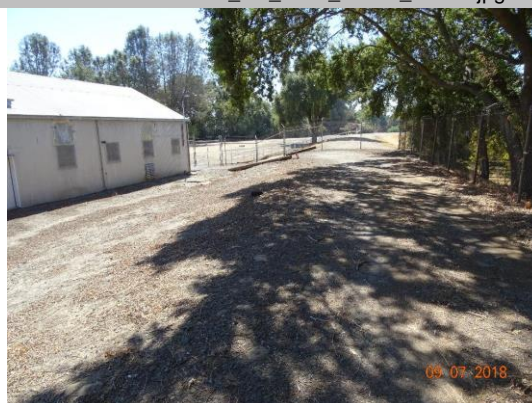
Photo 1 of 3 : UCIP_SP_2020_54261_80009.jpg

LM Start	0.25	Rating **	M	Issue No.	72	
LM End	0.25	Issue Type +	En	Location *		
Category	Supplemental			GPS Latitude/Longitude		
				Start		End
Item	DWR UCIP Field Study			38.597277 °		38.597277 °
				-121.543264 °		-121.543264 °
DWR ID	25546					
Comment Code						
Inspector Comment						
DS_ID:25546						
FS_ID:54261						
EP_NO: N/A						
Repair Type: Non-Urgent						
Crossing Status: Found						
UCIP Comments: 09/07/2018 Sediment clearing at pipe inlet is required. Pipe outlet is not visible on WS. O&M legacy system pipe. (O.Yakimov - DWR UCIP)						
FIELD_STRUCT_DESC: 12-inch corrugated metal drainage pipe through the levee, 19.0 feel below levee crown. [Additional Reference(s): USACE Sacramento O&M Manual 116, August 1955, Dwg No. 50-4-4179, page 9 of 19].						
FS Date: 9/7/2018

Levee crown near crossing

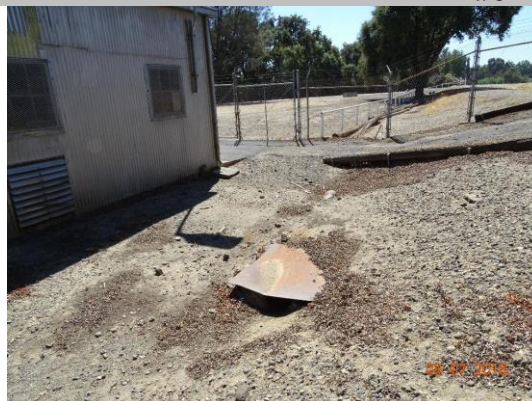
Photo 2 of 3 : UCIP_SP_2020_54261_80011.jpg

Covered concrete box at LS toe

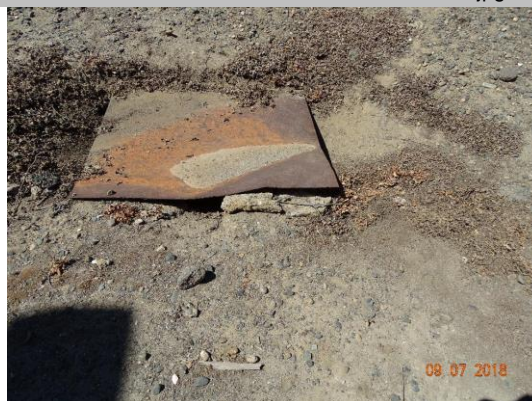
Photo 3 of 3 : UCIP_SP_2020_54261_80012.jpg

Pipe inlet concrete box is covered with metal sheeting

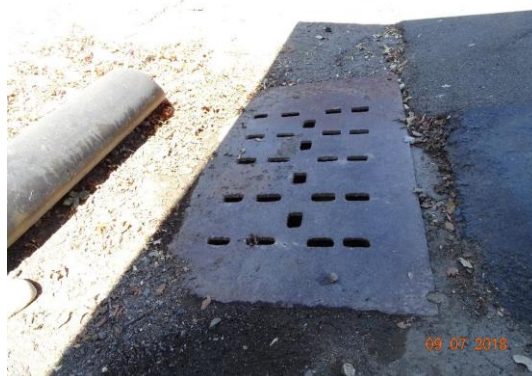
Photo 1 of 3 : UCIP_SP_2020_54262_80017.jpg

LM Start	0.32	Rating **	M	Issue No.	73
LM End	0.32	Issue Type +	En	Location *	
Category	Supplemental			GPS Latitude/Longitude	
				Start	End
Item	DWR UCIP Field Study			38.597915 °	38.597915 °
				-121.542264 °	-121.542264 °
DWR ID	25545				
Comment Code					
Inspector Comment					
DS_ID:25545 FS_ID:54262 EP_NO: N/A Repair Type: Non-Urgent Crossing Status: Found UCIP Comments: 09/07/2018 Record remains Non-Urgent. Pipe not visible at WS slope. No permit has been identified authorizing pipe. (O.Yakimov - DWR UCIP) FIELD_STRUCT_DESC: 12-inch corrugated metal drainage pipe through the levee, 23.3 feel below levee crown. [Additional Reference(s): USACE Sacramento O&M Manual 116, August 1955, Dwg No. 50-4-4179, page 9 of 19]. FS Date: 9/7/2018

Drainage pit at LS toe

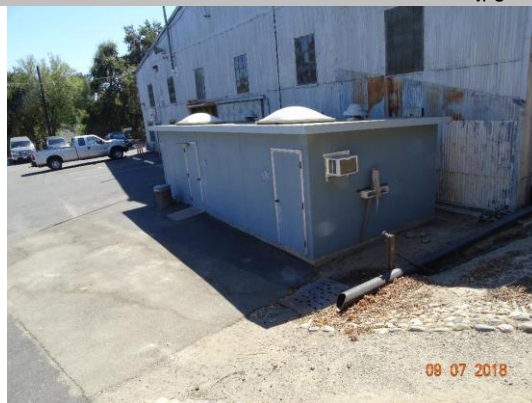
Photo 2 of 3 : UCIP_SP_2020_54262_80018.jpg

Structures at LS toe where drainage pit is located

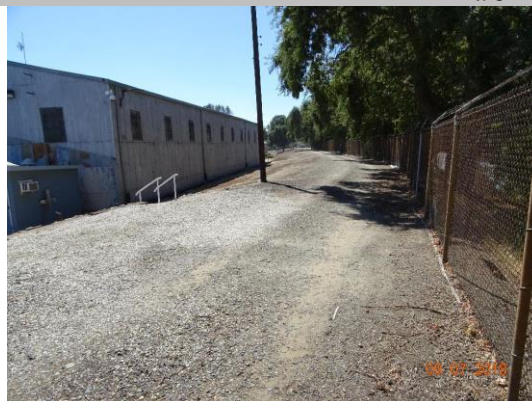
Photo 3 of 3 : UCIP_SP_2020_54262_80019.jpg

Levee crown at crossing

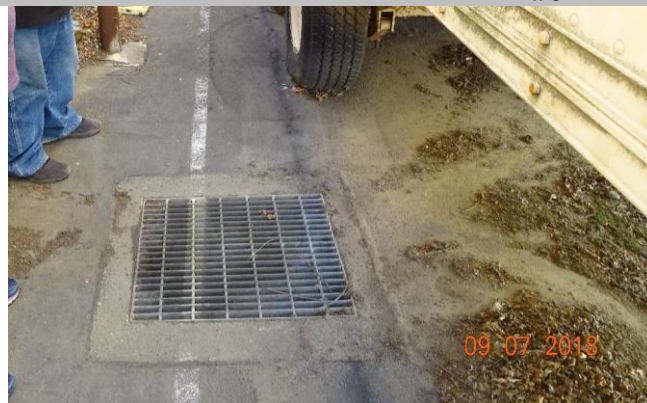
Photo 1 of 3 : UCIP_SP_2020_54255_80007.jpg

DS_ID:25547
 FS_ID:54255
 EP_NO: N/A
 Repair Type: Non-Urgent
 Crossing Status: Found
 UCIP Comments: 09/07/2018 Record remains Non-Urgent. No permit for this crossing was found. Estimated to be 6-inch HDPE drainage pipe inside of drainage box on landside closer to levee toe. (O.Yakimov - DWR UCIP)
 FIELD_STRUCT_DESC: 6-inch high-density polyethylene (HDPE) drainage pipe through the levee, unknown depth below levee crown. First drainage pit with grid is located in the middle of paved road, second is between 2 trailers toward levee toe inline with the first one.
 FS Date: 9/7/2018

Grided drainage pit between trailers on LS

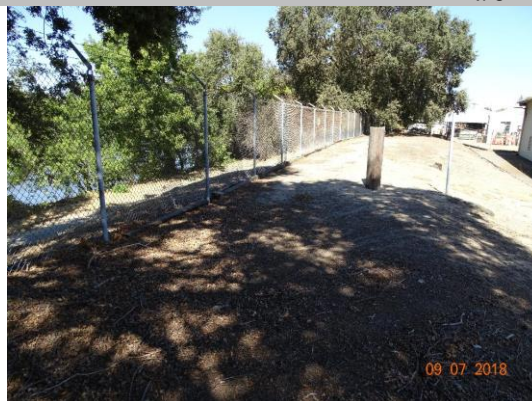
Photo 2 of 3 : UCIP_SP_2020_54255_80005.jpg

View of levee crown at crossing

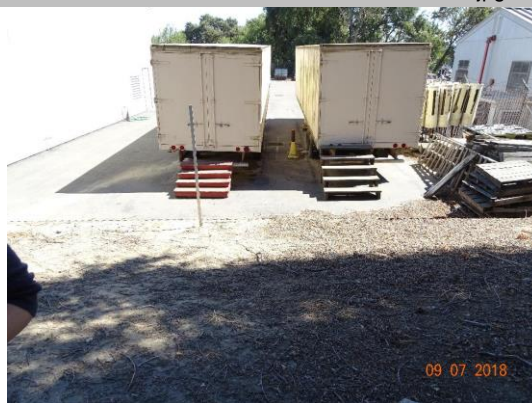
Photo 3 of 3 : UCIP_SP_2020_54255_80006.jpg

View of landside looking from levee crown

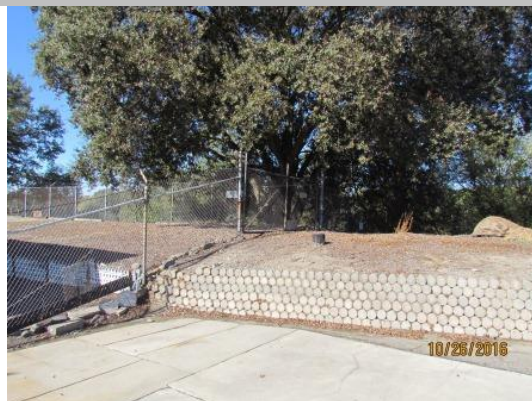
Photo 1 of 1 : SP_2020_MA0004_298_15_20200302_00008.jpg

View of fence crossing the crown on NE side of USACE facility. Fall 2016.

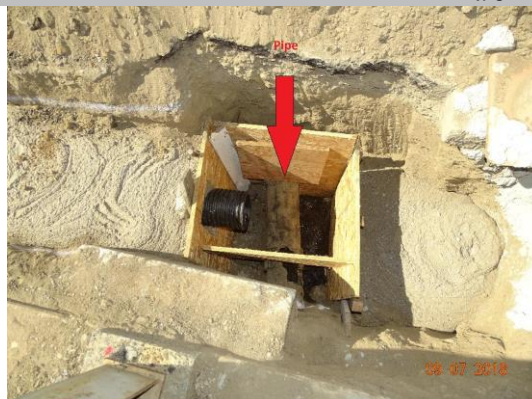
Photo 1 of 3 : UCIP_SP_2020_55303_81540.jpg

DS_ID:25544
FS_ID:55303
EP_NO: N/A
Repair Type: Non-Urgent
Crossing Status: Found
UCIP Comments: 10/10/2019 Record remains Non-Urgent. No permit has been identified authorizing pipe. According to FMO staff this pipe was disconnected from Sac Yard storm drainage system and grouted in place. Unable to locate a permit and confirm proper pipe abandonment. (O.Yakimov - DWR UCIP) 09/07/2018 Steel pipe at the bottom of drainage box is visible. Large reconstruction project is going on the property. Contact Brian Murphy with FMO after work is completed to request as-builts. (O.Yakimov - DWR UCIP)
FIELD_STRUCT_DESC: 8-inch steel drainage pipe through the levee, 12.1 feet below levee crown. [Additional Reference(s): USACE Sacramento O&M Manual 116, August 1955, (Station 53+72), Dwg No. 50-4-4179, page 9 of 19].
FS Date: 10/10/2019 8:51:06 AM

8-inch steel pipe at the bottom of drainage box on LS goes towards levee

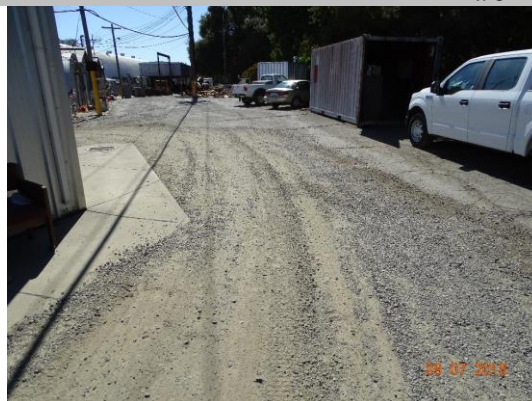
Photo 1 of 3 : UCIP_SP_2020_55305_80008.jpg

Comment Code						
Inspector Comment						
DS_ID:25550 FS_ID:55305 EP_NO: N/A Repair Type: Non-Urgent Crossing Status: Not Found UCIP Comments: 10/10/2019 Record remains Non-Urgent. Crossing not found. According to FMO staff this pipe was disconnected from Sac Yard storm drainage system and grouted in place. Unable to locate a permit and confirm proper pipe abandonment. No permit has been identified authorizing pipe. (O.Yakimov - DWR UCIP) 09/07/2018 Crossing not found (O.Yakimov - DWR UCIP) FIELD_STRUCT_DESC: 6-inch vitrified clay drainage pipe through the levee, 16.1 feet below levee crown. [Additional Reference(s): USACE Sacramento O&M Manual 116, August 1955), Dwg No. 50-4-4179, page 9 of 19]. FS Date: 10/10/2019 9:04:32 AM

Top of levee at crossing

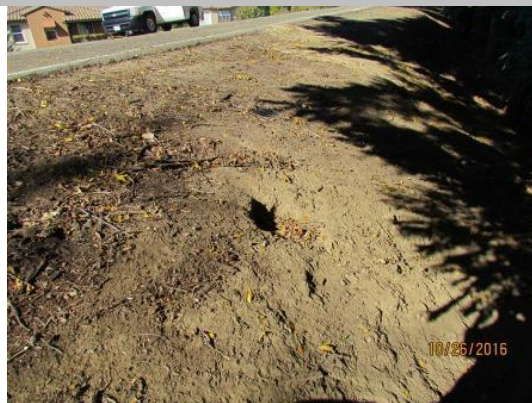
Photo 1 of 1 : SP_2020_MA0004_298_18_20200302_00011.jpg

View of animal holes on the WS slope. Fall 2016.

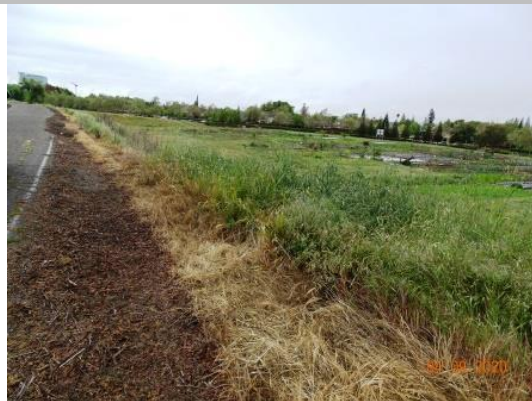
Photo 1 of 1 : SP_2020_MA0004_298_41_20200409_00071.jpg

View of wild growth on the landside slope looking downstream. Spring 2020

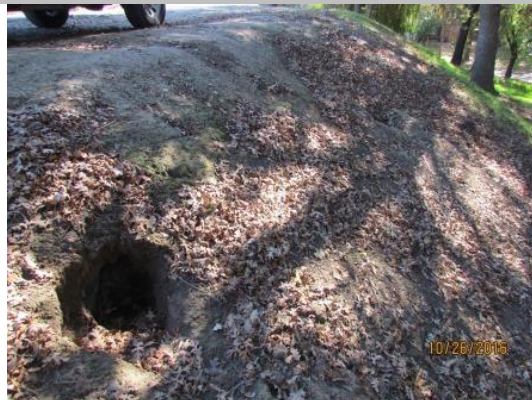
Photo 1 of 1 : SP_2020_MA0004_298_20_20200302_00012.jpg

LM Start	2.63	Rating **	A/W	Issue No.	20
LM End	2.63	Issue Type +	Ma	Location *	LS
Category	Earthen Levee			GPS Latitude/Longitude	
				Start	End
Item	Animal Control			38.591532 °	38.591532 °
				-121.511646 °	-121.511646 °
DWR ID	DWR_MA0004_01_f_2016_20				
Comment Code					
A3 : No rodents visible, but rodent burrows visible; need to backfill and compact or grout burrows.					
Inspector Comment					
LMA backfilled animal hole and recommend monitoring.

Large diameter animal burrows on LS slope. Fall 2016.

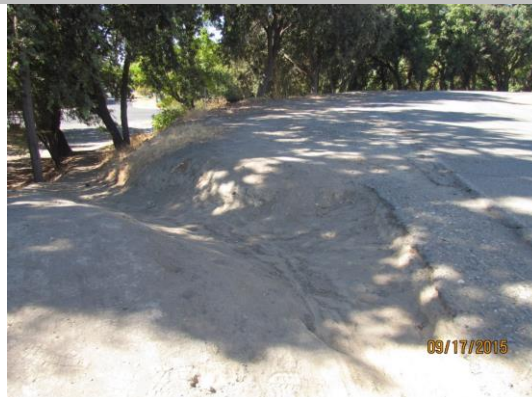
Photo 1 of 1 : SP_2020_MA0004_298_22_20200302_00014.jpg

LM Start	2.65	Rating **	A/W	Issue No.	22
LM End	2.65	Issue Type +	Ma	Location *	LS
Category	Earthen Levee			GPS Latitude/Longitude	
				Start	End
Item	Slope Stability			38.591380 °	38.591380 °
				-121.511345 °	-121.511345 °
DWR ID	DWR_MA0004_01_f _ 2015_22				
Comment Code					
S2 : Repair the levee slope damaged by foot traffic and prevent access where possible.					
Inspector Comment

View looking upstream of the depression on the landward side of the levee due to foot traffic. Fall 2015.

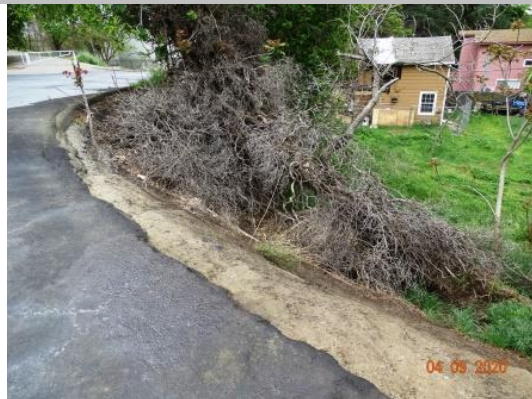
Photo 1 of 1 : SP_2020_MA0004_298_65_20200409_00072.jpg

View of a fallen tree and dying landscape vegetation on the landside slope. Spring 2020

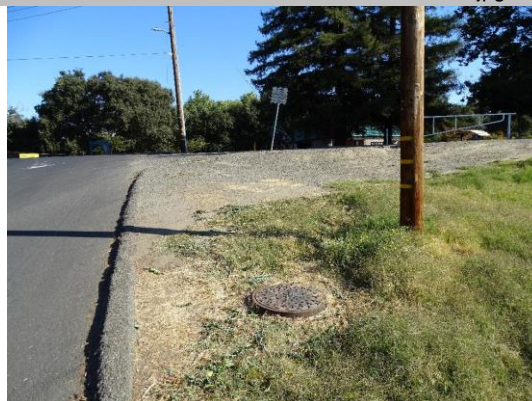
Photo 1 of 3 : UCIP_SP_2020_55300_81531.jpg

Comment Code						
Inspector Comment						
DS_ID:19405						
FS_ID:55300						
EP_NO: N/A						
Repair Type: Non-Urgent						
Crossing Status: Found						
UCIP Comments: 10/10/2019 Record remains Non-Urgent. No permit for this crossing was found. A public restroom on WS and a manhole located on road shoulder may be associated with this crossing.						
(O.Yakimov - DWR UCIP)						
09/12/2012 Found during the field survey, not listed in the desk study.

Manhole on the road shoulder on LS

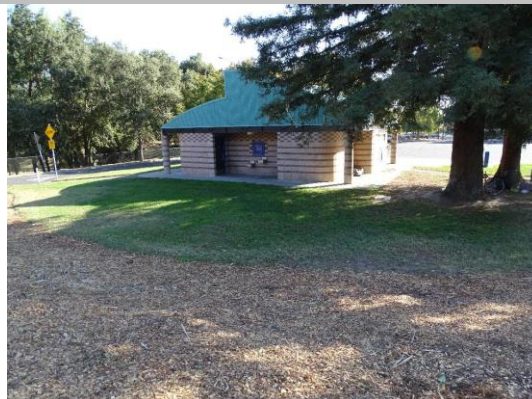
Photo 2 of 3 : UCIP_SP_2020_55300_81532.jpg

Public restroom on WS

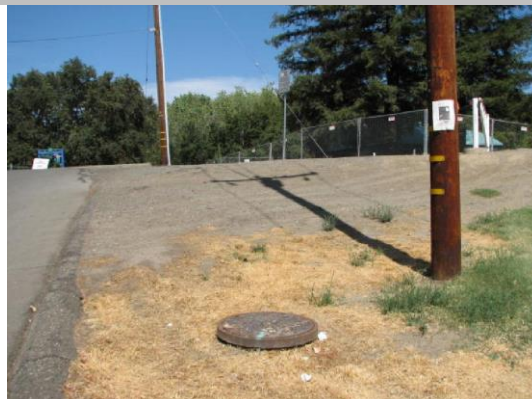
Photo 3 of 3 : UCIP_SP_2020_55300_83349.jpg

Older photo of a manhole on the road shoulder on LS

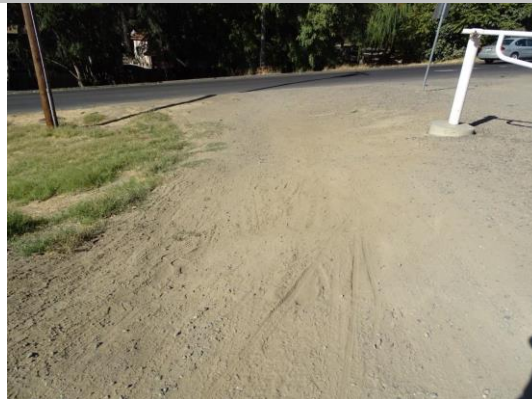
Photo 1 of 1 : SP_2020_MA0004_298_17_20200302_00010.jpg

LM Start	2.70	Rating **	A/W	Issue No.	17
LM End	2.70	Issue Type +	Ma	Location *	LS
Category	Earthen Levee			GPS Latitude/Longitude	
				Start	End
Item	Slope Stability			38.590802 °	38.590802 °
				-121.510736 °	-121.510736 °
DWR ID	DWR_MA0004_01_f_2018_17				
Comment Code					
S3 : Repair the levee slope damaged by vehicle traffic and prevent access where possible.					
Inspector Comment					
Monitor slope damage from vehicular traffic bypassing gate. Consider placement of a barrier.

View of slope damage from vehicular traffic bypassing gate. Fall 2018

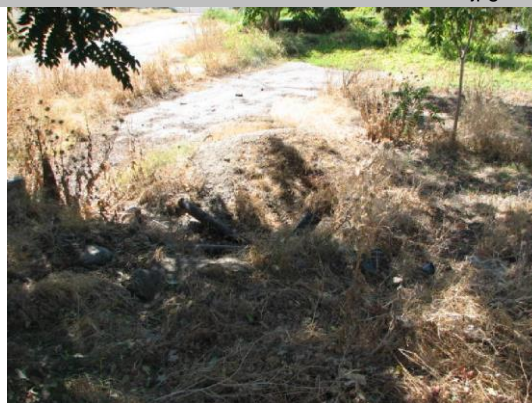
Photo 3 of 3 : UCIP_SP_2020_55315_9770.jpg

Land side view- abandoned pipes inside the tower area

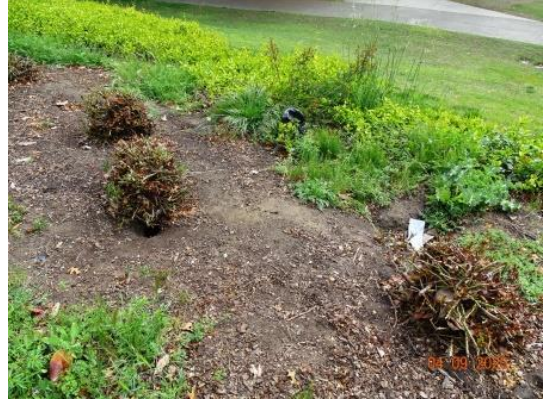
Photo 1 of 1 : SP_2020_MA0004_298_71_20200409_00073.jpg

View of active animal burrows on the landside slope. Spring 2020
