**Flood Control Project Maintenance
Levee Inspections
LMA District Cover Sheet**

Sacramento Maintenance Yard Maintenance Area 0004

Levee Inspection Report By Mile - Spring 2021

Waterway	Bank	Unit Miles	Inspection Start/End	Inspector
Unit No. 01 Sacramento River	Right	3.47	04/21/2021 04/21/2021	Saskia Donovan

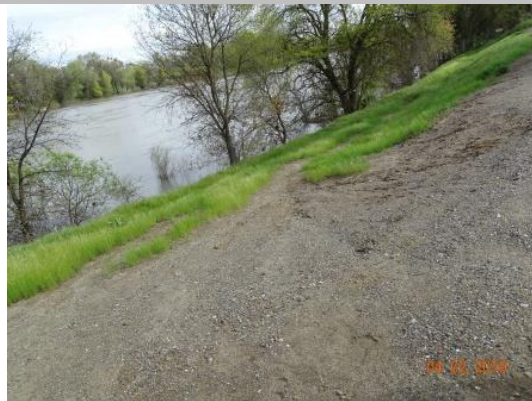
Photo 1 of 1 : SP_2021_MA0004_298_7_20210223_00002.jpg

LM Start	0.21	Rating **	A/W	Issue No.	7
LM End	0.22	Issue Type +	Ma	Location *	WS
Category	Earthen Levee			GPS Latitude/Longitude	
				Start	End
Item	Slope Stability			38.596840 °	38.596947 °
				-121.543848 °	-121.543727 °
DWR ID	DWR_MA0004_01_s_2019_7				
Comment Code					
S2 : Repair the levee slope damaged by foot traffic and prevent access where possible.					
Inspector Comment					
Monitor footpath and erosion on the waterside berm.

View looking north at footpath and erosion rills. Spring 2019

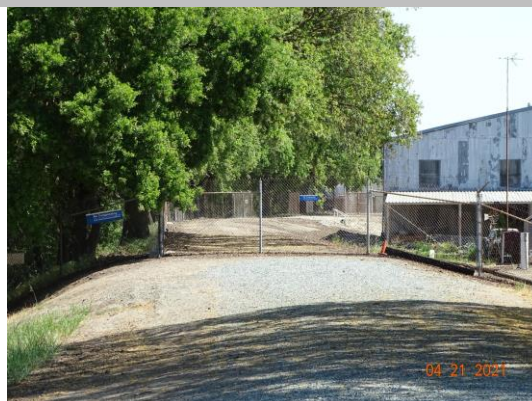
Photo 1 of 1 : SP_2021_MA0004_298_2_20210504_00072.jpg

LM Start	0.24	Rating **	U	Issue No.	2
LM End	0.24	Issue Type +	En	Location *	CR
Category	Earthen Levee			GPS Latitude/Longitude	
				Start	End
Item	Encroachments			38.597193 °	38.597193 °
				-121.543421 °	-121.543421 °
DWR ID	DWR_MA0004_01_s_2012_2				
Comment Code					
FE : Fence					
Inspector Comment					
This is the USACE yard, and the chain link fence crosses the levee. The fence runs the length of the yard on the crown.

View of the fence across the levee crown at the SW side of the USACE facility. Spring 2021.

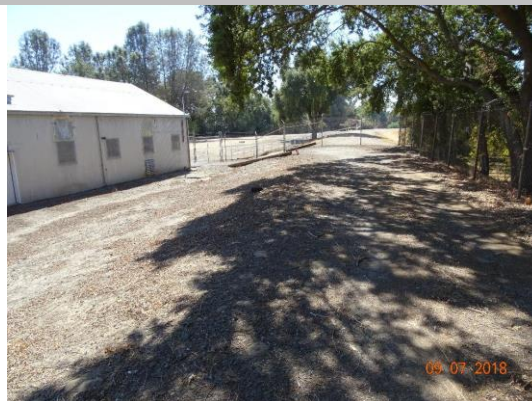
Photo 1 of 3 : UCIP_SP_2021_59983_80009.jpg

Comment Code						
Inspector Comment						
FS_ID:59983						
DS_ID:25546						
EP_NO: N/A						
Repair Type: Non-Urgent						
Crossing Status: Found						
UCIP Comments: 09/07/2018 Record is considered Non-Urgent.						
Sediment clearing at pipe inlet is required. Pipe outlet is not visible on						
WS. O&M legacy system pipe. (O.Yakimov - DWR UCIP)						
FIELD_STRUCT_DESC: 12-inch corrugated metal drainage pipe						
through the levee, 19.0 feet below levee crown. [Additional						
Reference(s): Drawing No. 50-04-4179, Sheet 11.2 and 18.1, pdf page						
9 and 17 of 19, associated with USACE Sacramento O&M Manual, Unit						
116, August 1955, Revised 29 Dec 2016, shows 12-inch CMP						
referenced as Sta 44+92 (Site Mile 62.25 RT)].						
FS Date: 9/7/2018

Levee crown near crossing

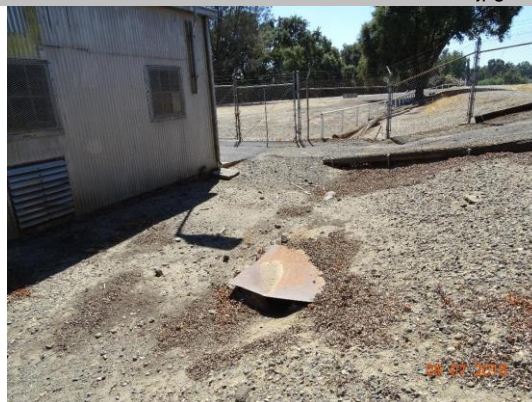
Photo 2 of 3 : UCIP_SP_2021_59983_80011.jpg

Covered concrete box at LS toe

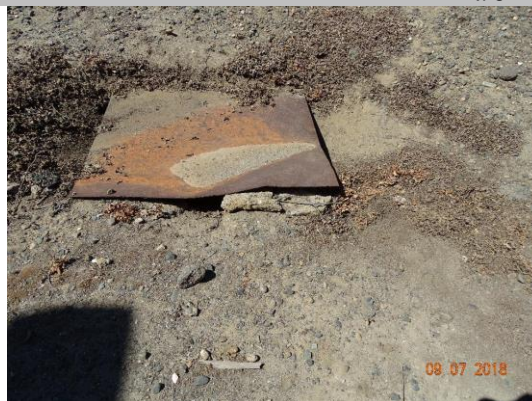
Photo 3 of 3 : UCIP_SP_2021_59983_80012.jpg

Pipe inlet concrete box is covered with metal sheeting

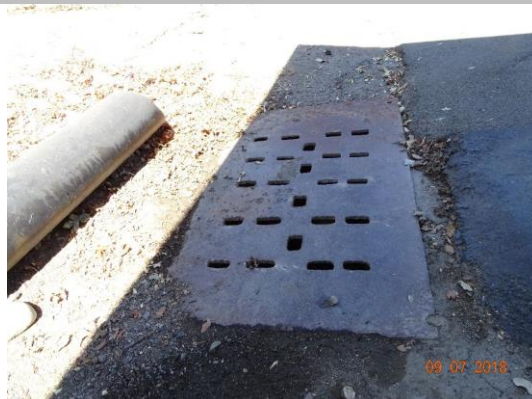
Photo 1 of 3 : UCIP_SP_2021_59819_80017.jpg

FS_ID:59819
 DS_ID:25545
 EP_NO: N/A
 Repair Type: Non-Urgent
 Crossing Status: Found
 UCIP Comments: 09/07/2018 Record remains Non-Urgent. Pipe not visible at WS slope. No permit has been identified authorizing pipe. (O.Yakimov - DWR UCIP)
 FIELD_STRUCT_DESC: 12-inch corrugated metal drainage pipe through the levee, 23.3 feet below levee crown. [Additional Reference(s): Drawing No. 50-04-4179, Sheet 11.2 and 18.1, pdf page 9 and 17 of 19, associated with USACE Sacramento O&M Manual, Unit 116, August 1955, Revised 29 Dec 2016, shows 12-inch CMP referenced as Sta 48+62 (Site Mile 62.25 RT)].
 FS Date: 9/7/2018

Drainage pit at LS toe

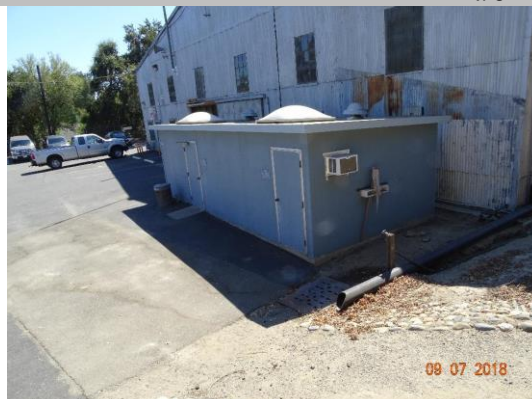
Photo 2 of 3 : UCIP_SP_2021_59819_80018.jpg

Structures at LS toe where drainage pit is located

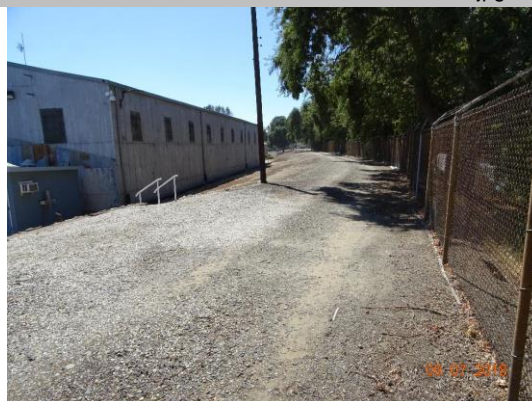
Photo 3 of 3 : UCIP_SP_2021_59819_80019.jpg

Levee crown at crossing

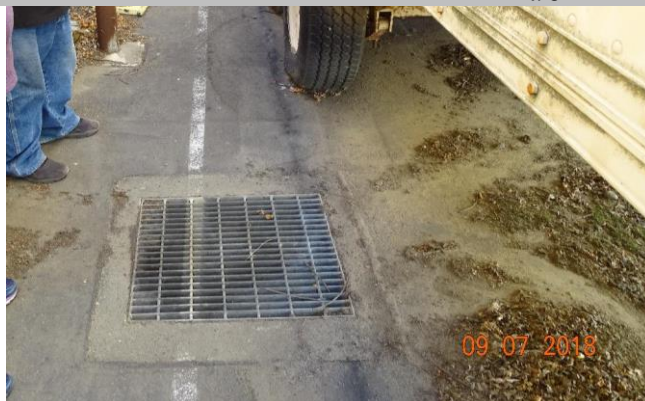
Photo 1 of 3 : UCIP_SP_2021_54255_80007.jpg

LM Start	0.38	Rating **	M	Issue No.	5	
LM End	0.38	Issue Type +	En	Location *		
Category	Supplemental			GPS Latitude/Longitude		
				Start		End
Item	DWR UCIP Field Study			38.598480 °		38.598480 °
				-121.541376 °		-121.541376 °
DWR ID	25547					
Comment Code						
Inspector Comment						
FS_ID:54255 DS_ID:25547 EP_NO: N/A Repair Type: Non-Urgent Crossing Status: Found UCIP Comments: 09/07/2018 Record remains Non-Urgent. No permit for this crossing was found. Estimated to be 6-inch HDPE drainage pipe inside of drainage box on landside closer to levee toe. (O.Yakimov - DWR UCIP) FIELD_STRUCT_DESC: 6-inch high-density polyethylene (HDPE) drainage pipe through the levee, unknown depth below levee crown. First drainage pit with grid is located in the middle of paved road, second is between 2 trailers toward levee toe inline with the first one. FS Date: 9/7/2018

Grided drainage pit between trailers on LS

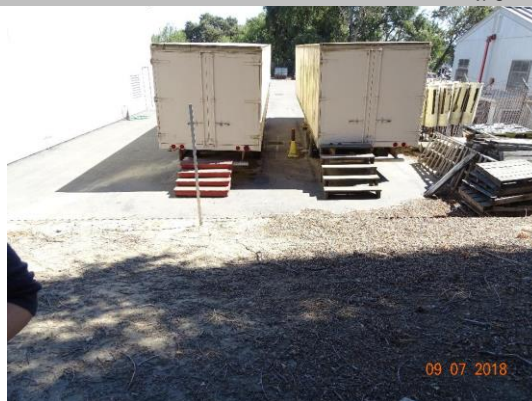
Photo 3 of 3 : UCIP_SP_2021_54255_80006.jpg

View of landside looking from levee crown

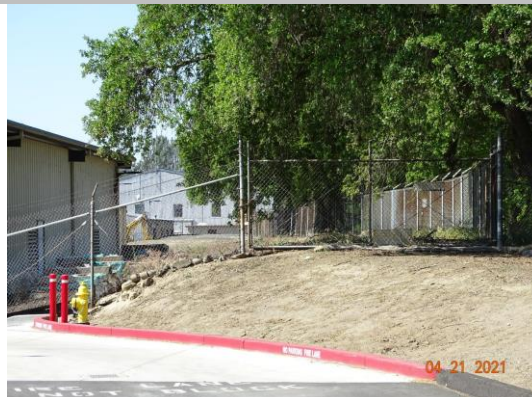
Photo 1 of 1 : SP_2021_MA0004_298_15_20210504_00071.jpg

View of the fence across the levee crown on the NE side of the USACE facility. Spring 2021.

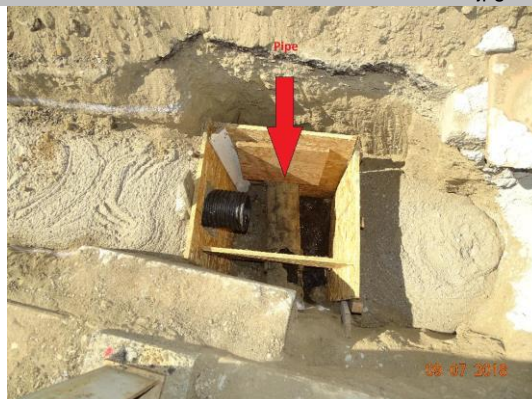
Photo 1 of 3 : UCIP_SP_2021_58977_81540.jpg

Comment Code						
Inspector Comment						
FS_ID:58977						
DS_ID:25544						
EP_NO: N/A						
Repair Type: Non-Urgent						
Crossing Status: Found						
UCIP Comments: 10/10/2019 Record remains Non-Urgent. No permit has been identified authorizing pipe. According to FMO staff this pipe was disconnected from Sac Yard storm drainage system and grouted in place. Unable to locate a permit and confirm proper pipe abandonment (O.Yakimov - DWR UCIP)09/07/2018 Steel pipe at the bottom of drainage box is visible. Large reconstruction project is going on the property. Contact Brian Murphy with FMO after work is completed to request as-builts. (O.Yakimov - DWR UCIP)						
FIELD_STRUCT_DESC: 8-inch steel drainage pipe through the levee, 12.1 feet below levee crown. [Additional Reference(s): Drawing No. 50-04-4179, Sheet 11.2 and 18.1, pdf page 9 and 17 of 19, associated with USACE Sacramento O&M Manual, Unit 116, August 1955, Revised 29 Dec 2016, shows 8-inch CMP referenced as Sta 54+53 (Site Mile 62.25 RT)].

8-inch steel pipe at the bottom of drainage box on LS goes towards levee

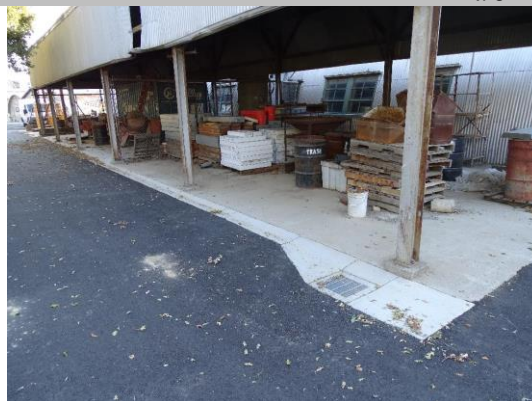
Photo 2 of 3 : UCIP_SP_2021_58977_81512.jpg

View of drainage box on levee crown

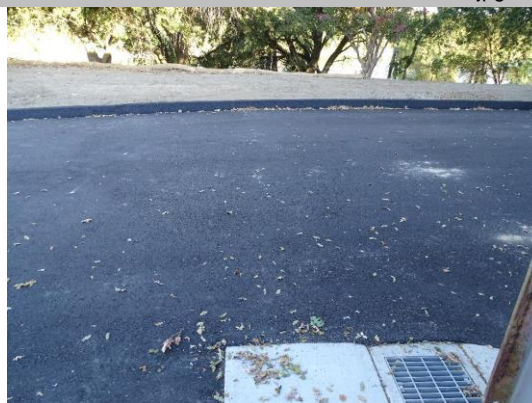
Photo 3 of 3 : UCIP_SP_2021_58977_81539.jpg

Drainage box on levee crown

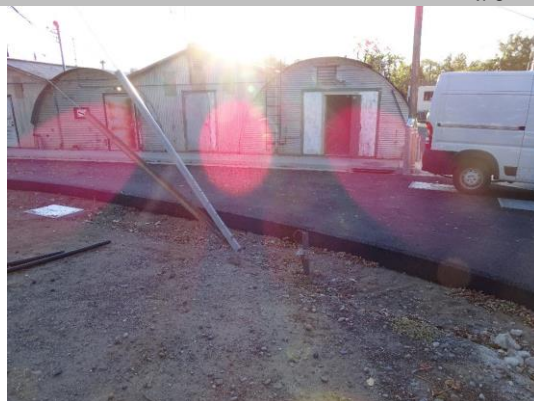
Photo 1 of 3 : UCIP_SP_2021_58971_81541.jpg

FS_ID:58971
DS_ID:25552
EP_NO: N/A
Repair Type: Non-Urgent
Crossing Status: Not Found
UCIP Comments: 10/10/2019 Record remains Non-Urgent. Crossing not found. According to FMO staff this pipe was disconnected from Sac Yard storm drainage system and grouted in place. Unable to locate a permit and confirm proper pipe abandonment. No permit has been identified authorizing pipe. (O.Yakimov - DWR UCIP) 09/07/2018
Crossing not found (O.Yakimov - DWR UCIP)
FIELD_STRUCT_DESC: 9-inch steel drainage pipe through the levee, 17 feet below levee crown. [Additional Reference(s): Drawing No. 50-04-4179, Sheet 11.2 and 18.1, pdf page 9 and 17 of 19, associated with USACE Sacramento O&M Manual, Unit 116, August 1955, Revised 29 Dec 2016, shows 9-inch steel pipe referenced as Sta 56+02 (Site Mile 62.25 RT)]
FS Date: 10/10/2019 9:03:00 AM

View of levee crown at potential crossing

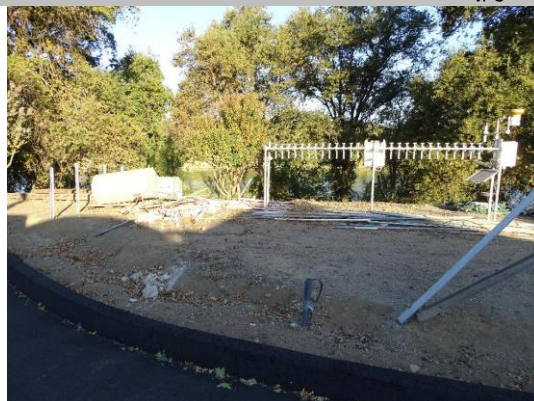
Photo 2 of 3 : UCIP_SP_2021_58971_83345.jpg

View of levee crown at the crossing

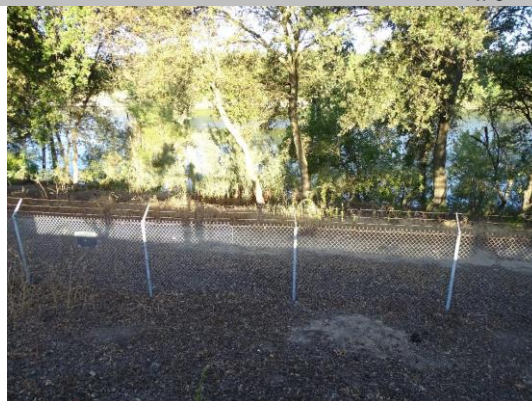
Photo 3 of 3 : UCIP_SP_2021_58971_83346.jpg

View of WS levee slope

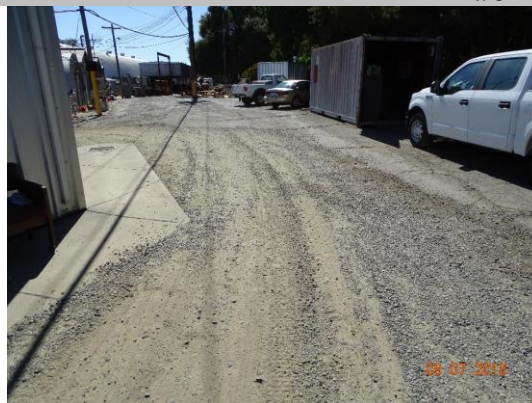
Photo 1 of 3 : UCIP_SP_2021_58714_80008.jpg

Top of levee at crossing

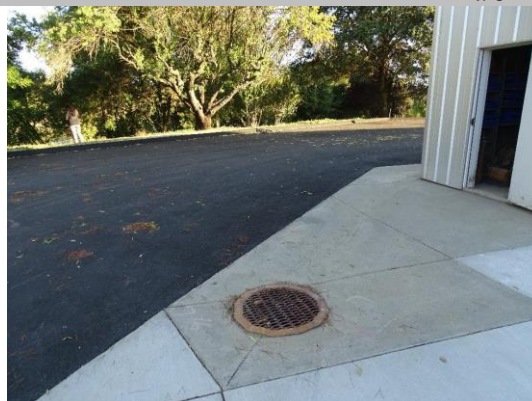
Photo 2 of 3 : UCIP_SP_2021_58714_83347.jpg

View of crown at crossing

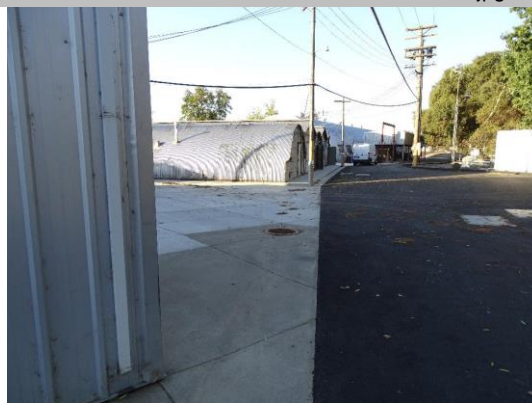
Photo 3 of 3 : UCIP_SP_2021_58714_83348.jpg

View of crown at crossing

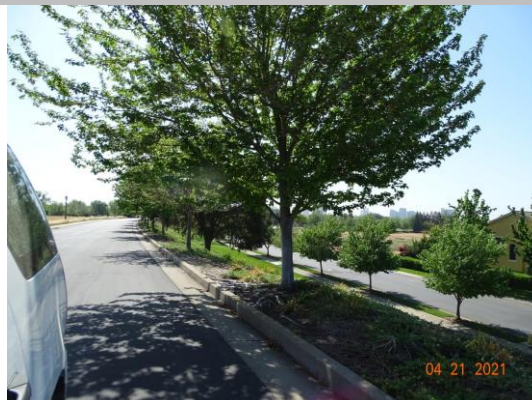
Photo 1 of 1 : SP_2021_MA0004_298_60_20210504_00070.jpg

View of the trees on the LS levee shoulder. Spring 2021.

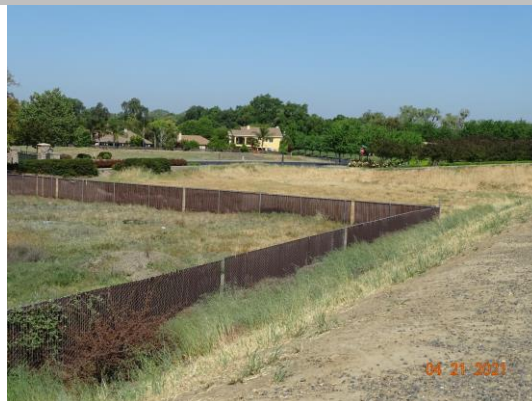
Photo 1 of 1 : SP_2021_MA0004_298_58_20210504_00069.jpg

View of the privacy fence along the LS levee slope. Spring 2021.

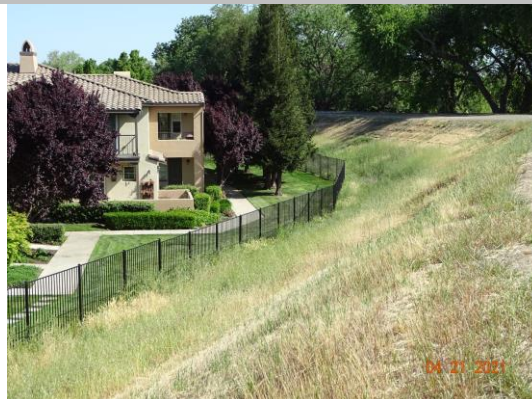
Photo 1 of 1 : SP_2021_MA0004_298_14_20210504_00067.jpg

View of the fence along the LS levee toe. Spring 2021.

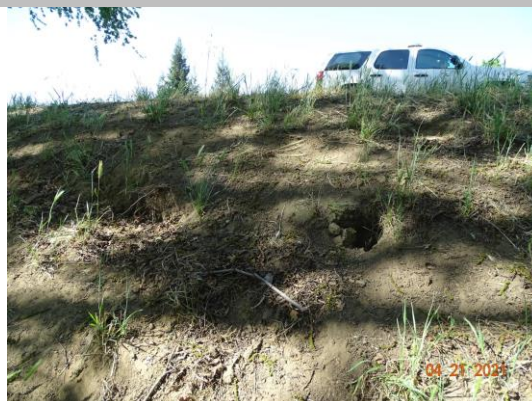
Photo 1 of 1 : SP_2021_MA0004_298_18_20210504_00068.jpg

View of the animal holes on the WS levee slope. Spring 2021.

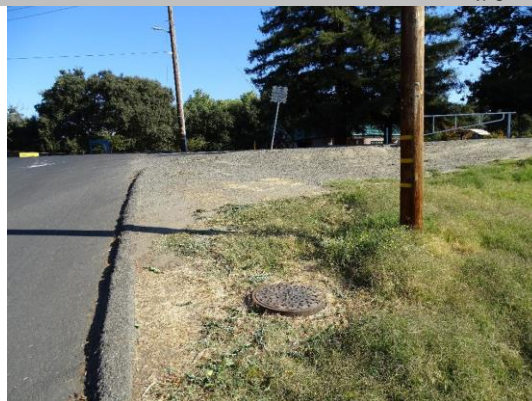
Photo 1 of 3 : UCIP_SP_2021_58715_81531.jpg

Manhole on the road shoulder on LS

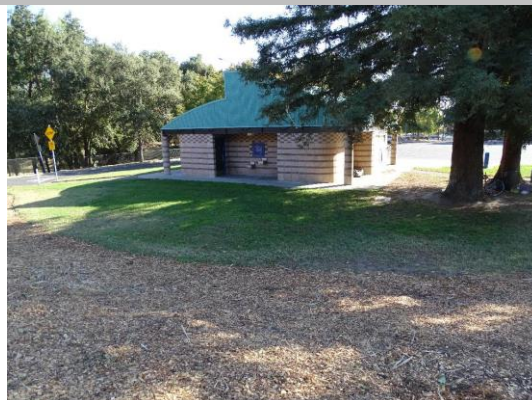
Photo 2 of 3 : UCIP_SP_2021_58715_81532.jpg

Public restroom on WS

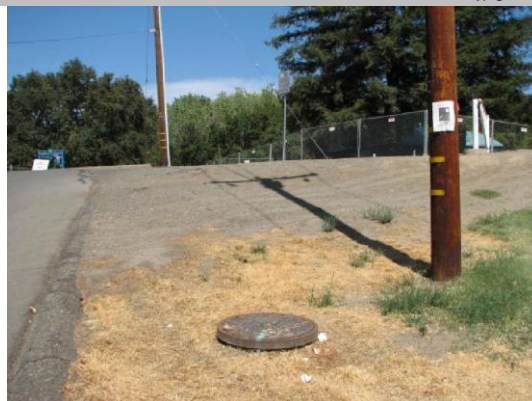
Photo 3 of 3 : UCIP_SP_2021_58715_83349.jpg

Older photo of a manhole on the road shoulder on LS

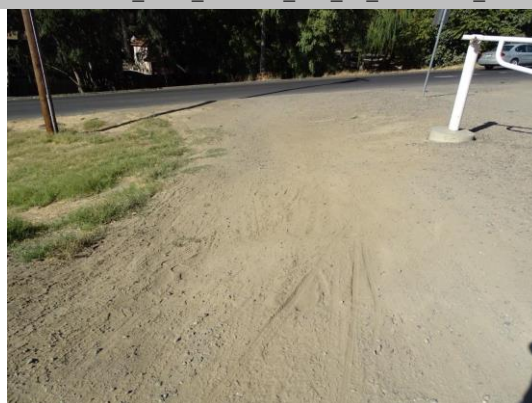
Photo 1 of 1 : SP_2021_MA0004_298_17_20210223_00006.jpg

LM Start	2.70	Rating **	M	Issue No.	53
LM End	2.70	Issue Type +	Ma	Location *	CR
Category	Earthen Levee			GPS Latitude/Longitude	
				Start	End
Item	Repair Gates			38.590877 °	38.590877 °
				-121.510810 °	-121.510810 °
DWR ID	DWR_MA0004_01_f _ 2020_53				
Comment Code					
Inspector Comment					
Replace lock that may be damaged from tampering.

View of slope damage from vehicular traffic bypassing gate. Fall 2018

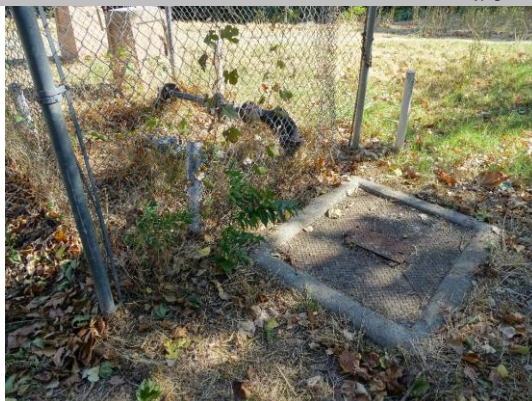
Photo 1 of 3 : UCIP_SP_2021_58716_81566.jpg

Waterside view: a control valve box with a metal lid

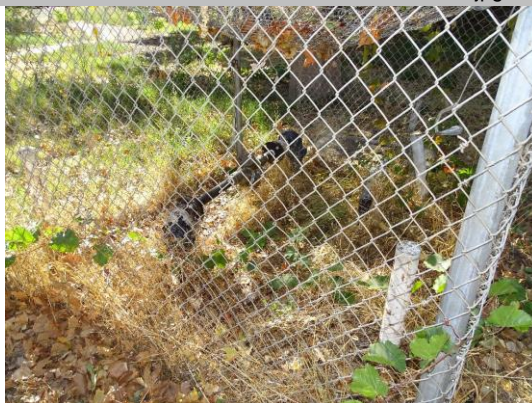
Photo 2 of 3 : UCIP_SP_2021_58716_81567.jpg

Waterside view: pipe daylights in a metal cage

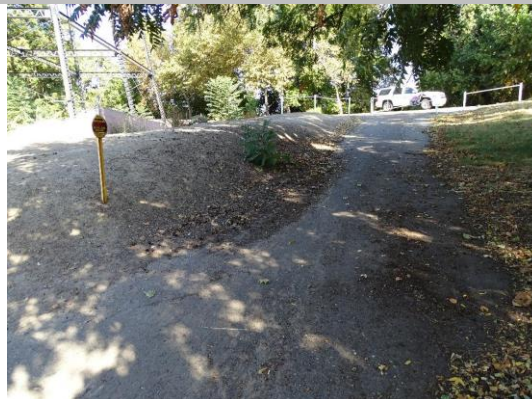
Photo 3 of 3 : UCIP_SP_2021_58716_81568.jpg

View of landside at the crossing

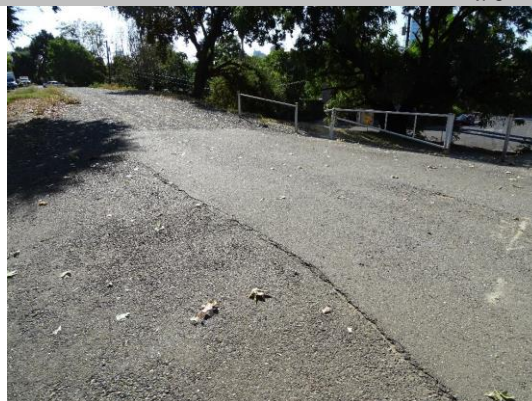
Photo 1 of 3 : UCIP_SP_2021_59816_81569.jpg

Levee crown at the crossing

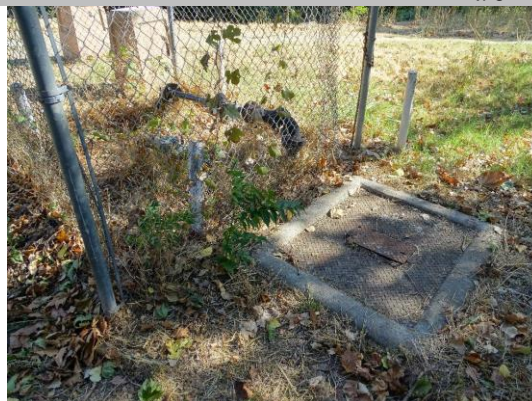
Photo 2 of 3 : UCIP_SP_2021_59816_81570.jpg

Waterside view: a control valve box with a metal lid

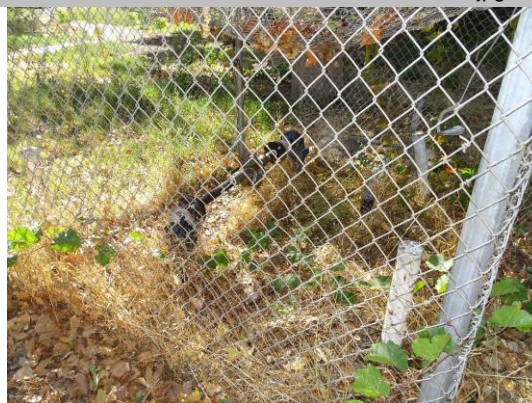
Photo 3 of 3 : UCIP_SP_2021_59816_81571.jpg

Waterside view: pipe daylights in a metal cage

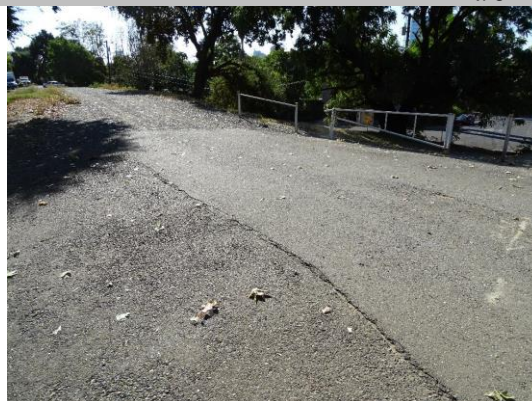
Photo 1 of 3 : UCIP_SP_2021_55310_81562.jpg

View of levee crown at crossing

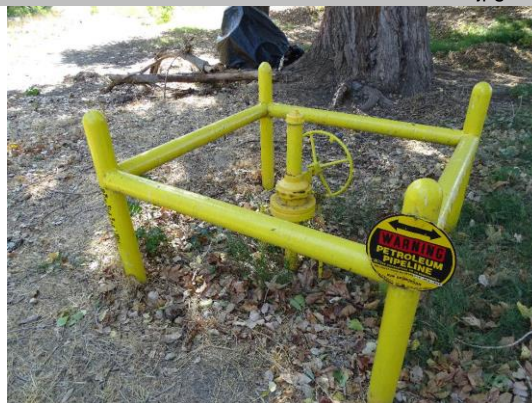
Photo 2 of 3 : UCIP_SP_2021_55310_81564.jpg

Petroleum line marker on WS

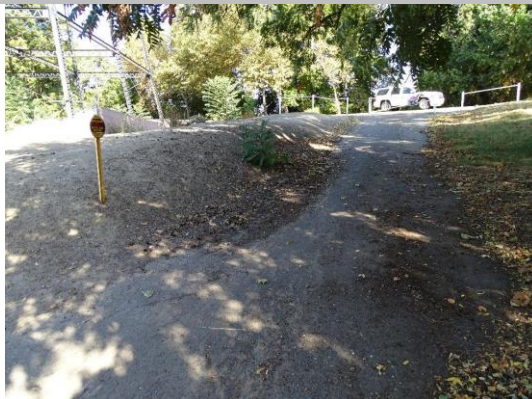
Photo 3 of 3 : UCIP_SP_2021_55310_81565.jpg

Petroleum line marker and ramp on LS

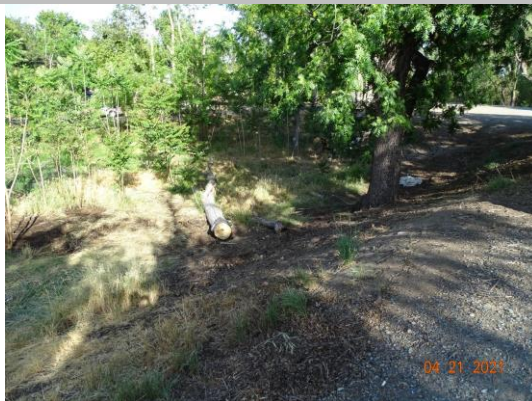
Photo 1 of 1 : SP_2021_MA0004_298_44_20210504_00066.jpg

View of the tree limbs on the LS levee toe. Spring 2021.

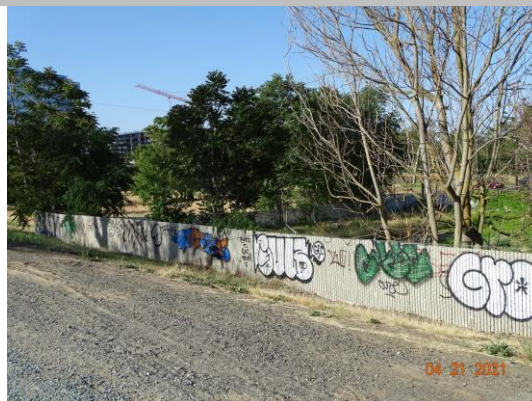
Photo 1 of 1 : SP_2021_MA0004_298_23_20210504_00065.jpg

View of the fence on the LS levee slope. Spring 2021.

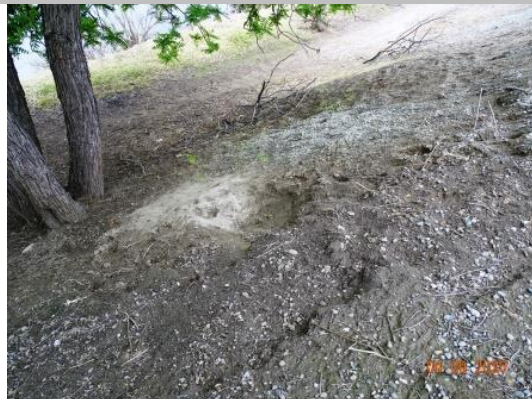
Photo 1 of 1 : SP_2021_MA0004_298_28_20210223_00011.jpg

View of a hole dug into the waterside slope. Spring 2020

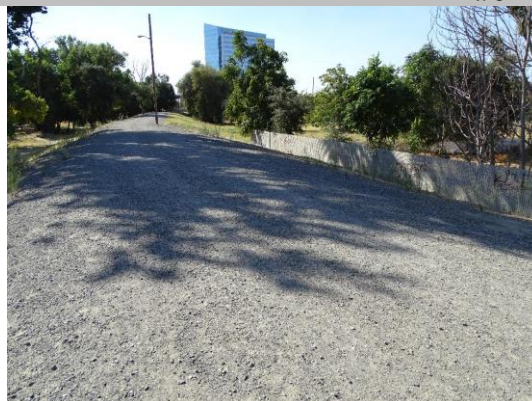
Photo 1 of 3 : UCIP_SP_2021_59773_81572.jpg

View of levee crown at crossing

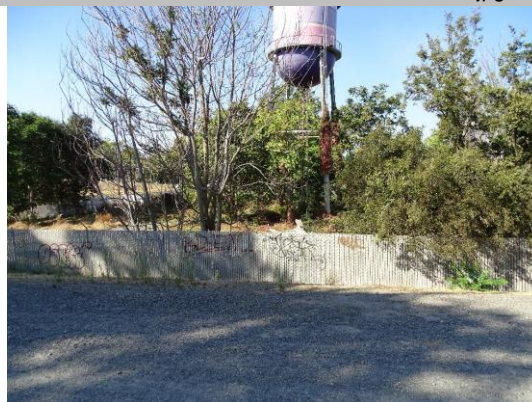
Photo 2 of 3 : UCIP_SP_2021_59773_81574.jpg

Land side view- inside water tower area

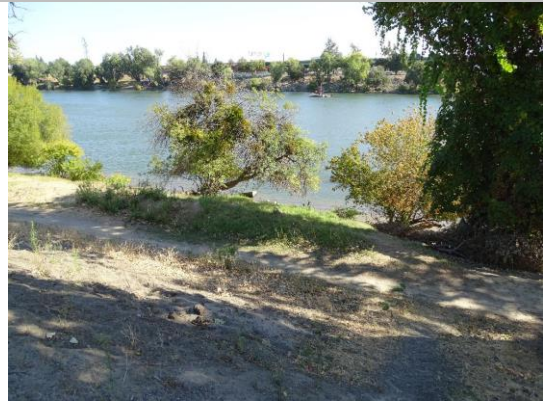
Photo 2 of 3 : UCIP_SP_2021_59775_81579.jpg

Overview of waterside at pipe crossing

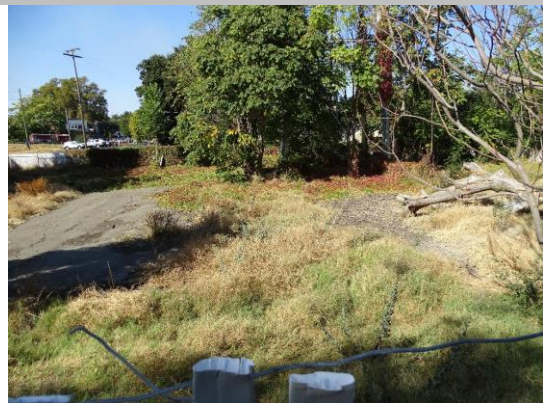
Photo 3 of 3 : UCIP_SP_2021_59775_81580.jpg

View inside of water tower area

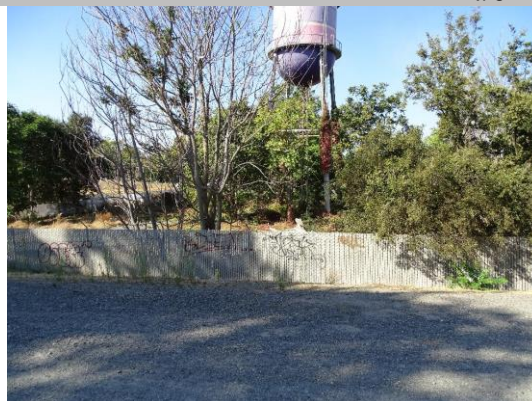
Photo 1 of 3 : UCIP_SP_2021_59774_81576.jpg

Land side view: water tower area

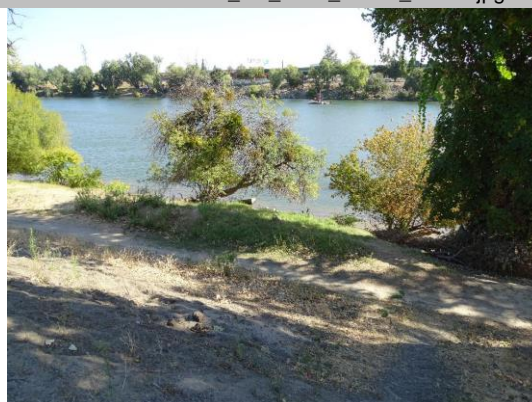
Photo 2 of 3 : UCIP_SP_2021_59774_81577.jpg

Overview of waterside at pipe crossing

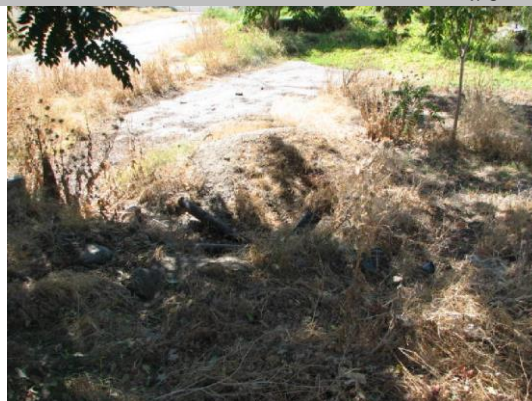
Photo 3 of 3 : UCIP_SP_2021_59774_9770.jpg

Land side view- abandoned pipes inside the tower area

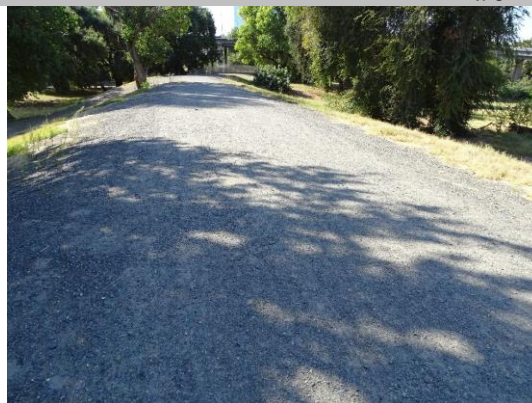
Photo 1 of 3 : UCIP_SP_2021_55317_81581.jpg

View of levee crown at possible crossing

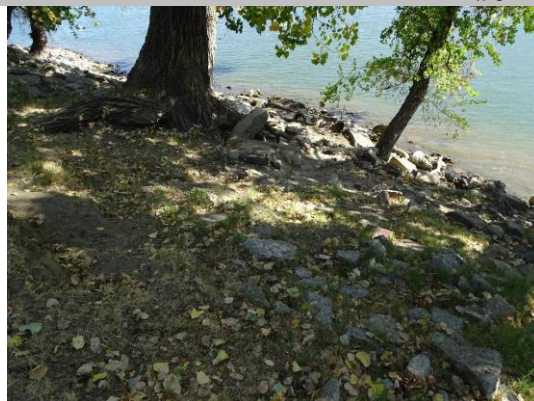
Photo 2 of 3 : UCIP_SP_2021_55317_81582.jpg

Riverbank near possible crossing

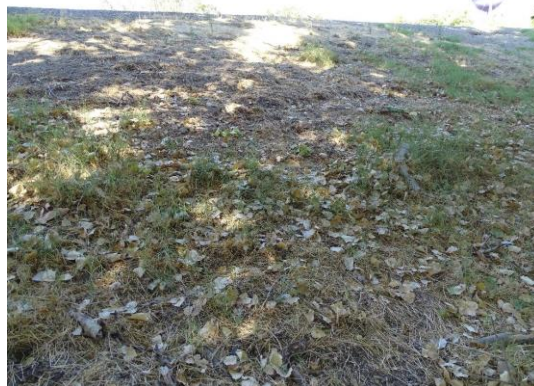
Photo 3 of 3 : UCIP_SP_2021_55317_81583.jpg

View of WS slope at possible crossing

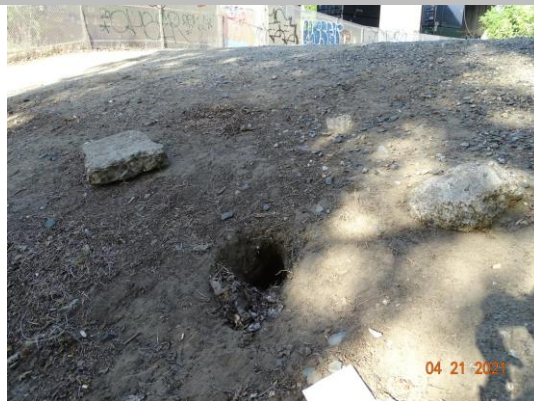
Photo 1 of 1 : SP_2021_MA0004_298_43_20210504_00064.jpg

View of the rodent hole on the WS levee slope. Spring 2021.

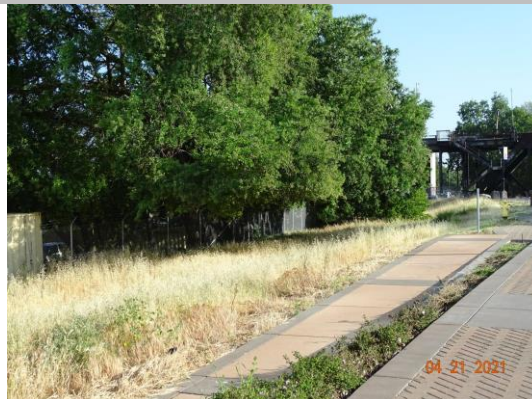
Photo 1 of 1 : SP_2021_MA0004_298_56_20210504_00063.jpg

View of the annual grass on the LS levee slope. Spring 2021.

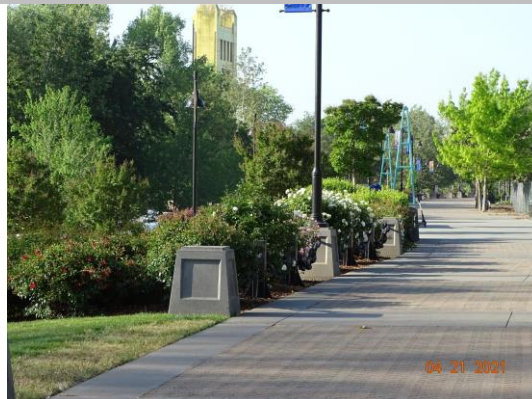
Photo 1 of 1 : SP_2021_MA0004_298_12_20210504_00062.jpg

View of the landscaping on River Walk. Spring 2021.

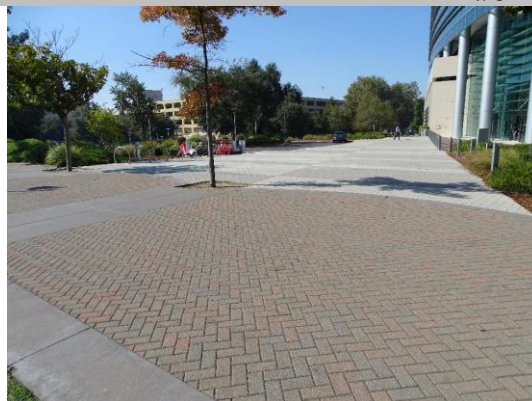
Photo 1 of 1 : UCIP_SP_2021_55346_81587.jpg

Paved levee crown at possible crossing

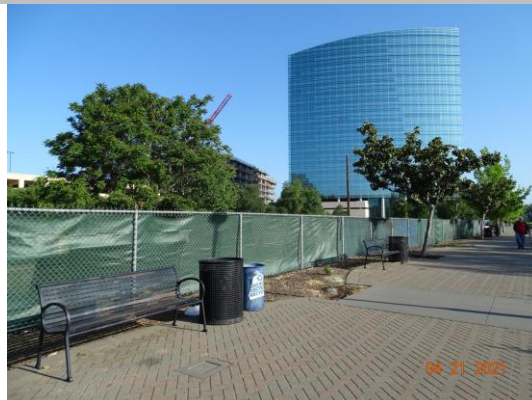
Photo 1 of 1 : SP_2021_MA0004_298_27_20210504_00061.jpg

View of the fence on the LS levee shoulder. Spring 2021.

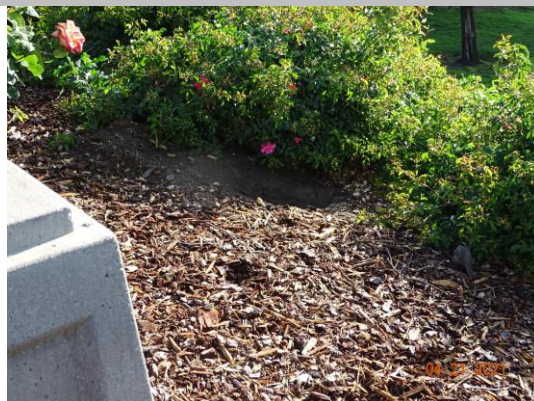
Photo 1 of 1 : SP_2021_MA0004_298_59_20210504_00060.jpg

View of the rodent hole on the WS levee slope. Spring 2021.

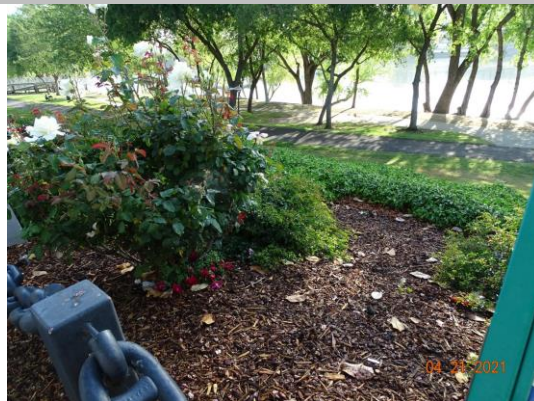
Photo 1 of 1 : SP_2021_MA0004_298_71_20210504_00059.jpg

View of the burrowing area covered with mulch on the WS levee slope. Spring 2021.

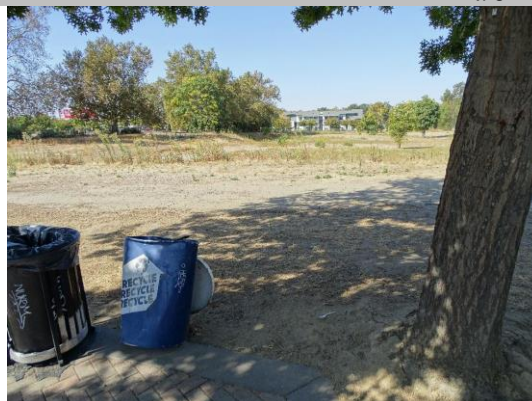
Photo 1 of 2 : UCIP_SP_2021_55349_81591.jpg

View of LS at potential crossing

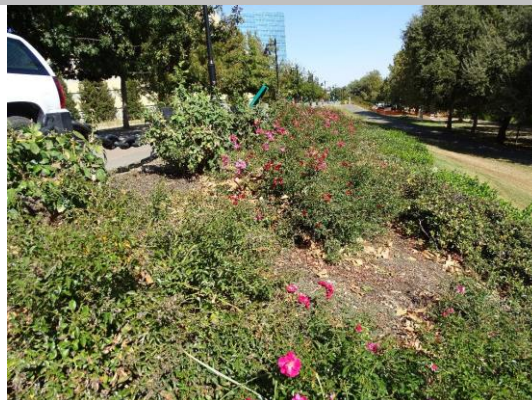
Photo 2 of 2 : UCIP_SP_2021_55349_81592.jpg

View of WS slope at potential crossing
