**Flood Control Project Maintenance
Levee Inspections
LMA District Cover Sheet**

**Flood Control Project Maintenance
Levee Inspections
Unit Cover Sheet**

Levee Inspection Report By Mile - Spring 2022

Waterway	Bank	Unit Miles	Inspection Start/End	Inspector
Unit No. 01 Sacramento River	Right	3.47	03/28/2022 03/28/2022	Marvin Marshall

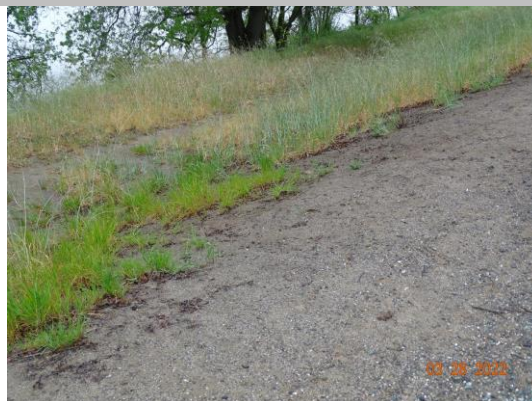
Photo 1 of 1 : SP_2022_MA0004_298_7_20220412_00069.jpg

LM Start	0.21	Rating **	A/W	Issue No.	7
LM End	0.21	Issue Type +	Ma	Location *	WS
Category	Earthen Levee			GPS Latitude/Longitude	
				Start	End
Item	Erosion / Foot Traffic			38.596963 °	38.596963 °
				-121.543772 °	-121.543772 °
DWR ID	DWR_MA0004_01_s_2019_7				
Comment Code					
E3 : Repair the levee slope damaged by foot traffic and prevent access where possible.					
Inspector Comment					
Monitor footpath for erosion on the waterside berm.

Foot path on the water side slope. Spring 2022

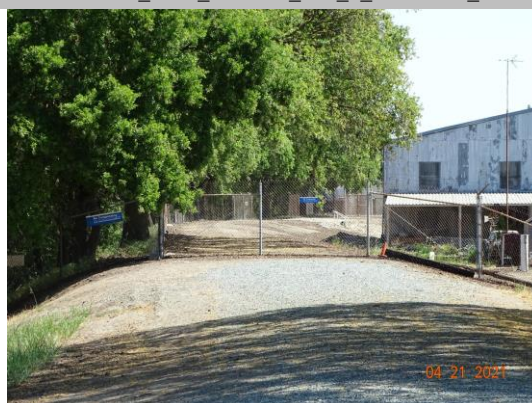
Photo 1 of 1 : SP_2022_MA0004_298_2_20220307_00001.jpg

LM Start	0.24	Rating **	U	Issue No.	2
LM End	0.24	Issue Type +	En	Location *	CR
Category	Earthen Levee			GPS Latitude/Longitude	
				Start	End
Item	Encroachments			38.597193 °	38.597193 °
				-121.543421 °	-121.543421 °
DWR ID	DWR_MA0004_01_s_2012_2				
Comment Code					
FE : Fence					
Inspector Comment					
This is the USACE yard, and the chain link fence crosses the levee. The fence runs the length of the yard on the crown.

View of the fence across the levee crown at the SW side of the USACE facility. Spring 2021.

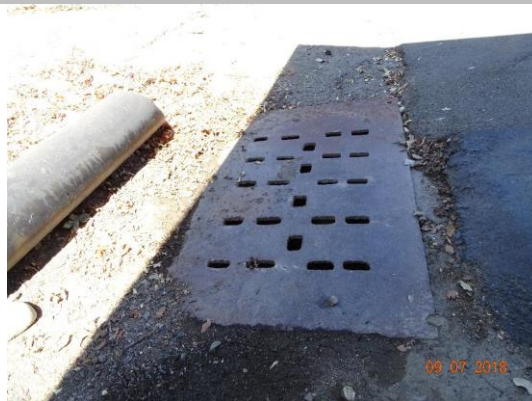
Photo 1 of 3 : UCIP_SP_2022_59819_80017.jpg

FS_ID:59819
DS_ID:25545
EP_NO: N/A
Repair Type: Non-Urgent
Crossing Status: Found
UCIP Comments: 09/07/2018 Record remains Non-Urgent. Pipe not visible at WS slope. No permit has been identified authorizing pipe. (O.Yakimov - DWR UCIP)
FIELD_STRUCT_DESC: 12-inch corrugated metal drainage pipe through the levee, 23.3 feet below levee crown. [Additional Reference(s): Drawing No. 50-04-4179, Sheet 11.2 and 18.1, pdf page 9 and 17 of 19, associated with USACE Sacramento O&M Manual, Unit 116, August 1955, Revised 29 Dec 2016, shows 12-inch CMP referenced as Sta 48+62 (Site Mile 62.25 RT)].
FS Date: 9/7/2018

Drainage pit at LS toe

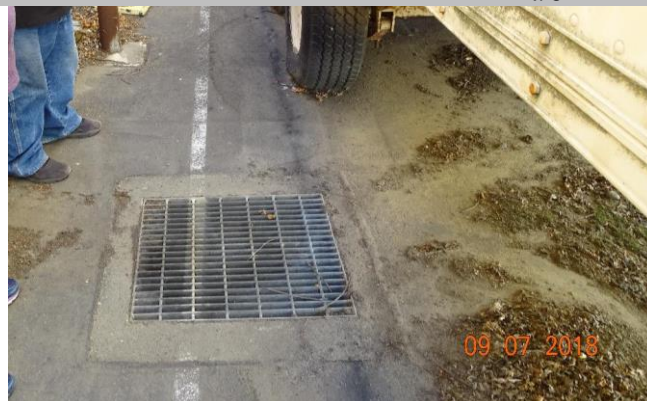
Photo 1 of 3 : UCIP_SP_2022_54255_80007.jpg

Comment Code						
Inspector Comment						
FS_ID:54255						
DS_ID:25547						
EP_NO: N/A						
Repair Type: Non-Urgent						
Crossing Status: Found						
UCIP Comments: 09/07/2018 Record remains Non-Urgent. No permit for this crossing was found. Estimated to be 6-inch HDPE drainage pipe inside of drainage box on landside closer to levee toe. (O.Yakimov - DWR UCIP)						
FIELD_STRUCT_DESC: 6-inch high-density polyethylene (HDPE) drainage pipe through the levee, unknown depth below levee crown. First drainage pit with grid is located in the middle of paved road, second is between 2 trailers toward levee toe inline with the first one.						
FS Date: 9/7/2018

Grided drainage pit between trailers on LS

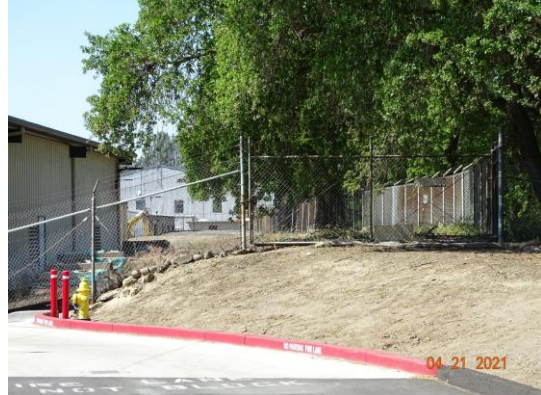
Photo 1 of 1 : SP_2022_MA0004_298_15_20220307_00005.jpg

View of the fence across the levee crown on the NE side of the USACE facility. Spring 2021.

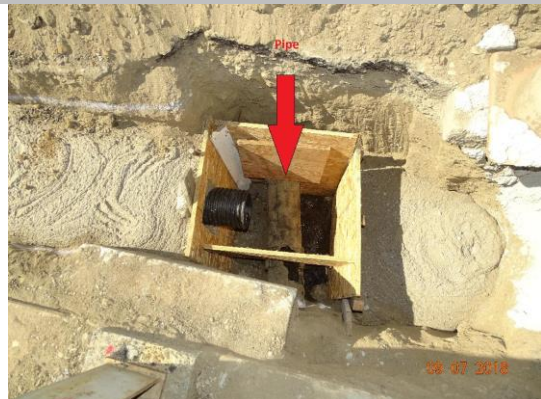
Photo 1 of 3 : UCIP_SP_2022_58977_81540.jpg

Comment Code						
Inspector Comment						
FS_ID:58977 DS_ID:25544 EP_NO: N/A Repair Type: Non-Urgent Crossing Status: Found UCIP Comments: 10/10/2019 Record remains Non-Urgent. No permit has been identified authorizing pipe. According to FMO staff this pipe was disconnected from Sac Yard storm drainage system and grouted in place. Unable to locate a permit and confirm proper pipe abandonment. (O.Yakimov - DWR UCIP)09/07/2018 Steel pipe at the bottom of drainage box is visible. Large reconstruction project is going on the property. Contact Brian Murphy with FMO after work is completed to request as-builts. (O.Yakimov - DWR UCIP) FIELD_STRUCT_DESC: 8-inch steel drainage pipe through the levee, 12.1 feet below levee crown. [Additional Reference(s): Drawing No. 50-04-4179, Sheet 11.2 and 18.1, pdf page 9 and 17 of 19, associated with USACE Sacramento O&M Manual, Unit 116, August 1955, Revised 29 Dec 2016, shows 8-inch CMP referenced as Sta 54+53 (Site Mile 62.25 RT)]. FS Date: 10/10/2019 8:51:00 AM

8-inch steel pipe at the bottom of drainage box on LS goes towards levee

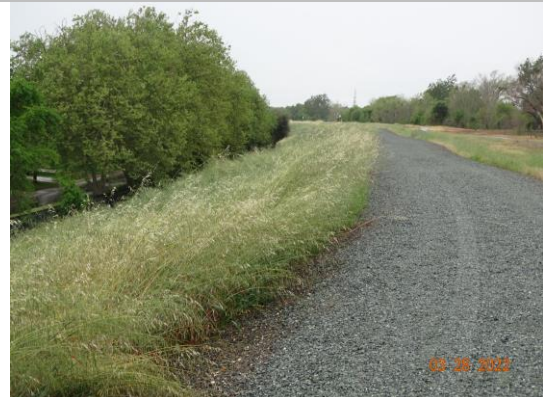
Photo 1 of 1 : SP_2022_MA0004_298_39_20220412_00070.jpg

Annual vegetation on the land side slope. Spring 2022

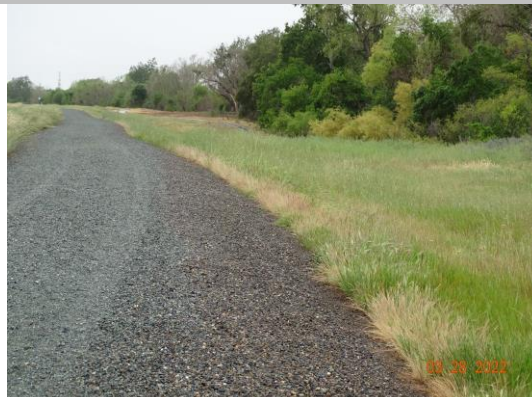
Photo 1 of 1 : SP_2022_MA0004_298_40_20220412_00071.jpg

Annual vegetation growth on the water side slope. Spring 2022

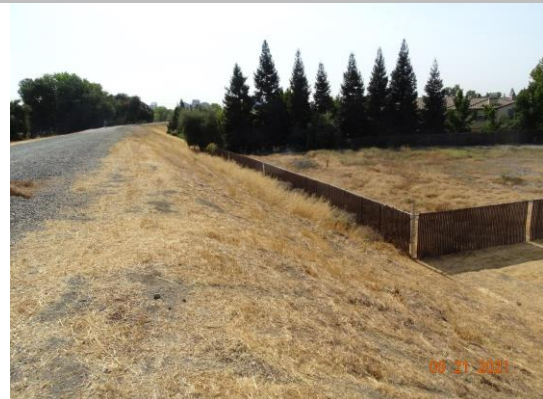
Photo 1 of 1 : SP_2022_MA0004_298_58_20220307_00017.jpg

Fencing along LS toe of slope. Fall 2021

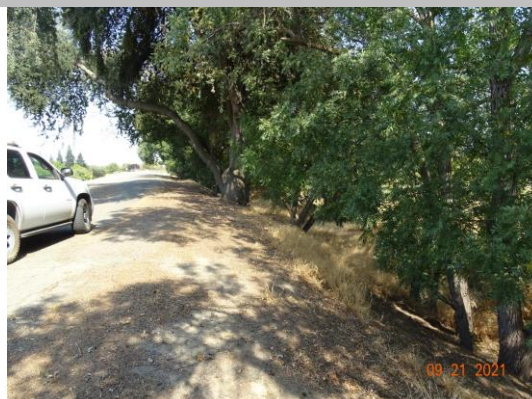
Photo 1 of 1 : SP_2022_MA0004_298_50_20220307_00015.jpg

Trees on the WS slope to be trimmed 5' above grade. Fall 2021

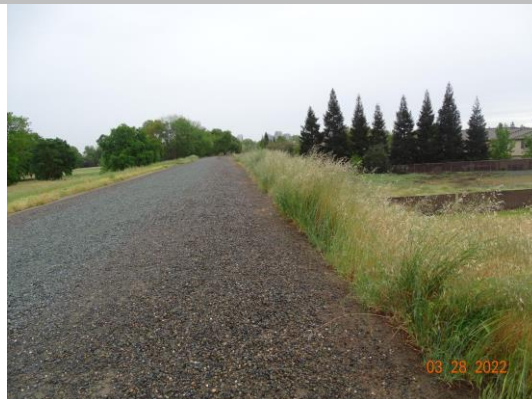
Photo 1 of 1 : SP_2022_MA0004_298_43_20220412_00072.jpg

Annual vegetation on the land side slope. Spring 2022

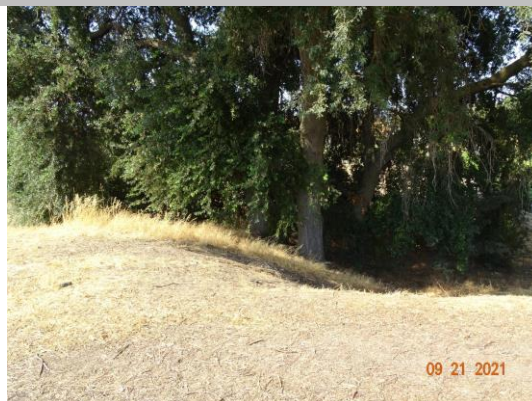
Photo 1 of 1 : SP_2022_MA0004_298_49_20220307_00014.jpg

Small Oak tree grove on the LS slope. Fall 2021

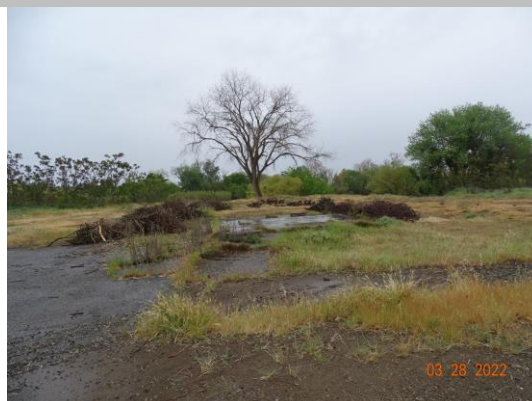
Photo 1 of 1 : SP_2022_MA0004_298_46_20220412_00073.jpg

Pruning piles on the water side berm. Spring 2022

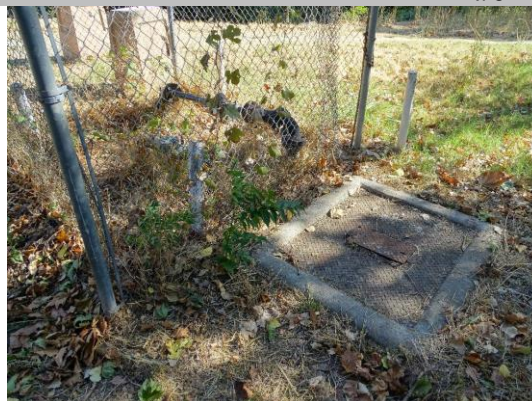
Photo 1 of 3 : UCIP_SP_2022_58716_81566.jpg

FS_ID:58716
 DS_ID:19406
 EP_NO: N/A
 Repair Type: Non-Urgent
 Crossing Status: Found
 UCIP Comments: 10/10/2019 Record remains Non-Urgent. No permit for this crossing was found. (O.Yakimov - DWR UCIP) 09/12/2012 Found during field survey. Not listed in the desk study. (P. Amatya - DWR UCIP)
 FIELD_STRUCT_DESC: 1 of 2: 3-inch wrapped galvanized iron (GI) water pipe through the levee, at an unknown depth. Pipe daylights in a metal cage box. Valve box for the pipe is also found.
 FS Date: 10/10/2019 11:45:00 AM

Waterside view: a control valve box with a metal lid

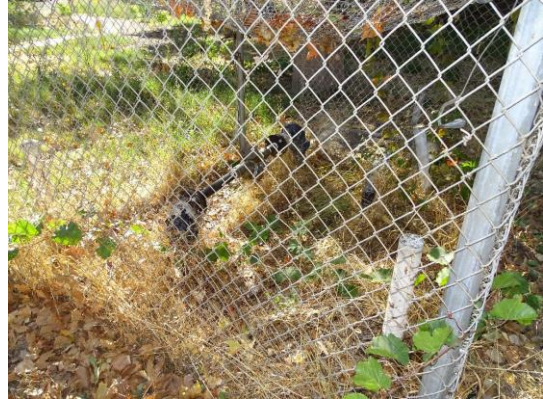
Photo 2 of 3 : UCIP_SP_2022_58716_81567.jpg

Waterside view: pipe daylights in a metal cage

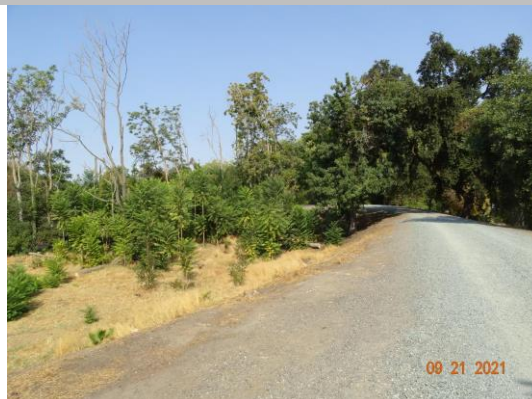
Photo 1 of 1 : SP_2022_MA0004_298_44_20220307_00011.jpg

Large tree trunk at tow of LS slope. Fall 2021

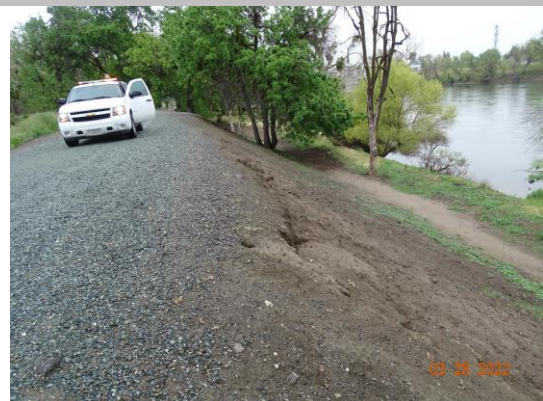
Photo 1 of 1 : SP_2022_MA0004_298_47_20220412_00074.jpg

Burrows and footpaths on the water side slope. Spring 2022

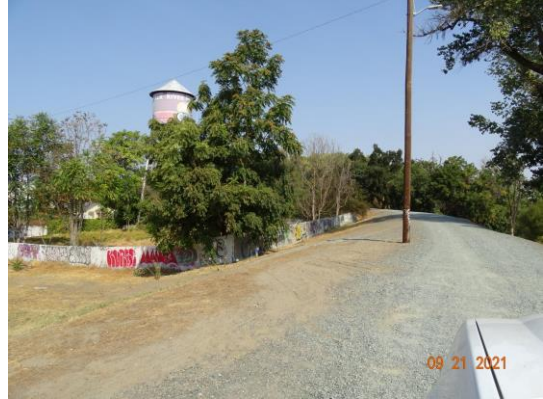
Photo 1 of 2 : SP_2022_MA0004_298_23_20220307_00006.jpg

View of the fence on the LS toe. Fall 2021.

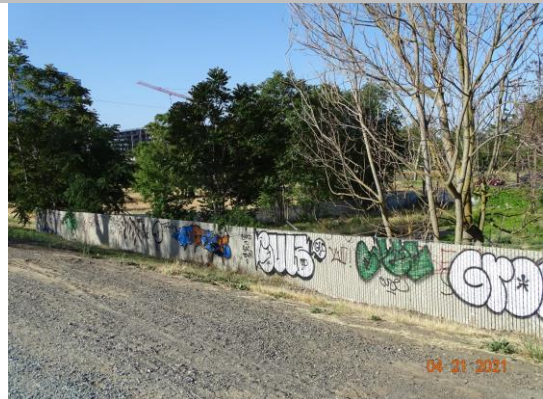
Photo 2 of 2 : SP_2022_MA0004_298_23_20220307_00007.jpg

View of the fence on the LS levee slope. Spring 2021.

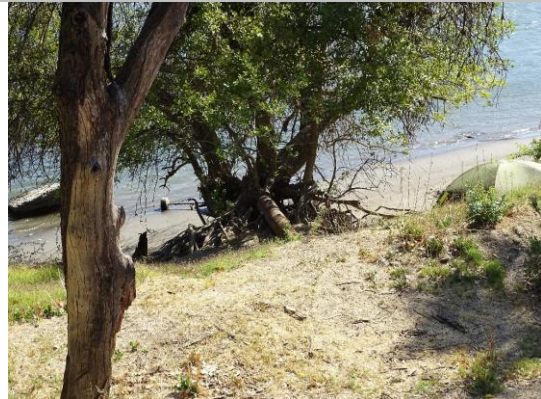
Photo 3 of 3 : UCIP_SP_2022_59773_81575.jpg

Water side view: abandoned and grouted 10-inch pipe

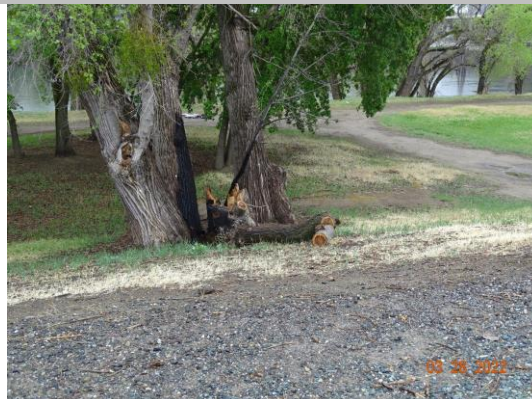
Photo 1 of 1 : SP_2022_MA0004_298_42_20220412_00075.jpg

Tree stump and trunk on the water side toe. Spring 2022

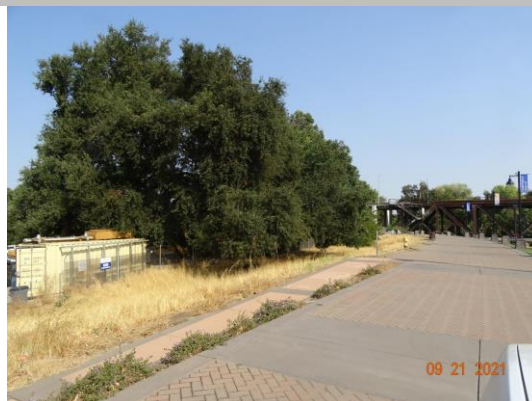
Photo 1 of 1 : SP_2022_MA0004_298_41_20220307_00009.jpg

Trees to be trimmed 5' above grade. Fall 2021

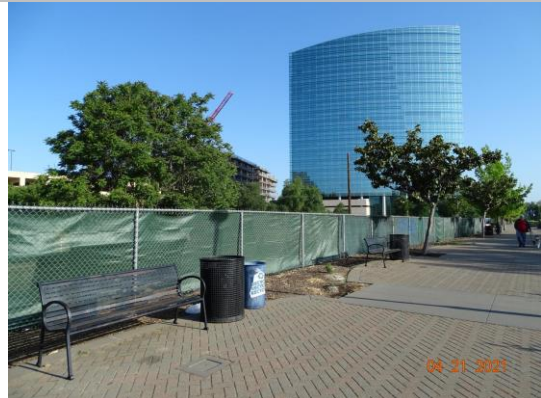
Photo 1 of 1 : SP_2022_MA0004_298_27_20220307_00008.jpg

View of the fence on the LS levee shoulder. Spring 2021.

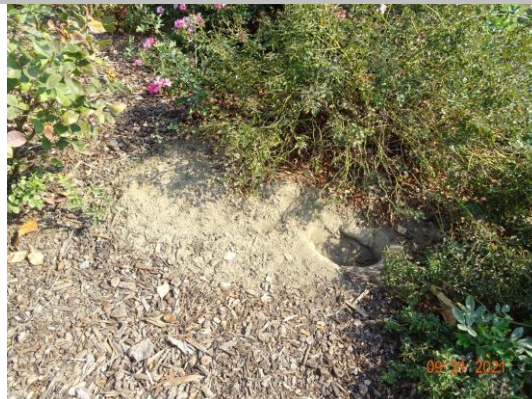
Photo 1 of 2 : SP_2022_MA0004_298_59_20220307_00018.jpg

Burrows in WS planter. Fall 2021

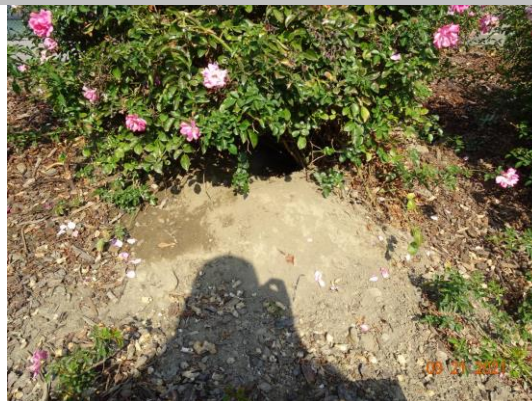
Photo 2 of 2 : SP_2022_MA0004_298_59_20220307_00019.jpg

Burrows in WS planter. Fall 2021

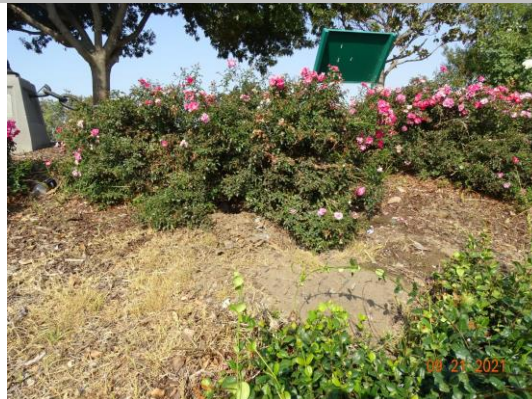
Photo 1 of 1 : SP_2022_MA0004_298_71_20220307_00022.jpg

Active burrows in the planter near the waterside crown. Fall 2021
