**Flood Control Project Maintenance
Levee Inspections
LMA District Cover Sheet**

Sacramento Maintenance Yard Maintenance Area 0004

Levee Inspection Report By Mile - Spring 2023

Waterway	Bank	Unit Miles	Inspection Start/End	Inspector
Unit No. 01 Sacramento River	Right	3.47	04/18/2023 04/18/2023	Marvin Marshall

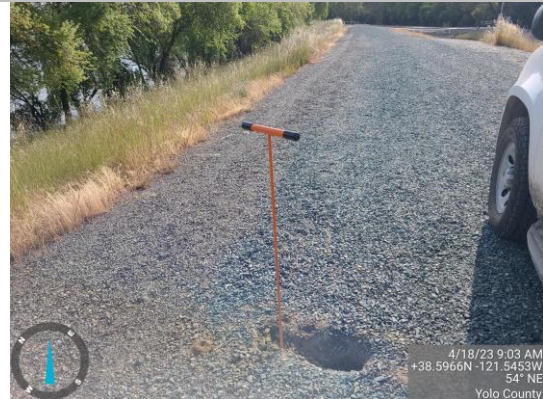
Photo 1 of 1 : SP_2023_MA0004_298_3_20230418_00021.jpg

LM Start	0.12	Rating **	M	Issue No.	3
LM End	0.12	Issue Type +	Ma	Location *	CR
Category	Earthen Levee			GPS Latitude/Longitude	
				Start	End
Item	Animal Control			38.596587°	38.596587°
				-121.545471°	-121.545471°
DWR ID	DWR_MA0004_01_s_2023_3				
Comment Code					
A3 : No rodents visible, but rodent burrows visible; need to backfill and compact or grout burrows.					
Inspector Comment					
Repair burrow in crown.

Burrow in the crown. Spring 2023

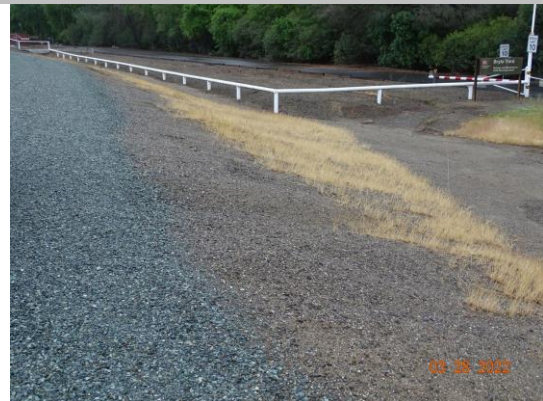
Photo 1 of 1 : SP_2023_MA0004_298_38_20230306_00009.jpg

LM Start	0.15	Rating **	M	Issue No.	38
LM End	0.20	Issue Type +	Ma	Location *	LS
Category	Earthen Levee			GPS Latitude/Longitude	
				Start	End
Item	Erosion / Rills			38.596660°	38.596822°
				-121.544852°	-121.544053°
DWR ID	DWR_MA0004_01_s_2022_38				
Comment Code					
E5 : Schedule repair of rills prior to the next inspection.					
Inspector Comment					
Repair rilling on LS slope. Other rilling in area on WS slope.

Rilling on the landside. Spring 2022

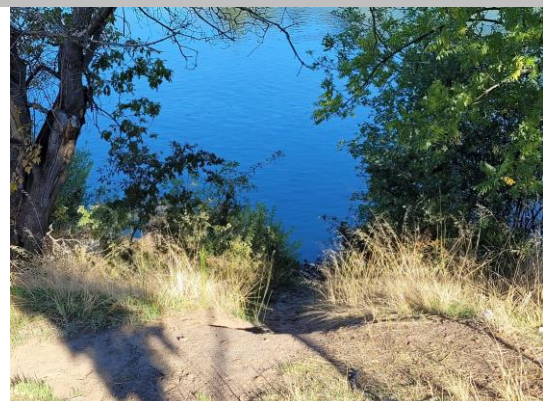
Photo 1 of 1 : SP_2023_MA0004_298_7_20230306_00002.jpg

LM Start	0.21	Rating **	A/W	Issue No.	7
LM End	0.21	Issue Type +	Ma	Location *	WS
Category	Earthen Levee			GPS Latitude/Longitude	
				Start	End
Item	Erosion / Foot Traffic			38.596963°	38.596963°
				-121.543772°	-121.543772°
DWR ID	DWR_MA0004_01_f_2022_7				
Comment Code					
E3 : Repair the levee slope damaged by foot traffic and prevent access where possible.					
Inspector Comment					
Monitor footpath for erosion on the waterside berm.

Foot path on the WS berm. Fall 2022

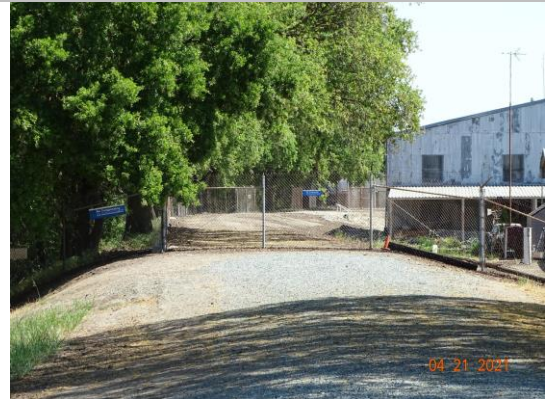
Photo 1 of 1 : SP_2023_MA0004_298_2_20230306_00001.jpg

LM Start	0.24	Rating **	A/W	Issue No.	2
LM End	0.72	Issue Type +	En	Location *	CR
Category	Earthen Levee			GPS Latitude/Longitude	
				Start	End
Item	Encroachments			38.597193°	38.601041°
				-121.543421°	-121.536557°
DWR ID	DWR_MA0004_01_s_2012_2				
Comment Code					
MISC : Miscellaneous					
Inspector Comment					
This is the USACE and DWR SMY. There are various buildings and fences along this section.

View of the fence across the levee crown at the SW side of the USACE facility. Spring 2021.

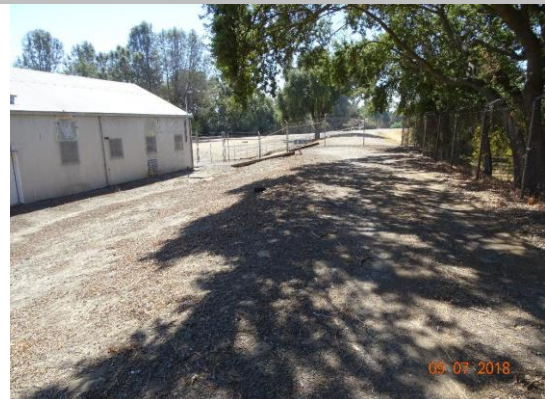
Photo 1 of 3 : UCIP_SP_2023_59983_80009.jpg

Comment Code					
Inspector Comment					
DS_ID:25546 FS_ID:59983 EP_NO: N/A Repair Type: Non-Urgent EVAL Issue: 11, Maintenance Compliance Issue Crossing Status: Found UCIP Comments: 09/07/2018 Record is considered Non-Urgent. Sediment clearing at pipe inlet is required. Pipe outlet is not visible on WS. O&M legacy system pipe. (O.Yakimov - DWR UCIP) FIELD_STRUCT_DESC: 12-inch corrugated metal drainage pipe through the levee, 19.0 feet below levee crown. [Additional Reference(s): Drawing No. 50-04-4179, Sheet 11.2 and 18.1, pdf page 9 and 17 of 19, associated with USACE Sacramento O&M Manual, Unit 116, August 1955, Revised 29 Dec 2016, shows 12-inch CMP referenced as Sta 44+92 (Site Mile 62.25 RT)]. FS Date: 9/7/2018

Levee crown near crossing

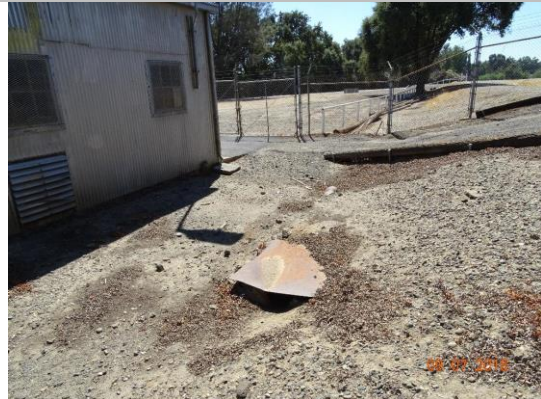
Photo 2 of 3 : UCIP_SP_2023_59983_80011.jpg

Covered concrete box at LS toe

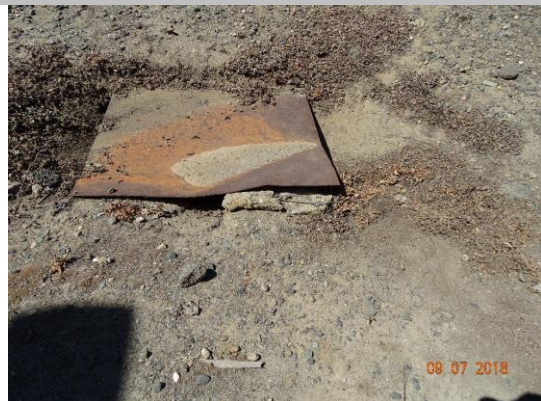
Photo 3 of 3 : UCIP_SP_2023_59983_80012.jpg

Pipe inlet concrete box is covered with metal sheeting

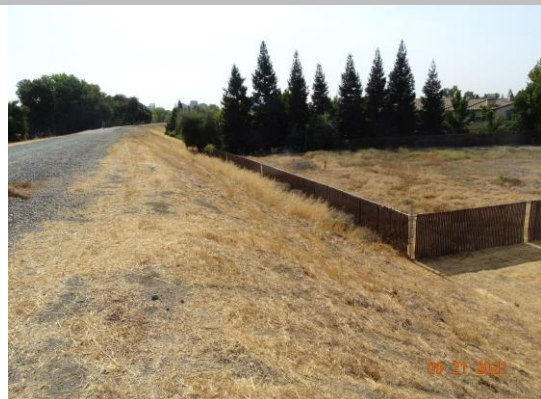
Photo 1 of 1 : SP_2023_MA0004_298_58_20230306_00016.jpg

LM Start	2.03	Rating **	U	Issue No.	58
LM End	2.05	Issue Type +	En	Location *	LS
Category	Earthen Levee			GPS Latitude/Longitude	
				Start	End
Item	Encroachments			38.599786°	38.599442°
				-121.513973°	-121.513698°
DWR ID	DWR_MA0004_01_s_2021_58				
Comment Code					
FE : Fence					
Inspector Comment					
Chain link fence with privacy slats in the LS easement.

Fencing along LS toe of slope. Fall 2021

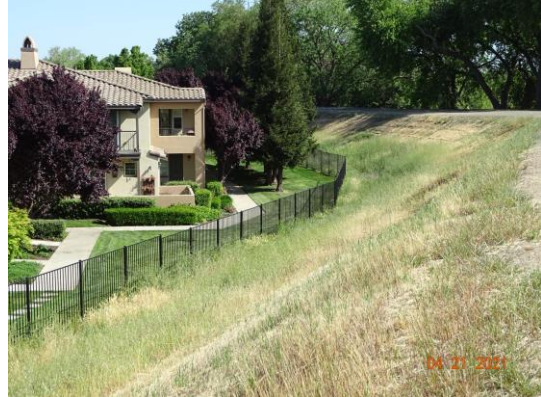
Photo 1 of 1 : SP_2023_MA0004_298_14_20230306_00004.jpg

LM Start	2.05	Rating **	M	Issue No.	14
LM End	2.21	Issue Type +	En	Location *	LS
Category	Earthen Levee			GPS Latitude/Longitude	
				Start	End
Item	Encroachments			38.599439°	38.597533°
				-121.513708°	-121.513134°
DWR ID	DWR_MA0004_01_s_2017_14				
Comment Code					
FE : Fence					
Inspector Comment					
Landscaping and fence block access and visibility.

View of the fence along the LS levee toe. Spring 2021.

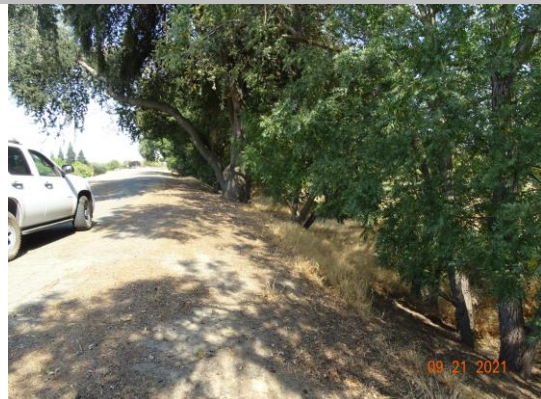
Photo 1 of 1 : SP_2023_MA0004_298_50_20230306_00015.jpg

LM Start	2.11	Rating **	M	Issue No.	50
LM End	2.16	Issue Type +	Ma	Location *	WS
Category	Earthen Levee			GPS Latitude/Longitude	
				Start	End
Item	Trim / Thin Trees			38.598708°	38.598142°
				-121.513104°	-121.512695°
DWR ID	DWR_MA0004_01_f _ 2021_50				
Comment Code					
T1 : Trim and thin trees to at least five feet above ground level to allow visibility of the ground and room to flood fight.					
Inspector Comment					
Trim trees to 5' above grade.

Trees on the WS slope to be trimmed 5' above grade. Fall 2021

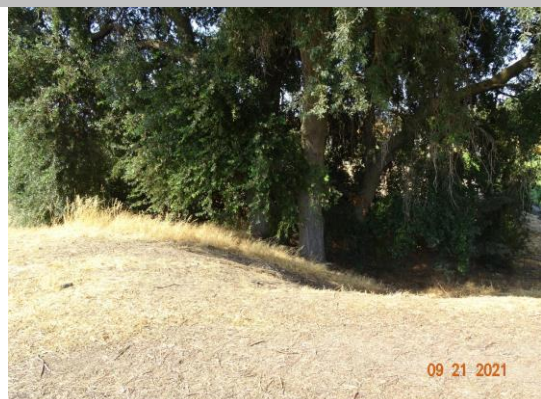
Photo 1 of 1 : SP_2023_MA0004_298_49_20230306_00014.jpg

LM Start	2.25	Rating **	M	Issue No.	49
LM End	2.25	Issue Type +	Ma	Location *	LS
Category	Earthen Levee			GPS Latitude/Longitude	
				Start	End
Item	Trim / Thin Trees			38.596989°	38.596989°
				-121.513261°	-121.513261°
DWR ID	DWR_MA0004_01_f_2021_49				
Comment Code					
T1 : Trim and thin trees to at least five feet above ground level to allow visibility of the ground and room to flood fight.					
Inspector Comment					
Trim trees to 5' above grade within 10' of the toe of slope.

Small oak tree grove on the LS slope. Fall 2021

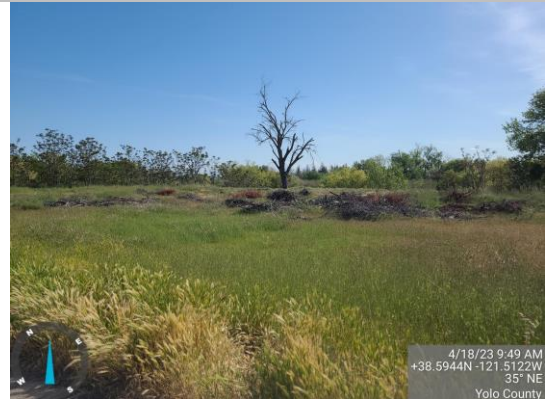
Photo 1 of 1 : SP_2023_MA0004_298_46_20230418_00022.jpg

LM Start	2.41	Rating **	M	Issue No.	46
LM End	2.41	Issue Type +	Ma	Location *	WS
Category	Earthen Levee			GPS Latitude/Longitude	
				Start	End
Item	Encroachments			38.594700°	38.594700°
				-121.512276°	-121.512276°
DWR ID	DWR_MA0004_01_s_2023_46				
Comment Code					
PR : Prunings					
Inspector Comment					
Remove pruning piles from waterside embankment.

Pruning piles on the waterside berm. Spring 2023

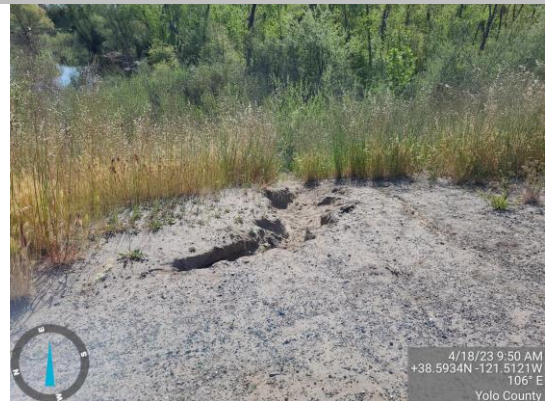
Photo 1 of 1 : SP_2023_MA0004_298_4_20230418_00023.jpg

LM Start	2.50	Rating **	U	Issue No.	4
LM End	2.50	Issue Type +	Ma	Location *	WS
Category	Earthen Levee			GPS Latitude/Longitude	
				Start	End
Item	Erosion / Rills			38.593472°	38.593472°
				-121.512047°	-121.512047°
DWR ID	DWR_MA0004_01_s_2023_4				
Comment Code					
E5 : Schedule repair of rills prior to the next inspection.					
Inspector Comment					
Repair rilling on the WS slope.

Rilling on the WS slope. Spring 2023

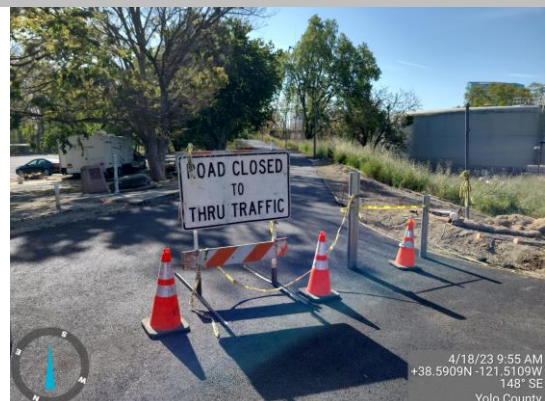
Photo 1 of 1 : SP_2023_MA0004_298_5_20230418_00024.jpg

LM Start	2.69	Rating **	A/W	Issue No.	5
LM End	3.08	Issue Type +	En	Location *	CR
Category	Earthen Levee			GPS Latitude/Longitude	
				Start	End
Item	Encroachments			38.591015°	38.586473°
				-121.510900°	-121.508088°
DWR ID	DWR_MA0004_01_s_2023_5				
Comment Code					
LC : Authorized Levee Construction					
Inspector Comment					
Newly paved bike trail prevents inspection from LM 2.69-3.08. Issues in this area are marked A/W until accessible for inspection.

Newly paved bike trail on the crown. Spring 2023

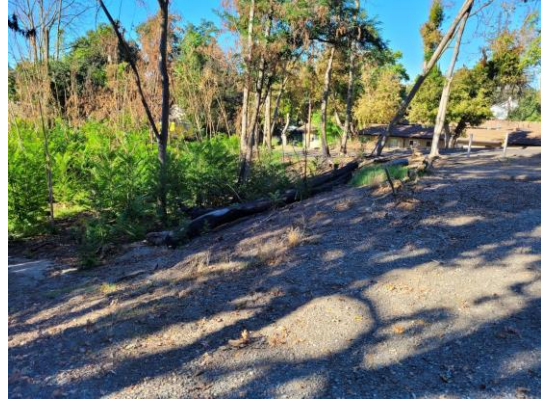
Photo 1 of 1 : SP_2023_MA0004_298_44_20230306_00011.jpg

LM Start	2.89	Rating **	A/W	Issue No.	44
LM End	2.89	Issue Type +	En	Location *	LS
Category	Earthen Levee			GPS Latitude/Longitude	
				Start	End
Item	Trim / Thin Trees			38.589183°	38.589183°
				-121.508032°	-121.508032°
DWR ID	DWR_MA0004_01_s_2021_44				
Comment Code					
T2 : Tree or limb.					
Inspector Comment					
Remove large cut trunks and branches from landside easement.

Large tree trunk at tow of LS slope. Fall 2022

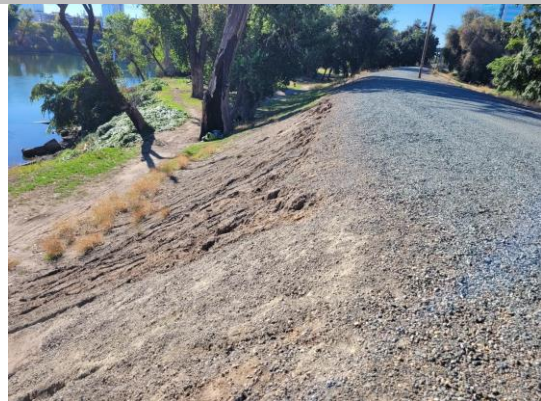
Photo 1 of 1 : SP_2023_MA0004_298_47_20230306_00013.jpg

LM Start	2.92	Rating **	A/W	Issue No.	47
LM End	2.96	Issue Type +	Ma	Location *	WS
Category	Earthen Levee			GPS Latitude/Longitude	
				Start	End
Item	Erosion / Rills			38.588824°	38.588223°
				-121.507904°	-121.507876°
DWR ID	DWR_MA0004_01_s_2022_47				
Comment Code					
E5 : Schedule repair of rills prior to the next inspection.					
Inspector Comment					
Repair rilling, footpaths and burrows on the WS slope.

Rilling, burrows and footpaths on the waterside slope. Fall 2022

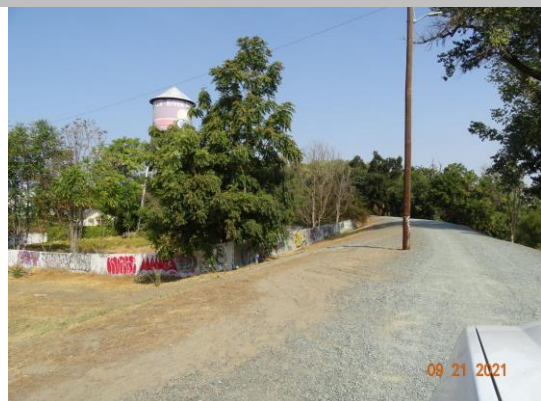
Photo 1 of 2 : SP_2023_MA0004_298_23_20230306_00006.jpg

LM Start	2.92	Rating **	A/W	Issue No.	23
LM End	2.95	Issue Type +	En	Location *	LS
Category	Earthen Levee			GPS Latitude/Longitude	
				Start	End
Item	Encroachments			38.588762°	38.588384°
				-121.507951°	-121.507894°
DWR ID	DWR_MA0004_01_f_2016_23				
Comment Code					
FE : Fence					
Inspector Comment					
Fence along toe of LS levee slope prevents access and visibility.

View of the fence on the LS toe. Fall 2021.

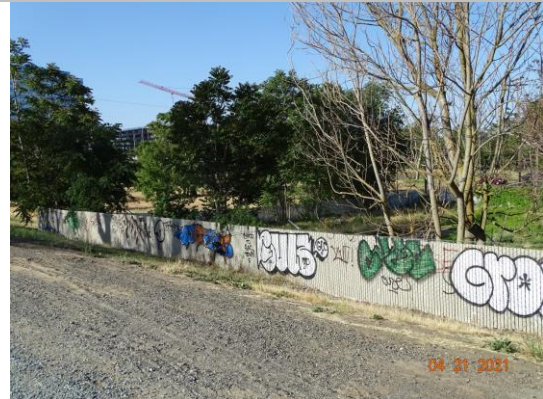
Photo 2 of 2 : SP_2023_MA0004_298_23_20230306_00007.jpg

View of the fence on the LS levee slope. Spring 2021.

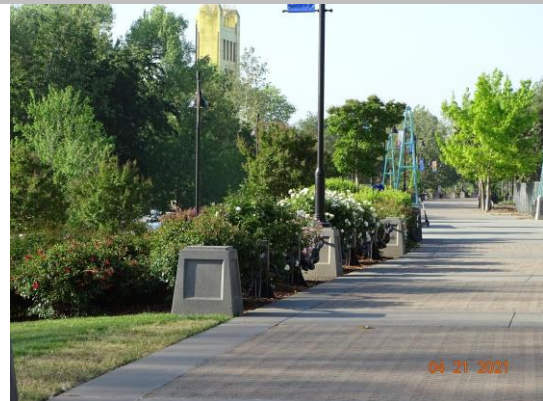
Photo 1 of 1 : SP_2023_MA0004_298_12_20230306_00003.jpg

V6 : Landscaping

West Sacramento's River Walk runs from the Tower Bridge to the I Street bridge.

View of the landscaping on River Walk. Spring 2021.

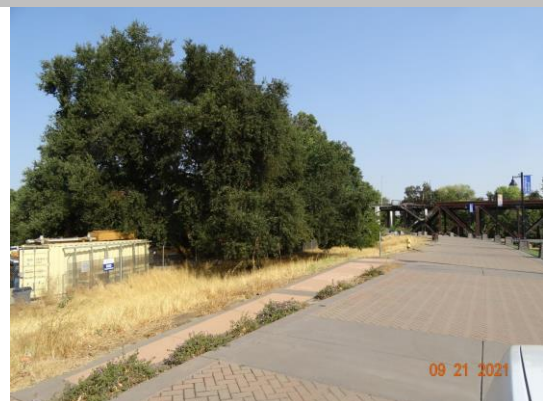
Photo 1 of 1 : SP_2023_MA0004_298_41_20230306_00010.jpg

Trees to be trimmed 5' above grade. Fall 2021

T1 : Trim and thin trees to at least five feet above ground level to allow visibility of the ground and room to flood fight.

Trim trees to 5' above grade.

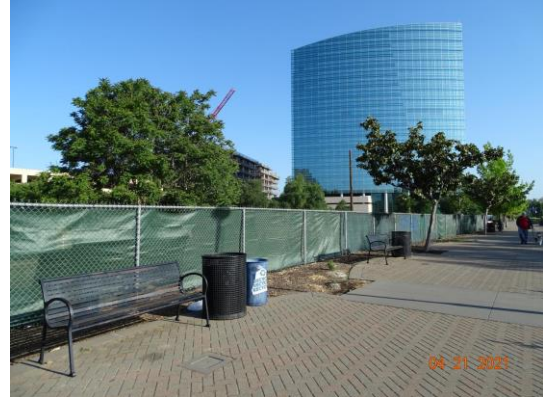
Photo 1 of 1 : SP_2023_MA0004_298_27_20230306_00008.jpg

LM Start	3.24	Rating **	M	Issue No.	27
LM End	3.29	Issue Type +	En	Location *	LS
Category	Earthen Levee			GPS Latitude/Longitude	
				Start	End
Item	Encroachments			38.584168°	38.583435°
				-121.508632°	-121.508785°
DWR ID	DWR_MA0004_01_f_2015_27				
Comment Code					
FE : Fence					
Inspector Comment					
The fence on the levee shoulder appears to be unauthorized.

View of the fence on the LS levee shoulder. Spring 2021.

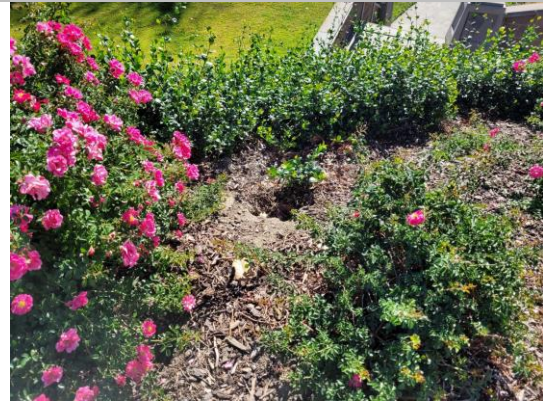
Photo 1 of 1 : SP_2023_MA0004_298_59_20230306_00017.jpg

LM Start	3.29	Rating **	A/W	Issue No.	59
LM End	3.29	Issue Type +	Ma	Location *	WS
Category	Earthen Levee			GPS Latitude/Longitude	
				Start	End
Item	Animal Control			38.583437°	38.583437°
				-121.508788°	-121.508788°
DWR ID	DWR_MA0004_01_f_2020_59				
Comment Code					
A3 : No rodents visible, but rodent burrows visible; need to backfill and compact or grout burrows.					
Inspector Comment					
Burrows visible near top of levee in planter do not appear to be active. Continue rodent control program.

Rodent burrow in the planter on the WS slope. Fall 2022
