Flood Control Project Maintenance  
Levee Inspections  
LMA District Cover Sheet

Sacramento Maintenance Yard Maintenance Area 0004

**Levee Inspection Report By Mile - Spring 2024**

Waterway	Bank	Unit Miles	Inspection Start/End	Inspector
Unit No. 01 Sacramento River	Right	3.47	04/09/2024 04/11/2024	Marvin Marshall

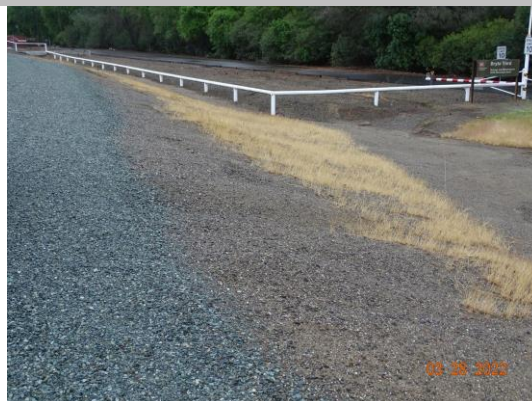
Photo 1 of 1 : SP\_2024\_MA0004\_298\_38\_20240212\_00008.jpg

LM Start	0.15	Rating **	A/W	Issue No.	38
LM End	0.20	Issue Type +	Ma	Location *	LS
Category	Earthen Levee			GPS Latitude/Longitude	
				Start	End
Item	Erosion / Rills			38.596660°	38.596822°
				-121.544852°	-121.544053°
DWR ID	DWR_MA0004_01_s_2022_38				
Comment Code					
E5 : Schedule repair of rills prior to the next inspection.					
Inspector Comment

Rilling on the landside. Spring 2022

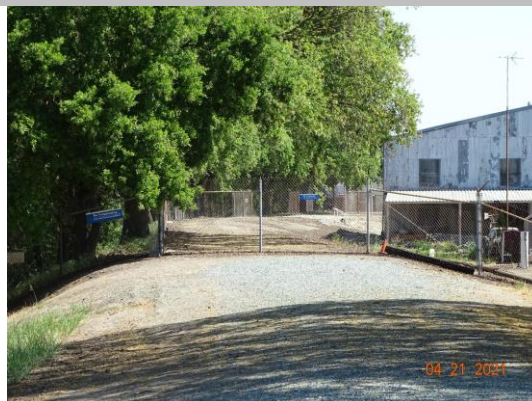
Photo 1 of 1 : SP\_2024\_MA0004\_298\_2\_20240212\_00001.jpg

LM Start	0.24	Rating **	A/W	Issue No.	2
LM End	0.72	Issue Type +	En	Location *	CR
Category	Earthen Levee			GPS Latitude/Longitude	
				Start	End
Item	Encroachments			38.597193°	38.601041°
				-121.543421°	-121.536557°
DWR ID	DWR_MA0004_01_s_2012_2				
Comment Code					
MISC : Miscellaneous					
Inspector Comment					
This is the USACE and DWR SMY. There are various buildings and fences along this section.

View of the fence across the levee crown at the SW side of the USACE facility. Spring 2021.

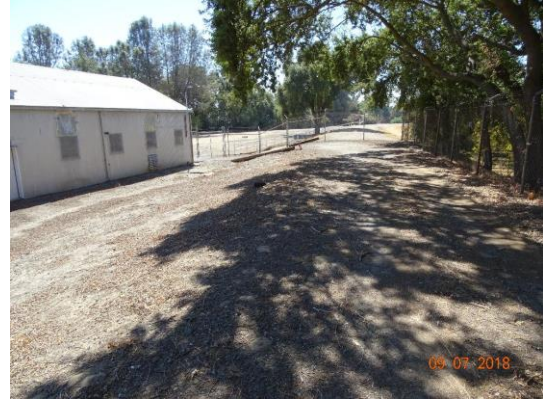
Photo 1 of 3 : UCIP\_SP\_2024\_82760\_80009.jpg

Comment Code					
Inspector Comment					
DS_ID:25546 FS_ID:82760 EP_NO: N/A Repair Type: Non-Urgent EVAL Issue: 11, Maintenance Compliance Issue Crossing Status: Found UCIP Comments: 03/25/2024 Crossing was not inspected as it is inside the USACE facility. Access could not be acquired as the entrance gate was closed and could not reach anyone inside the facility. (J. Singh - DWR UCIP)09/07/2018 Record is considered Non-Urgent. Sediment clearing at pipe inlet is required. Pipe outlet is not visible on WS. O&M legacy system pipe. (O.Yakimov - DWR UCIP) FIELD_STRUCT_DESC: 12-inch corrugated metal drainage pipe through the levee, 19.0 feet below levee crown. [Additional Reference(s): Drawing No. 50-04-4179, Sheet 11.2 and 18.1, pdf page 9 and 17 of 19, associated with USACE Sacramento O&M Manual, Unit 116, August 1955, Revised 29 Dec 2016, shows 12-inch CMP referenced as Sta 44+92 (Site Mile 62.25 RT)]. FS Date: 3/25/2024 11:44:42 PM

Levee crown near crossing

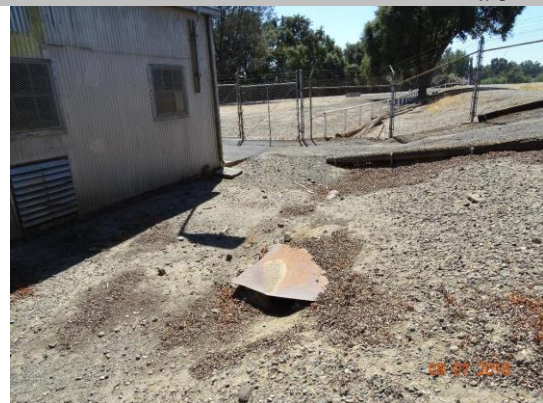
Photo 2 of 3 : UCIP\_SP\_2024\_82760\_80011.jpg

Covered concrete box at LS toe

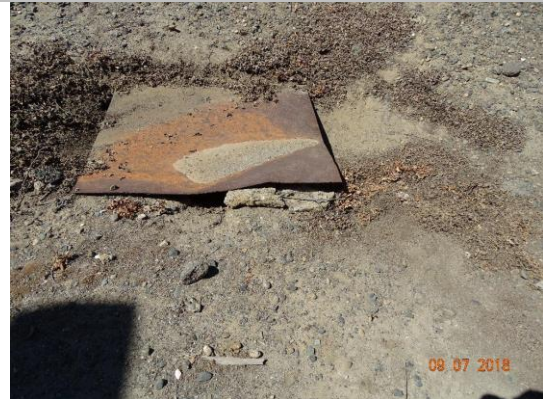
Photo 3 of 3 : UCIP\_SP\_2024\_82760\_80012.jpg

Pipe inlet concrete box is covered with metal sheeting

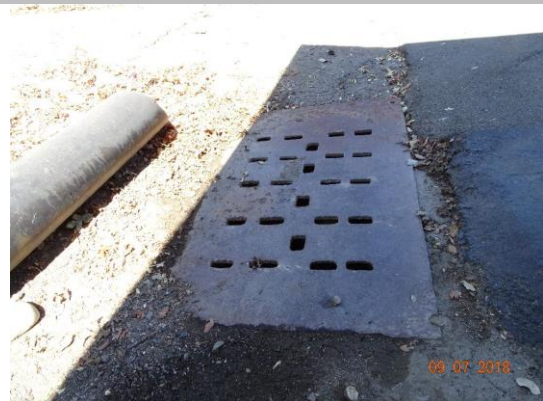
Photo 1 of 3 : UCIP\_SP\_2024\_82761\_80017.jpg

DS\_ID:25545  
FS\_ID:82761  
EP\_NO: N/A  
Repair Type: Non-Urgent  
EVAL Issue:  
Crossing Status: Found  
UCIP Comments: 03/25/2024 Crossing was not inspected as it is inside the USACE facility. Access could not be acquired as the entrance gate was closed and could not reach anyone inside the facility. (J. Singh - DWR UCIP)09/07/2018 Record remains Non-Urgent. Pipe not visible at WS slope. No permit has been identified authorizing pipe. (O.Yakimov - DWR UCIP)  
FIELD\_STRUCT\_DESC: 12-inch corrugated metal drainage pipe through the levee, 23.3 feet below levee crown. [Additional Reference(s): Drawing No. 50-04-4179, Sheet 11.2 and 18.1, pdf page 9 and 17 of 19, associated with USACE Sacramento O&M Manual, Unit 116, August 1955, Revised 29 Dec 2016, shows 12-inch CMP referenced as Sta 48+62 (Site Mile 62.25 RT)].  
FS Date: 3/25/2024 11:45:06 PM

Drainage pit at LS toe

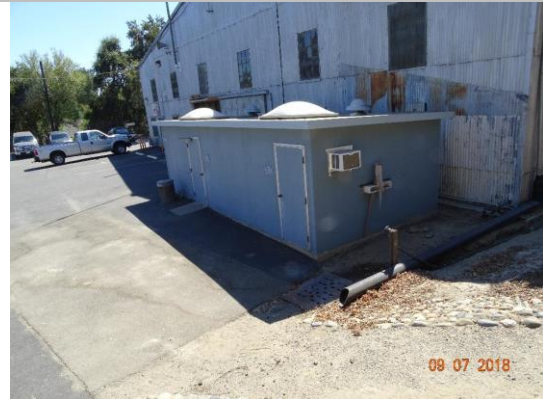
Photo 2 of 3 : UCIP\_SP\_2024\_82761\_80018.jpg

Structures at LS toe where drainage pit is located

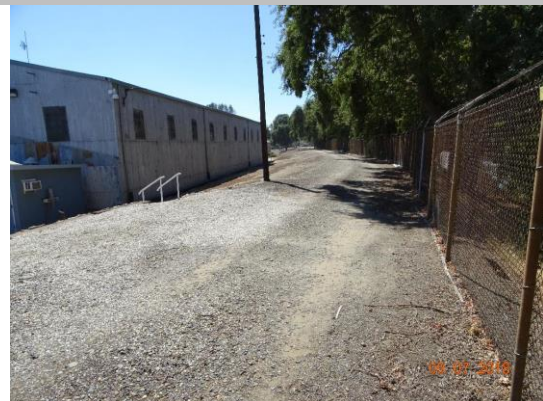
Photo 3 of 3 : UCIP\_SP\_2024\_82761\_80019.jpg

Levee crown at crossing

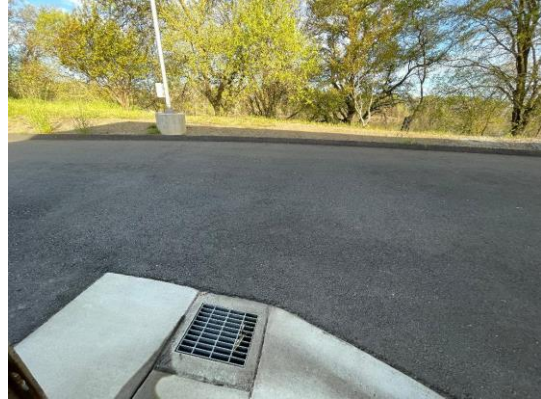
Photo 1 of 3 : UCIP\_SP\_2024\_82754\_120212.jpg

Comment Code						
Inspector Comment						
DS_ID:25544 FS_ID:82754 EP_NO: N/A Repair Type: Non-Urgent EVAL Issue: Crossing Status: Found UCIP Comments: 03/25/2024 The facility has new drainage, electrical, communications and water lines installed as part of the Sacramento Yard Rehabilitation Project. Thorough review of as-builts needs to be performed to verify which lines crossings were removed/replaced. (J. Singh - DWR UCIP)10/10/2019 Record remains Non-Urgent. No permit has been identified authorizing pipe. According to FMO staff this pipe was disconnected from Sac Yard storm drainage system and grouted in place. Unable to locate a permit and confirm proper pipe abandonment. (O.Yakimov - DWR UCIP)09/07/2018 Steel pipe at the bottom of drainage box is visible. Large reconstruction project is going on the property. Contact Brian Murphy with FMO after work is completed to request as-builts. (O.Yakimov - DWR UCIP) FIELD_STRUCT_DESC: 8-inch steel drainage pipe through the levee, 12.1 feet below levee crown. [Additional Reference(s): Drawing No. 50-04-4179, Sheet 11.2 and 18.1, pdf page 9 and 17 of 19, associated with USACE Sacramento O&M Manual, Unit 116, August 1955, Revised 29 Dec 2016, shows 8-inch CMP referenced as Sta 54+53 (Site Mile 62.25 RT)]. FS Date: 3/25/2024 10:54:20 PM

View of drain inlet looking towards the waterside

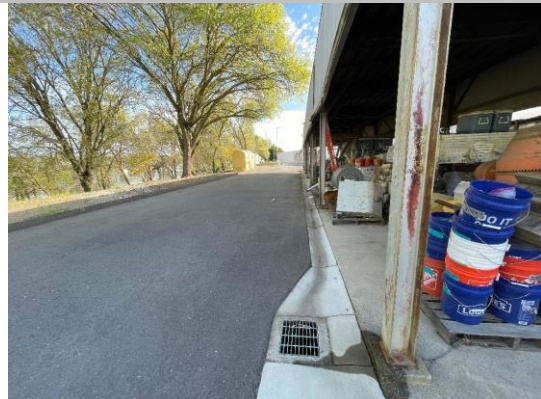
Photo 2 of 3 : UCIP\_SP\_2024\_82754\_120211.jpg

View of drain inlet along the crown looking downstream.

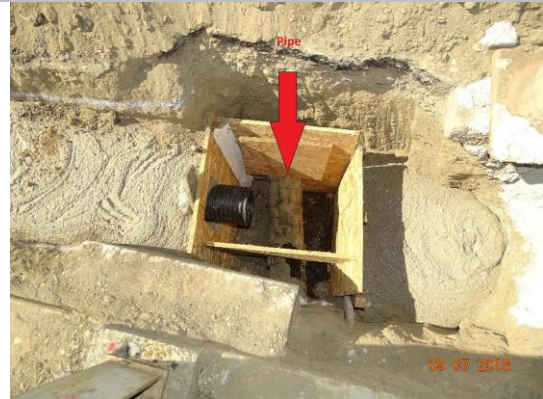
Photo 3 of 3 : UCIP\_SP\_2024\_82754\_81540.jpg

8-inch steel pipe at the bottom of drainage box on LS goes towards levee

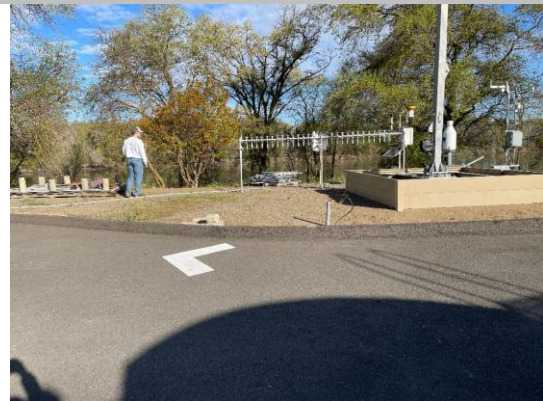
Photo 1 of 3 : UCIP\_SP\_2024\_82753\_120213.jpg

DS\_ID:25552  
 FS\_ID:82753  
 EP\_NO: N/A  
 Repair Type: Non-Urgent  
 EVAL Issue:  
 Crossing Status: Not Found  
 UCIP Comments: 03/25/2024 The facility has new drainage, electrical, communications and water lines installed as part of the Sacramento Yard Rehabilitation Project. Thorough review of as-builts needs to be performed to verify which lines crossings were removed/replaced. (J. Singh - DWR UCIP)10/10/2019 Record remains Non-Urgent. Crossing not found. According to FMO staff this pipe was disconnected from Sac Yard storm drainage system and grouted in place. Unable to locate a permit and confirm proper pipe abandonment. No permit has been identified authorizing pipe. (O.Yakimov - DWR UCIP) 09/07/2018 Crossing not found (O.Yakimov - DWR UCIP)  
 FIELD\_STRUCT\_DESC: 9-inch steel drainage pipe through the levee, 17 feet below levee crown. [Additional Reference(s): Drawing No. 50-04-4179, Sheet 11.2 and 18.1, pdf page 9 and 17 of 19, associated with USACE Sacramento O&M Manual, Unit 116, August 1955, Revised 29 Dec 2016, shows 9-inch steel pipe referenced as Sta 56+02 (Site Mile 62.25 RT)]

View from looking towards the waterside

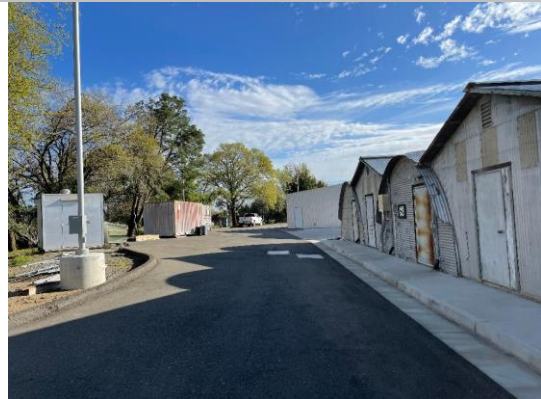
Photo 2 of 3 : UCIP\_SP\_2024\_82753\_120214.jpg

View from the crown looking downstream (note the new lighting pole and utility boxes)

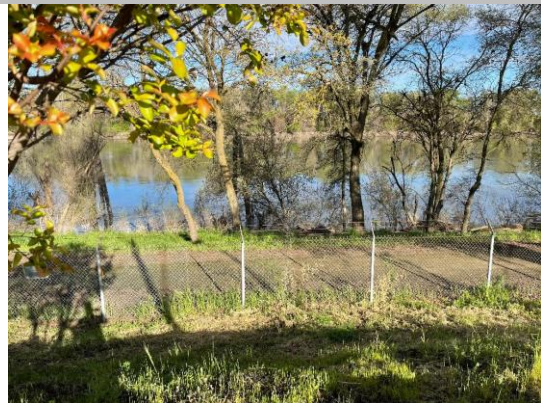
Photo 3 of 3 : UCIP\_SP\_2024\_82753\_120215.jpg

View of waterside slope from waterside shoulder

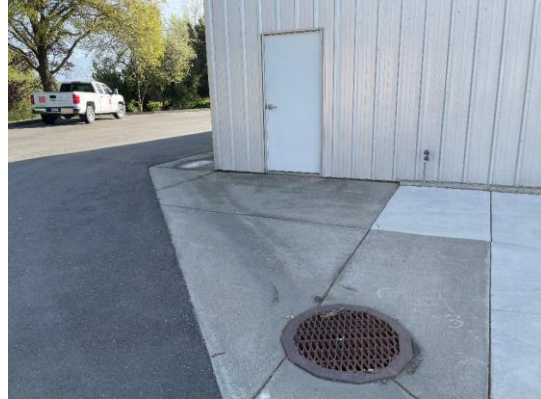
Photo 1 of 2 : UCIP\_SP\_2024\_82755\_120216.jpg

DS\_ID:25550  
FS\_ID:82755  
EP\_NO: N/A  
Repair Type: Non-Urgent  
EVAL Issue: 10, Unauthorized Modification or Non-Compliant Permit  
Crossing Status: Not Found  
UCIP Comments: 03/25/2024 The facility has new drainage, electrical, communications and water lines installed as part of the Sacramento Yard Rehabilitation Project. Thorough review of as-builts needs to be performed to verify which lines crossings were removed/replaced. (J. Singh - DWR UCIP)10/10/2019 Record remains Non-Urgent. Crossing not found. According to FMO staff this pipe was disconnected from Sac Yard storm drainage system and grouted in place. Unable to locate a permit and confirm proper pipe abandonment. (O.Yakimov - DWR UCIP) 09/07/2018 Crossing not found (O.Yakimov - DWR UCIP)  
FIELD\_STRUCT\_DESC: 6-inch vitrified clay drainage pipe through the levee, 16.1 feet below levee crown. [Additional Reference(s): Drawing No. 50-04-4179, Sheet 11.2 and 18.1, pdf page 9 and 17 of 19, associated with USACE Sacramento O&M Manual, Unit 116, August 1955, Revised 29 Dec 2016, shows combination of 6-inch vitrified clay pipe and 8-inch CMP referenced as Sta 56+96 (Site Mile 62.25 RT)]

View of drain inlet at the location of crossing

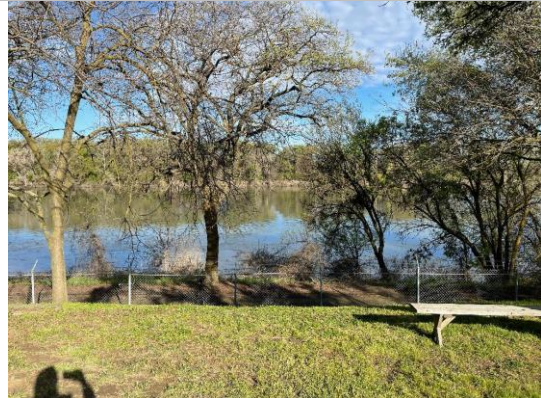
Photo 2 of 2 : UCIP\_SP\_2024\_82755\_120217.jpg

View of waterside slope from shoulder

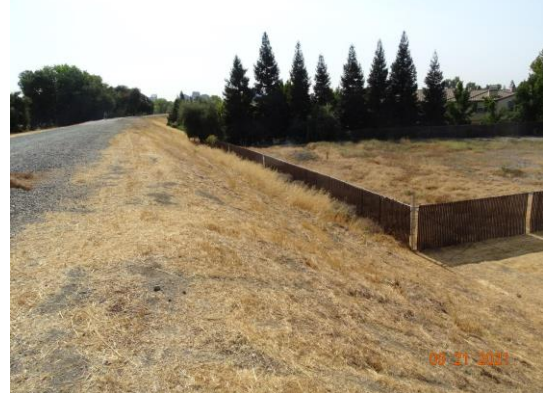
Photo 1 of 1 : SP\_2024\_MA0004\_298\_58\_20240212\_00012.jpg

LM Start	2.03	Rating **	U	Issue No.	58
LM End	2.05	Issue Type +	En	Location *	LS
Category	Earthen Levee			GPS Latitude/Longitude	
				Start	End
Item	Encroachments			38.599786°	38.599442°
				-121.513973°	-121.513698°
DWR ID	DWR_MA0004_01_s_2021_58				
Comment Code					
FE : Fence					
Inspector Comment					
Chain link fence with privacy slats in the LS easement.

Fencing along LS toe of slope. Fall 2021

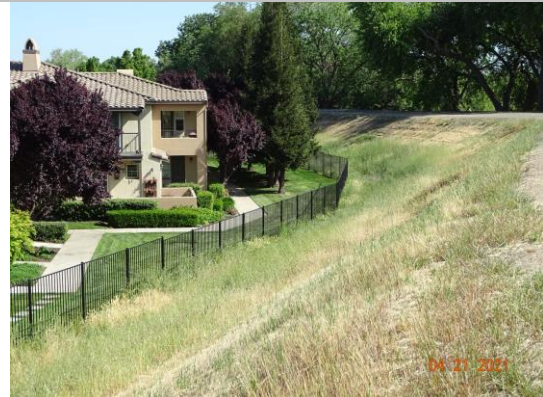
Photo 1 of 1 : SP\_2024\_MA0004\_298\_14\_20240212\_00002.jpg

LM Start	2.05	Rating **	M	Issue No.	14
LM End	2.21	Issue Type +	En	Location *	LS
Category	Earthen Levee			GPS Latitude/Longitude	
				Start	End
Item	Encroachments			38.599439°	38.597533°
				-121.513708°	-121.513134°
DWR ID	DWR_MA0004_01_s_2017_14				
Comment Code					
FE : Fence					
Inspector Comment					
Landscaping and fence block access and visibility.

View of the fence along the LS levee toe. Spring 2021.

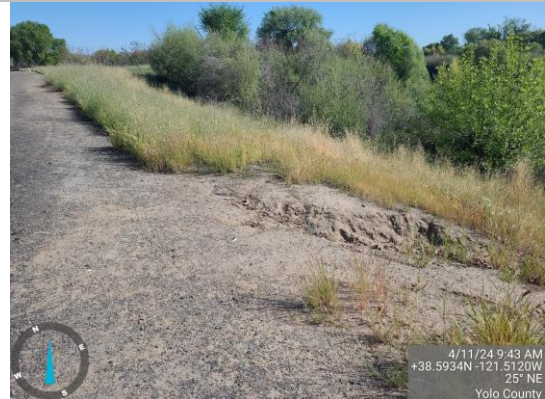
Photo 1 of 1 : SP\_2024\_MA0004\_298\_17\_20240417\_00030.jpg

LM Start	2.50	Rating **	M	Issue No.	17
LM End	2.50	Issue Type +	Ma	Location *	WS
Category	Earthen Levee			GPS Latitude/Longitude	
				Start	End
Item	Erosion / Foot Traffic			38.593400°	38.593400°
				-121.512000°	-121.512000°
DWR ID	DWR_MA0004_01_f _ 2023_17				
Comment Code					
E3 : Repair the levee slope damaged by foot traffic and prevent access where possible.					
Inspector Comment

Erosion on the WS slope. Spring 2024

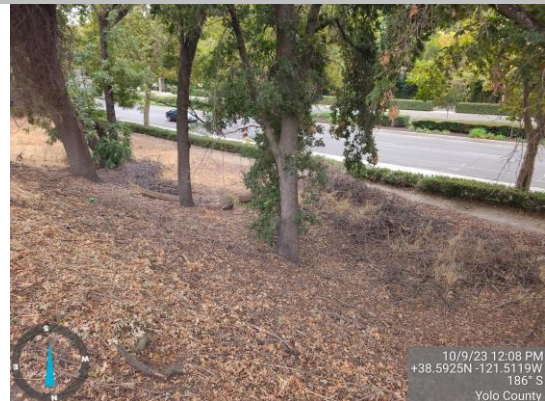
Photo 1 of 1 : SP\_2024\_MA0004\_298\_16\_20240212\_00003.jpg

LM Start	2.57	Rating **	M	Issue No.	16
LM End	2.57	Issue Type +	Ma	Location *	LS
Category	Earthen Levee			GPS Latitude/Longitude	
				Start	End
Item	Encroachments			38.592500°	38.592500°
				-121.511900°	-121.511900°
DWR ID	DWR_MA0004_01_f _ 2023_16				
Comment Code					
PR : Prunings					
Inspector Comment					
Remove prunings from LS slope and easement.

Pruning pile on the LS slope and easement. Fall 2023

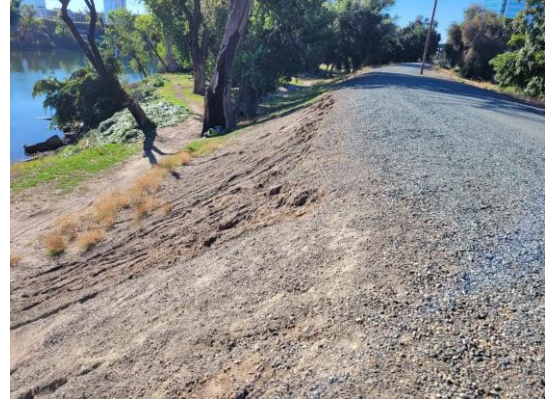
Photo 1 of 1 : SP\_2024\_MA0004\_298\_47\_20240212\_00011.jpg

LM Start	2.92	Rating **	M	Issue No.	47
LM End	2.96	Issue Type +	Ma	Location *	WS
Category	Earthen Levee			GPS Latitude/Longitude	
				Start	End
Item	Erosion / Rills			38.588824°	38.588223°
				-121.507904°	-121.507876°
DWR ID	DWR_MA0004_01_s_2022_47				
Comment Code					
E5 : Schedule repair of rills prior to the next inspection.					
Inspector Comment					
Repair rilling, footpaths and burrows on the WS slope.

Rilling, burrows and footpaths on the waterside slope. Fall 2022

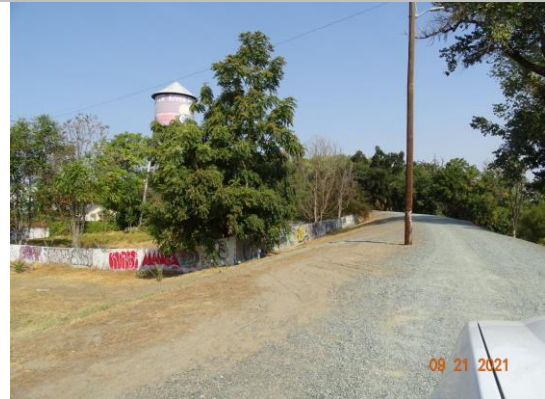
Photo 1 of 2 : SP\_2024\_MA0004\_298\_23\_20240212\_00005.jpg

LM Start	2.92	Rating **	U	Issue No.	23
LM End	2.95	Issue Type +	En	Location *	LS
Category	Earthen Levee			GPS Latitude/Longitude	
				Start	End
Item	Encroachments			38.588762°	38.588384°
				-121.507951°	-121.507894°
DWR ID	DWR_MA0004_01_f _ 2016_23				
Comment Code					
FE : Fence					
Inspector Comment					
Fence along toe of LS levee slope prevents access and visibility.

View of the fence on the LS toe. Fall 2021.

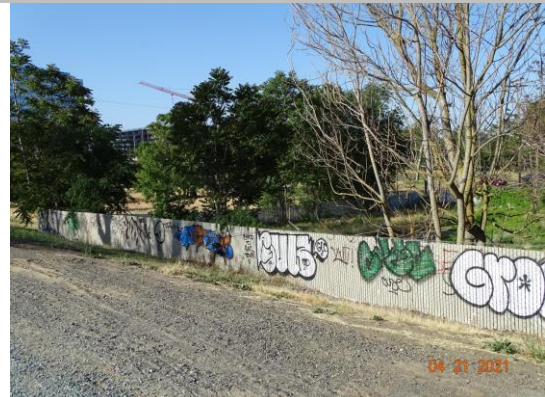
Photo 2 of 2 : SP\_2024\_MA0004\_298\_23\_20240212\_00006.jpg

View of the fence on the LS levee slope. Spring 2021.

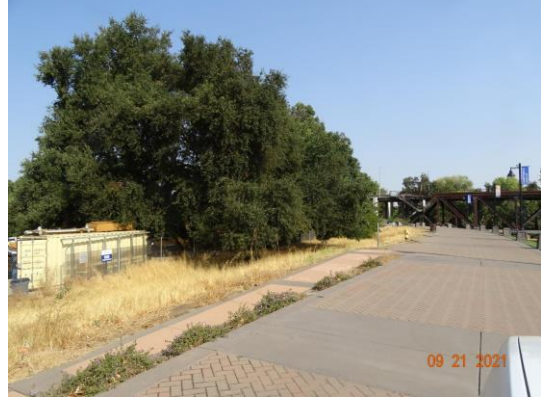
Photo 1 of 1 : SP\_2024\_MA0004\_298\_41\_20240212\_00009.jpg

LM Start	3.09	Rating **	M	Issue No.	41
LM End	3.09	Issue Type +	Ma	Location *	LS
Category	Earthen Levee			GPS Latitude/Longitude	
				Start	End
Item	Trim / Thin Trees			38.586332°	38.586332°
				-121.508080°	-121.508075°
DWR ID	DWR_MA0004_01_f_2021_41				
Comment Code					
T1 : Trim and thin trees to at least five feet above ground level to allow visibility of the ground and room to flood fight.					
Inspector Comment					
Trim trees to 5' above grade.

Trees to be trimmed 5' above grade. Fall 2021

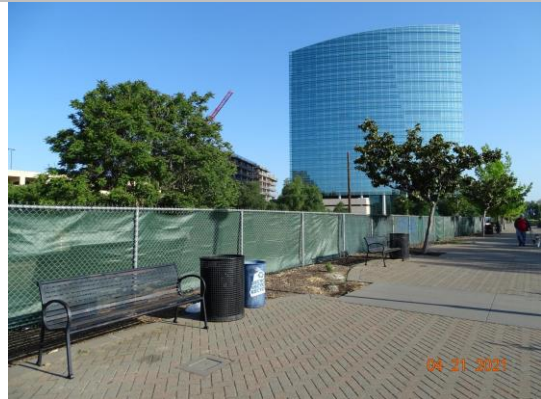
Photo 1 of 1 : SP\_2024\_MA0004\_298\_27\_20240212\_00007.jpg

LM Start	3.24	Rating **	M	Issue No.	27
LM End	3.29	Issue Type +	En	Location *	LS
Category	Earthen Levee			GPS Latitude/Longitude	
				Start	End
Item	Encroachments			38.584168°	38.583435°
				-121.508632°	-121.508785°
DWR ID	DWR_MA0004_01_f _ 2015_27				
Comment Code					
FE : Fence					
Inspector Comment					
The fence on the levee shoulder appears to be unauthorized.

View of the fence on the LS levee shoulder. Spring 2021.

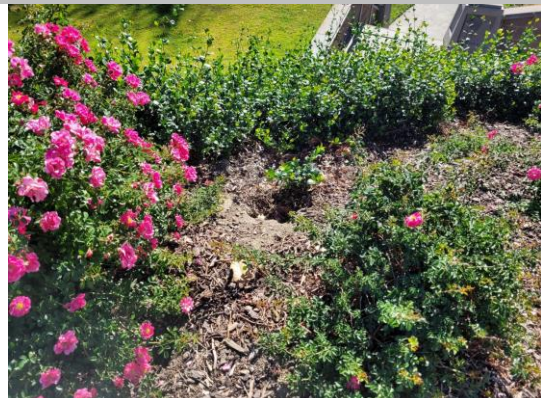
Photo 1 of 1 : SP\_2024\_MA0004\_298\_59\_20240212\_00013.jpg

LM Start	3.29	Rating **	A/W	Issue No.	59
LM End	3.29	Issue Type +	Ma	Location *	WS
Category	Earthen Levee			GPS Latitude/Longitude	
				Start	End
Item	Animal Control			38.583437°	38.583437°
				-121.508788°	-121.508788°
DWR ID	DWR_MA0004_01_f_2020_59				
Comment Code					
A3 : No rodents visible, but rodent burrows visible; need to backfill and compact or grout burrows.					
Inspector Comment					
Burrows do not appear to be active. Backfill voids.

Rodent burrow in the planter on the WS slope. Fall 2022

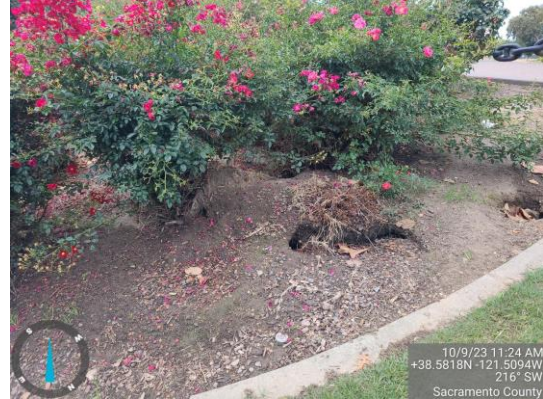
Photo 1 of 1 : SP\_2024\_MA0004\_298\_71\_20240212\_00014.jpg

LM Start	3.41	Rating **	A/W	Issue No.	71
LM End	3.42	Issue Type +	Ma	Location *	WS
Category	Earthen Levee			GPS Latitude/Longitude	
				Start	End
Item	Animal Control			38.581798°	38.581668°
				-121.509322°	-121.509382°
DWR ID	DWR_MA0004_01_s_2020_71				
Comment Code					
A3 : No rodents visible, but rodent burrows visible; need to backfill and compact or grout burrows.					
Inspector Comment					
Burrows do not appear to be active. Backfill and compact voids.

Burrows in the WS planter. Fall 2023
