**Flood Control Project Maintenance  
Levee Inspections**

**Fall 2015 Levee Maintenance Deficiency Summary Report**

**Sutter Maintenance Yard Maintenance Area 0005**

**Fall 2015 Levee Inspection Results**

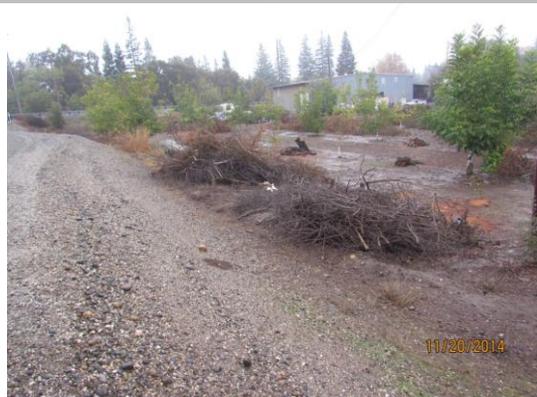
Photo 1 of 1 : FA\_2015\_MA0005\_196\_29\_20150910\_00009.jpg

View of the prunings along the landside toe.

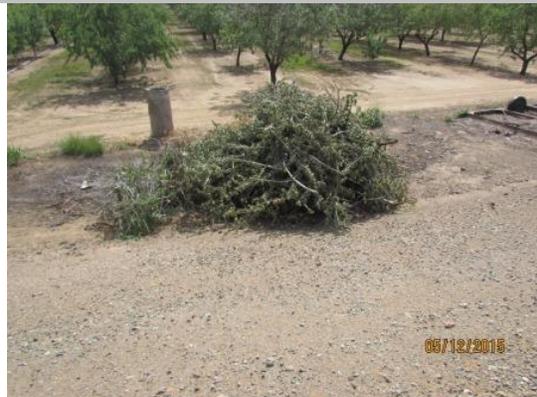
Photo 1 of 1 : FA\_2015\_MA0005\_196\_28\_20150910\_00008.jpg

View of the prunings along the landside toe.

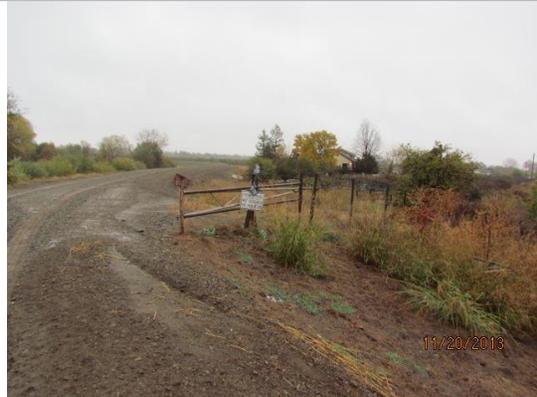
Photo 1 of 1 : FA\_2015\_MA0005\_196\_10\_20150910\_00006.jpg

LM Start	<b>2.09</b>	Rating **	M	Issue No.	<b>10</b>
LM End	<b>2.09</b>	Issue Type +	Ma	Location *	LS
Category	Earthen Levee		GPS Latitude/Longitude		
			Start	End	
Item	Repair Gates		39.670112 °	39.670112 °	
			-121.782012 °	-121.782012 °	
DWR ID	DWR_MA0005_01_s_2012_10				
Action/Comments					
Inspector Comments: No permit.

View of the unpermitted gate.

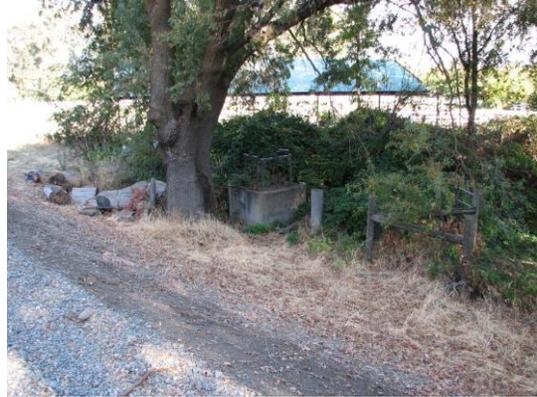
Photo 3 of 3 : UCIP\_FA\_2015\_4854.jpg

LM Start	<b>3.61</b>	Rating **	M	Issue No.	<b>904 (cont)</b>
LM End	<b>3.61</b>	Issue Type +	En	Location *	LS
Category	Supplemental			GPS Latitude/Longitude	
				Start	End
Item	DWR UCIP Field Study			39.649522 °	39.649522 °
				-121.787965 °	-121.787965 °
DWR ID					
Action/Comments					
Inspector Comments: FS_ID:46476 DS_ID:1615 EP_NO: N/A FS_HLM: 3.666 Repair Type: Non-Urgent Crossing Status: Found

Concrete distribution box on LS toe.

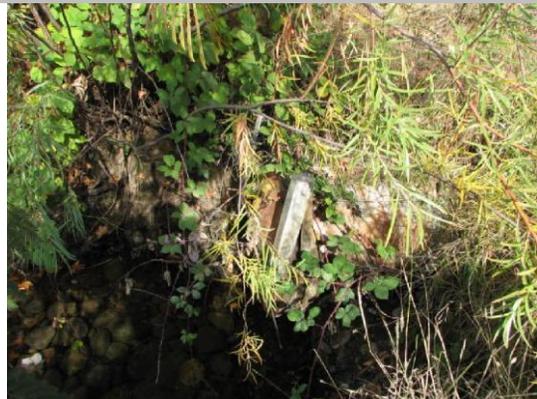
Photo 1 of 3 : UCIP\_FA\_2015\_4855.jpg

LM Start	<b>3.87</b>	Rating **	M	Issue No.	<b>905</b>
LM End	<b>3.87</b>	Issue Type +	En	Location *	LS
Category	Supplemental			GPS Latitude/Longitude	
				Start	End
Item	DWR UCIP Field Study			39.646217 °	39.646217 °
				-121.785431 °	-121.785431 °
DWR ID					
Action/Comments					
Inspector Comments: FS_ID:46477 DS_ID:1616 EP_NO: N/A FS_HLM: 3.936 Repair Type: Non-Urgent Crossing Status: Found UCIP Comments: 8/5/2015 WS pipe end is being overgrown by trees and other vegetation. Needs to be cleared back.5/29/2013 Same as last inspection.11/20/2013 Same as last inspection.6/11/2014 Same as last inspection.12/8/2014 Same as last inspection. FIELD_STRUCT_DESC: 24-inch pipe through the levee, 16.5 feet below the crown. Slide gate in CMP riser on WS slope. Flap gate at WS toe. (USACE 1955) FS Date: 08/06/2015

Flap gate in channel at WS toe.

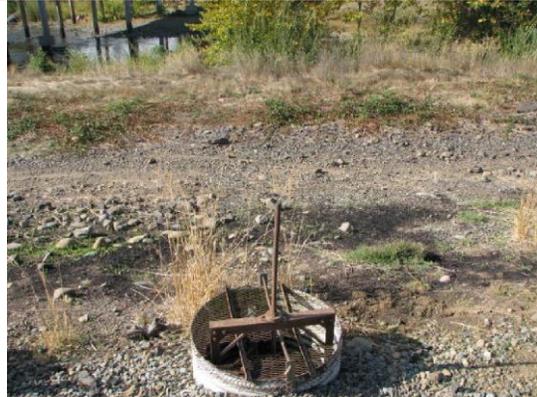
Photo 3 of 3 : UCIP\_FA\_2015\_4857.jpg

**Action/Comments**  
 Inspector Comments: FS\_ID:46477  
 DS\_ID:1616  
 EP\_NO: N/A  
 FS\_HLM: 3.936  
 Repair Type: Non-Urgent  
 Crossing Status: Found  
 UCIP Comments: 8/5/2015 WS pipe end is being overgrown by trees and other vegetation. Needs to be cleared back.5/29/2013 Same as last inspection.11/20/2013 Same as last inspection.6/11/2014 Same as last inspection.12/8/2014 Same as last inspection.  
 FIELD\_STRUCT\_DESC: 24-inch pipe through the levee, 16.5 feet below the crown. Slide gate in CMP riser on WS slope. Flap gate at WS toe. (USACE 1955)  
 FS Date: 08/06/2015

CMP riser and slide gate on WS shoulder.

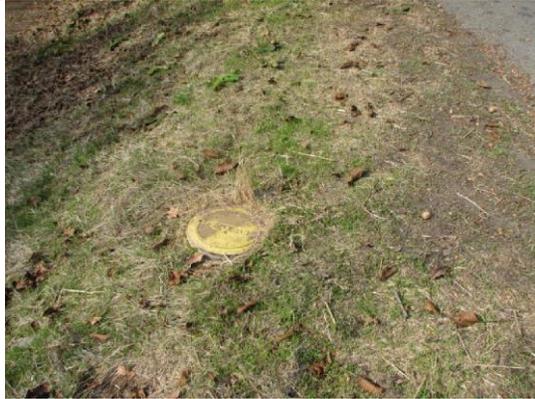
Photo 2 of 2 : UCIP\_FA\_2015\_4859.jpg

PG&E access lid on south edge of roadway.

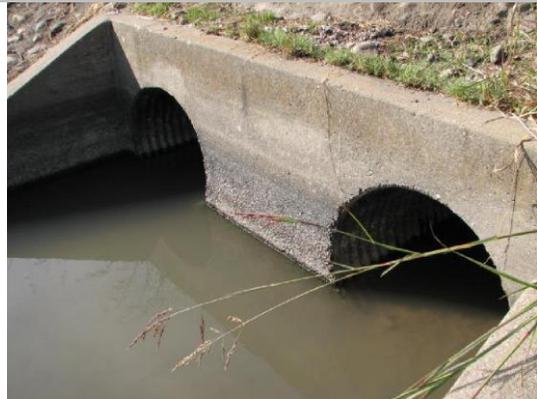
Photo 2 of 2 : UCIP\_FA\_2015\_6546.jpg

Headwall at LS toe.

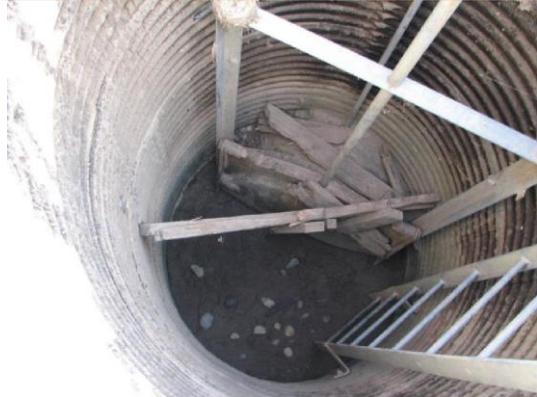
Photo 1 of 3 : UCIP\_FA\_2015\_4860.jpg

LM Start	<b>5.56</b>	Rating **	M	Issue No.	<b>908</b>
LM End	<b>5.56</b>	Issue Type +	En	Location *	LS
Category	Supplemental			GPS Latitude/Longitude	
				Start	End
Item	DWR UCIP Field Study			39.624559 °	39.624559 °
				-121.772141 °	-121.772141 °
DWR ID					
Action/Comments					
Inspector Comments: FS_ID:46481 DS_ID:1768 EP_NO: N/A FS_HLM: 5.65 Repair Type: Non-Urgent Crossing Status: Found

Slide gate at bottom of cmp riser.

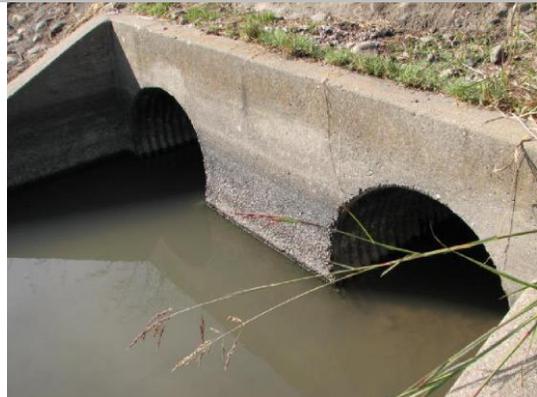
Photo 2 of 3 : UCIP\_FA\_2015\_4861.jpg

Headwall at LS toe.

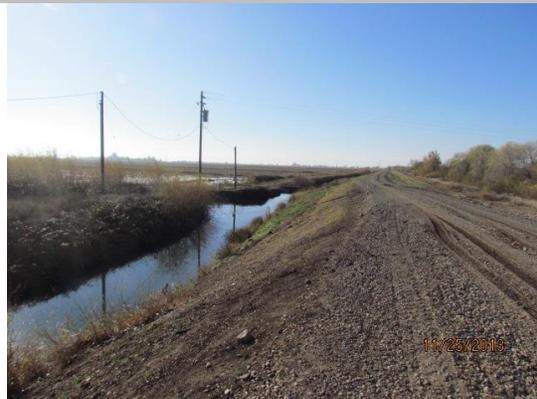
Photo 1 of 1 : FA\_2015\_MA0005\_196\_55\_20150910\_00016.jpg

LM Start	<b>5.69</b>	Rating **	M	Issue No.	<b>55</b>
LM End	<b>6.23</b>	Issue Type +	En	Location *	LS
Category	Earthen Levee			GPS Latitude/Longitude	
				Start	End
Item	Encroachments			39.622766 °	39.615666 °
				-121.773159 °	-121.777353 °
DWR ID	DWR_MA0005_01_s_2015_55				
Action/Comments					
Ditch

View of the irrigation ditch along the landside toe.

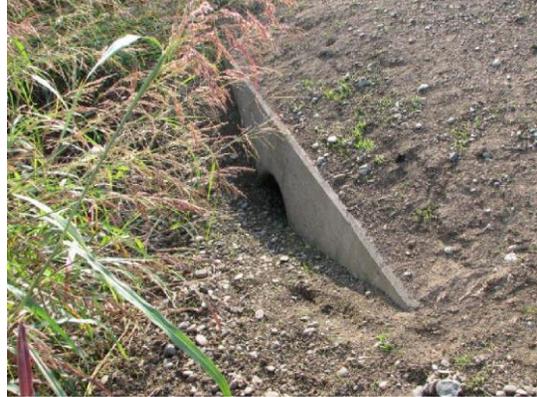
Photo 1 of 2 : UCIP\_FA\_2015\_6563.jpg

LM Start	<b>7.58</b>	Rating **	M	Issue No.	<b>909</b>
LM End	<b>7.58</b>	Issue Type +	En	Location *	LS
Category	Supplemental			GPS Latitude/Longitude	
				Start	End
Item	DWR UCIP Field Study			39.597725 °	39.597725 °
				-121.787257 °	-121.787257 °
DWR ID					
Action/Comments					
Inspector Comments: FS_ID:46503 DS_ID:1628 EP_NO: N/A FS_HLM: 7.7 Repair Type: Non-Urgent Crossing Status: Found UCIP Comments: 8/4/2015 LS pipe end filled about 50% with soil and WS pipe end is buried. Pipe filled with soil and outlet/appurtances are burried. 5/29/2013 Same as last inspection. 11/19/2013 Same as last inspection. 6/11/2014 Same as last inspection. 12/8/2014 Same as last inspection. FIELD_STRUCT_DESC: 24-inch pipe through levee, 8.5 feet below crown. Flap gate on the waterward end. Concrete "U" shaped headwall on LS toe. (USCE 1952) FS Date: 08/25/2015

Headwall at LS toe.

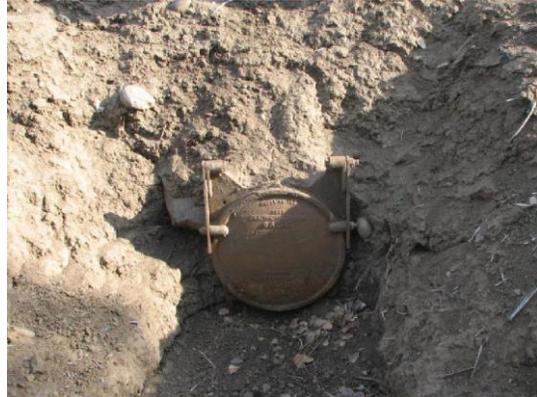
Photo 1 of 3 : UCIP\_FA\_2015\_6565.jpg

Flap gate at WS toe.

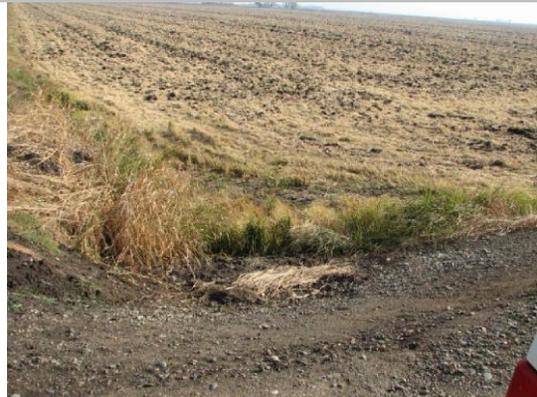
Photo 2 of 3 : UCIP\_FA\_2015\_6566.jpg

Buried inlet at LS toe.

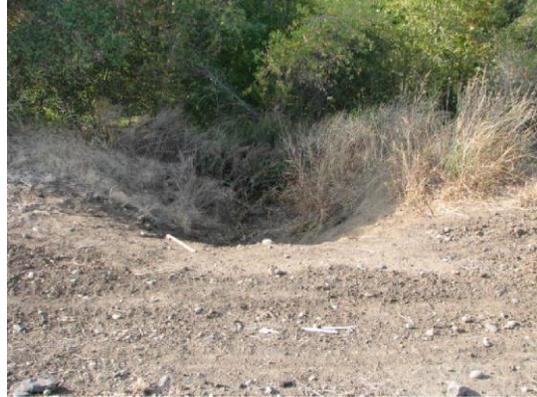
Photo 3 of 3 : UCIP\_FA\_2015\_6567.jpg

Outlet at WS toe.

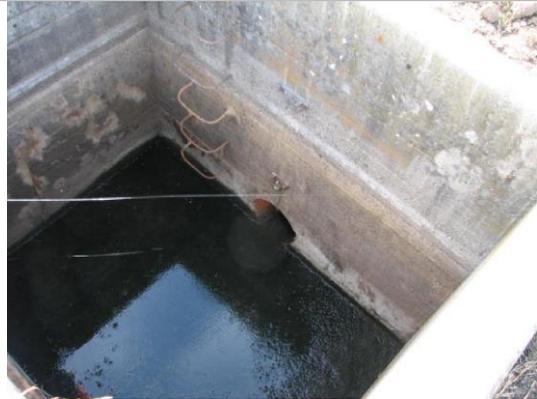
Photo 1 of 3 : UCIP\_FA\_2015\_6568.jpg

Item	DWR UCIP Field Study			39.579908 °	39.579908 °
				-121.802790 °	-121.802790 °
DWR ID					
Action/Comments					
Inspector Comments: FS_ID:46507 DS_ID:1631 EP_NO: N/A FS_HLM: 9.209 Repair Type: Non-Urgent Crossing Status: Found UCIP Comments: 8/4/2015 Abandoned pipe. Casey Wilder has started the steps to have the pipe properly abandoned and removed from the levee. Need to confirm proper abandonment of pipe. Pipe should be plugged on LS.5/29/2013 Same as last inspection. 11/19/2013 Same as last inspection. 6/11/2014 Same as last inspection. 12/8/2014 Same as last inspection. FIELD_STRUCT_DESC: 16-inch steel pipe through the levee, 11.5 feet below the crown. Distribution box at the landward toe. (USACE 1955) FS Date: 08/25/2015

Pipe at bottom of concrete distribution box.

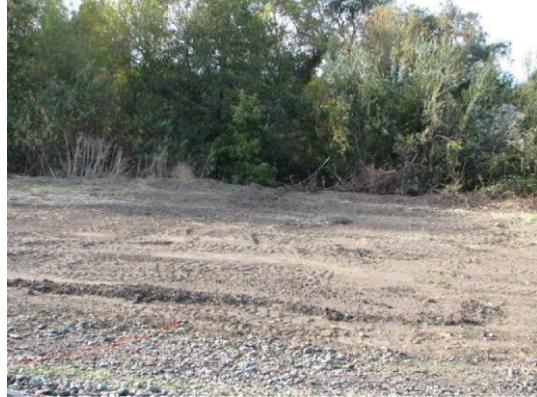
Photo 2 of 3 : UCIP\_FA\_2015\_6569.jpg

WS shoulder.

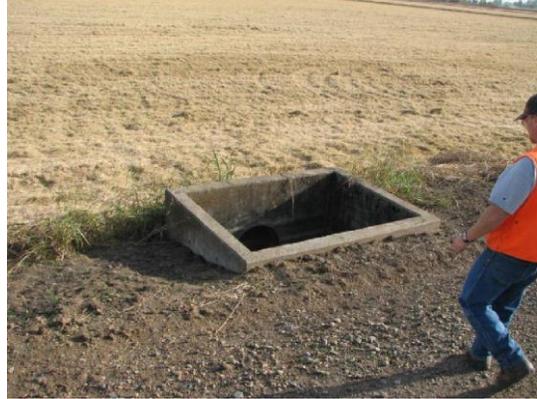
Photo 3 of 3 : UCIP\_FA\_2015\_6570.jpg

Concrete distribution box at LS toe.

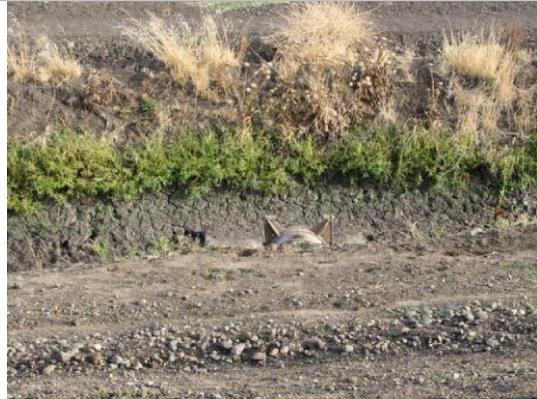
Photo 1 of 1 : UCIP\_FA\_2015\_6694.jpg

Item	DWR UCIP Field Study		39.570596 °	39.570596 °	
			-121.815215 °	-121.815215 °	
DWR ID					
Action/Comments					
Inspector Comments: FS_ID:46512 DS_ID:1633 EP_NO: N/A FS_HLM: 10.187 Repair Type: Non-Urgent Crossing Status: Found UCIP Comments: 8/4/2015 Abandoned pipe. Casey Wilder has started the steps to have the pipe properly abandoned and removed from the levee. Pipe and headwall buried on WS, no access to slide gate. 5/29/2013 Same as last inspection. 11/19/2013 Same as last inspection. 6/11/2014 Same as last inspection. 12/8/2014 Same as last inspection. FIELD_STRUCT_DESC: 24-inch corrugated metal pipe through the levee, 12.5 feet below the crown. Slide gate on the waterward end. Flap gate and headwall on the landward end. Concrete headwall at the waterward toe. (USCE 1952) FS Date: 08/25/2015

Flap gate and headwall at LS toe in irrigation or drainage ditch.

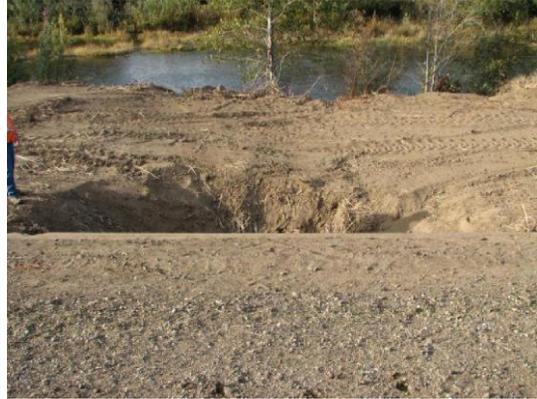
Photo 2 of 3 : UCIP\_FA\_2015\_6696.jpg

Inspector Comments: FS\_ID:46513  
 DS\_ID:1634  
 EP\_NO: N/A  
 FS\_HLM: 10.405  
 Repair Type: Non-Urgent  
 Crossing Status: Found  
 UCIP Comments: 8/4/2015 Abandoned pipe. Casey Wilder has started the steps to have the pipe properly abandoned and removed from the levee.5/29/2013 Same as last inspection.11/19/2013 Same as last inspection.6/11/2014 Same as last inspection.12/8/2014 Same as last inspection.  
 FIELD\_STRUCT\_DESC: 24-inch corrugated metal pipe through the levee, 14.5 feet below the crown. Slide gate on the waterward end on concrete headwall. Flap gate on the landward side. (USCE 1952)  
 FS Date: 08/25/2015

headwall at WS toe.

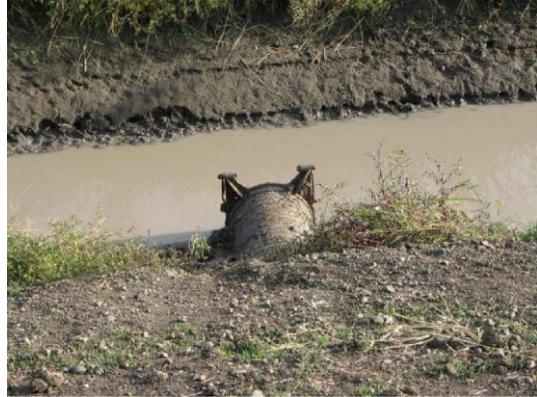
Photo 3 of 3 : UCIP\_FA\_2015\_6697.jpg

Pipe and flap gate on LS toe.

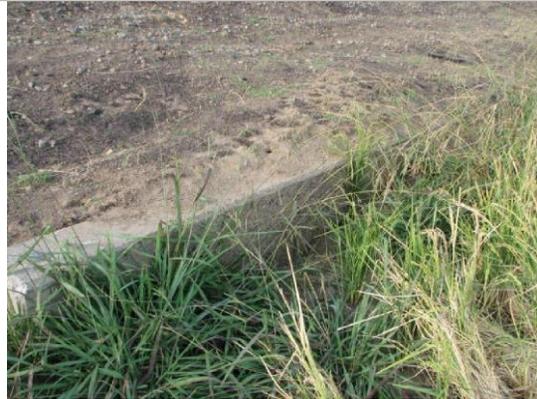
Photo 1 of 2 : UCIP\_FA\_2015\_6698.jpg

LM Start	<b>10.84</b>	Rating **	M	Issue No.	<b>914</b>
LM End	<b>10.84</b>	Issue Type +	En	Location *	LS
Category	Supplemental			GPS Latitude/Longitude	
				Start	End
Item	DWR UCIP Field Study			39.562559 °	39.562559 °
				-121.825808 °	-121.825808 °
DWR ID					
Action/Comments					
Inspector Comments: FS_ID:46514 DS_ID:1635 EP_NO: N/A FS_HLM: 10.987 Repair Type: Non-Urgent Crossing Status: Found UCIP Comments: 8/4/2015 Abandoned pipe. Casey Wilder has started the steps to have the pipe properly abandoned and removed from the levee. Pipe buried on both sides of levee. 5/29/2013 Same as last inspection. 11/19/2013 Same as last inspection. 6/11/2014 Same as last inspection. 12/8/2014 Same as last inspection. FIELD_STRUCT_DESC: 30-inch corrugated metal drainpipe through the levee, 12.2 feet below the crown. Flap gate on the waterward end. (USCE 1952) FS Date: 08/25/2015

Concrete headwall at LS toe.

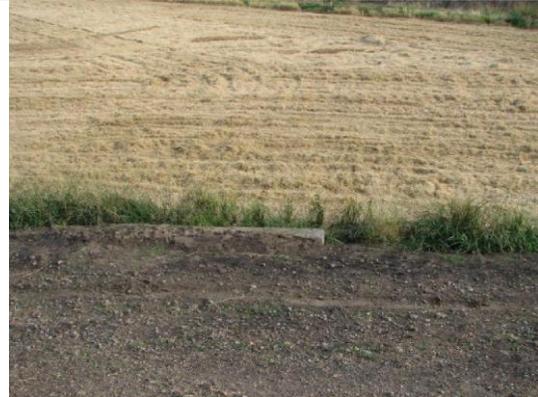
Photo 2 of 2 : UCIP\_FA\_2015\_6699.jpg

Concrete headwall at LS toe.

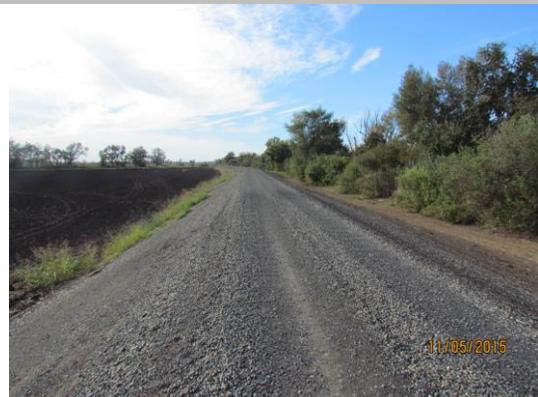
Photo 1 of 1 : FA\_2015\_MA0005\_196\_39\_20151109\_00021.jpg

LM Start	<b>11.11</b>	Rating **	A	Issue No.	<b>39</b>
LM End	<b>11.11</b>	Issue Type +	Ma	Location *	LS
Category	Earthen Levee			GPS Latitude/Longitude	
				Start	End
Item	Vegetation			39.559528 °	39.559528 °
				-121.828982 °	-121.828982 °
DWR ID	DWR_MA0005_01_f_2015_39				
Action/Comments					
Control annual grass and weeds on the levee slopes and easements. Inspector Comments: Sutter Yard burned and dragged both slopes.

View of no vegetation on both slopes.

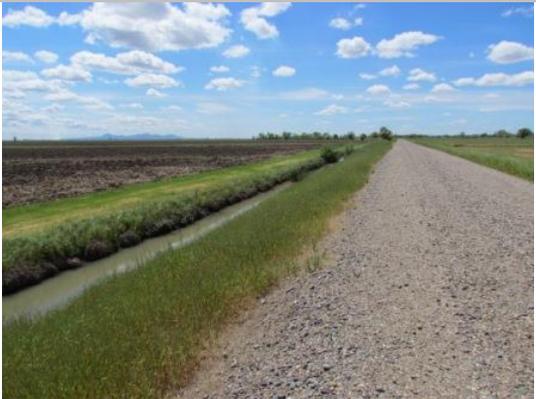
Photo 1 of 1 : FA\_2015\_MA0005\_196\_6\_20150910\_00004.jpg

View of the agricultural ditch along the L/S toe.

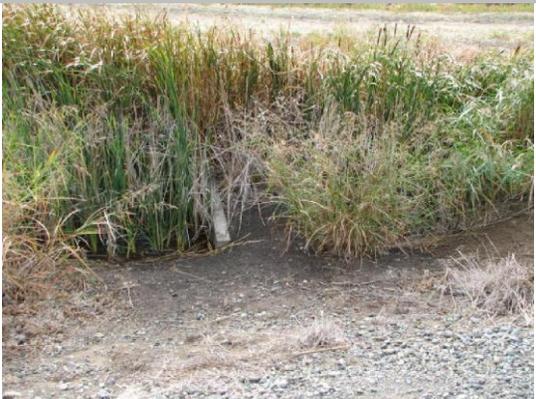
Photo 1 of 1 : UCIP\_FA\_2015\_6403.jpg

Buried pipe at concrete box, LS toe.

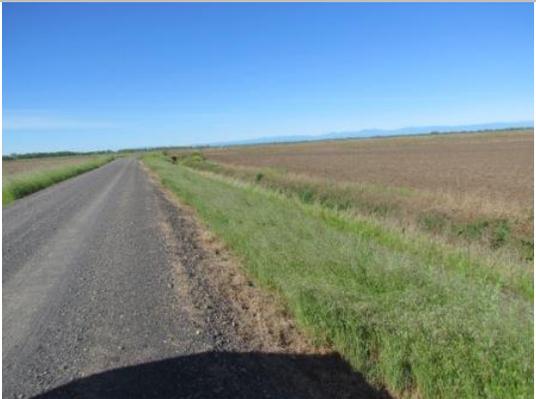
Photo 1 of 1 : FA\_2015\_MA0005\_197\_1\_20150910\_00001.jpg

View of the agricultural ditch along the landside toe.

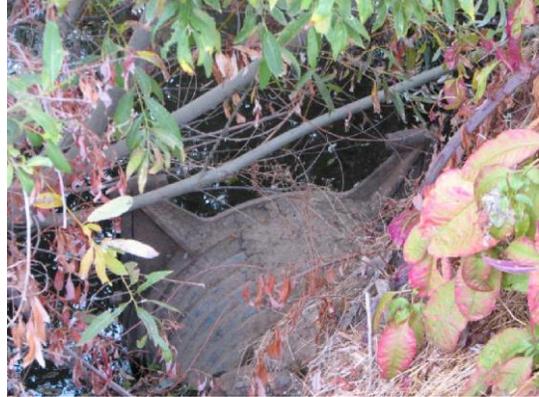
Photo 1 of 3 : UCIP\_FA\_2015\_6481.jpg

Flap gate on WS slope.

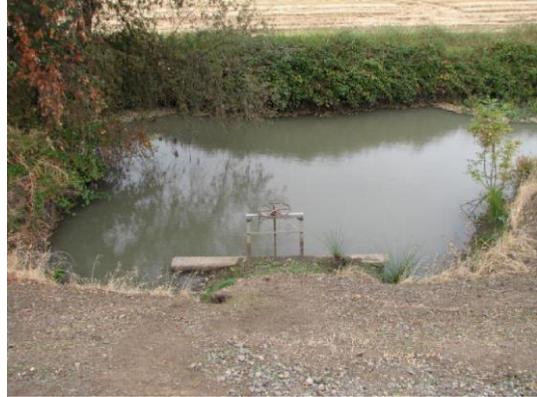
Photo 3 of 3 : UCIP\_FA\_2015\_6483.jpg

Concrete headwall and slide gate on LS toe.

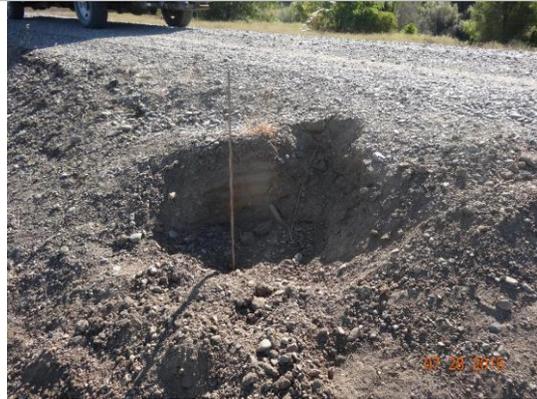
Photo 1 of 3 : UCIP\_FA\_2015\_6038.jpg

Spot where CMP riser was on the LS shoulder.

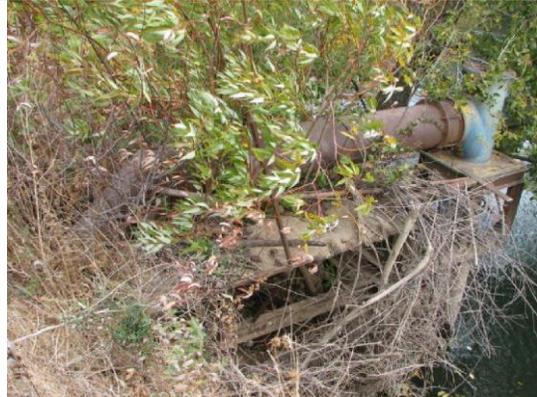
Photo 2 of 3 : UCIP\_FA\_2015\_6193.jpg

Pump on metal pier at WS toe.

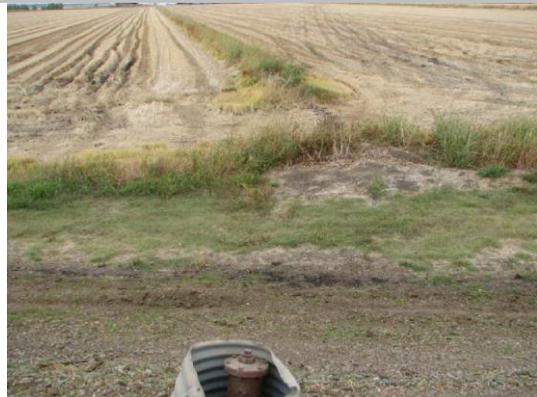
Photo 3 of 3 : UCIP\_FA\_2015\_6194.jpg

Air vent in 24-inch CMP riser on LS shoulder.

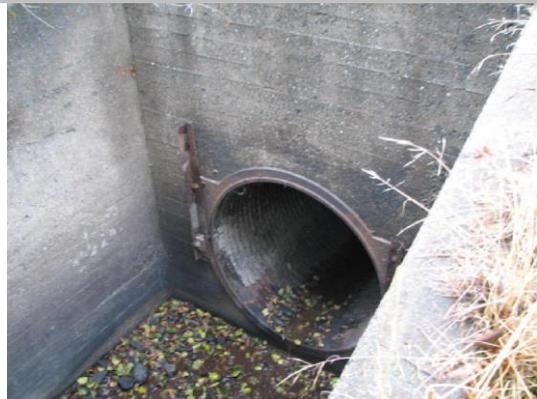
Photo 1 of 3 : UCIP\_FA\_2015\_6404.jpg

60-inch cmp open on WS.

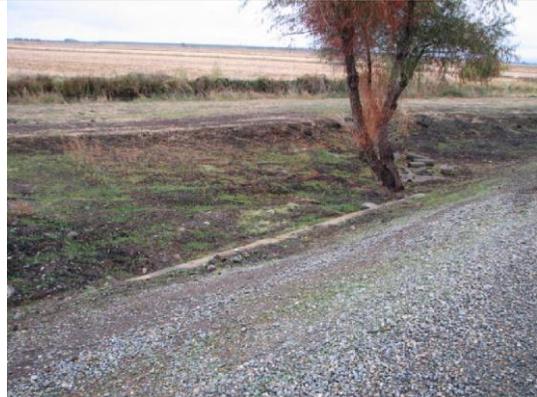
Photo 3 of 3 : UCIP\_FA\_2015\_6406.jpg

Concrete headwall on LS shoulder

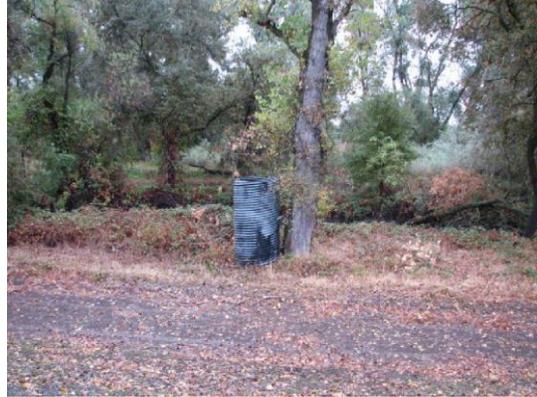
Photo 1 of 2 : UCIP\_FA\_2015\_6443.jpg

56-inch CMP riser on WS berm.

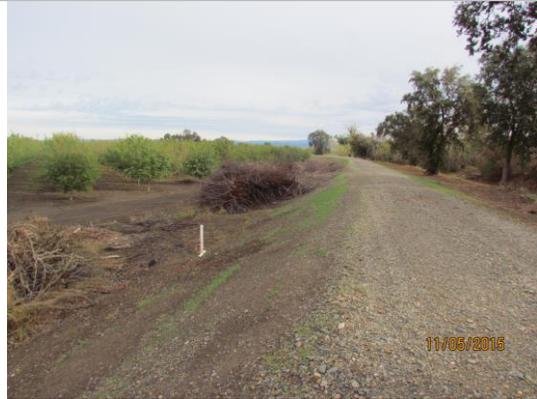
Photo 1 of 1 : FA\_2015\_MA0005\_197\_35\_20151109\_00020.jpg

View of the prunings along the landside slope.

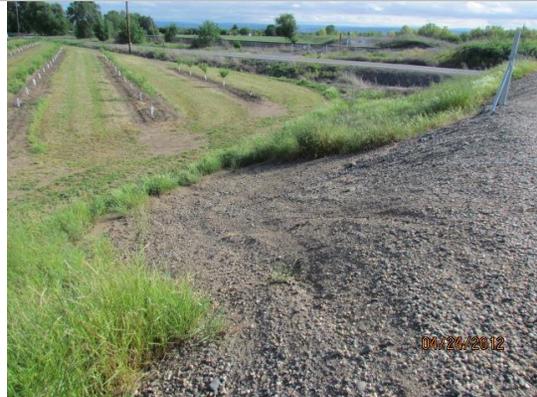
Photo 1 of 2 : FA\_2015\_MA0005\_197\_13\_20150910\_00005.jpg

View of the vehicle erosion along the slope.

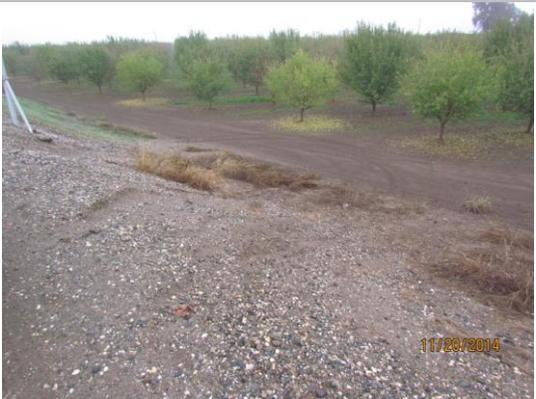
Photo 2 of 2 : FA\_2015\_MA0005\_197\_13\_20150910\_00006.jpg

View of the vehicle erosion along the landside slope.

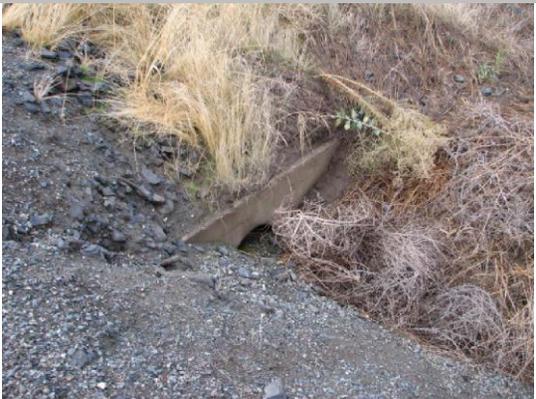
Photo 1 of 2 : UCIP\_FA\_2015\_6550.jpg

Concrete headwall on LS toe.

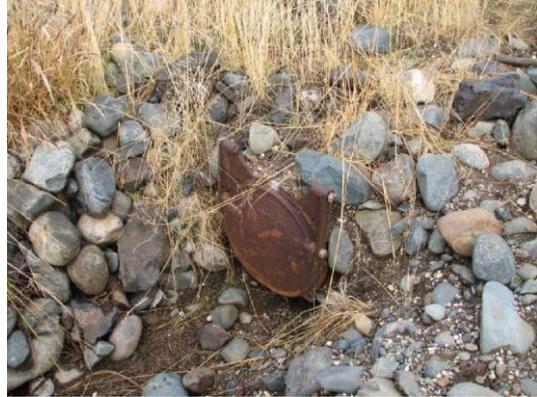
Photo 2 of 2 : UCIP\_FA\_2015\_6551.jpg

Flap gate at WS toe.

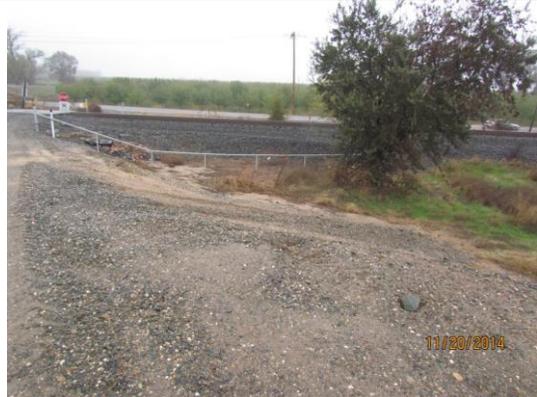
Photo 1 of 1 : FA\_2015\_MA0005\_197\_40\_20150910\_00016.jpg

View of the vehicle slope instability along the landside slope.

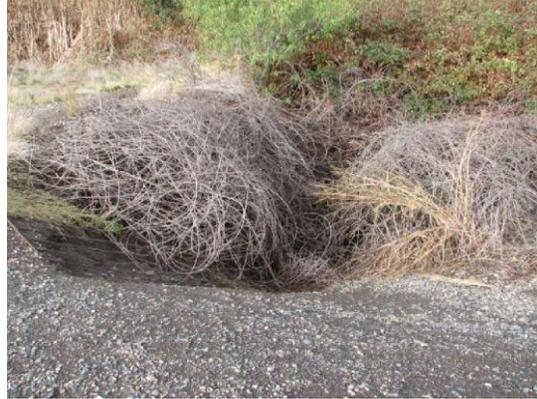
Photo 2 of 3 : UCIP\_FA\_2015\_4793.jpg

Brambles and soil over pipe at inlet.

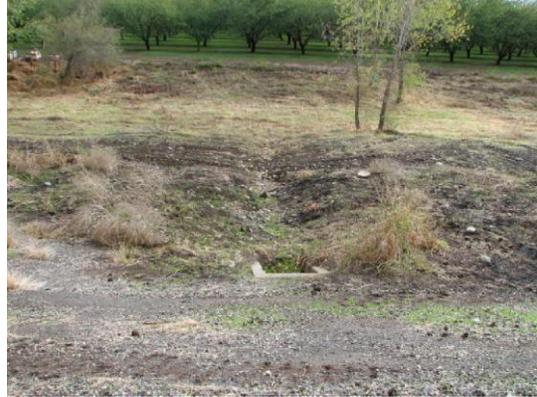
Photo 3 of 3 : UCIP\_FA\_2015\_4794.jpg

WS outlet and concrete U shaped headwall.

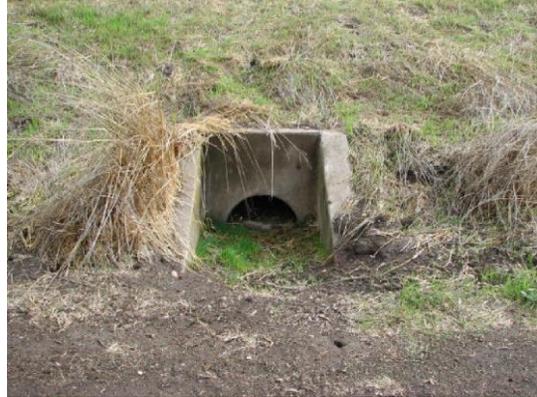
Photo 1 of 3 : UCIP\_FA\_2015\_4795.jpg

Concrete U-shaped headwall on LS toe.

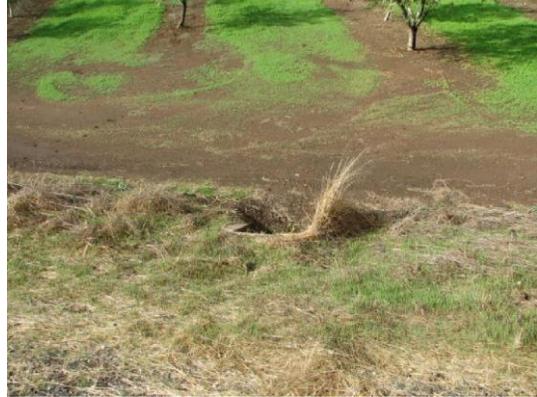
Photo 2 of 3 : UCIP\_FA\_2015\_4796.jpg

View of inlet on LS toe.

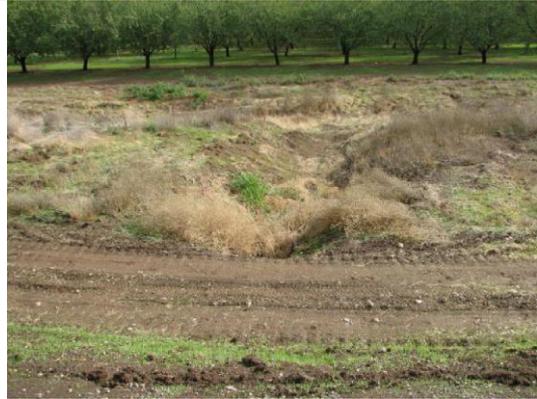
Photo 3 of 3 : UCIP\_FA\_2015\_4797.jpg

View of outlet looking toward WS toe.

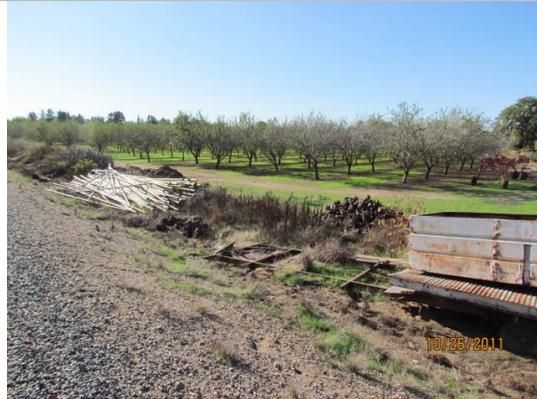
Photo 1 of 1 : FA\_2015\_MA0005\_197\_14\_20150910\_00007.jpg

View of the equipment along the Landside toe.

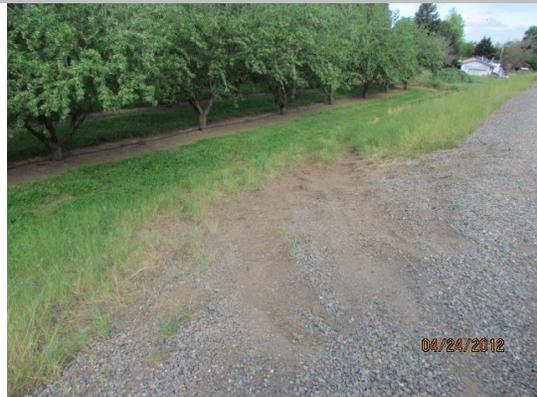
Photo 1 of 1 : FA\_2015\_MA0005\_197\_18\_20150910\_00008.jpg

View of the vehicle erosion along the slope of the levee.

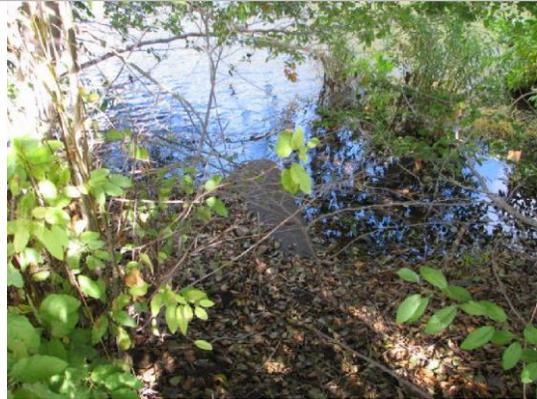
Photo 1 of 3 : UCIP\_FA\_2015\_4893.jpg

Concrete pipe at edge of creek on WS.

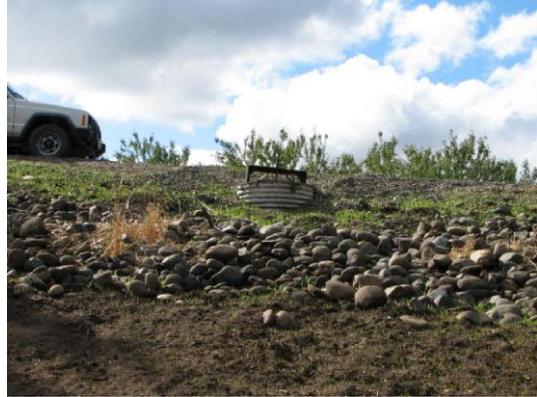
Photo 2 of 3 : UCIP\_FA\_2015\_4894.jpg

CM riser with slide gate on WS shoulder.

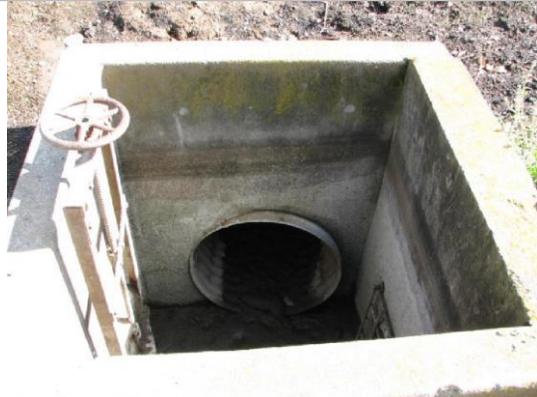
Photo 1 of 3 : UCIP\_FA\_2015\_4896.jpg

Pipe at inlet to 5X5 concrete distribution box at LS toe.

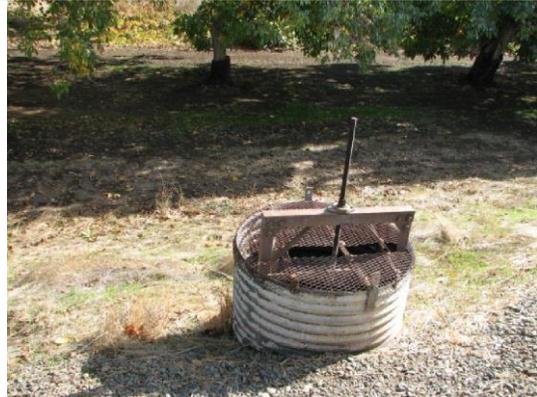
Photo 2 of 3 : UCIP\_FA\_2015\_4897.jpg

42-inch CMP riser on WS shoulder with slide gate.

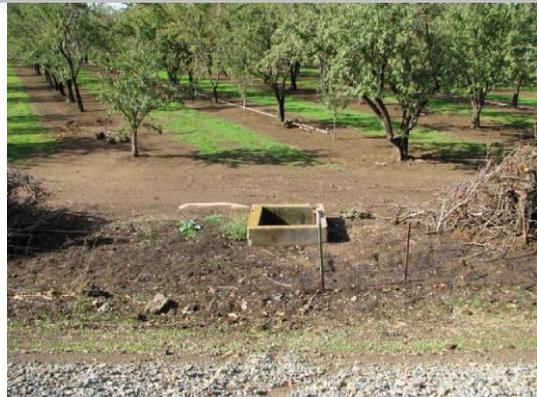
Photo 3 of 3 : UCIP\_FA\_2015\_4898.jpg

5X5 concrete distribution box at LS toe.

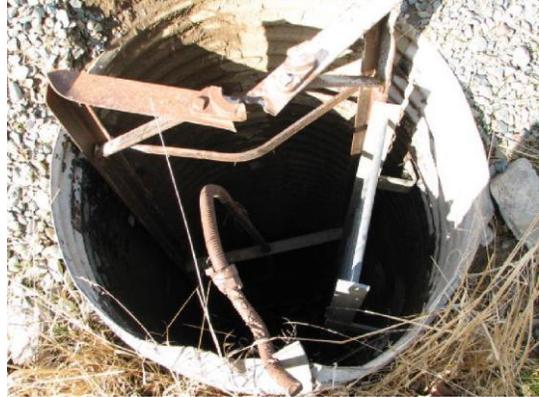
Photo 1 of 3 : UCIP\_FA\_2015\_4899.jpg

Broken slide gate in CM riser on WS slope.

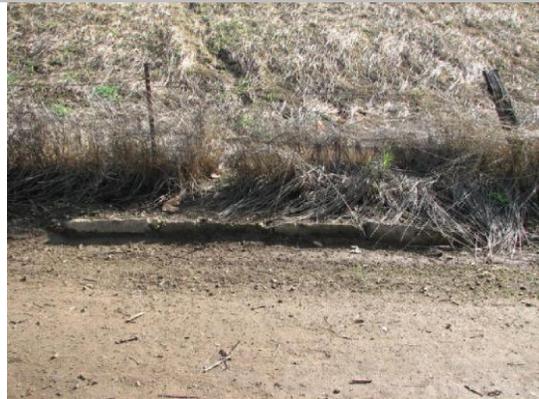
Photo 2 of 3 : UCIP\_FA\_2015\_4900.jpg

Abandoned headwall on LS toe.

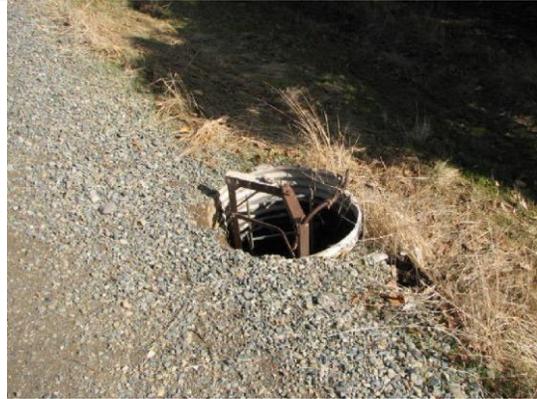
Photo 3 of 3 : UCIP\_FA\_2015\_6479.jpg

Broken slide gate in CM riser on WS slope.

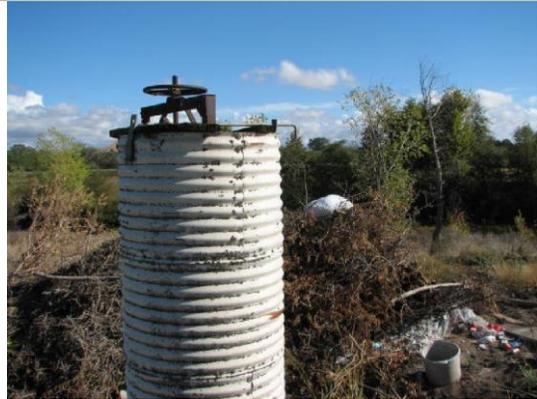
Photo 1 of 1 : UCIP\_FA\_2015\_6480.jpg

Slide gate in CM riser on WS toe.

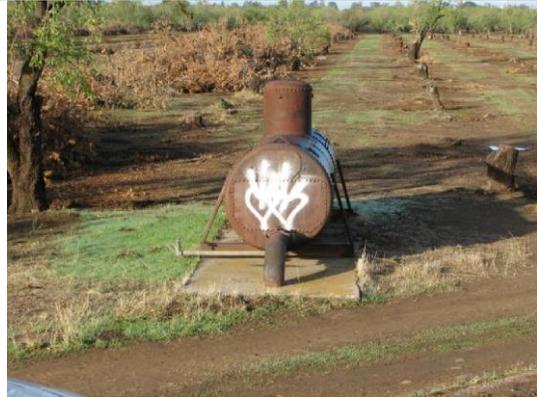
Photo 1 of 1 : UCIP\_FA\_2015\_6484.jpg

Pipe attached at boiler on LS toe.

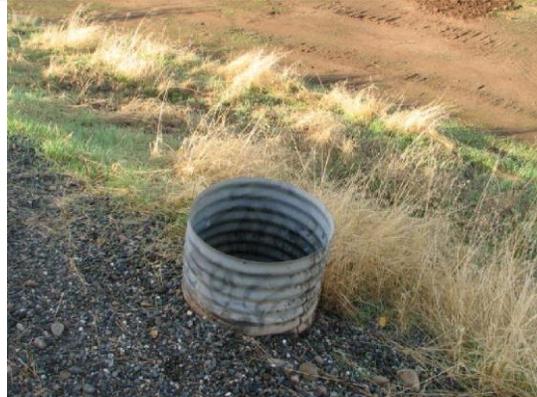
Photo 1 of 1 : UCIP\_FA\_2015\_6485.jpg

CM riser with siphon breaker on LS shoulder.

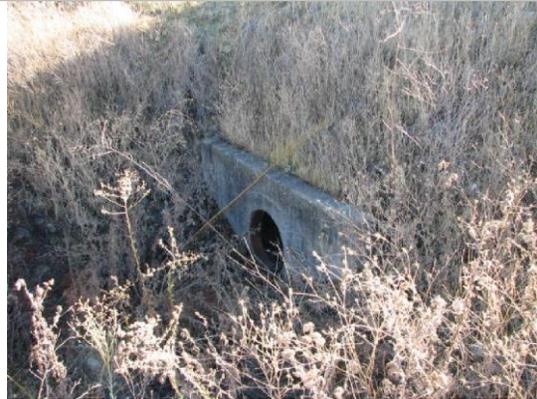
Photo 1 of 3 : UCIP\_FA\_2015\_3776.jpg

Concrete headwall on LS toe.

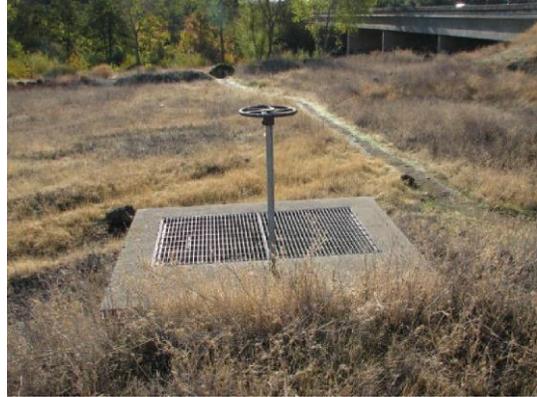
Photo 2 of 3 : UCIP\_FA\_2015\_3777.jpg

Concrete box and gate on WS shoulder.

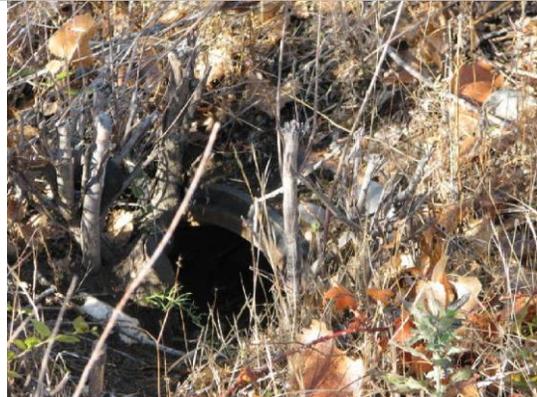
Photo 3 of 3 : UCIP\_FA\_2015\_6486.jpg

pipe at outlet with vegetation and soil blocking outlet.

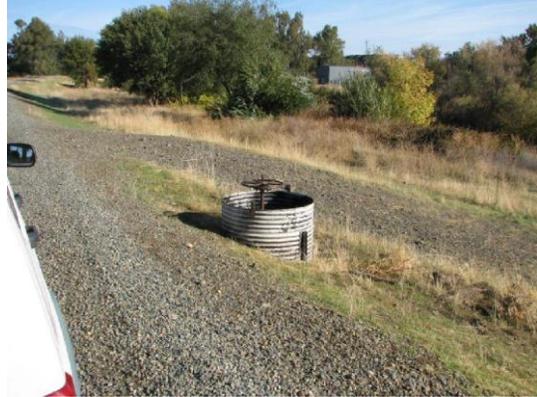
Photo 1 of 2 : UCIP\_FA\_2015\_3778.jpg

CMP riser on WS shoulder with slide gate.

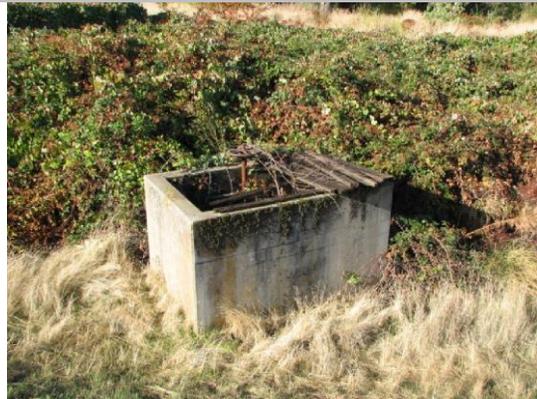
Photo 2 of 2 : UCIP\_FA\_2015\_3779.jpg

Concrete distribution box with slide gate on LS toe.

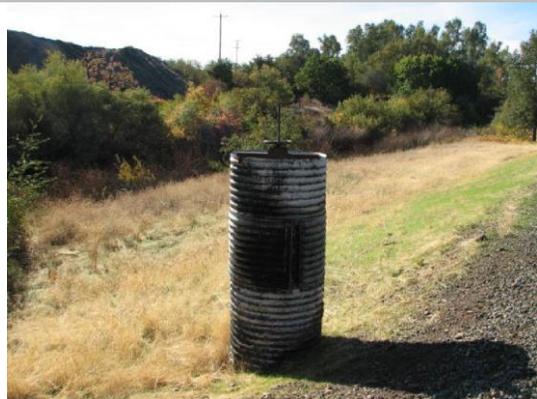
Photo 2 of 2 : UCIP\_FA\_2015\_3781.jpg

CMP riser on WS slope with slide gate.

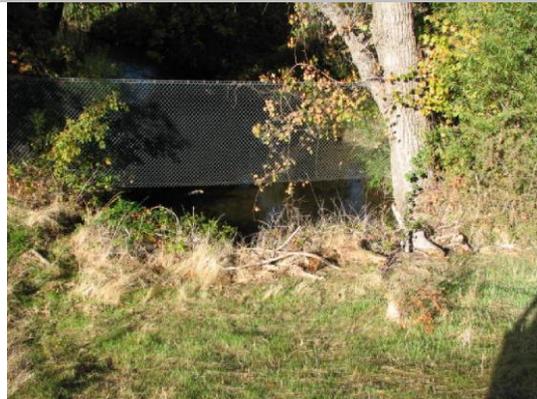
Photo 2 of 3 : UCIP\_FA\_2015\_3783.jpg

Irrigation ditch at LS toe.

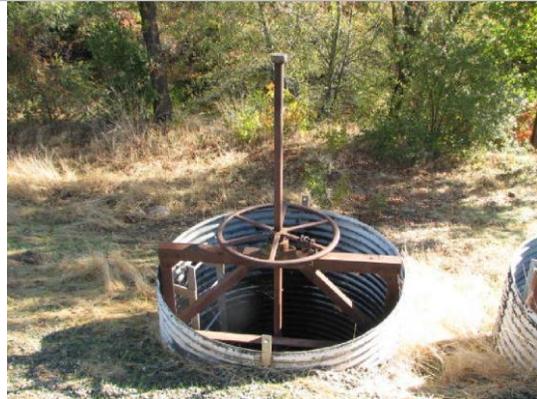
Photo 1 of 3 : UCIP\_FA\_2015\_3785.jpg

66-inch CMP riser on WS shoulder.

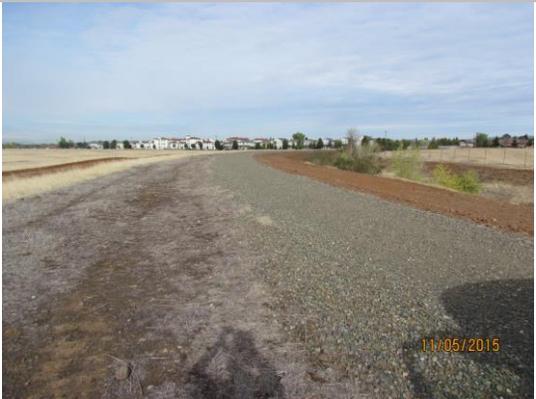
Photo 1 of 1 : FA\_2015\_MA0005\_198\_1\_20151109\_00001.jpg

View of no vegetation on both slopes.
