**Flood Control Project Maintenance
Levee Inspections
LMA District Cover Sheet
Spring 2010 Levee Inspection Results**

Spring 2010 Levee Inspection Results

Sutter Maintenance Yard Maintenance Area 0005

Waterway				Bank	Unit Miles
Unit No. 01 Butte Creek 1				Left	15.29

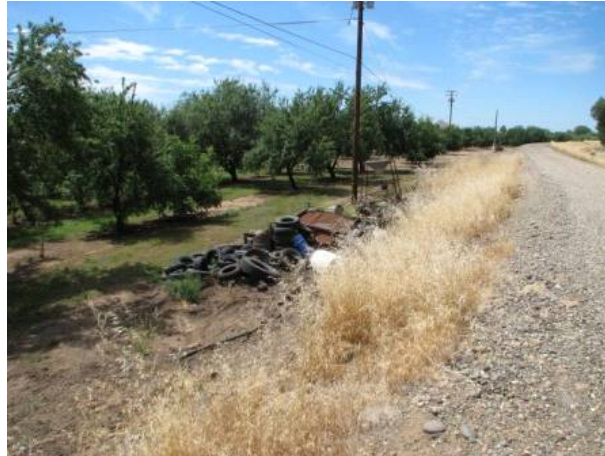
Levee Mile Report Line	2
Start Levee Mile	1.56
End Levee Mile	1.56
Location	Land Side
Category	Earthen Levee
Item	Encroachments

View of the garbage along landside toe of the levee.

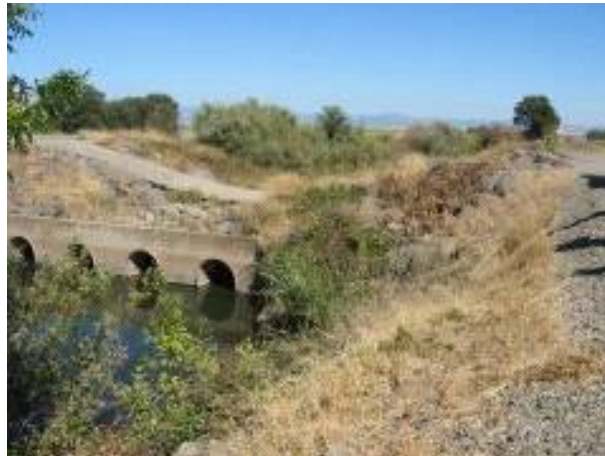
Levee Mile Report Line	14
Start Levee Mile	9.66
End Levee Mile	9.69
Location	Water Side
Category	Supplemental
Item	USACE Erosion Survey

13	3.48	3.48	Earthen Levee	Encroachments	LS	M	Prunings	39.652020 ° -121.789337 °	39.652020 ° -121.789337 °	905
14	9.66	9.69	Supplemental	USACE Erosion Survey	WS	U	Inspector Comments: 2009: no berm, vertical slope, no stability issues, sands and silts, 3.5 ft/s plus eddy currents [2009 SiteID:BTC_9-6_L]	39.574908 ° -121.807800 °	39.574875 ° -121.808108 °	7 Y

2009: no berm, vertical slope, no stability issues, sands and silts, 3.5 ft/s plus eddy currents [2009 SiteID:BTC_9-6_L]

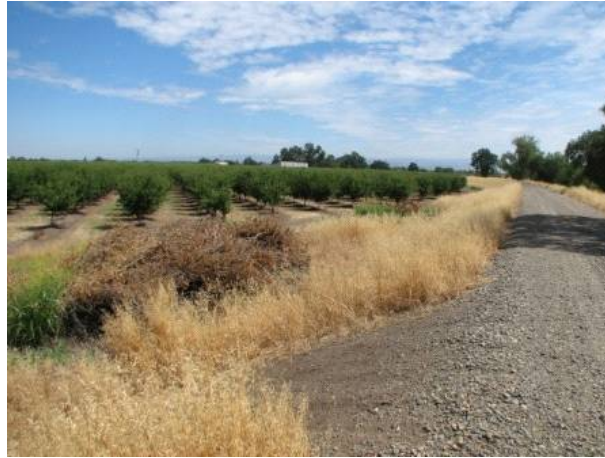
Levee Mile Report Line	2
Start Levee Mile	7.86
End Levee Mile	7.86
Location	Land Side
Category	Earthen Levee
Item	Encroachments

View of the debris and garbage along the landside toe of the levee.

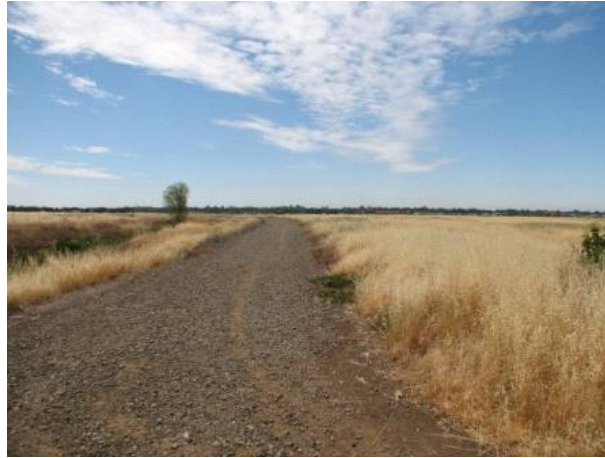
Levee Mile Report Line	1
Start Levee Mile	0.50
End Levee Mile	0.50
Location	Land Side
Category	Earthen Levee
Item	Vegetation

View of the native grasses along both slopes of the levee.

LMR No	Levee Mile		Category	Item	Location *	Rating **	Action/Comment	GPS Latitude/Longitude		Issue No.
	Start	End						Start	End	Photo
1	0.50	0.50	Earthen Levee	Vegetation	LS	A	Control annual grass and weeds on the levee slopes and easements.	39.726170 ° -121.781557 °	39.726170 ° -121.781557 °	3 Y
